Inspection Photos
Location Name: Horsetail #19N-1924M-R
API: 05-123-40630

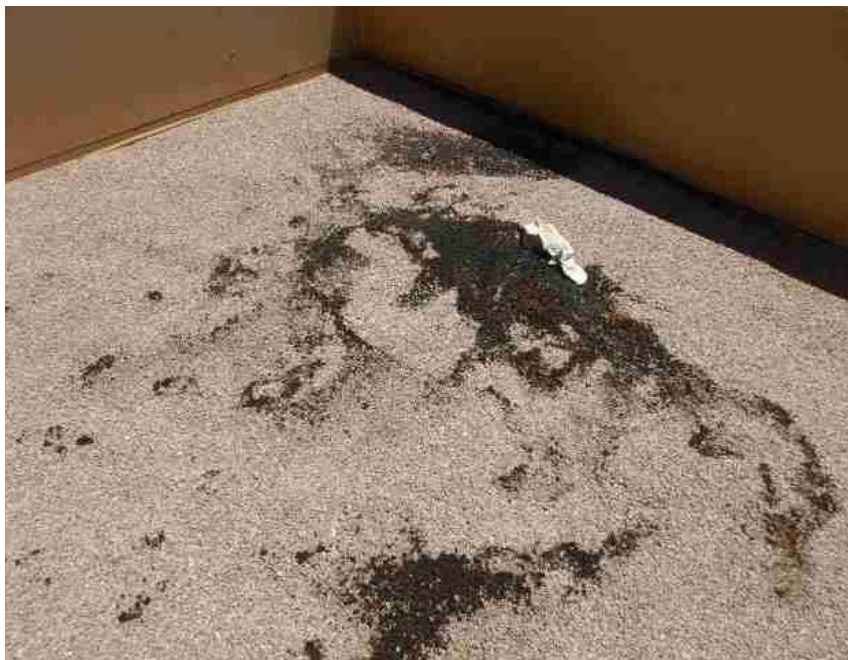
Photo from prior inspection for comparison purposes

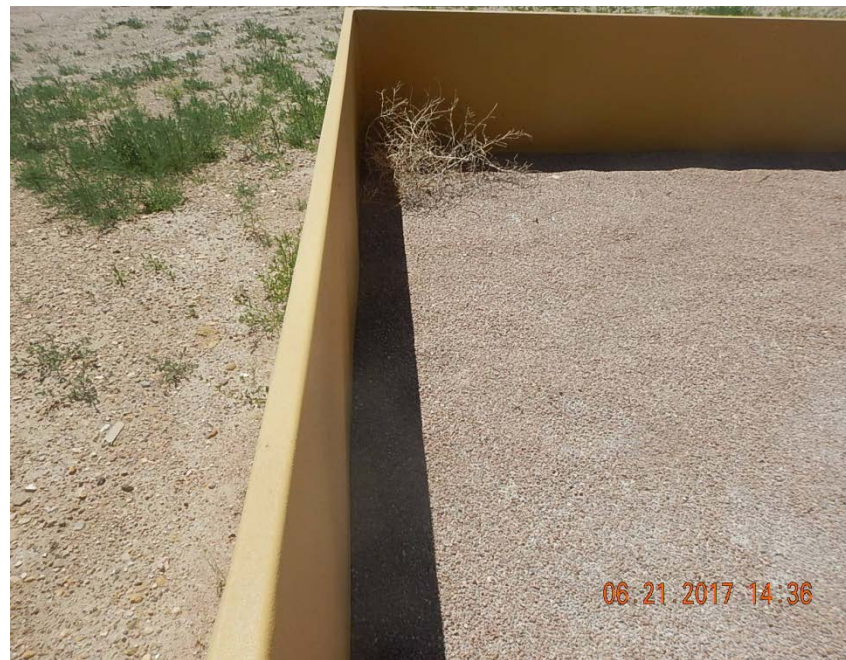
Photo 3: Stained soil remediated or removed

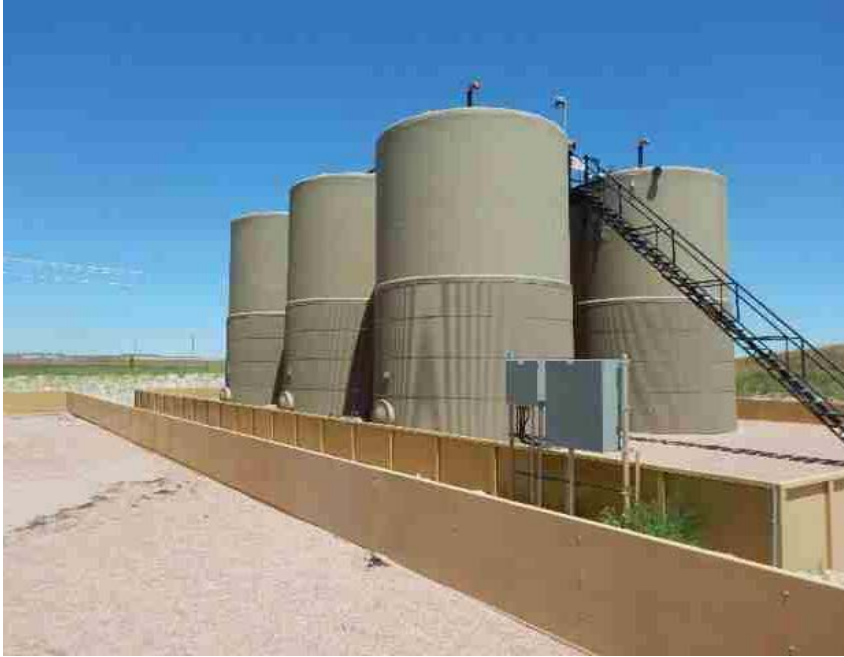
Photo from prior inspection for comparison purposes

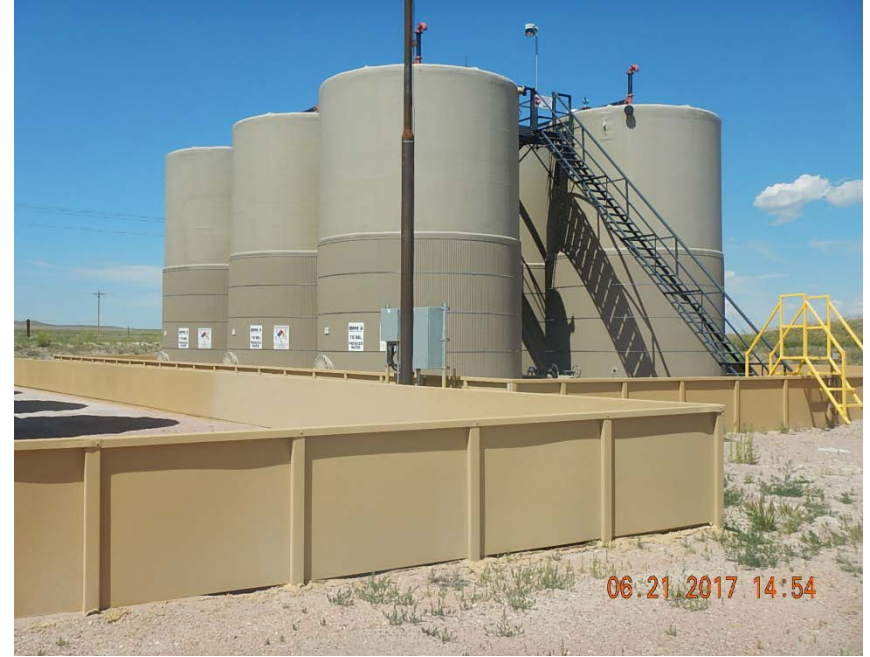
Photo 4: Tanks labeled
