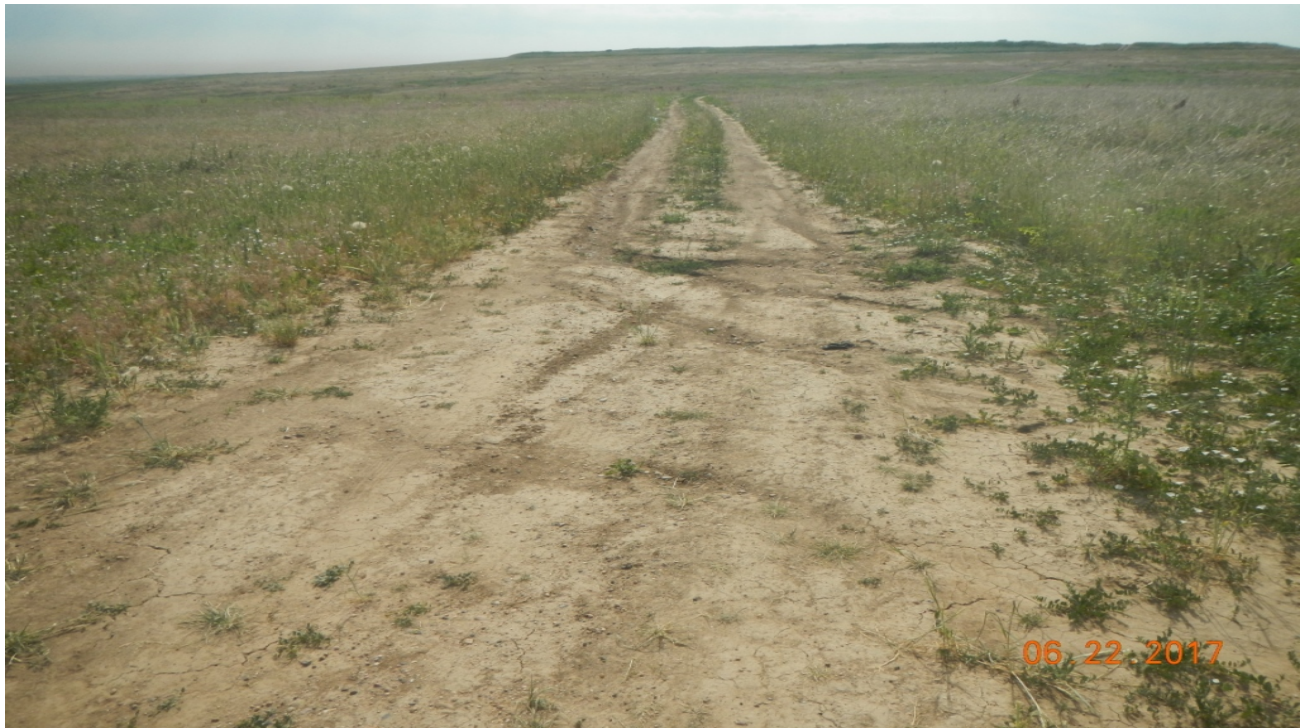
**photo 1:** Facing east toward the access road.

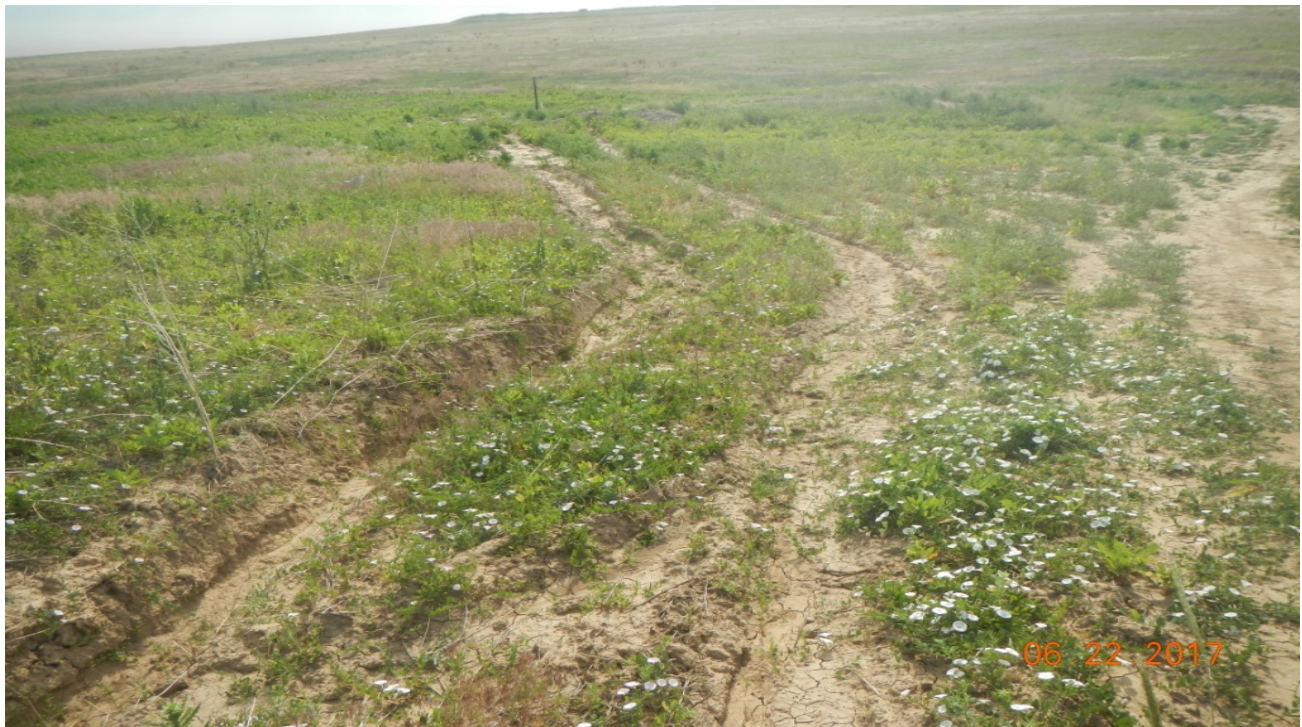
**photo 2:** Facing east toward the location.

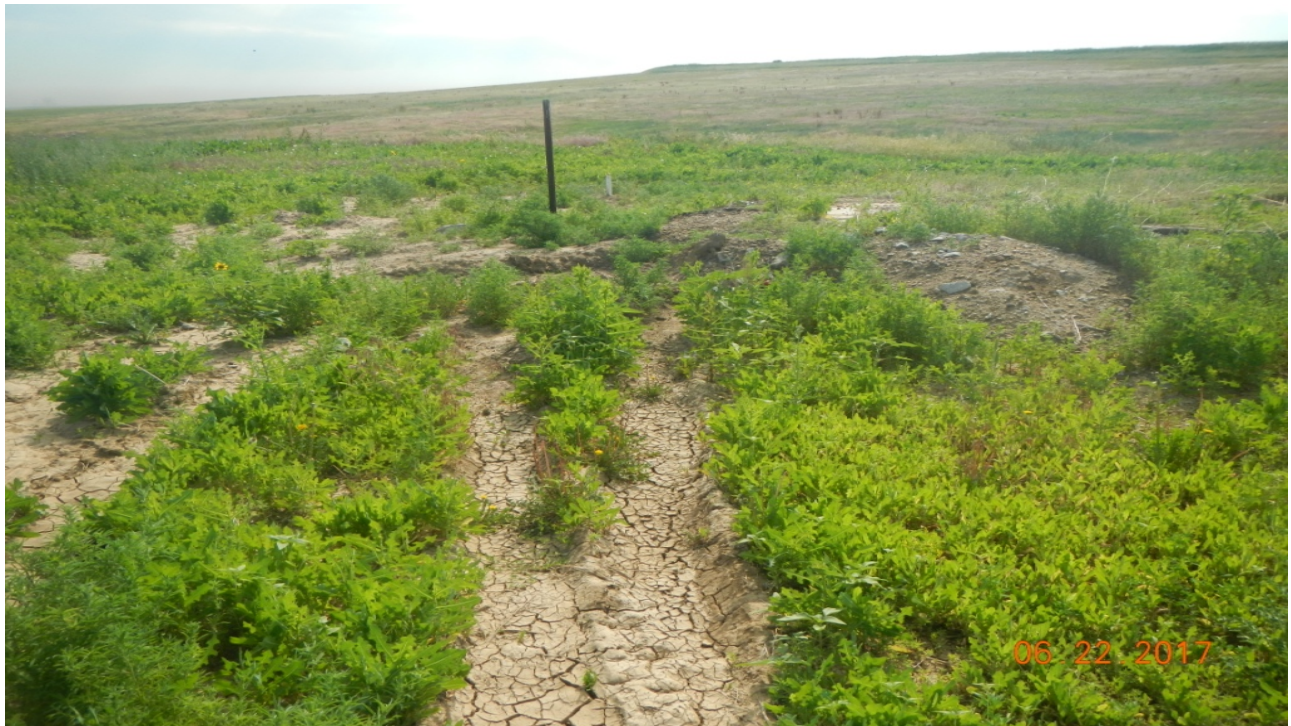
**photo 3:** Facing east at the location. There is a metal pipe at the center of the location.

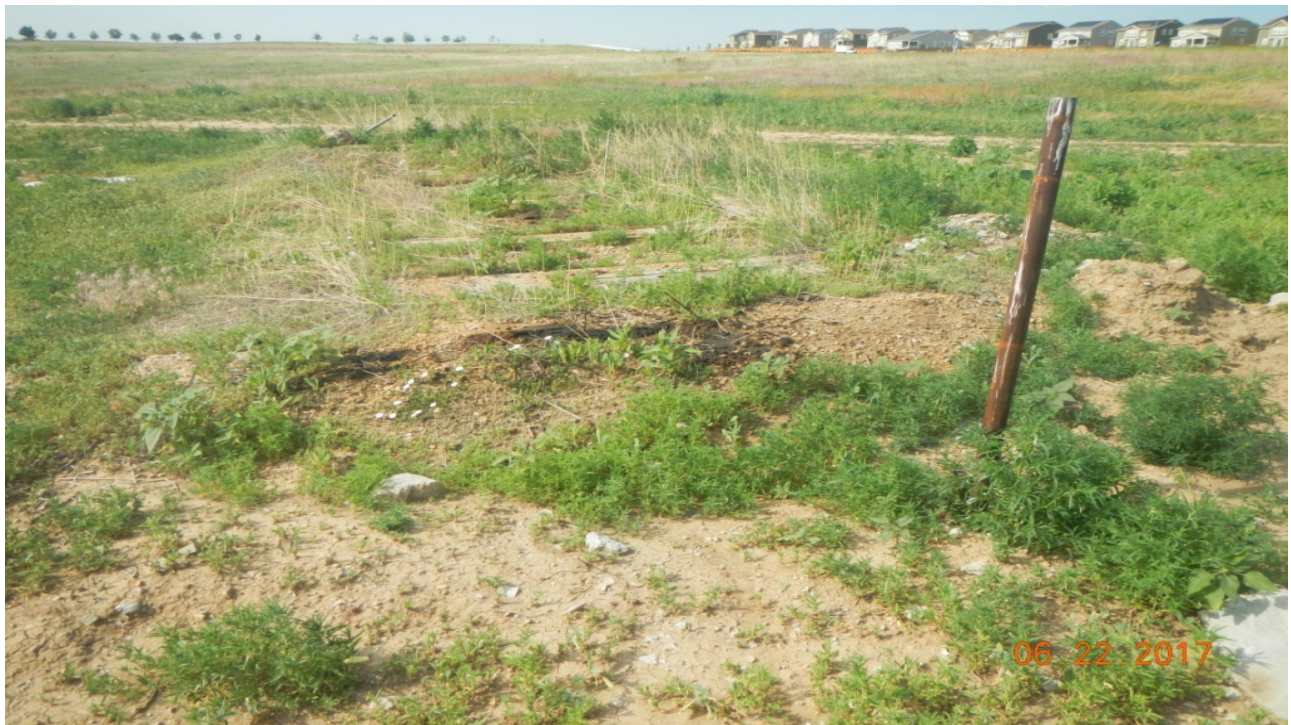
**photo 4:** Facing south at the location. There is a metal pipe at the center of the location.

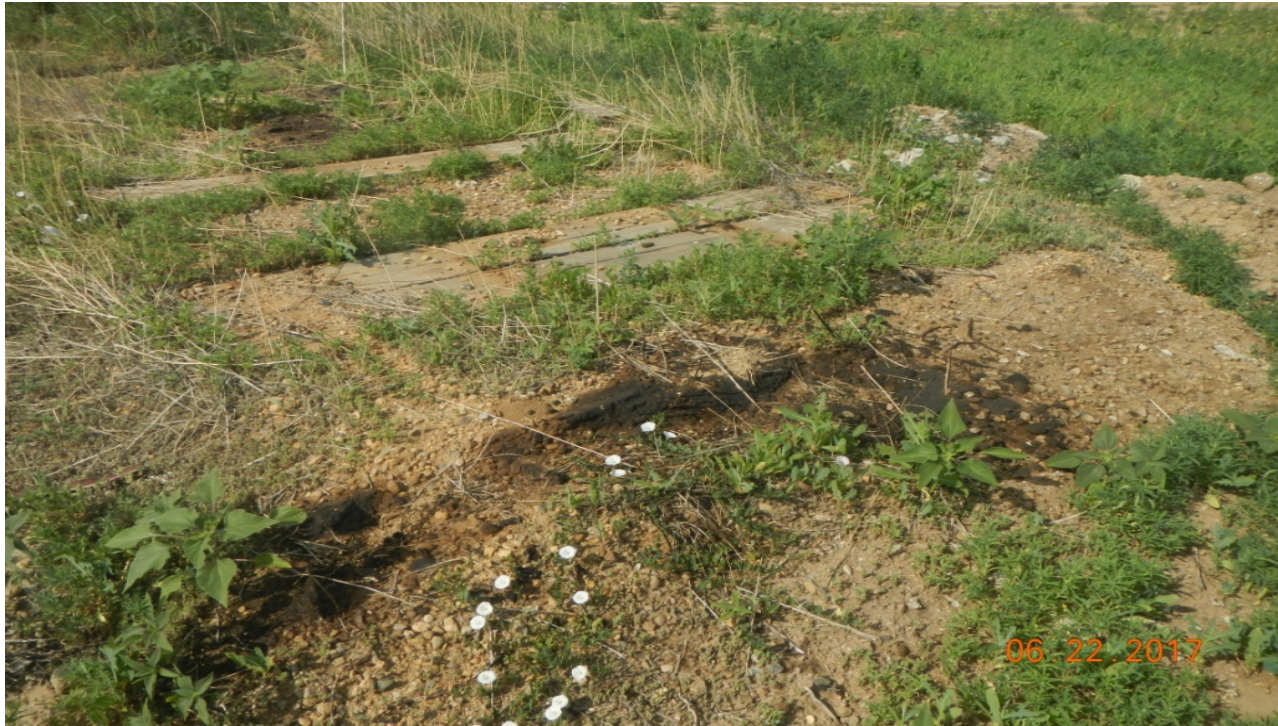
**photo 5:** There is wooden timbers and oil stained soil at the center of the location.

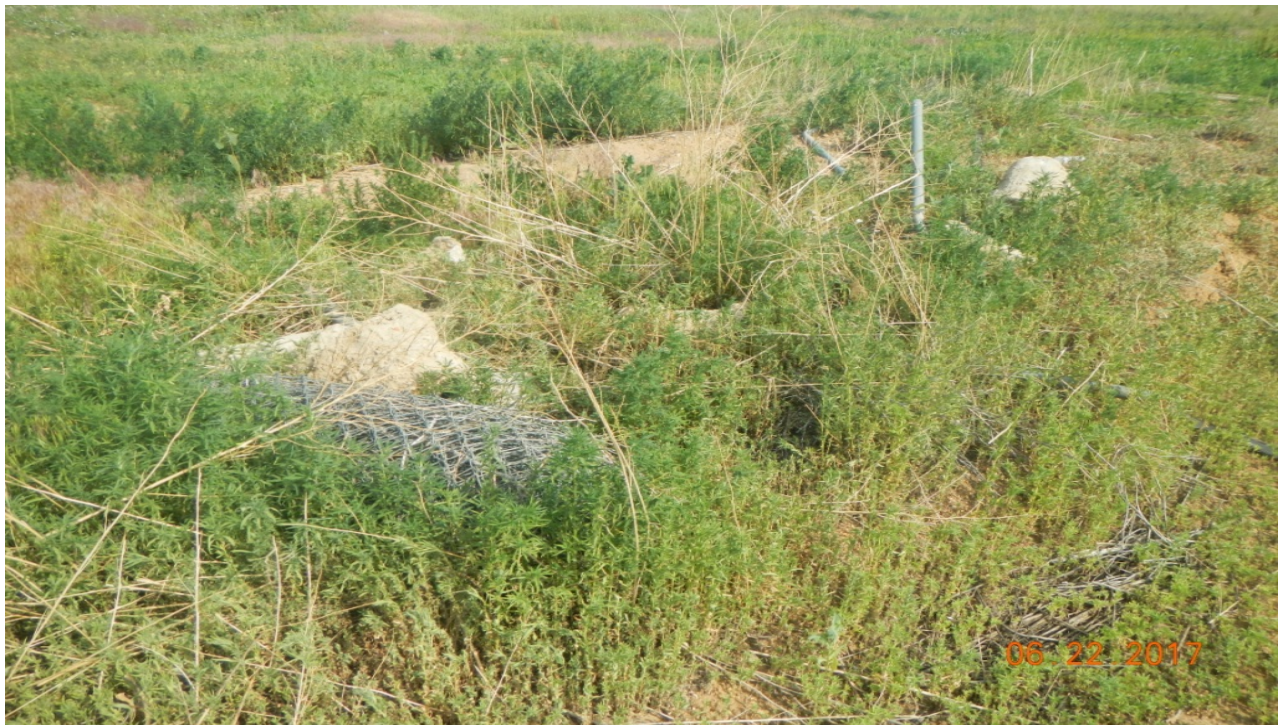
**photo 6:** There is cement blocks and fencing debris that remains at the location.

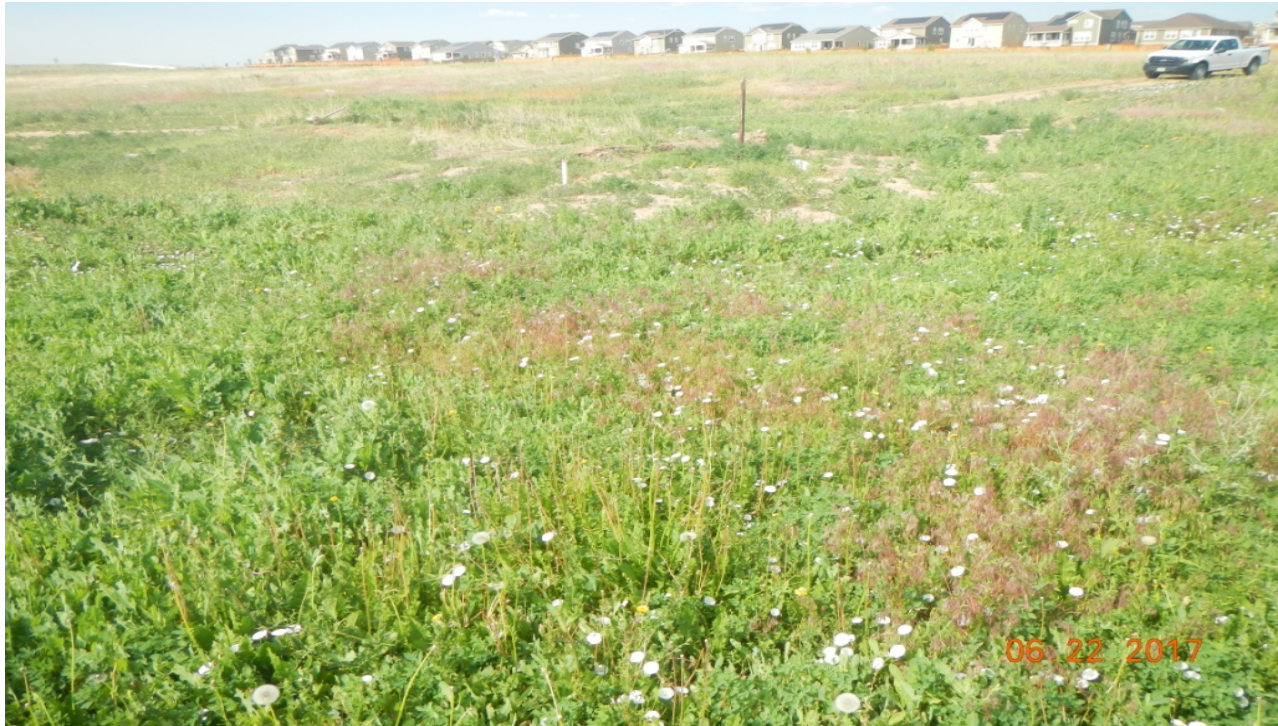
**photo 7:** Northeast side of the location facing southwest.

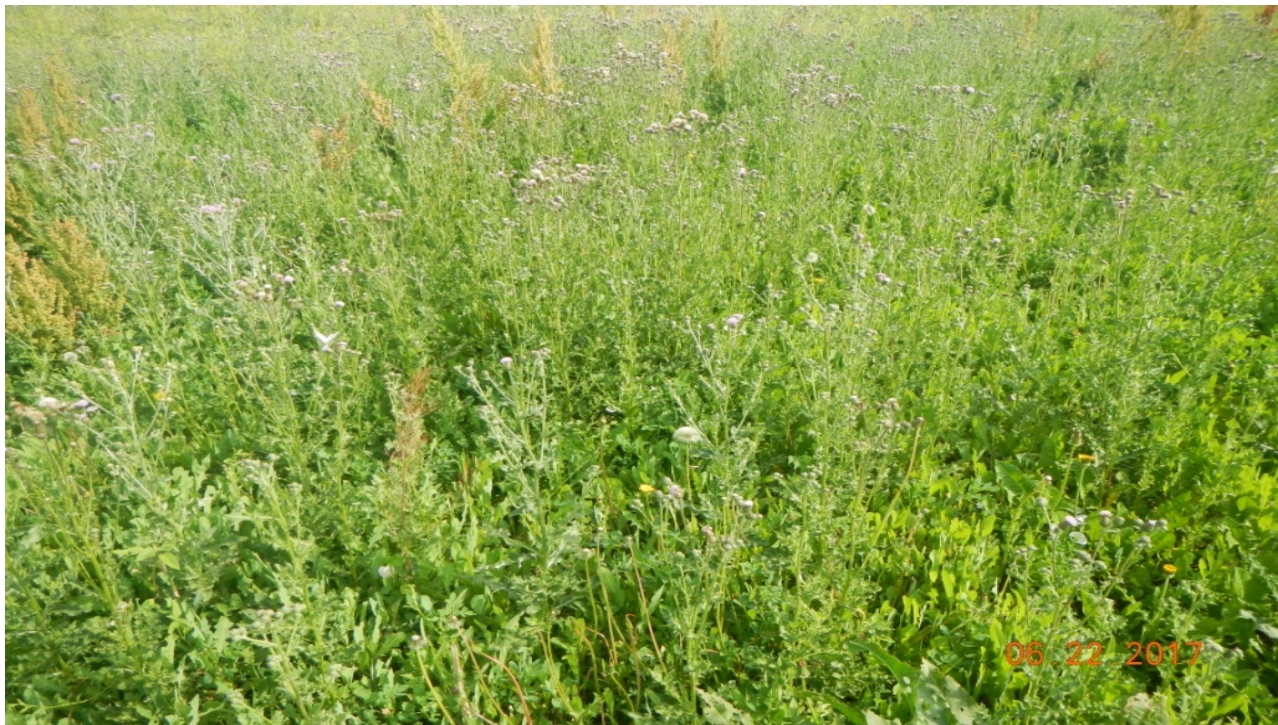
**photo 8:** There are noxious weeds (Canada thistle) around the northeastern side of the location.

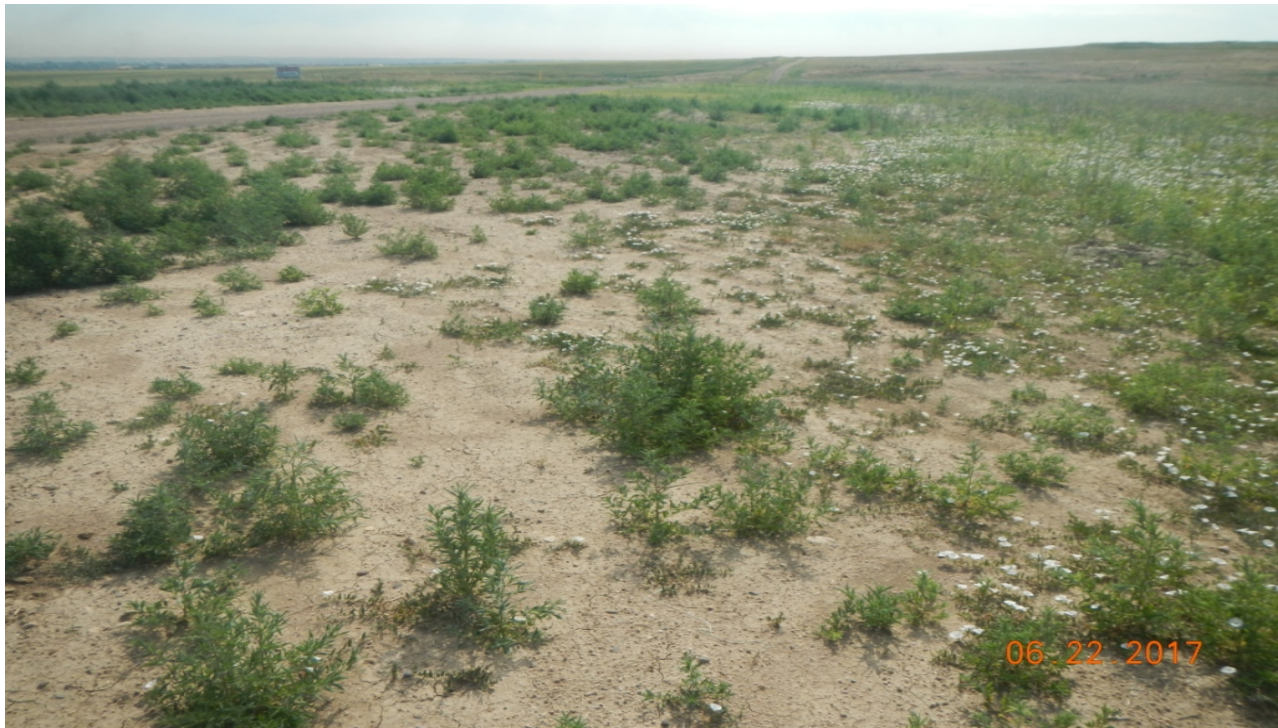
**photo 9:** Facing east at tank battery site northwest of the well; Lat/Long:39.95737,-104.92150.

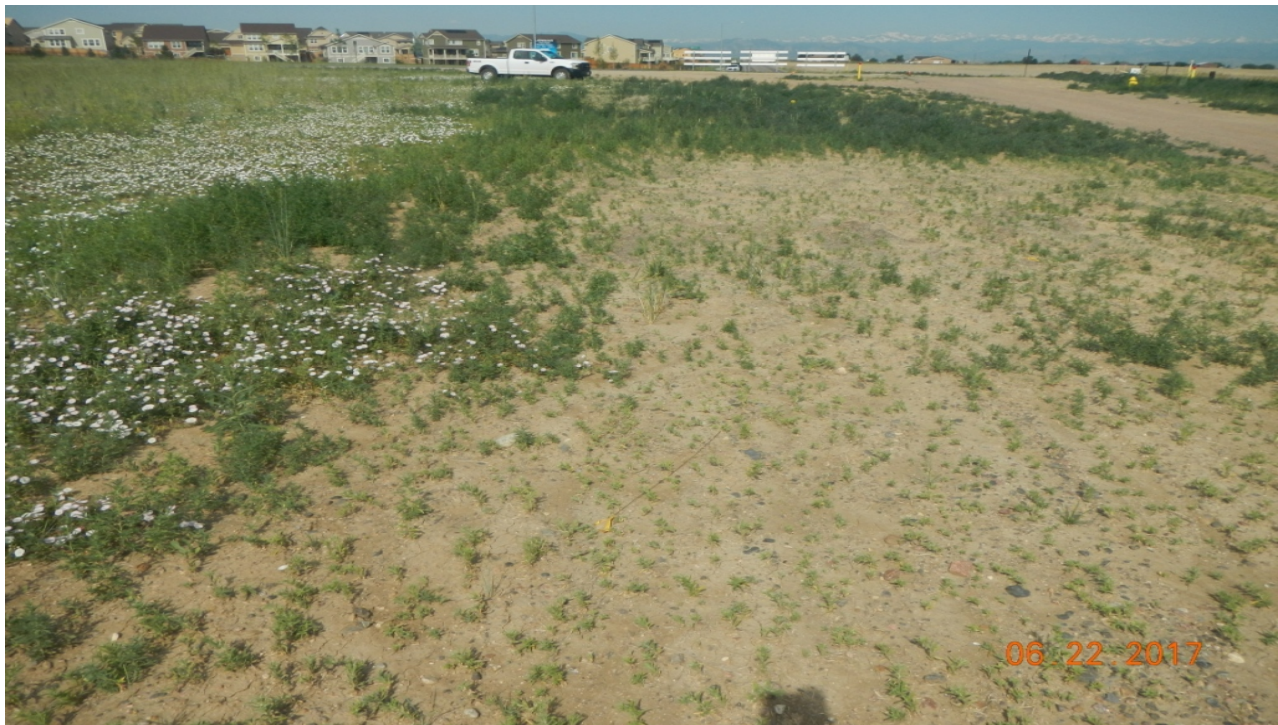
**photo 10:** Facing west at tank battery site northwest of the well; Lat/Long:39.95737,-104.92150.
