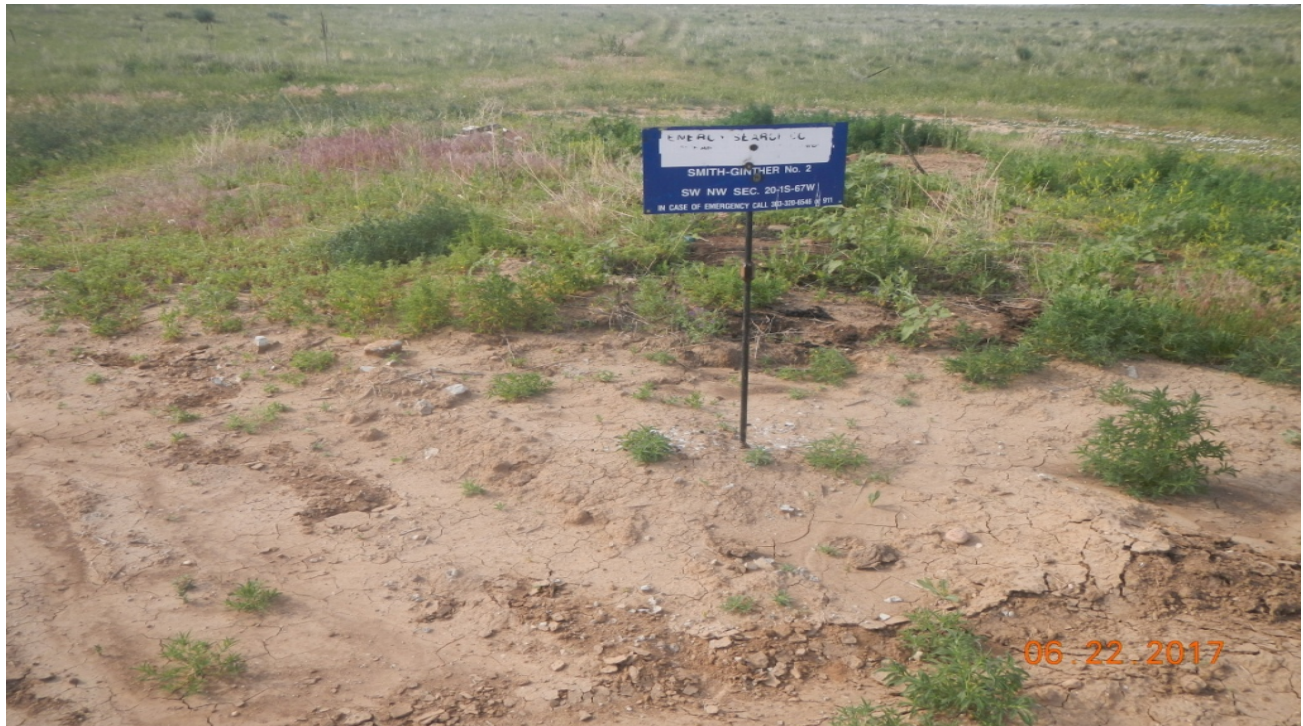
**photo 1:** Facing east toward the access road. Gravel remains along the road.

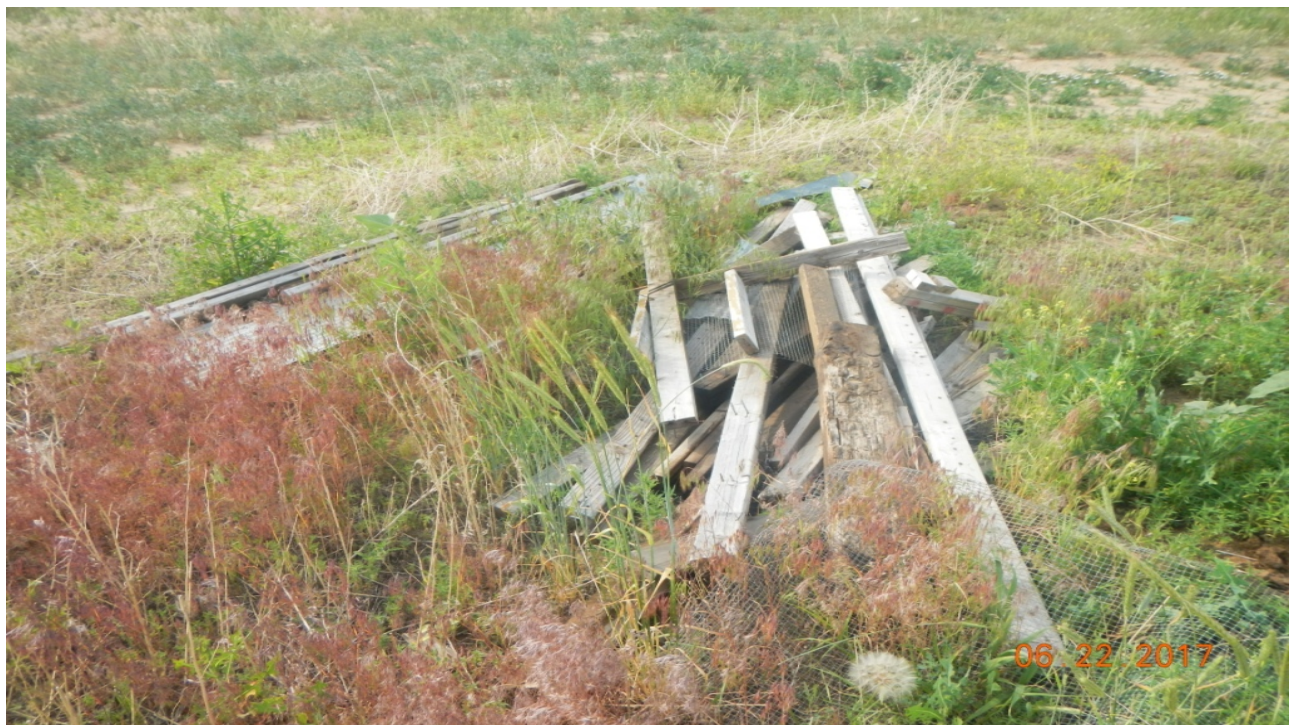
**photo 2:** There wood lumber debris that remains at the center of the location.

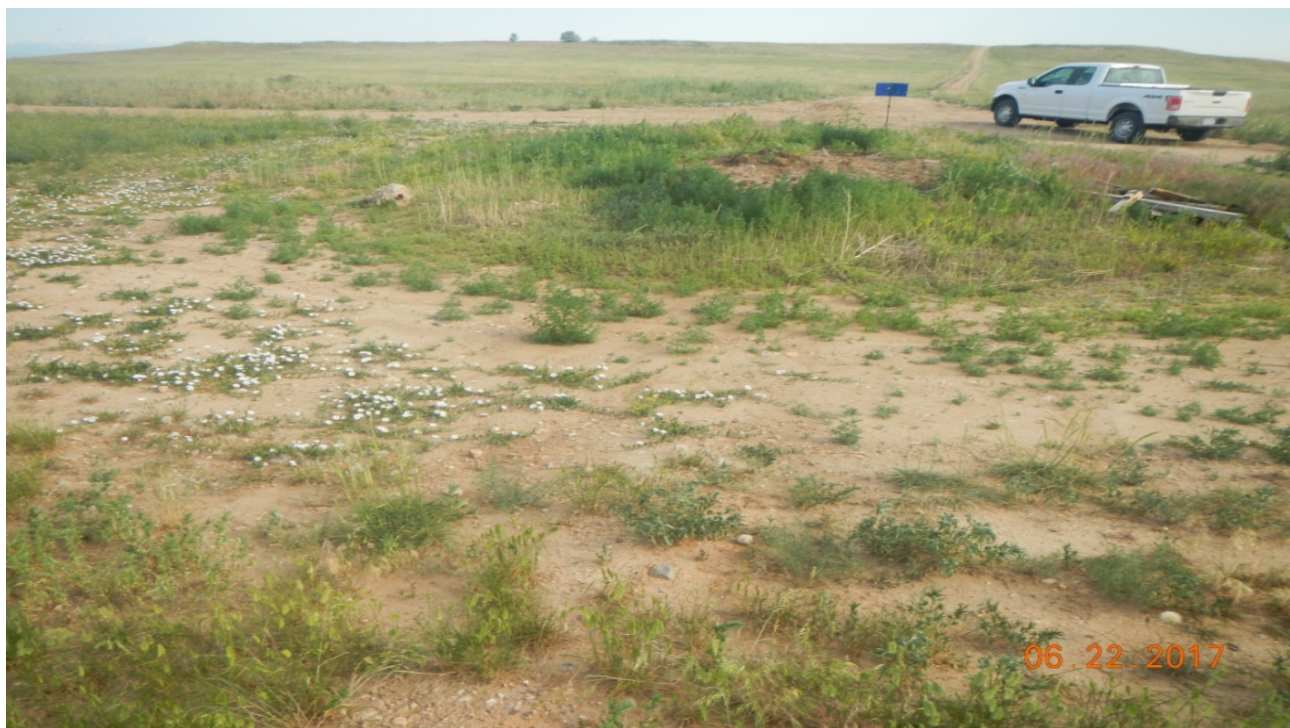
**photo 3:** South side of the location facing north.

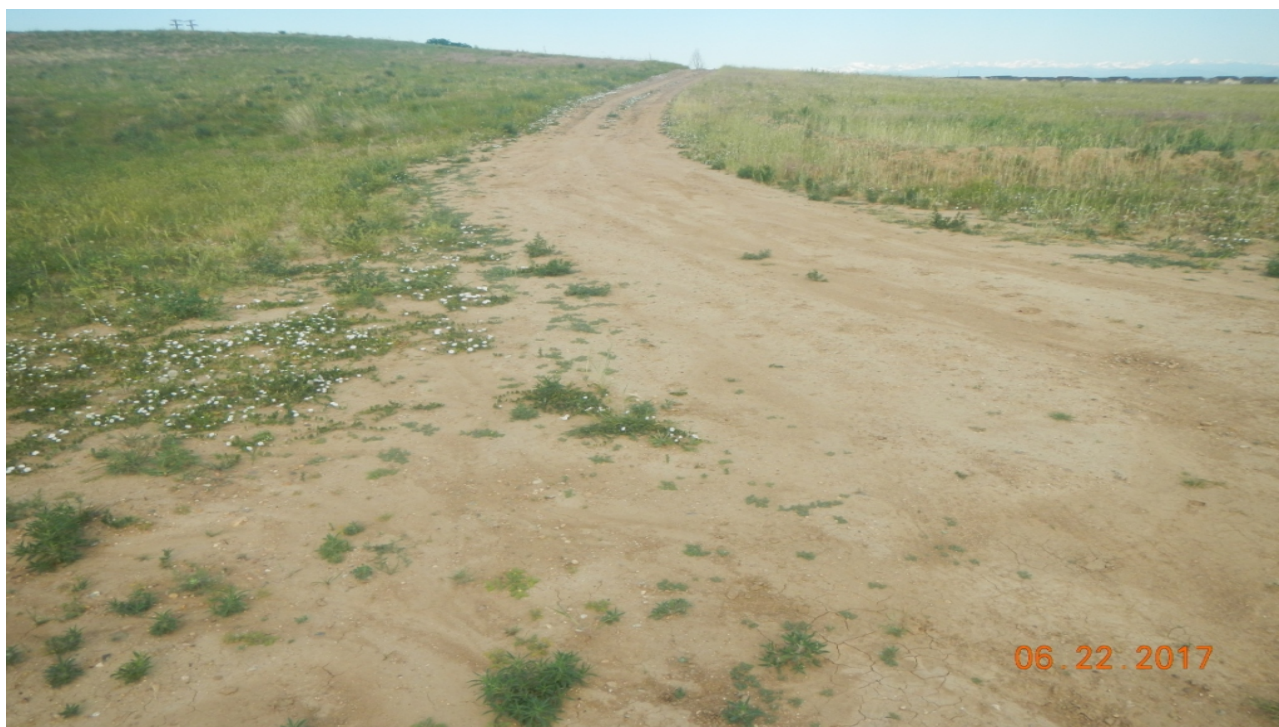
**photo 4:** Facing west toward the access road.

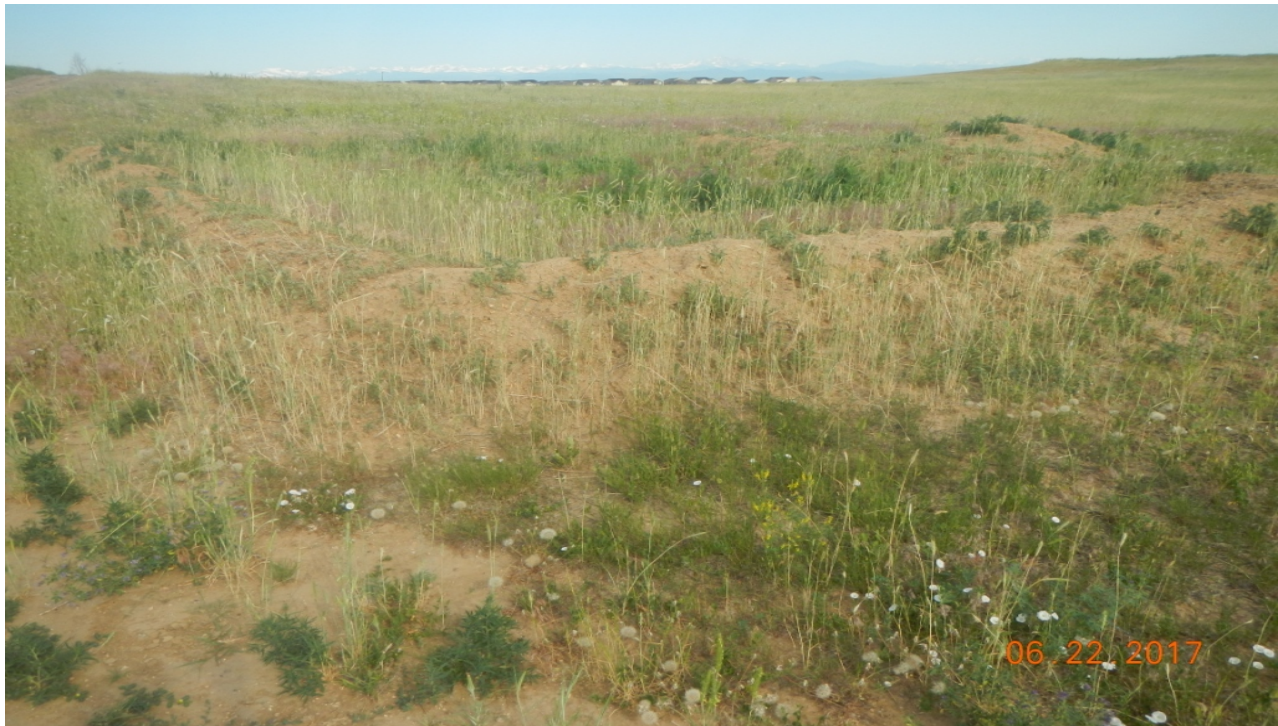
**photo 5:** There are berms that remain at the former battery site at the northwest side of the location.

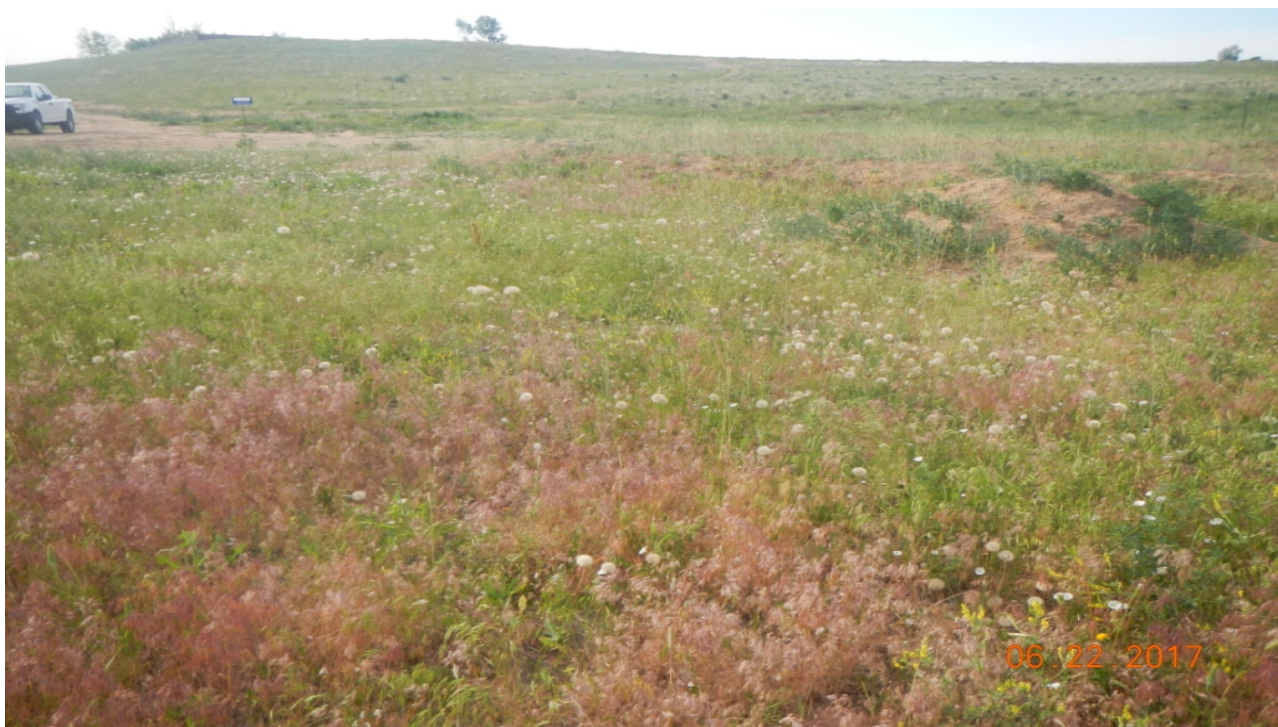
**photo 6:** North side of the location facing south.
