COLORADO
Oil & Gas Conservation
Commission
Department of Natural Resources

Inspection Photos: Encana PA Carpenter API#077-08454

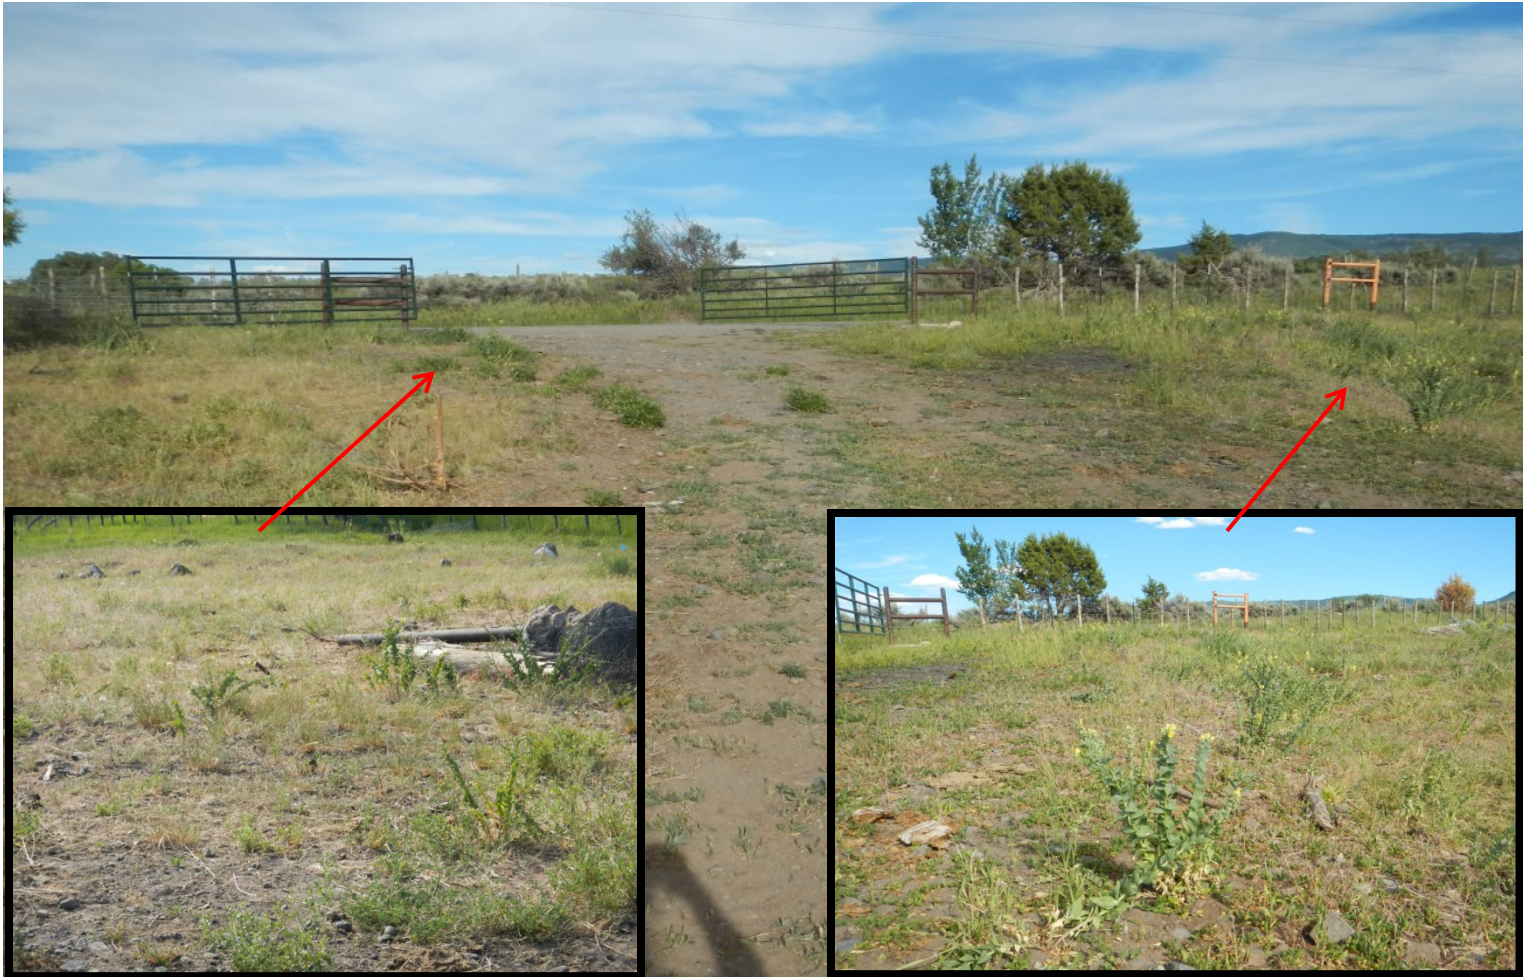
Photo#1:

View of Location entry looking out to County Road. Inserts are detail of Toadflax at either side of Gates.

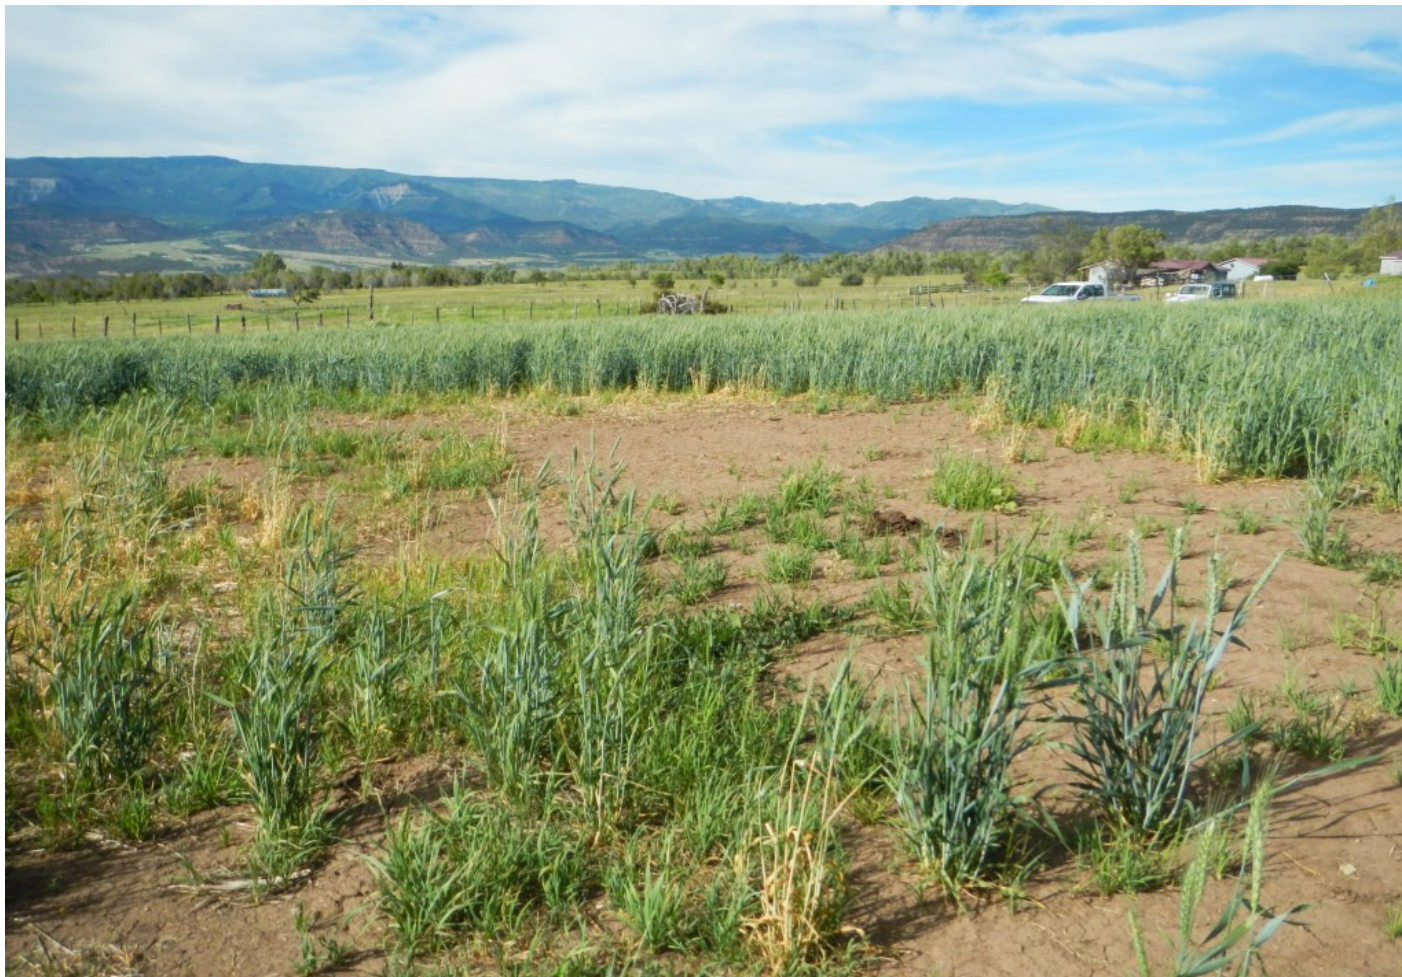
Photo#2:

View to NE over field area of sparse growth and bare ground.

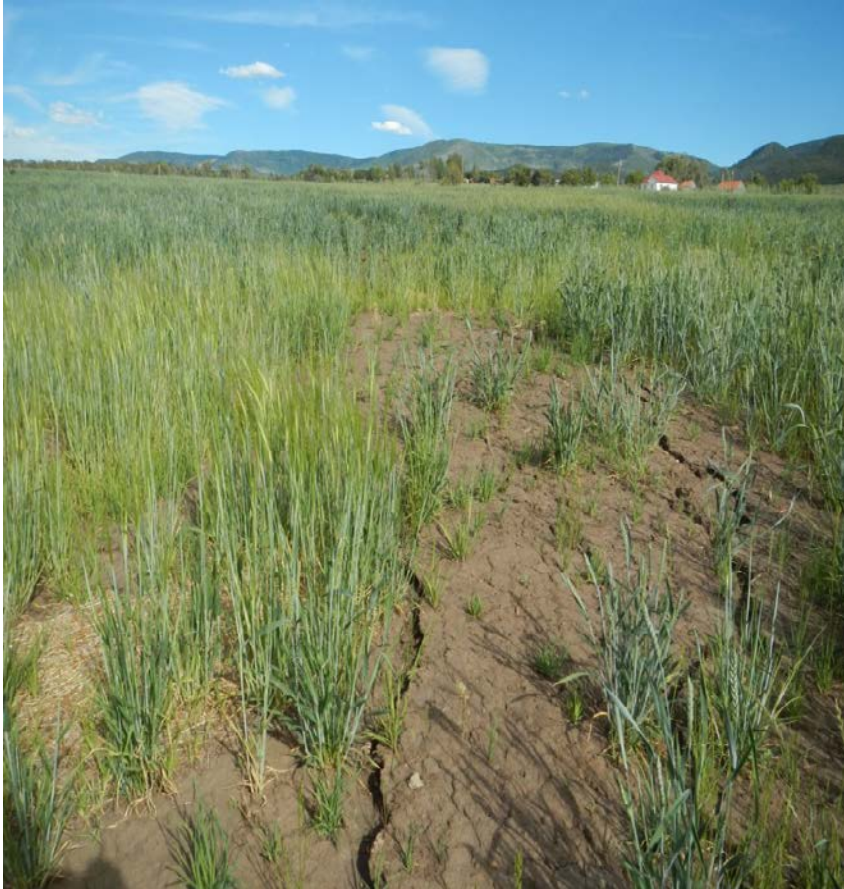
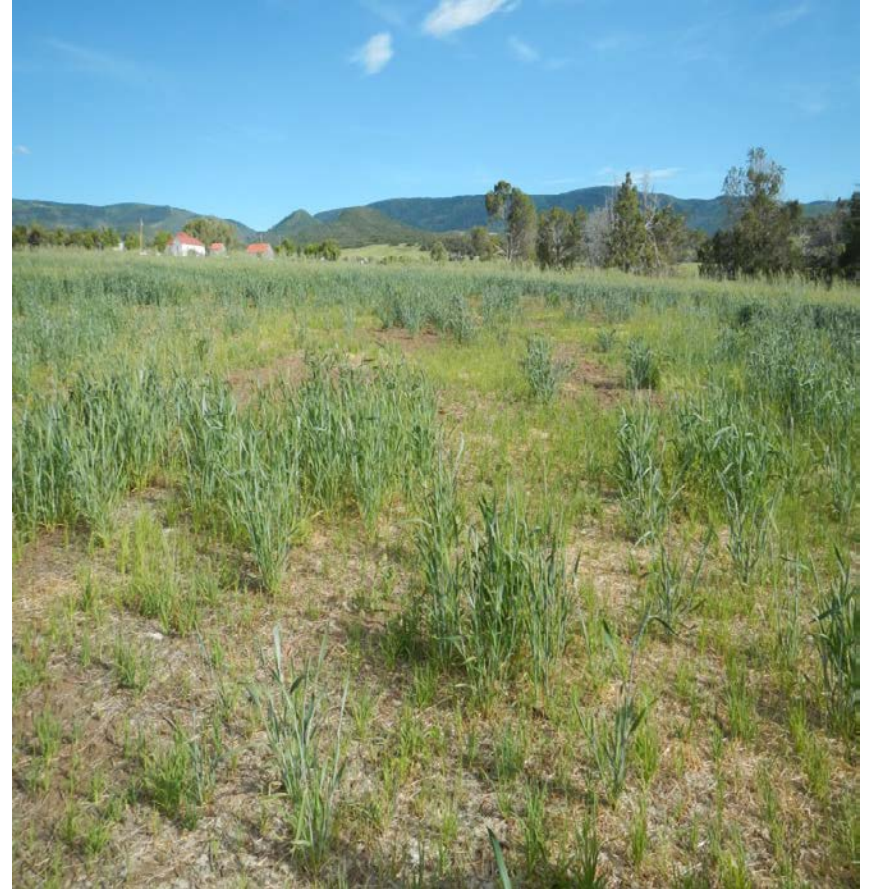
Views to SE of problem areas of spotty revegetation in Location.

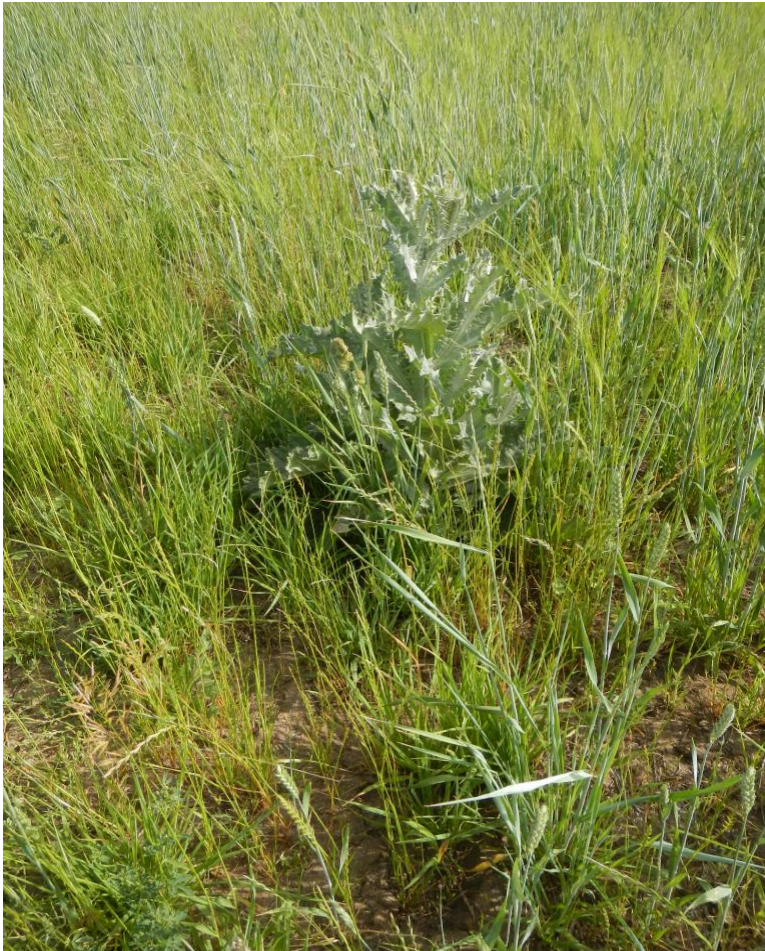
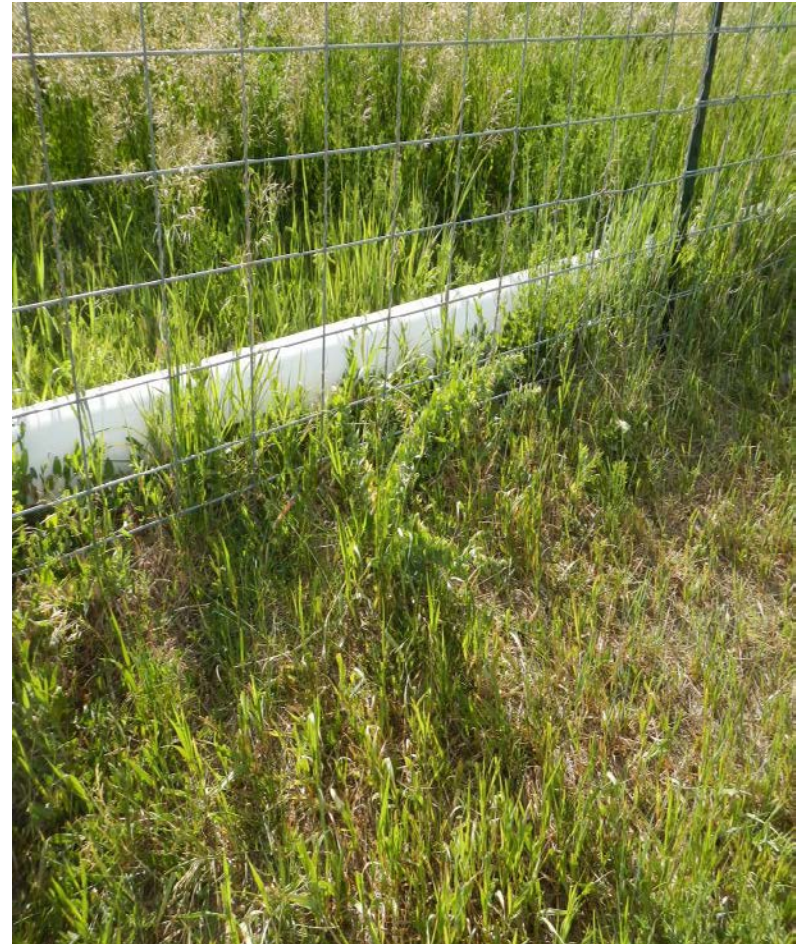
A few Scotch Thistle, Canada thistle and Toadflax plants noted in field area of Location.

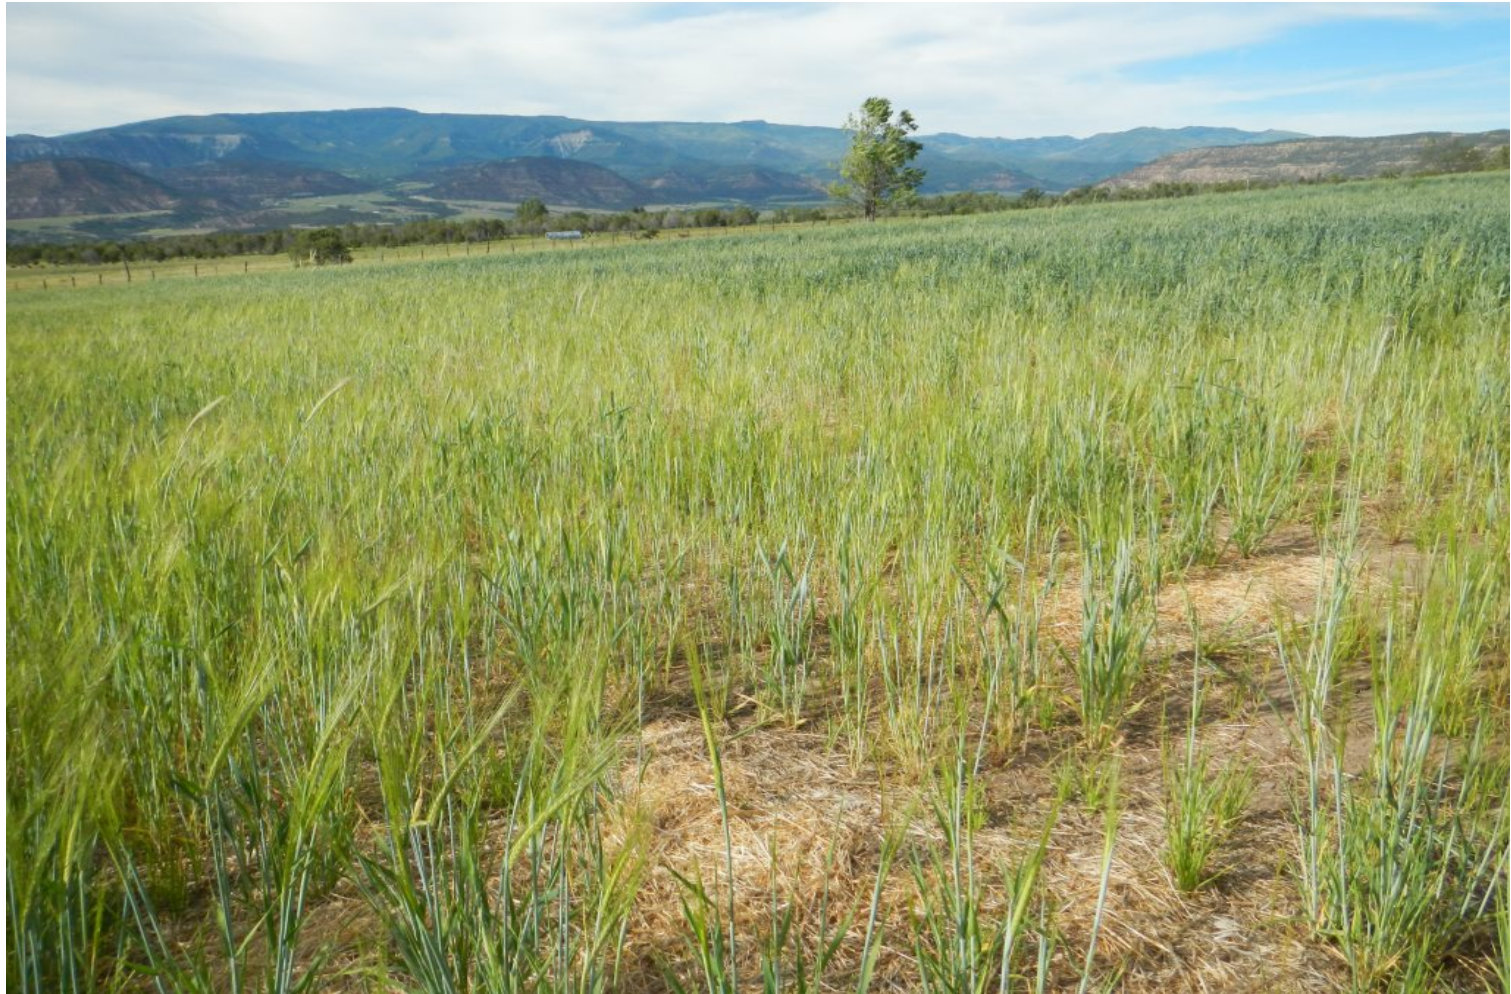
Photo#7:

Difference in color height & density of vegetation is easily noticeable across Location
