# Inspection Photos

Operator: GRAND MESA OPERATING CO - 35080

Location ID: 450631

Inspection Doc. Number: 682502323

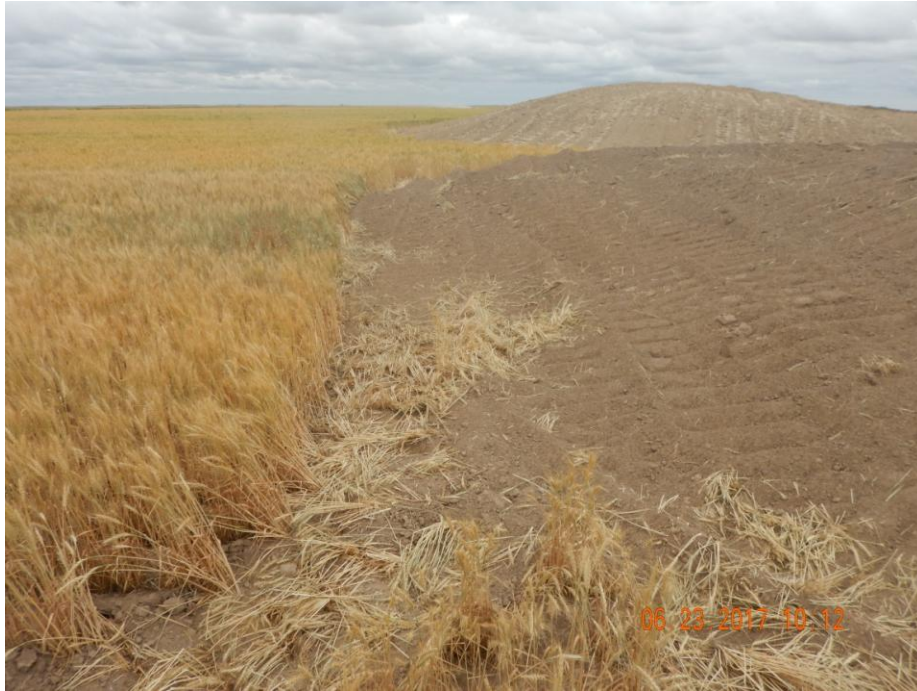
**Photo 1:** Photo taken from the southwest end of the location, facing north. Photo shows topsoil stockpiles on the west end of the location. Photo also shows perimeter stormwater and sediment BMP controls have not been implemented.

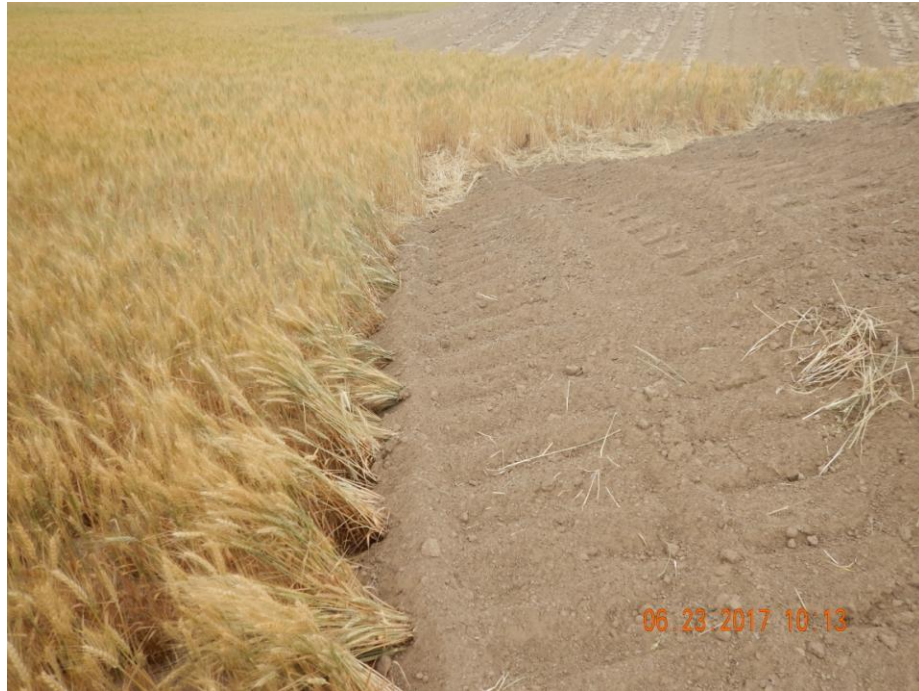
**Photo 3:** Photo taken from the west end of the location. Photo shows topsoil stockpiles on the west end of the location. Photo also shows perimeter stormwater and sediment BMP controls have not been implemented.

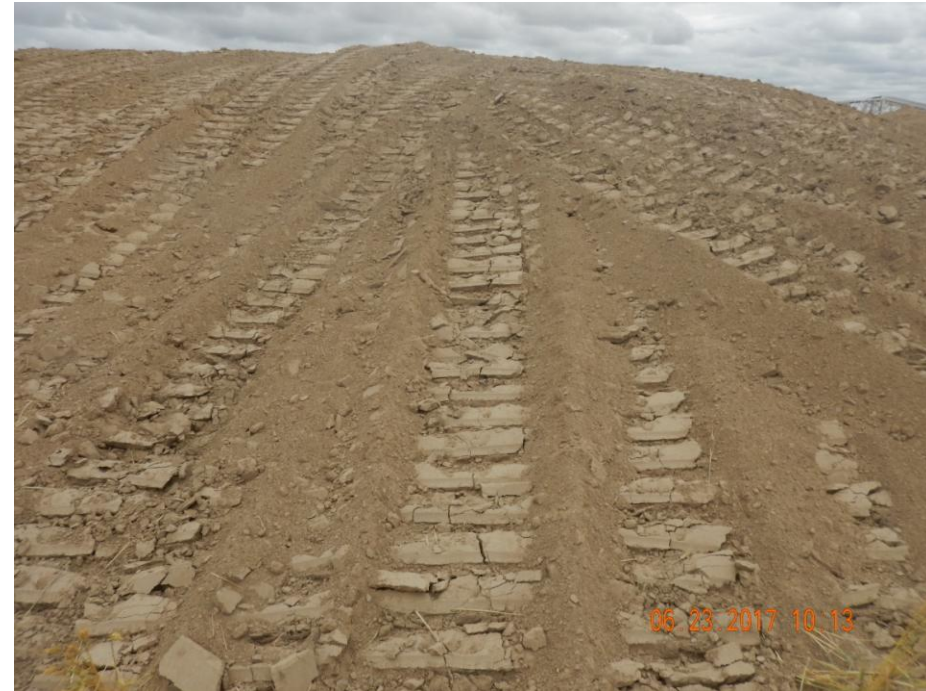
**Photo 4:** Photo taken from the west end of the location. Photo shows topsoil piles have been insufficiently tracked.

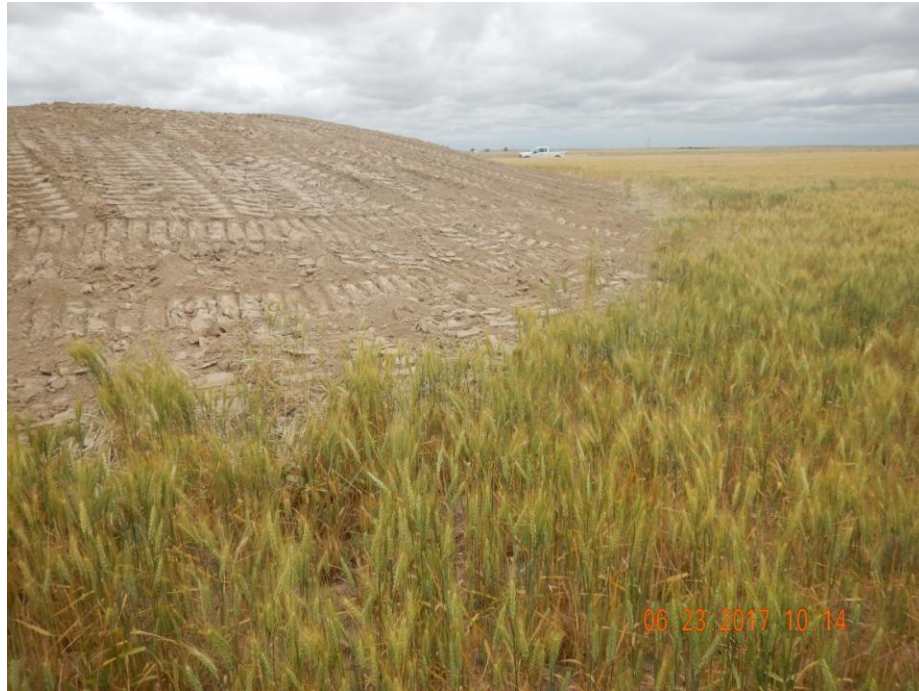
**Photo 5:** Photo taken from the northwest end of the location, facing south. Photo shows topsoil stockpiles on the west end of the location . Photo also shows perimeter stormwater and sediment BMP controls have not been implemented.

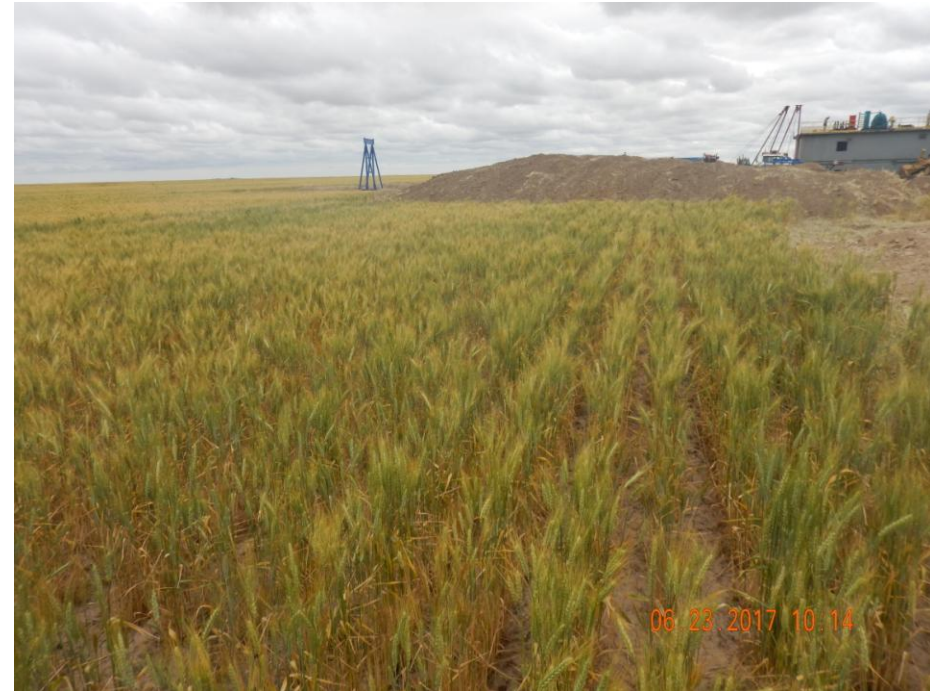
**Photo 6:** Photo taken from the northwest end of the location, facing east. Photo shows perimeter stormwater and sediment BMP controls have not been implemented.

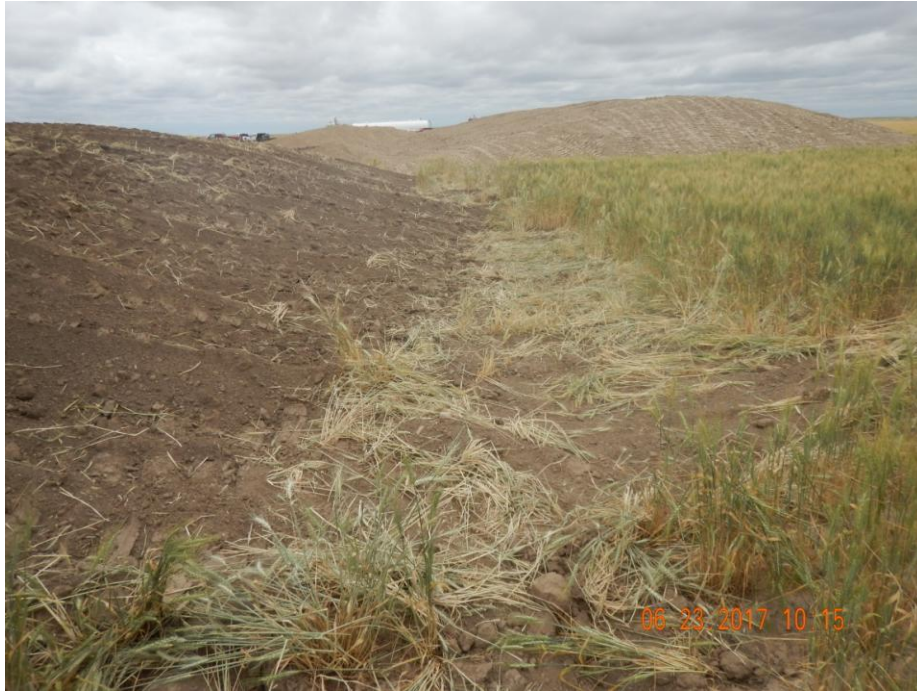
**Photo 7:** Photo taken from the north end of the location, facing southwest. Photo shows perimeter stormwater and sediment BMP controls have not been implemented.

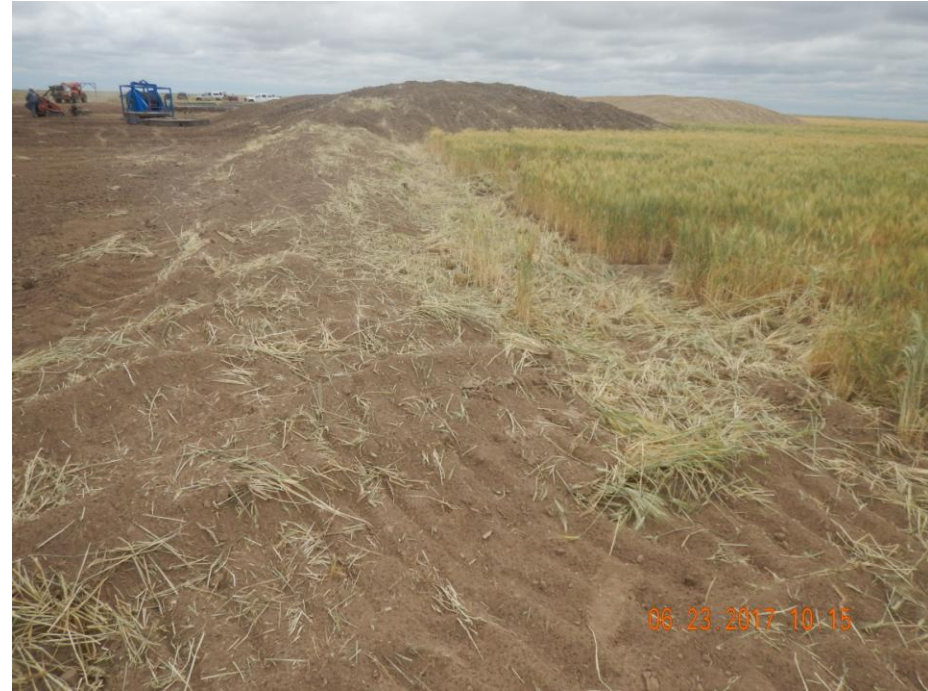
**Photo 8:** Photo taken from the north end of the location, facing south. Photo shows perimeter stormwater and sediment BMP controls have not been implemented.

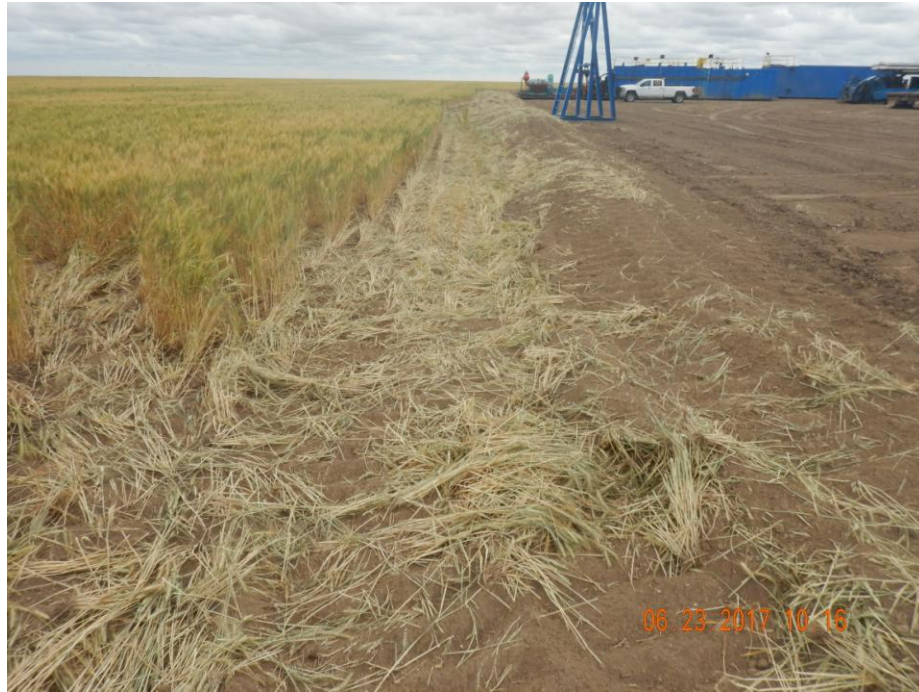
**Photo 9:** Photo taken from the north end of the location, facing east. Photo shows berm that appears to be sufficiently consolidated.

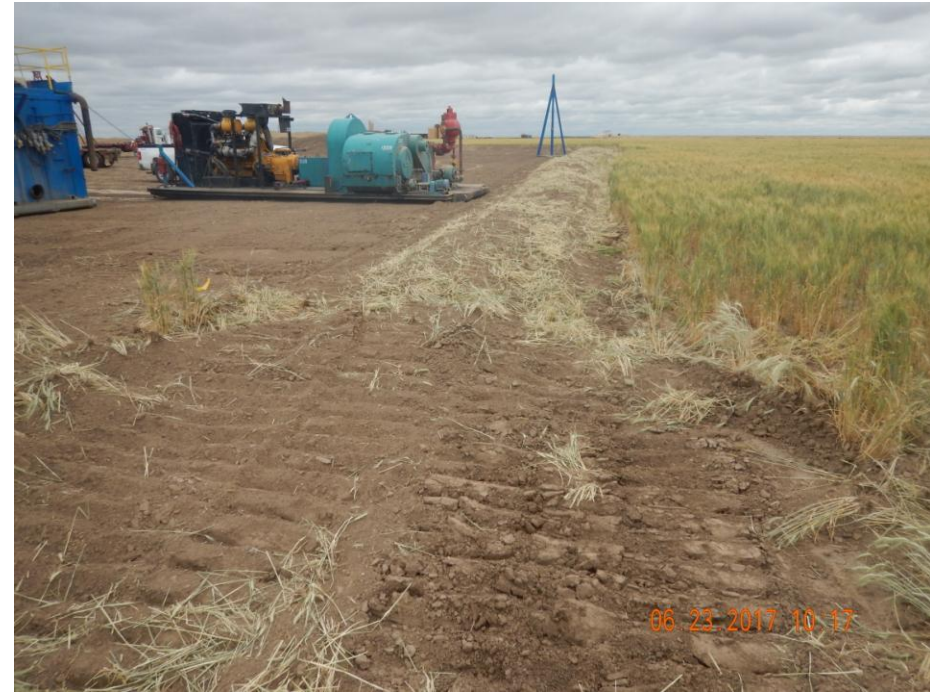
**Photo 10:** Photo taken from the northeast end of the location, facing west. Photo shows berm that appears to be sufficiently consolidated.

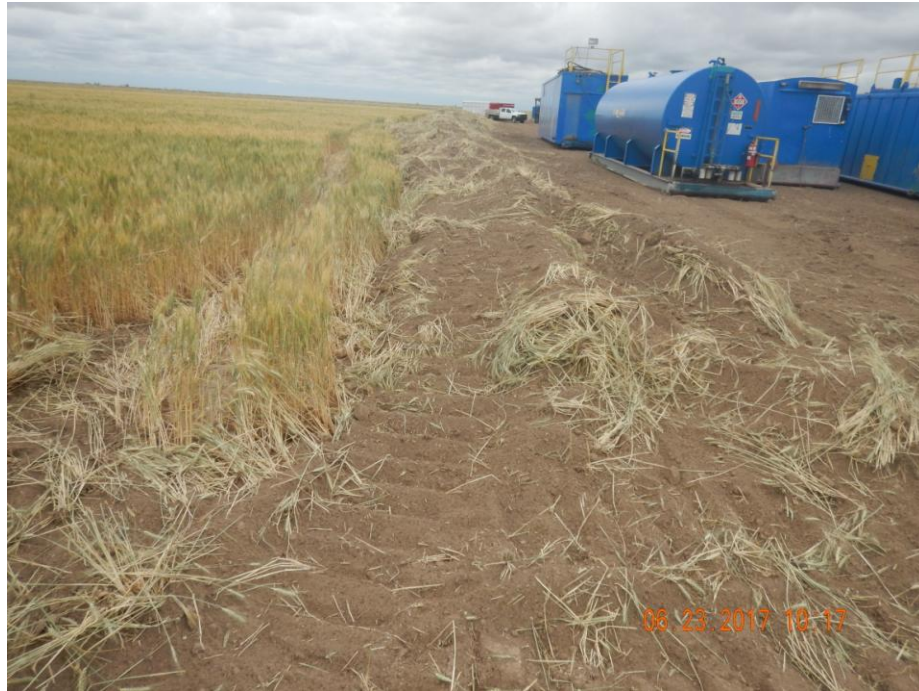
**Photo 11:** Photo taken from the northeast end of the location, facing south. Photo shows berm constructed on the eastern perimeter of the location. Berm has not been constructed with good engineering practices; berm has not been sufficiently consolidated and not in proper functioning conduction.

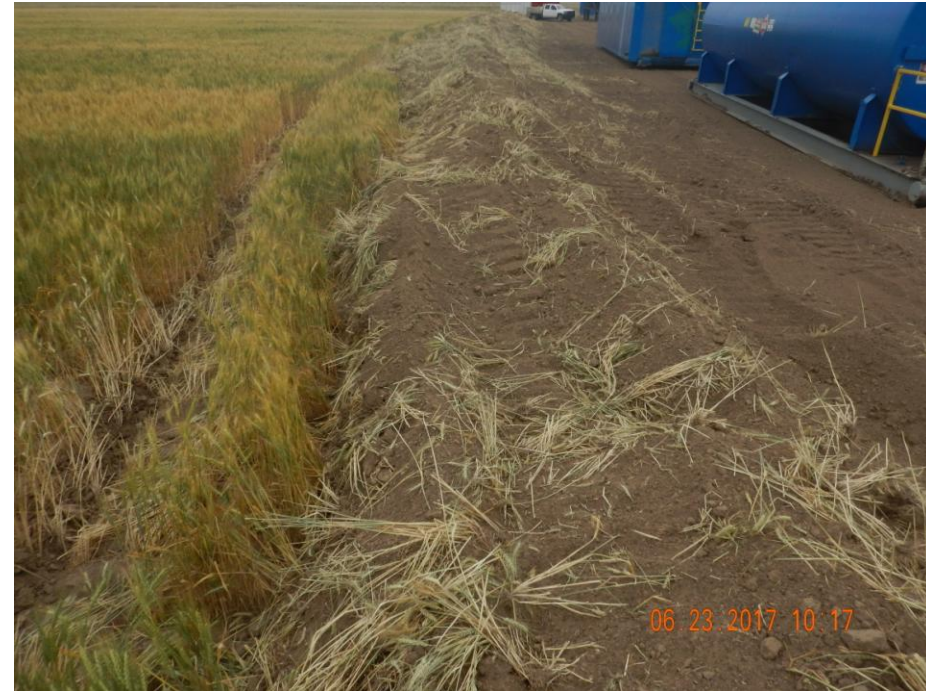
**Photo 12:** Photo taken from the northeast end of the location, facing south. Photo shows berm constructed on the eastern perimeter of the location. Berm has not been constructed with good engineering practices; berm has not been sufficiently consolidated and not in proper functioning conduction.

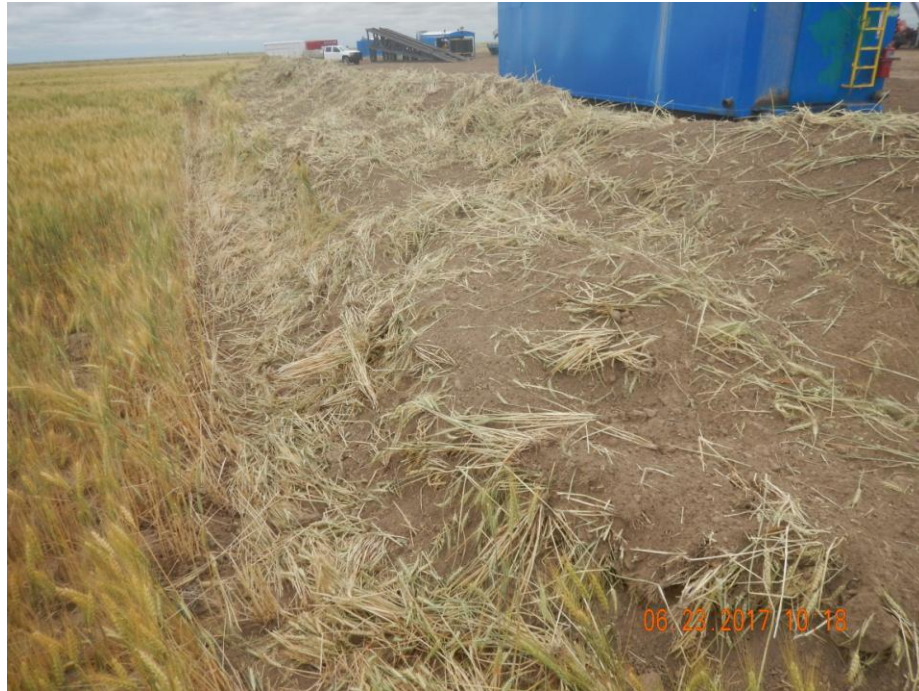
**Photo 13:** Photo taken from the north end of the location, facing south. Photo shows berm constructed on the eastern perimeter of the location. Berm has not been constructed with good engineering practices; berm has not been sufficiently consolidated and not in proper functioning conduction.

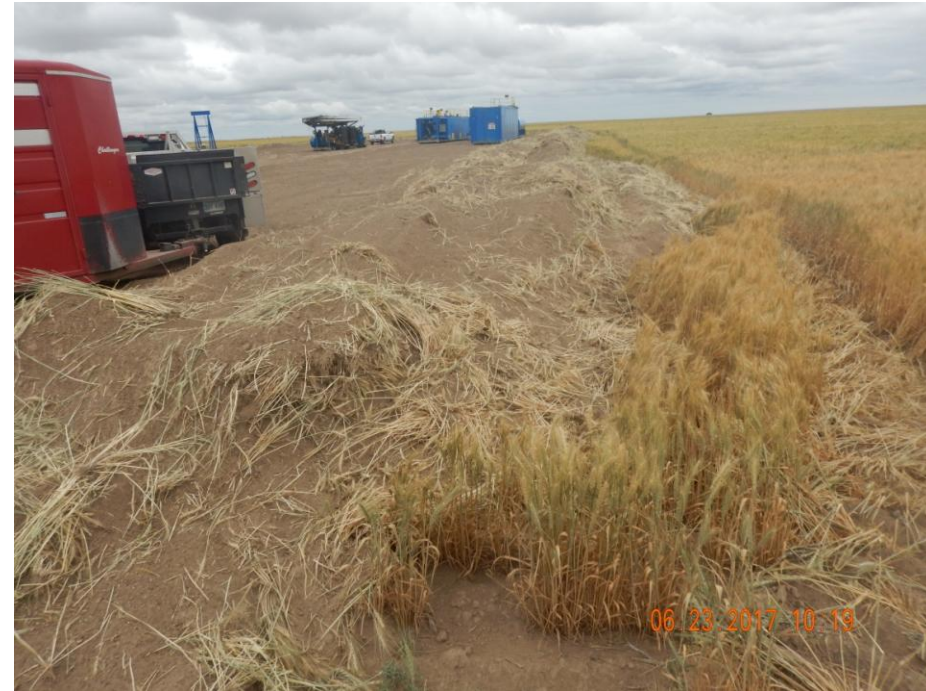
**Photo 14:** Photo taken from the southeast end of the location, facing north. Photo shows berm constructed on the eastern perimeter of the location. Berm has not been constructed with good engineering practices; berm has not been sufficiently consolidated and not in proper functioning conduction.

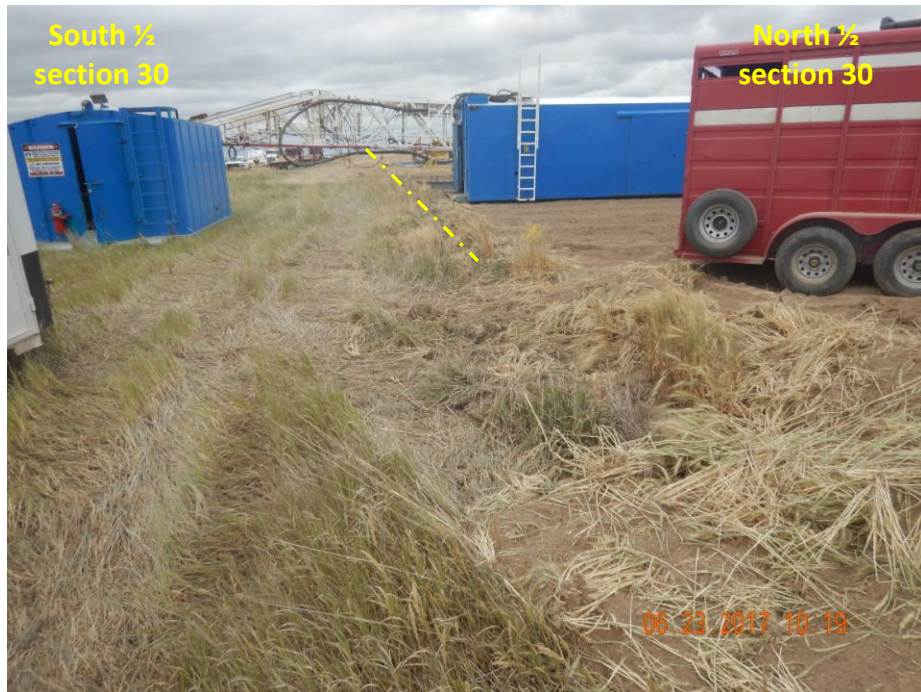
**Photo 15:** Photo taken from the southeast end of the location, facing west. Photo shows equipment being stored off location. Access road (yellow line) appears to straddle the North and Southern 1/2 of section 30. Washington County Assessor indicated that the North half of section 30 is owned by the surface owners listed in the 2A, however the southwest 1/4 of section 30 is listed under a surface owner not on the 2A. It appears operator is parking equipment/disturbing a separate surface owner's property. This issue is being forwarded to OGLA

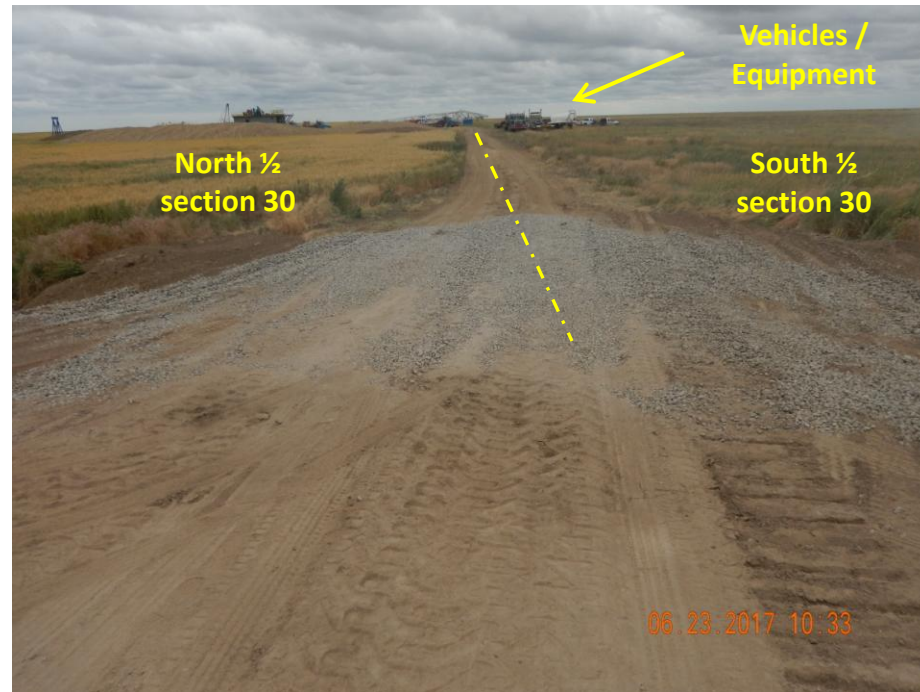
**Photo 16:** Photo taken from the access road, west of the location, facing east. Photo shows rock material used as a tracking pad. Access road (yellow line) appears to straddle the North and Southern 1/2 of section 30. Washington County Assessor indicated that the North half of section 30 is owned by the surface owners listed in the 2A, however the southwest 1/4 of section 30 is listed under a surface owner not on the 2A. It appears operator is parking equipment/disturbing a separate surface owner's property. This issue is being forwarded to OGLA

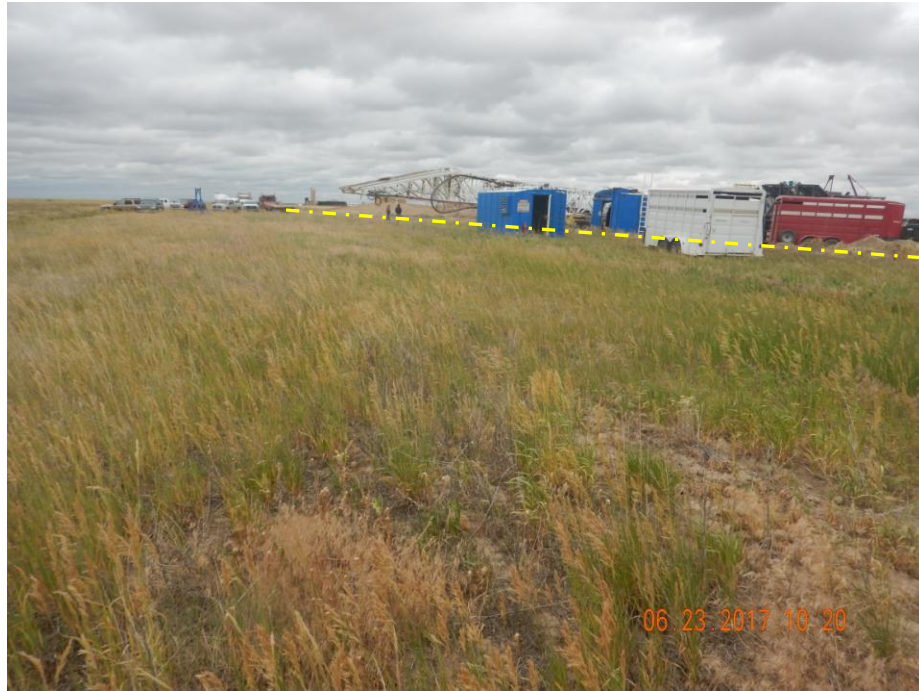
**Photo 17:** Photo taken from the southeast of the location, facing north west. Photo shows equipment and vehicles parked off location. Yellow line indicates the approximate border between the North and Southern ½ of section 30. Washington County Assessor indicated that the North half of section 30 is owned by the surface owners listed in the 2A, however the southwest ¼ of section 30 is listed under a surface owner not on the 2A. It appears operator is parking equipment/disturbing a separate surface owner's property. This issue is being forwarded to OGLA

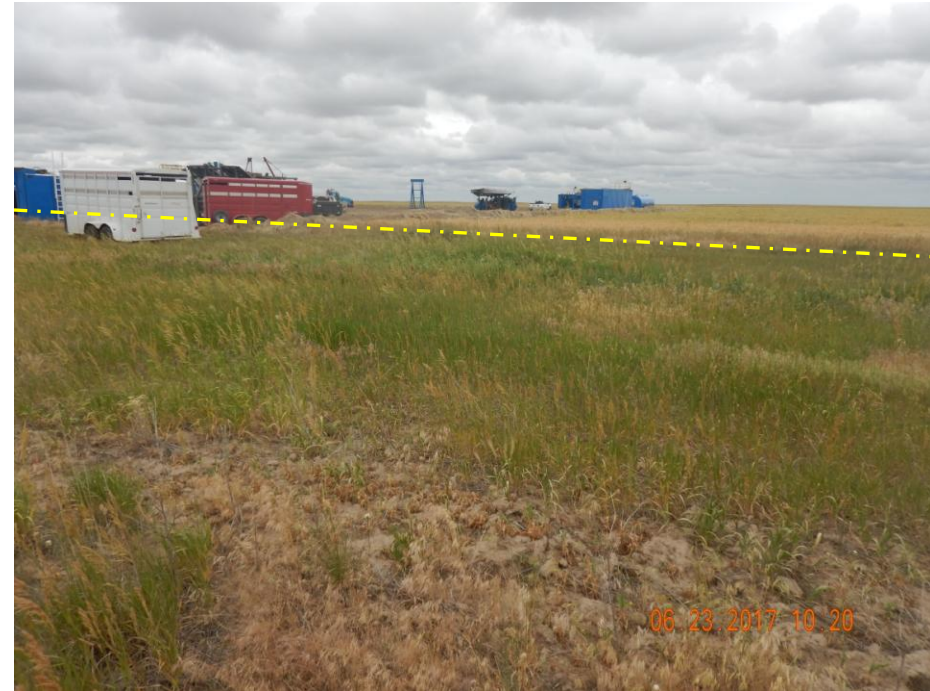
**Photo 18:** Photo taken from the southeast of the location, facing north. Yellow line indicates the approximate border between the North and Southern ½ of section 30. Washington County Assessor indicated that the North half of section 30 is owned by the surface owners listed in the 2A, however the southwest ¼ of section 30 is listed under a surface owner not on the 2A. It appears operator is parking equipment/disturbing a separate surface owner's property. This issue is being forwarded to OGLA
