COLORADO
Oil & Gas Conservation
Commission
Department of Natural Resources

Inspection Photos: Biasi Bruno Woosley Loc#399062

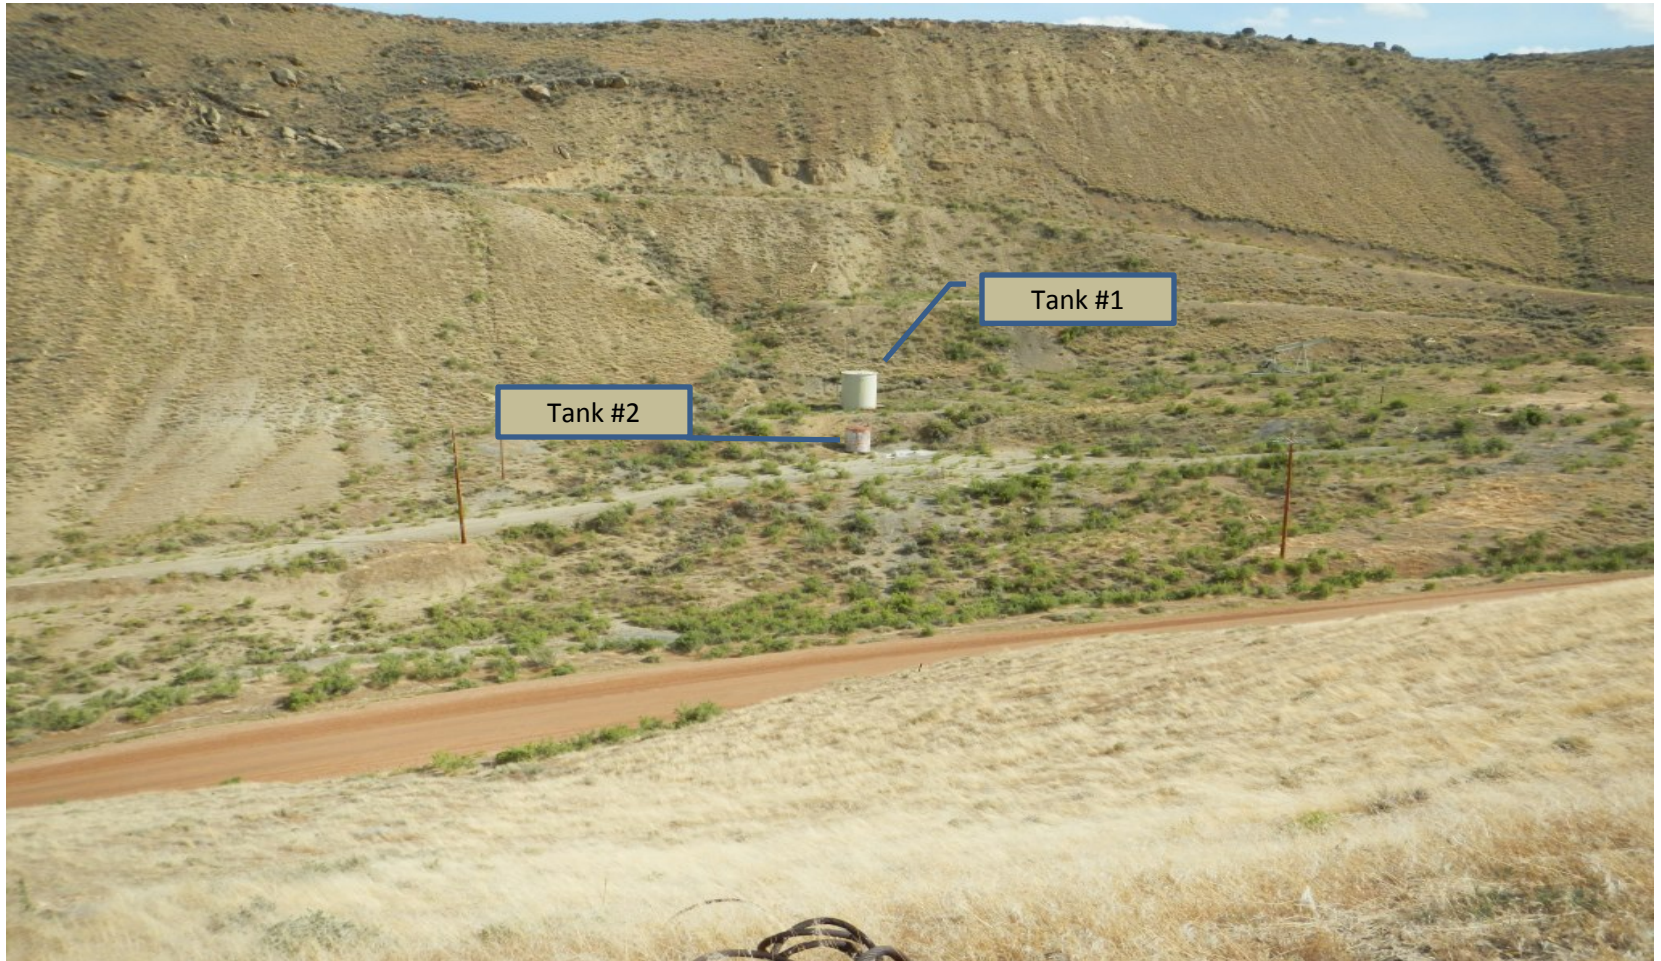
Photo#1:

Overview of Location to South. Contributing Wells are North, South & West of Tanks.

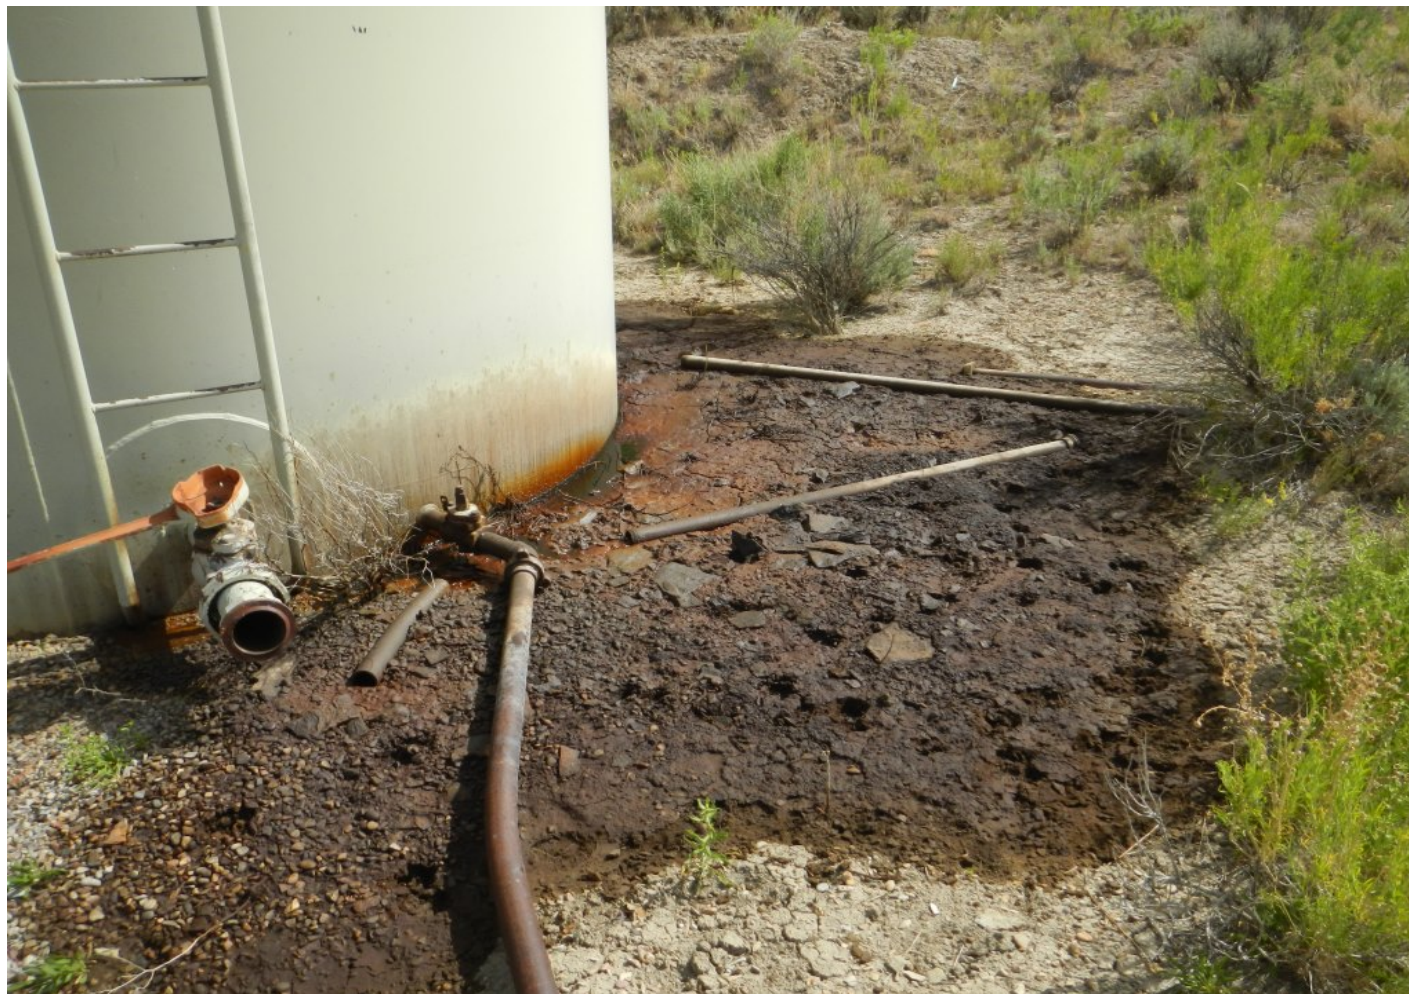
Photo#2:
Tank #1, rusted at base & leaking.

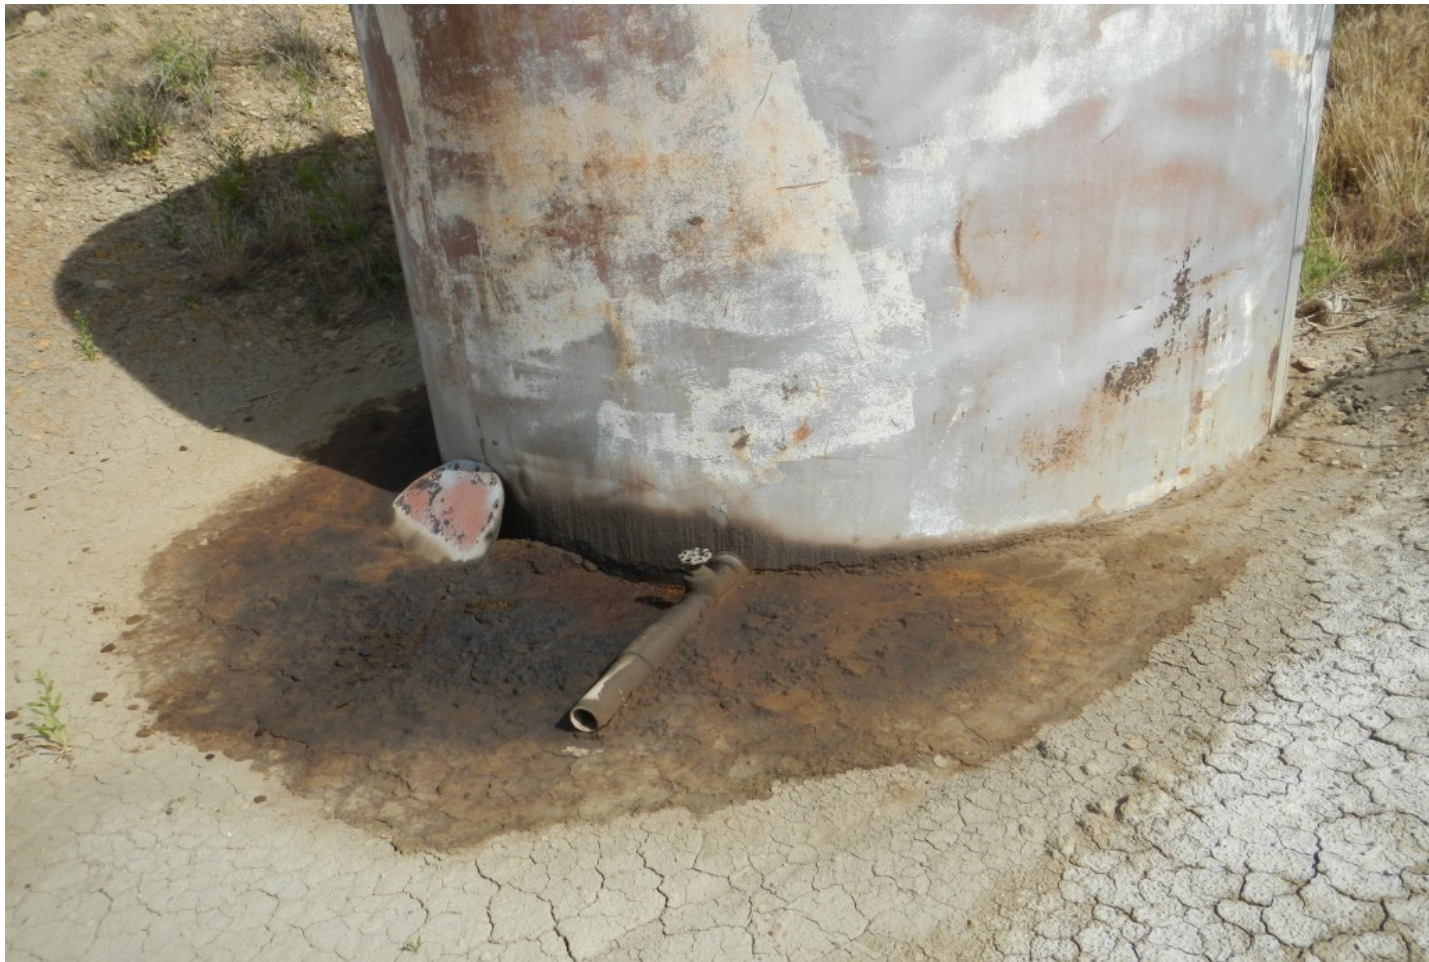
Photo#3:

Tank #2, rusted at base & leaking.

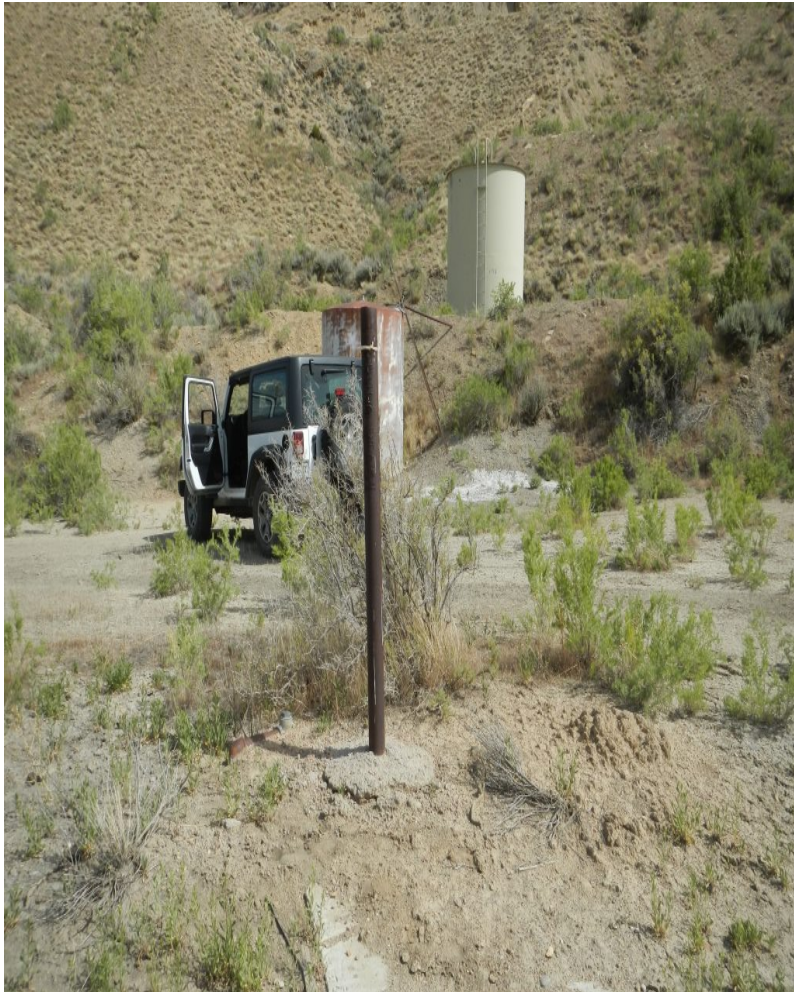
Photo#4:
Woosley#1, PA Marker North of Tanks

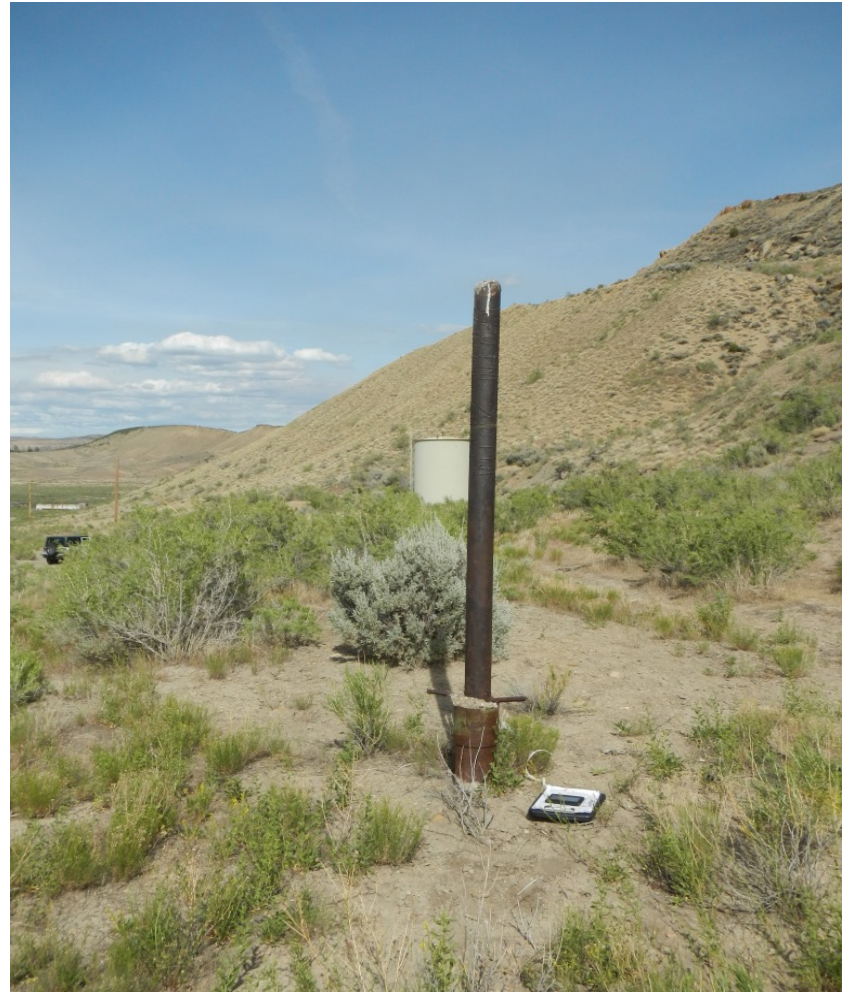
Photo#5:
Woosley #2, PA Marker West of Tanks.

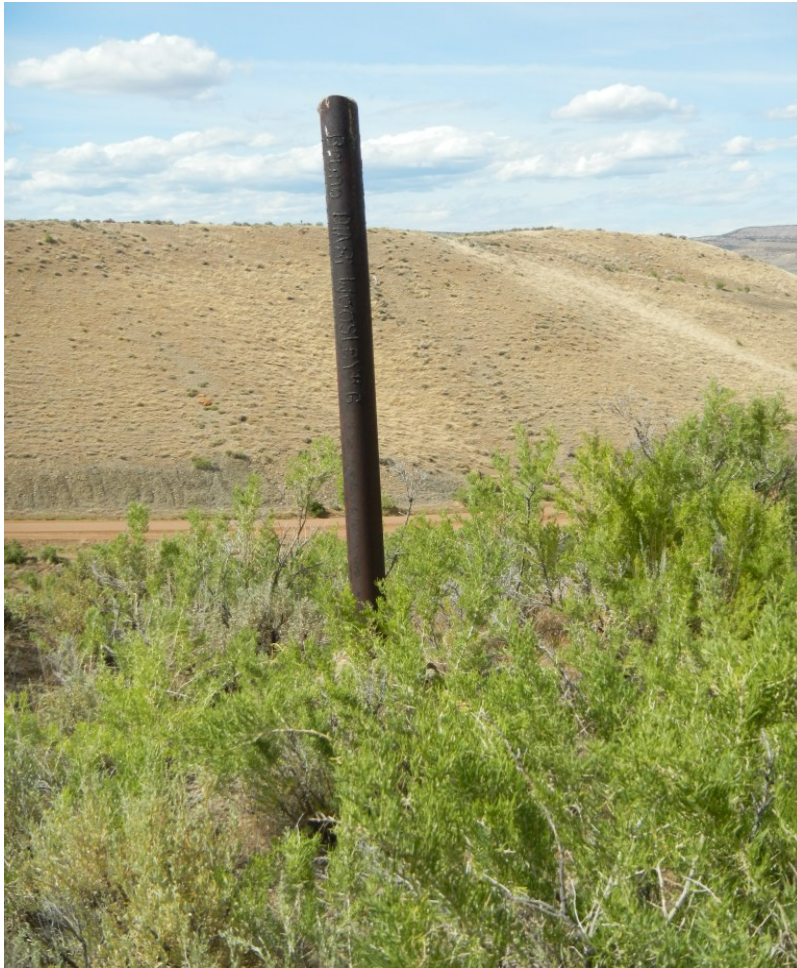
Photo#6:

Woosley #6, PA Marker, South of Tanks

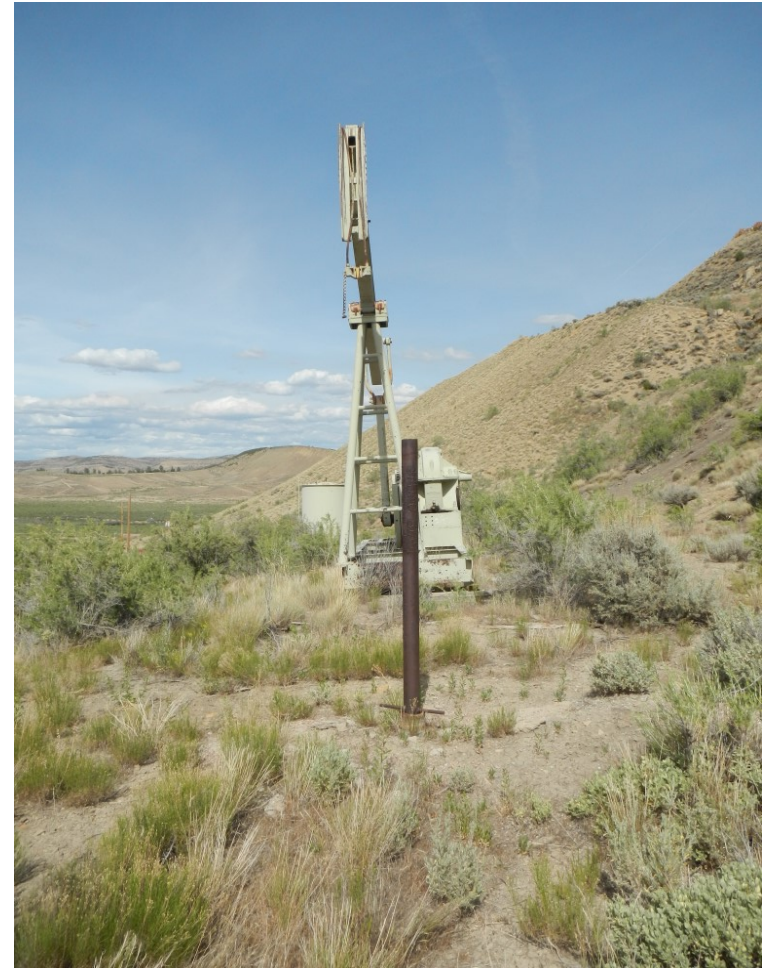
Photo#7:

Woosley #7, PA Marker West of Pump Jack

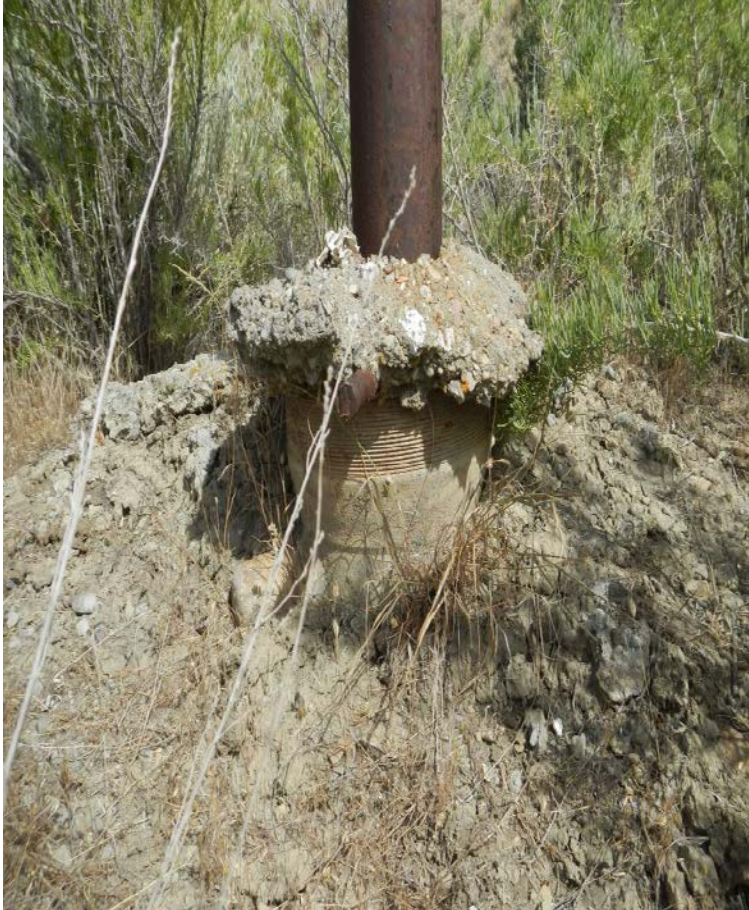
Photo#8:

Base of PA Marker Woosley #6.

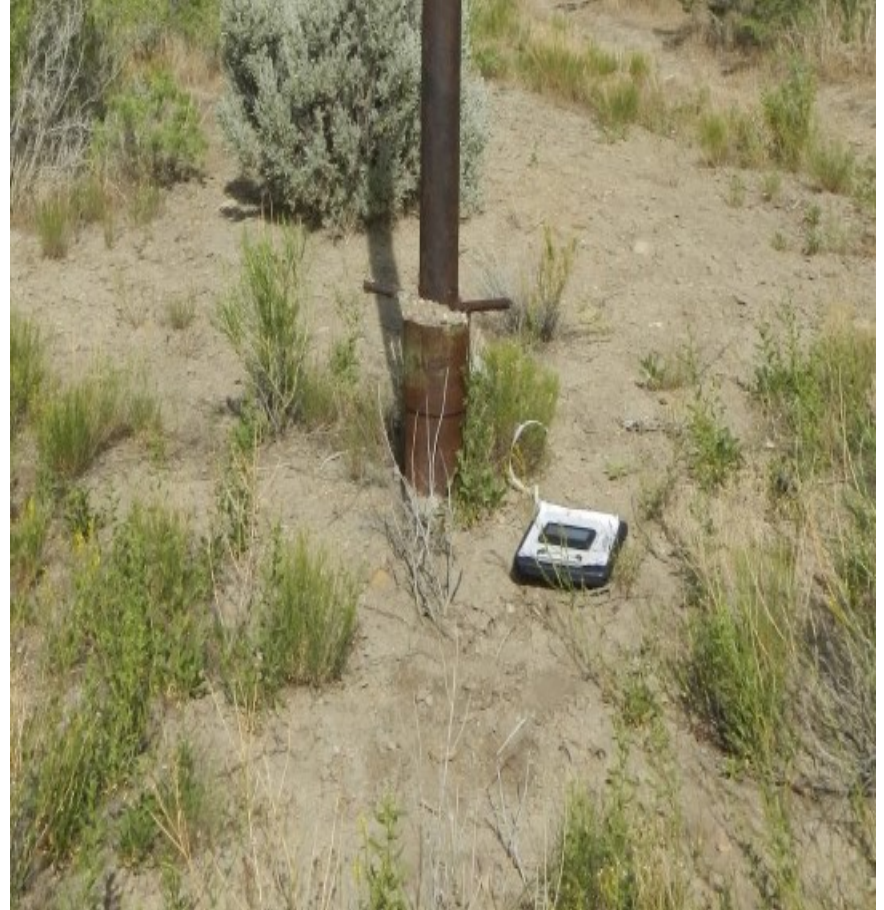
Photo#9:

Base of PA Marker Woosley #2.

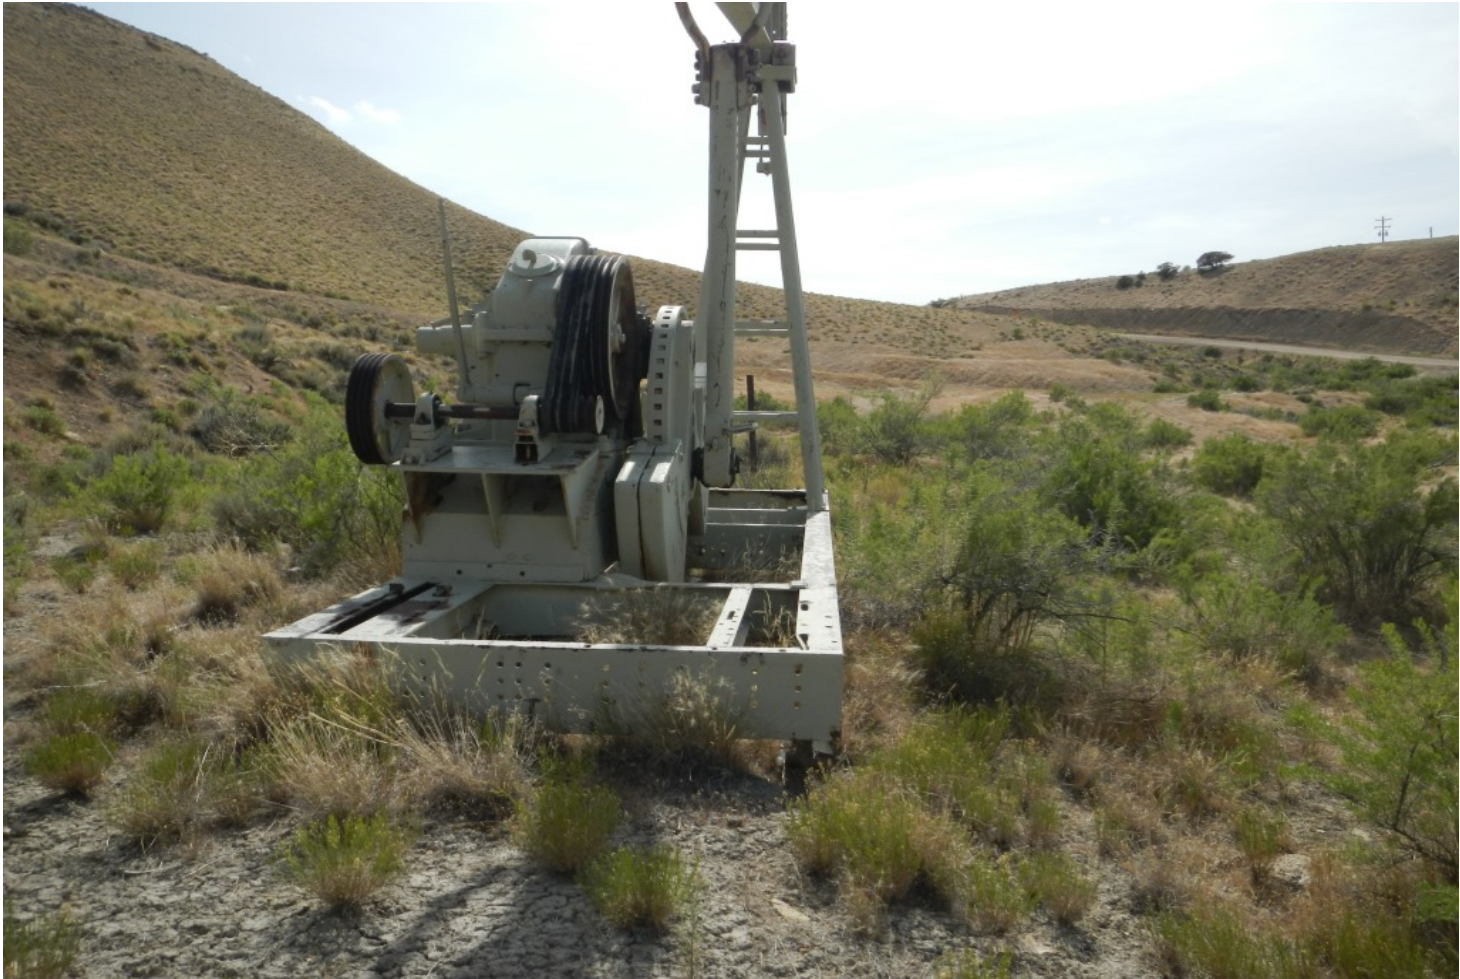
Photo#10:
Pump Jack on Location..

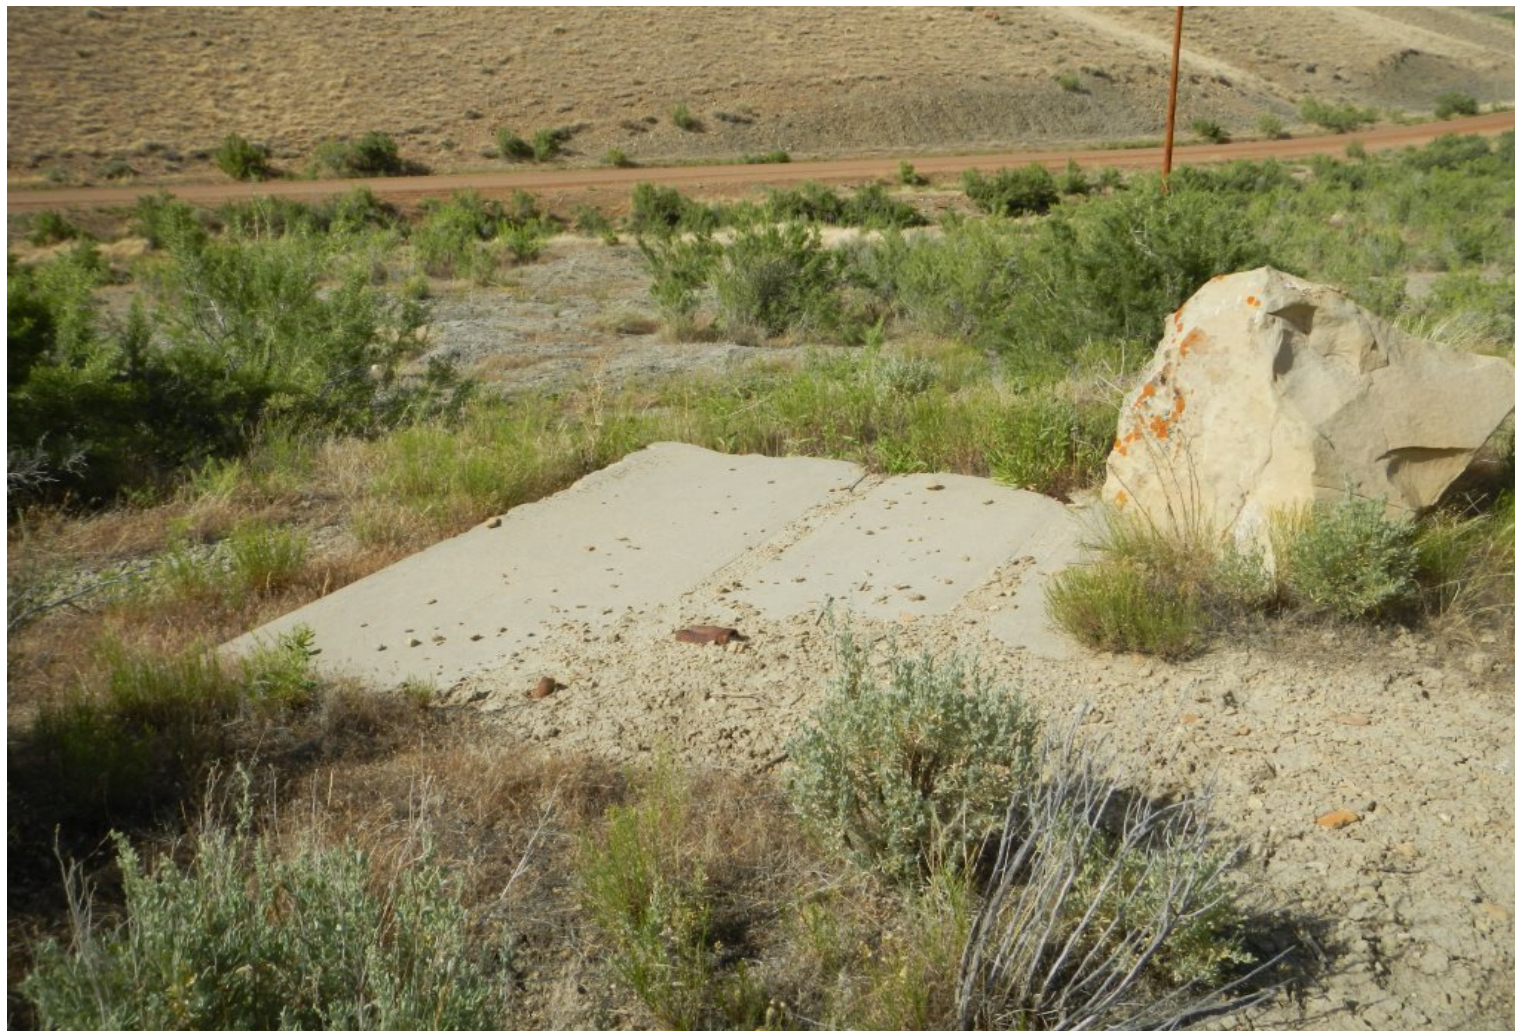
Photo#11:
Concrete Slabs on Location..

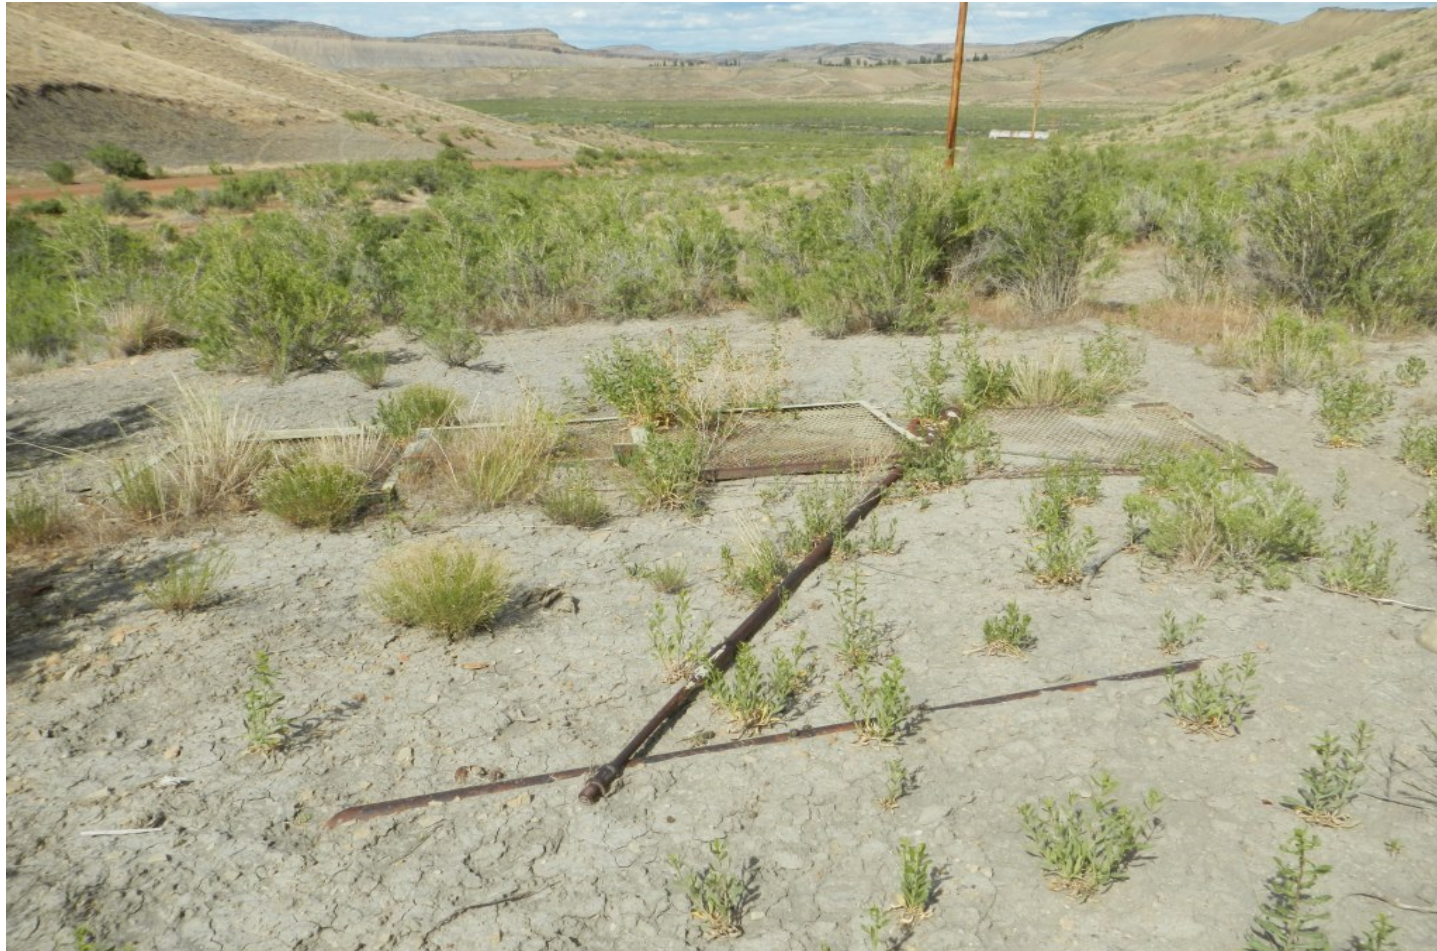
Photo#12:
Various Piping & Debris on Location.
