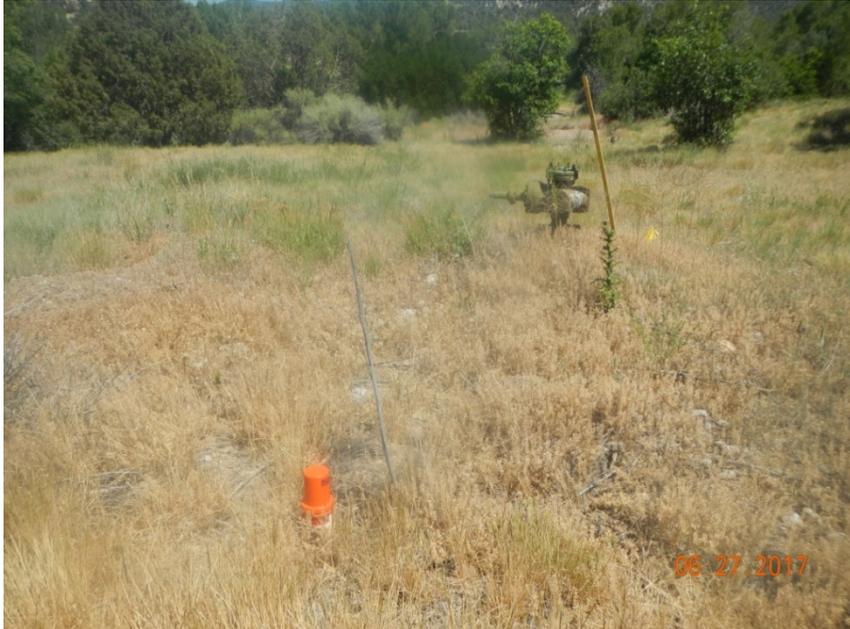
**Photo 1: View of risers at 37.10197, -107.85541, in southeastern portion of the project area.**

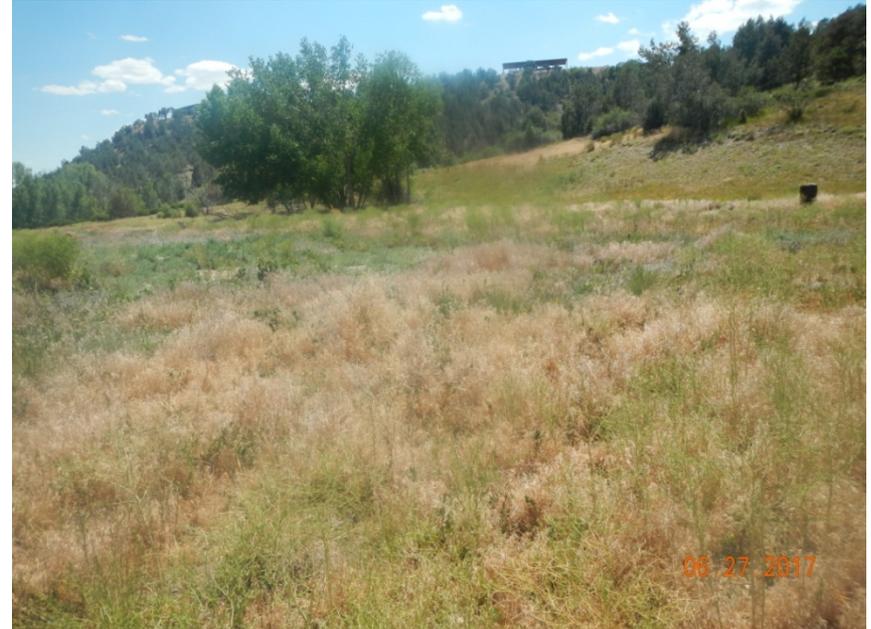
**Photo 2: View of the project area from the northeastern corner facing center. Well pad was not recontoured and largely vegetated with weeds.**

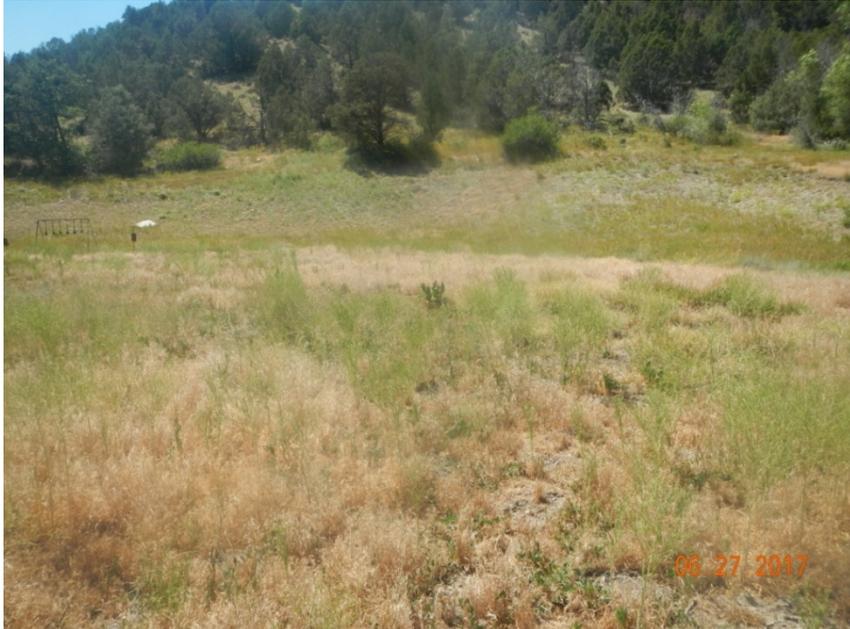
**Photo 3: View of the northern portion of the project area from the northeastern corner facing westward. Cut slope is still in place well pad is flat.**

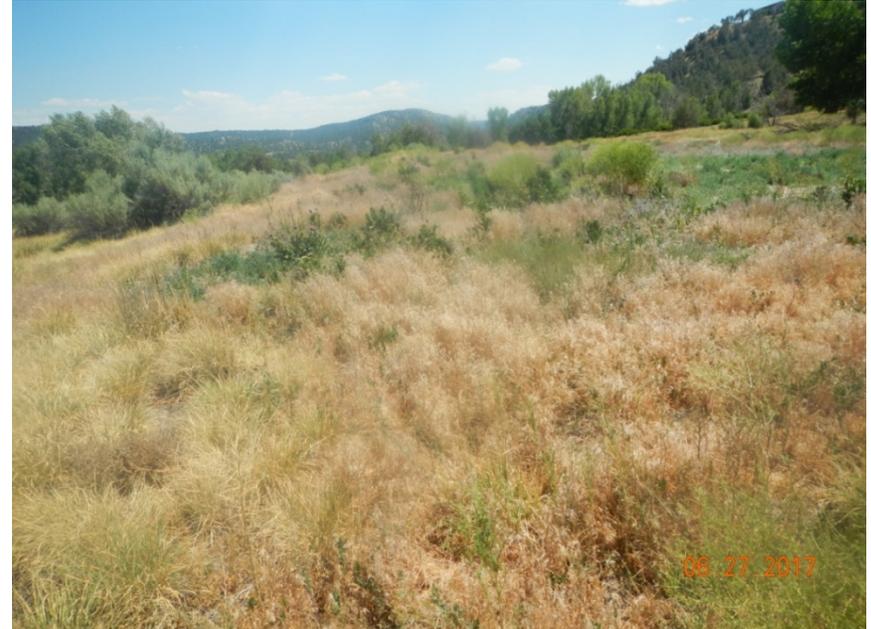
**Photo 4: View of the eastern portion of the project area from the northeastern corner facing southward.**

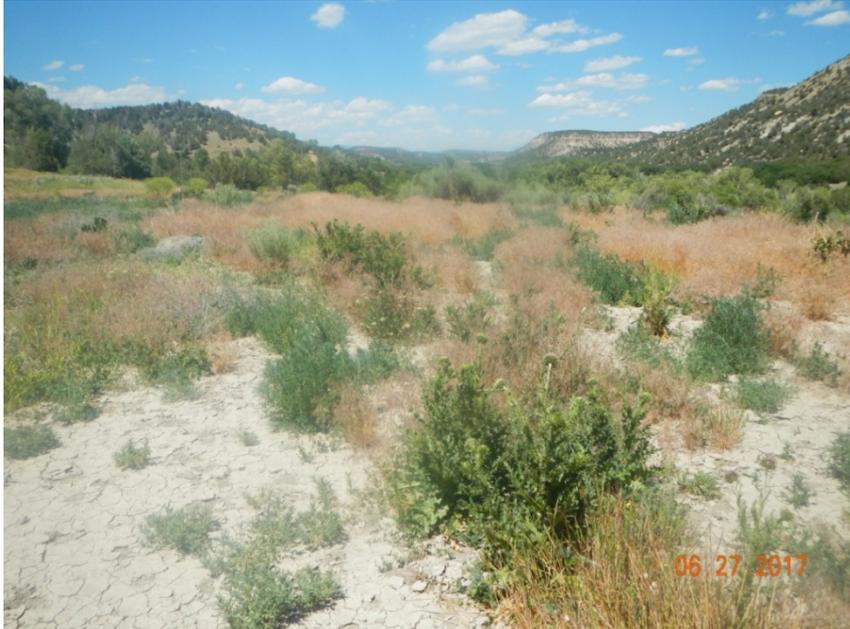
**Photo 5: View of musk thistles (*Carduus nutans*), approximately 200 growing within the well pad area.**

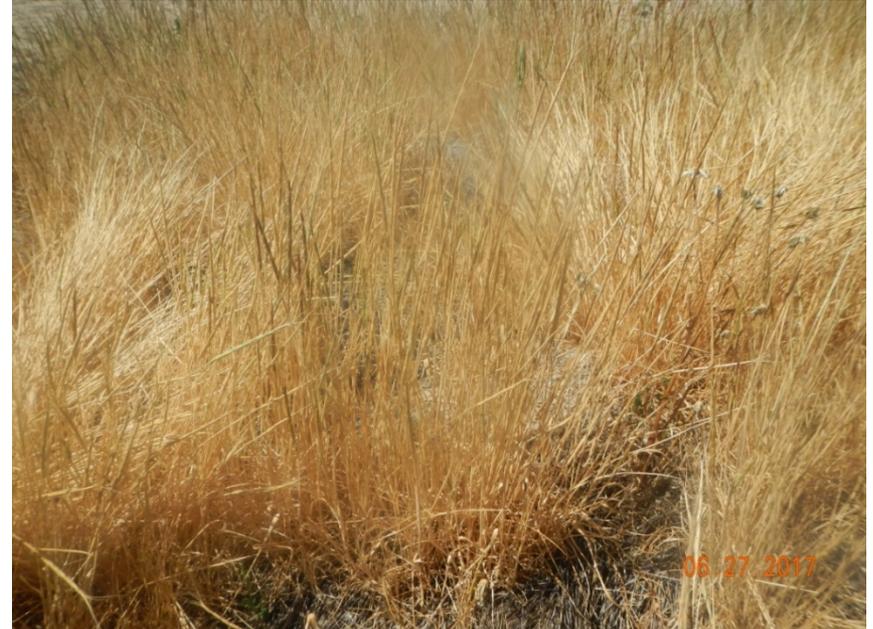
**Photo 6: View of jointed goatgrass (*Acroptilon repens*), approximately 1000 within the project area.**

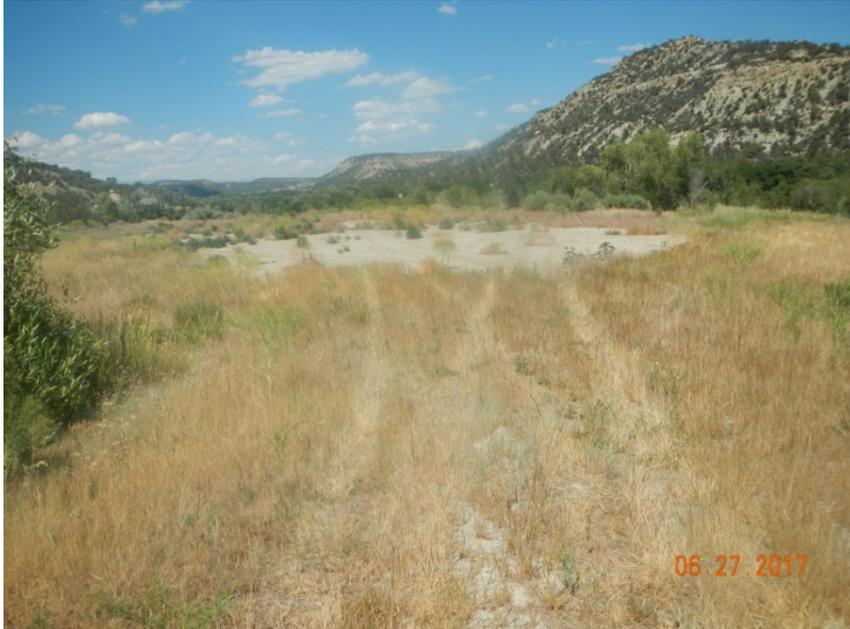
**Photo 7: View of the well pad from the access road facing northeastward. Little to no desirable vegetation growing on well pad that is not reclaimed.**
