COGCC Environmental Field Inspection Report Photo Attachment

Inspection Date: **June 30, 2017**

Steven J. Arauza, P.G.

**Oil & Gas Conservation
Commission**

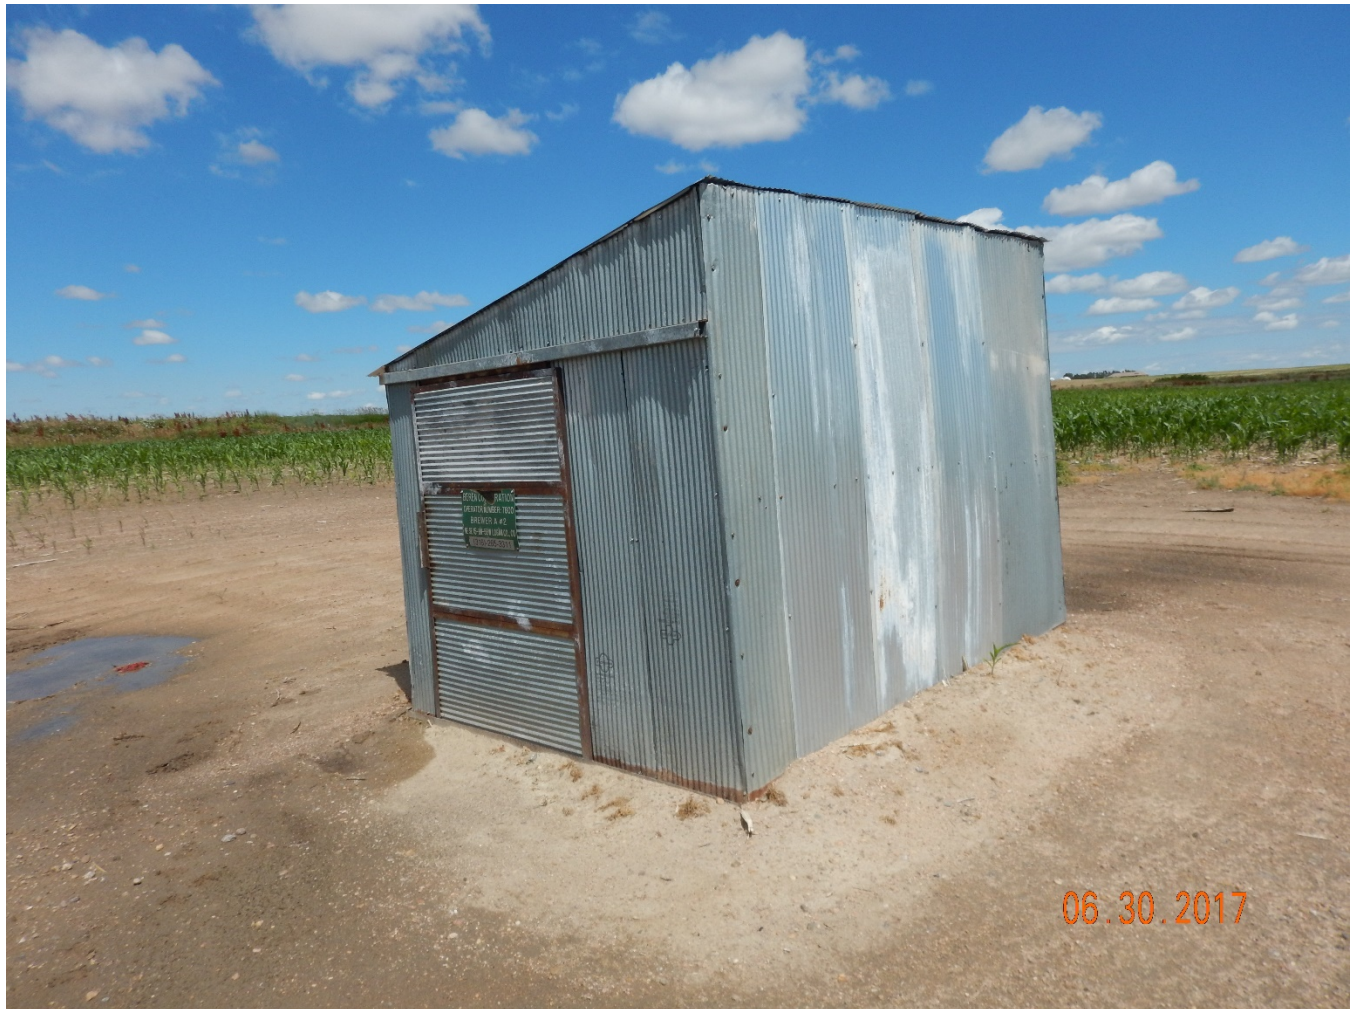
Figure 1 - Well shed with damaged sign.

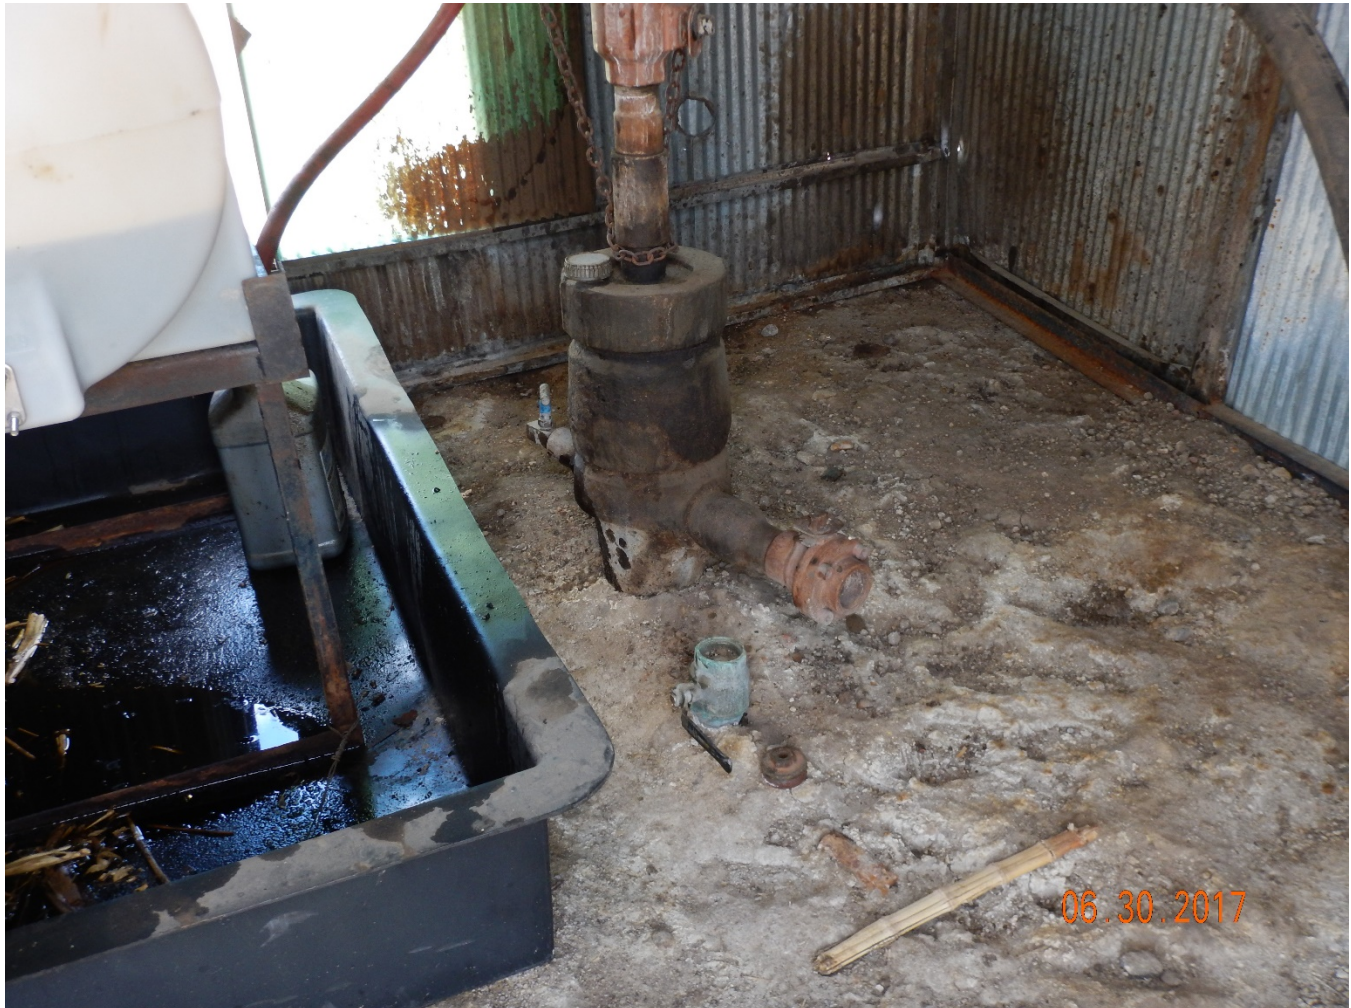
Figure 2 - Localized, oil-stained soil inside of shed.

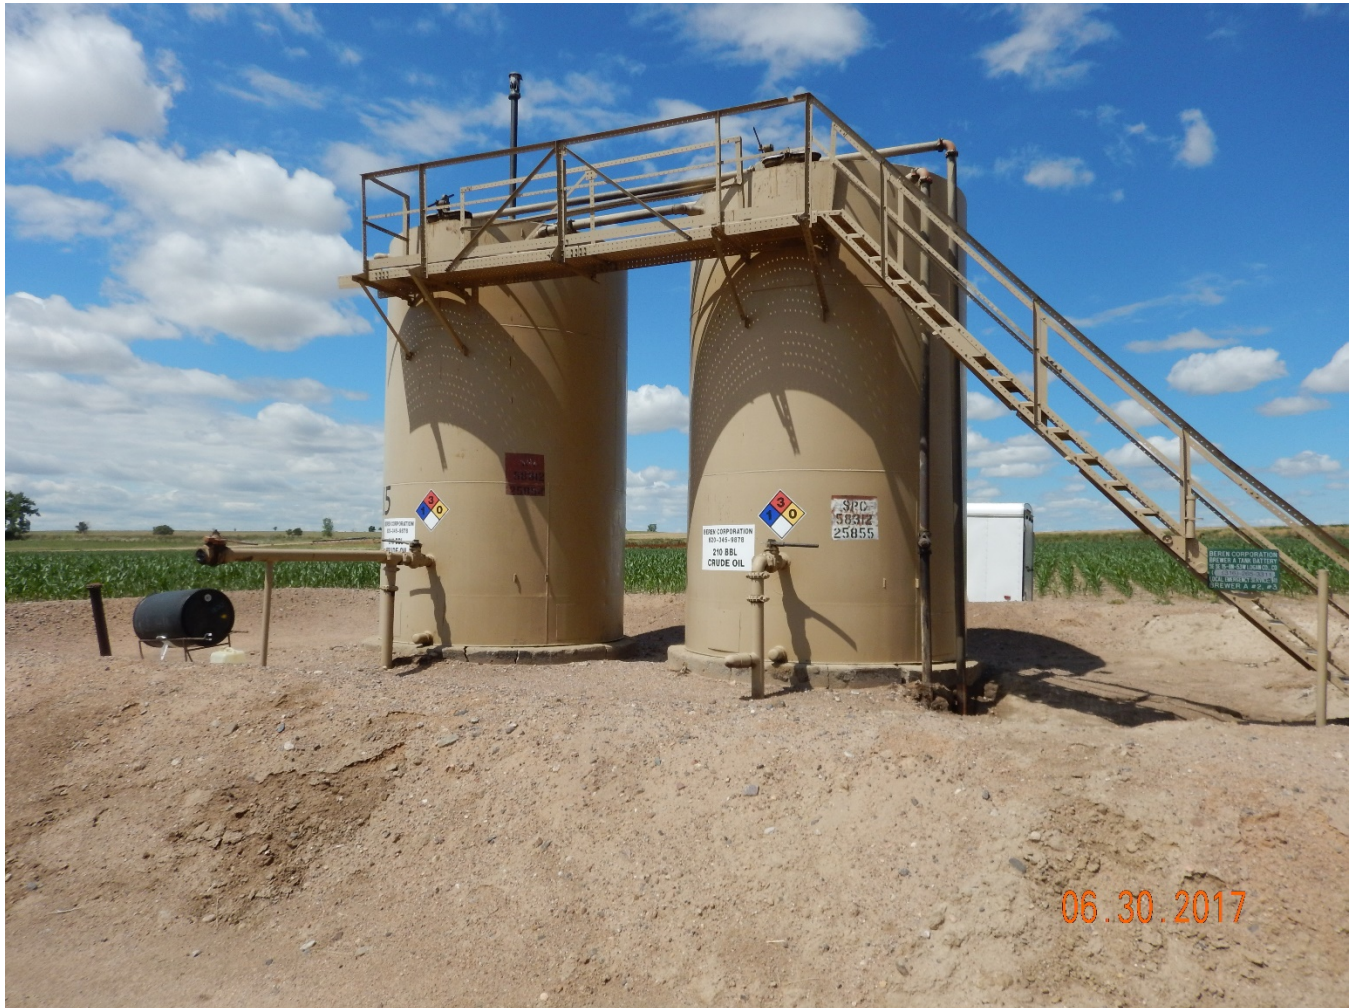
Figure 3 - Crude oil ASTs.

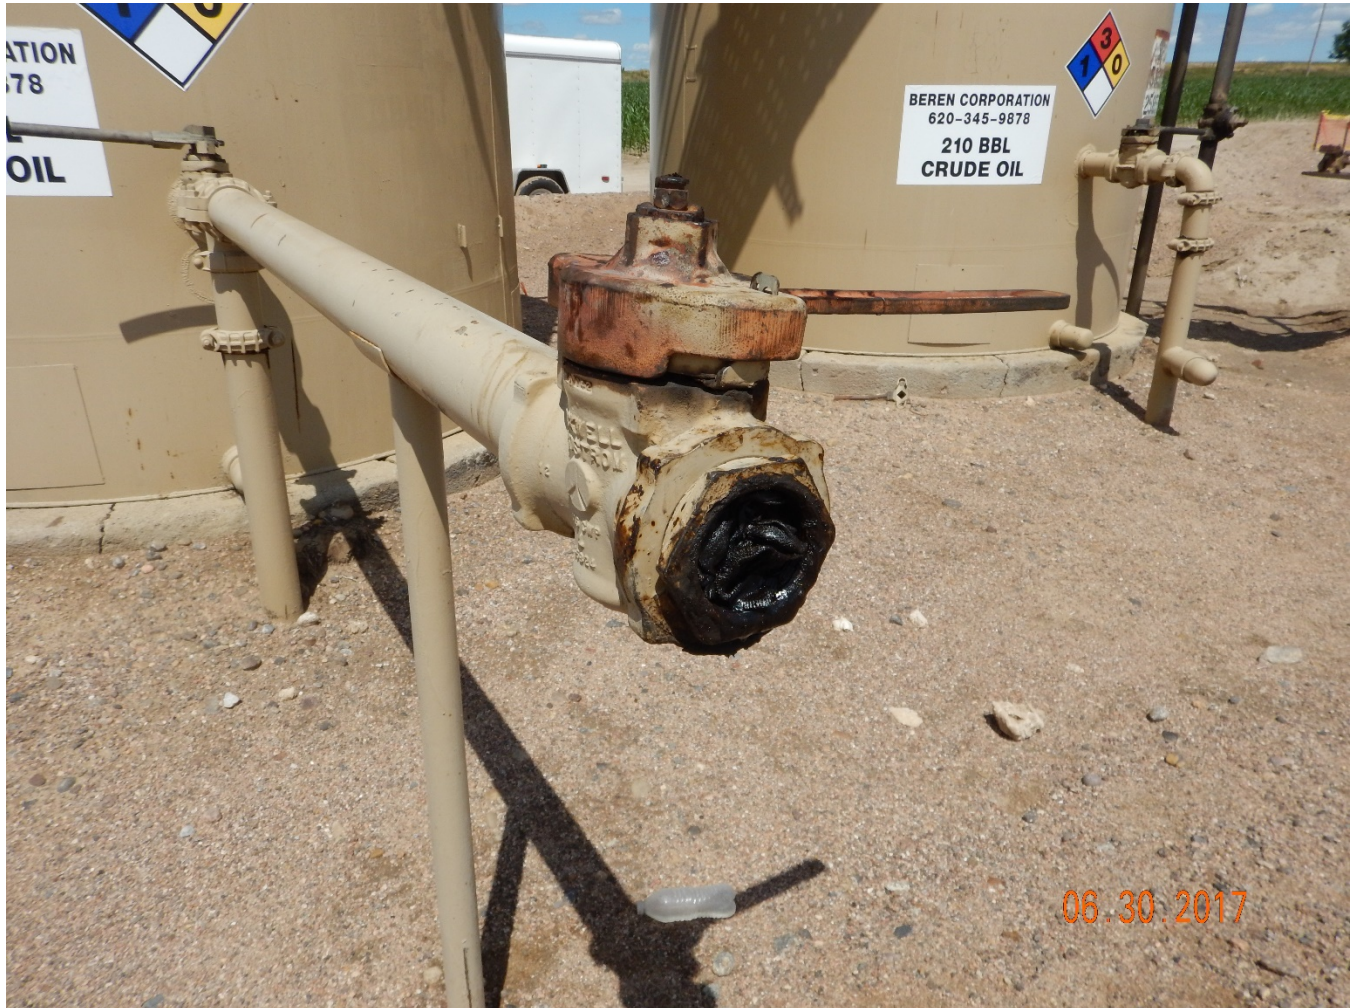
Figure 4 - Oily rag stuffed into loadout on SE side of crude oil ASTs.

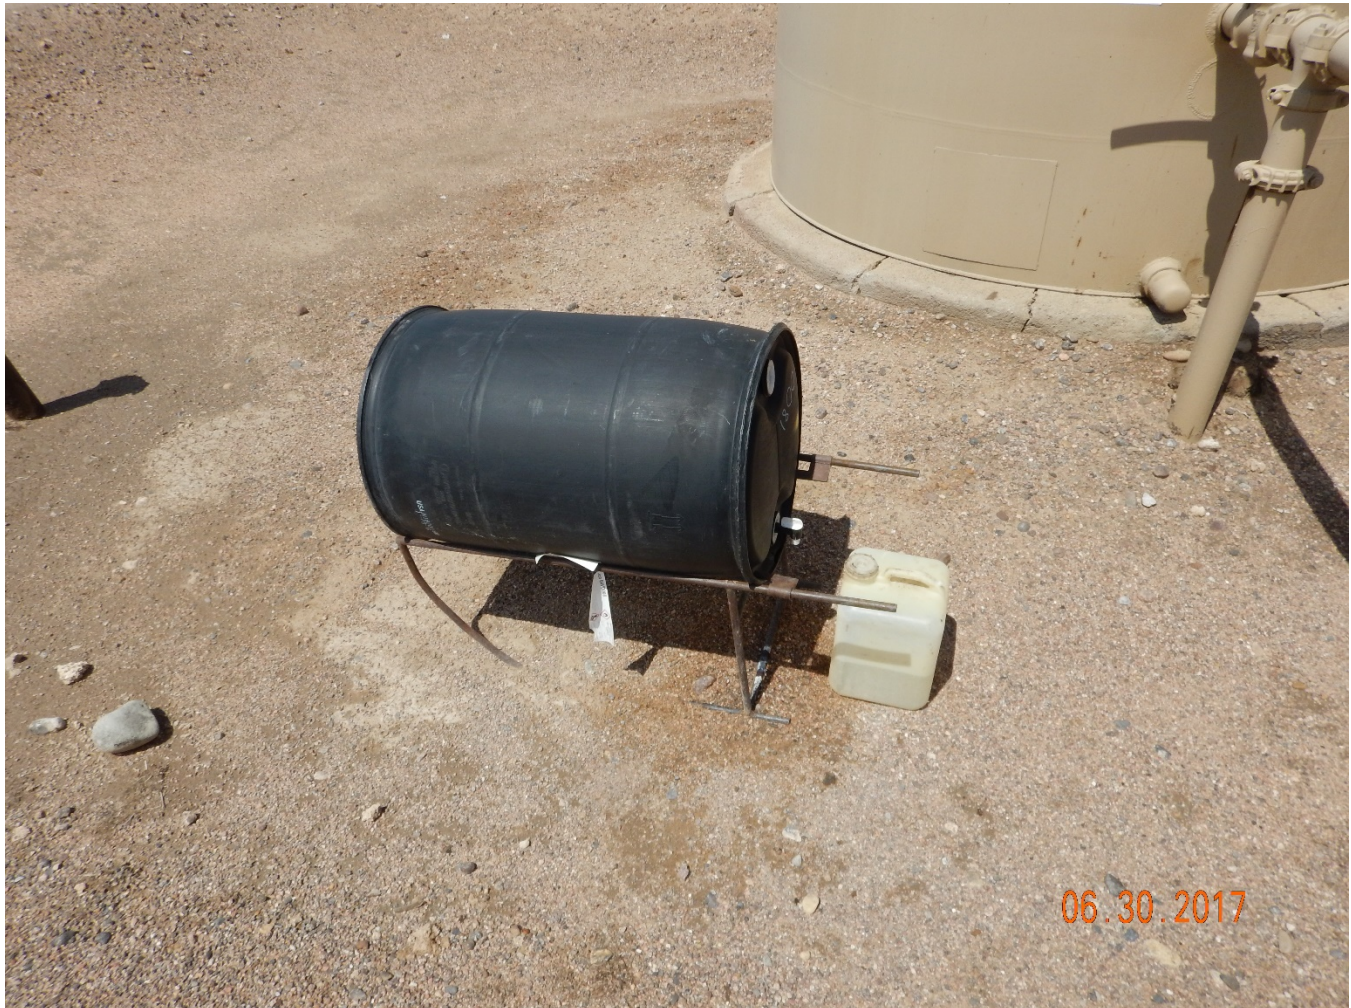
Figure 5 - Unused containers stored inside of earthen berm.

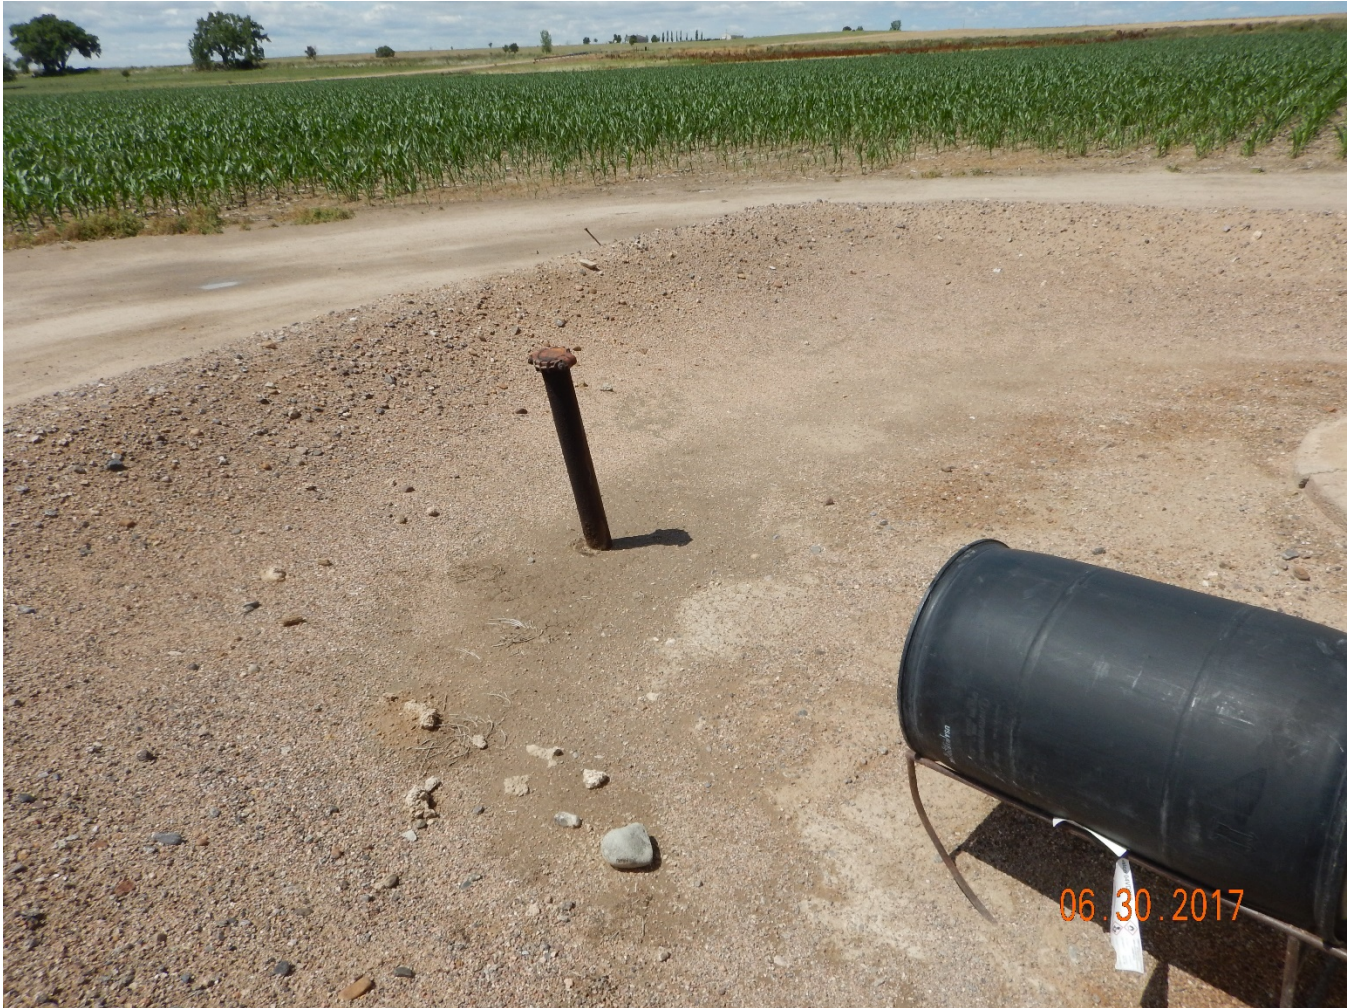
Figure 6 - Abandoned flowline riser S of crude oil ASTs.

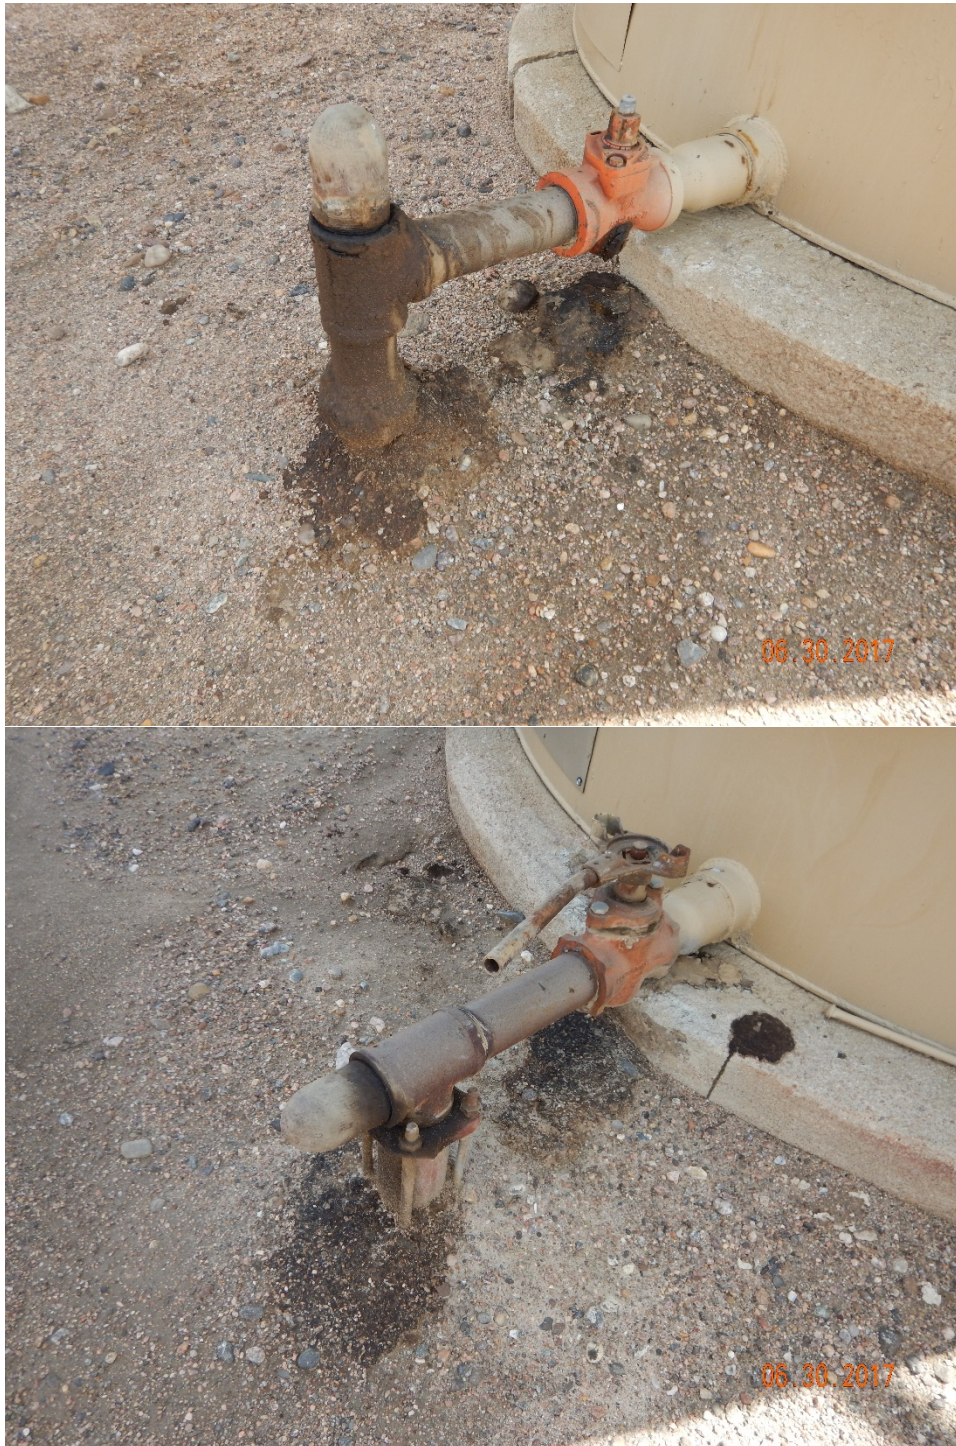
Figure 7 - Localized, oil-stained soil beneath valves on west side of crude oil ASTs.

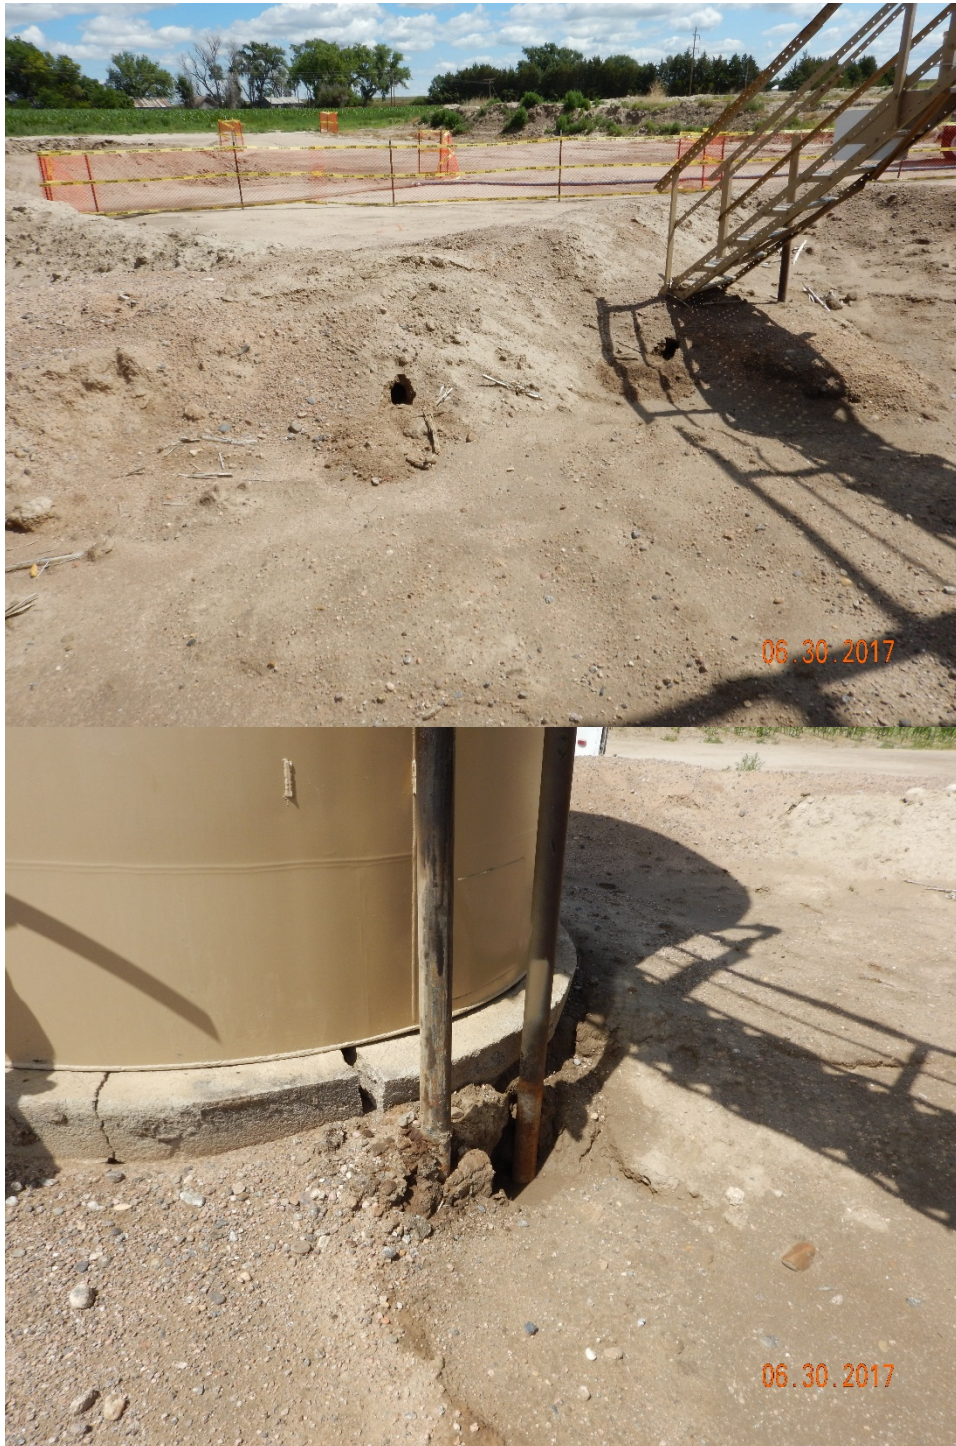
Figure 8 - Earthen berm around crude oil ASTs needs repair (top: north wall; bottom: base of berm on north side of crude oil tanks).

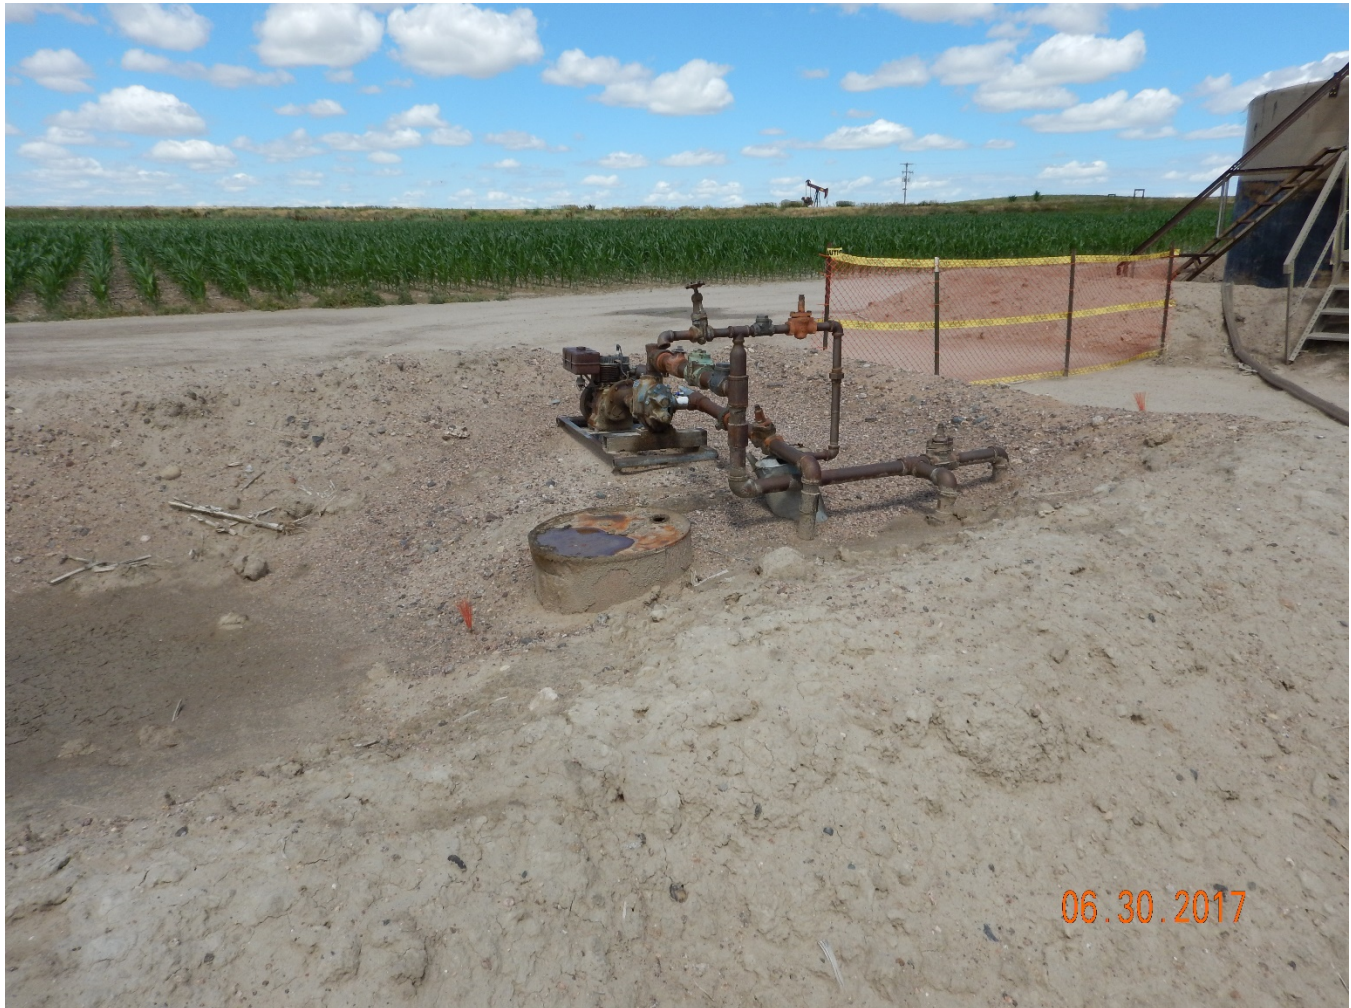
Figure 9 - Compressor with flowline risers and partially-buried 55-gallon drum located north of crude oil ASTs.

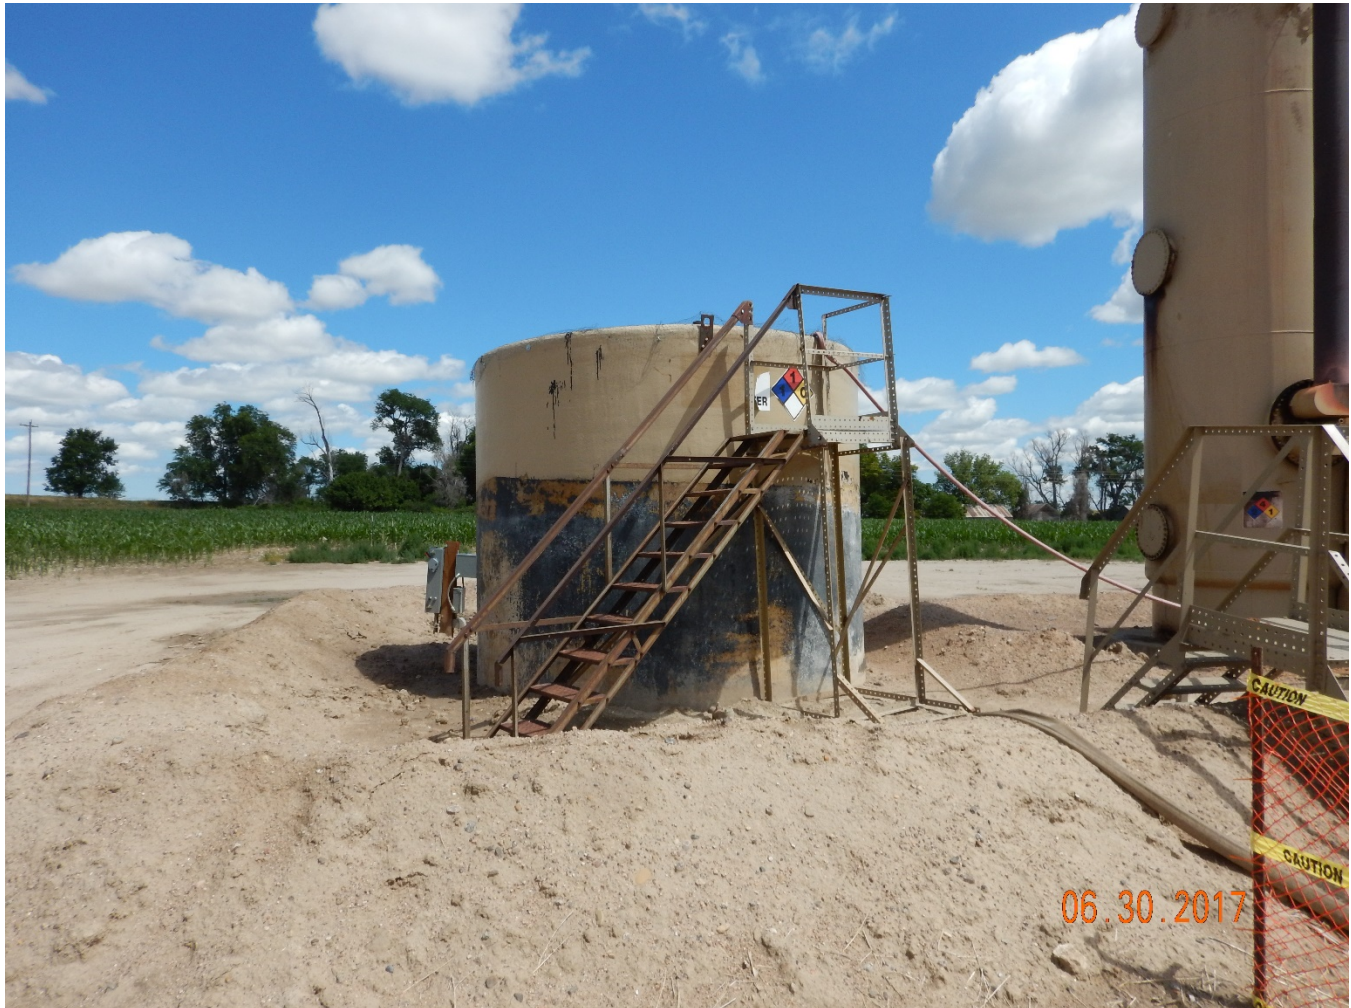
Figure 10 - Produced water tank missing content and volume labels.

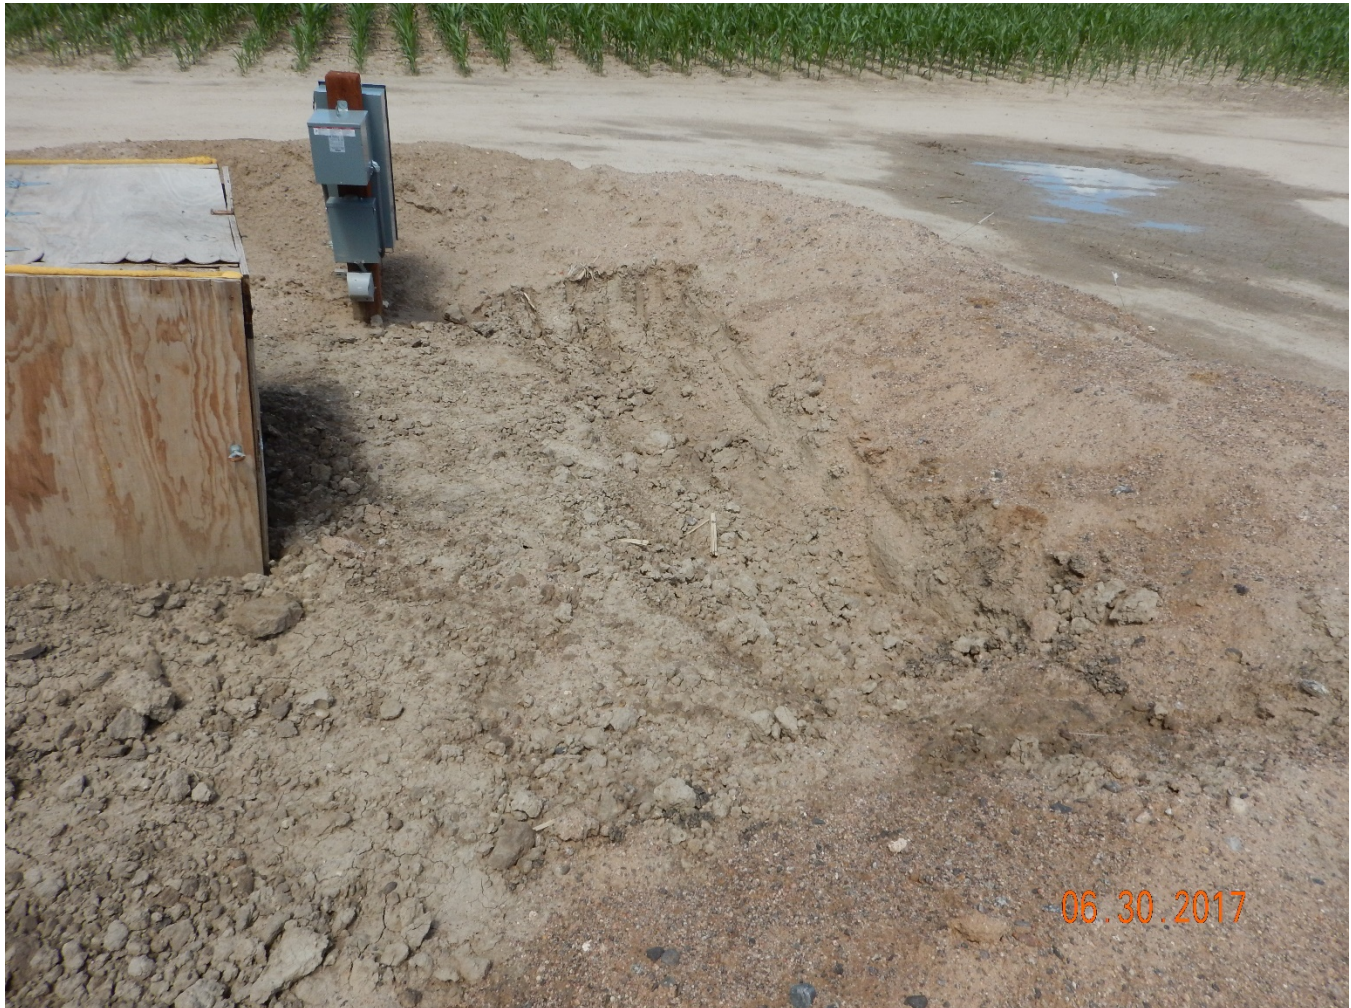
Figure 11 - Earthen berm north of produced water tank has been damaged by an excavator and is in need of repair.

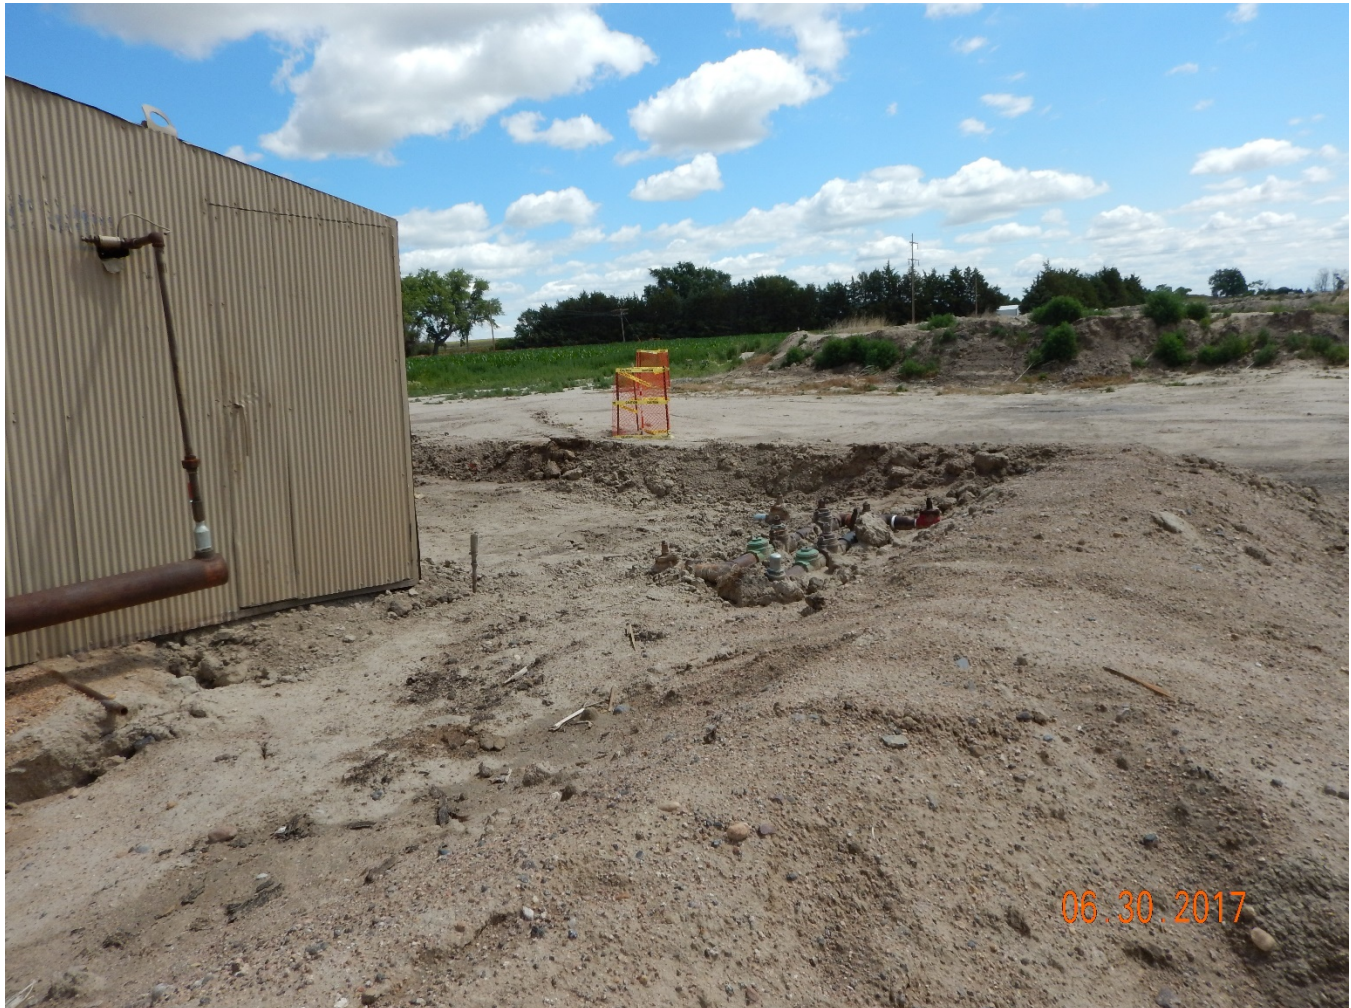
Figure 12 - Berm base and walls in need of repair at SE corner of separator shed. Earthen berm is shared by separator and produced water tank.

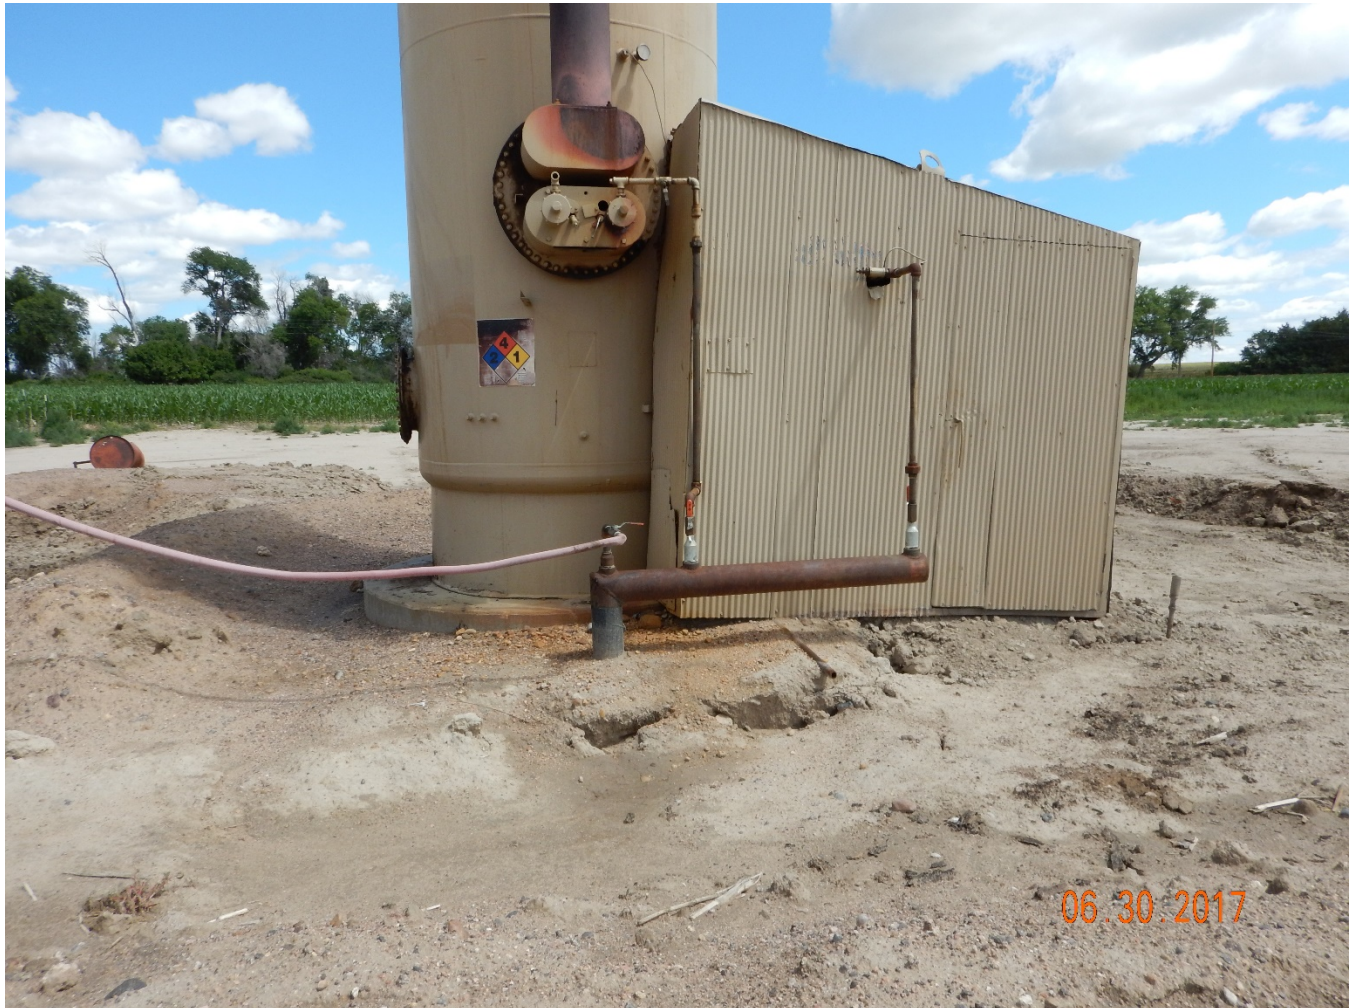
Figure 13 - Erosion on south side of separator shed.

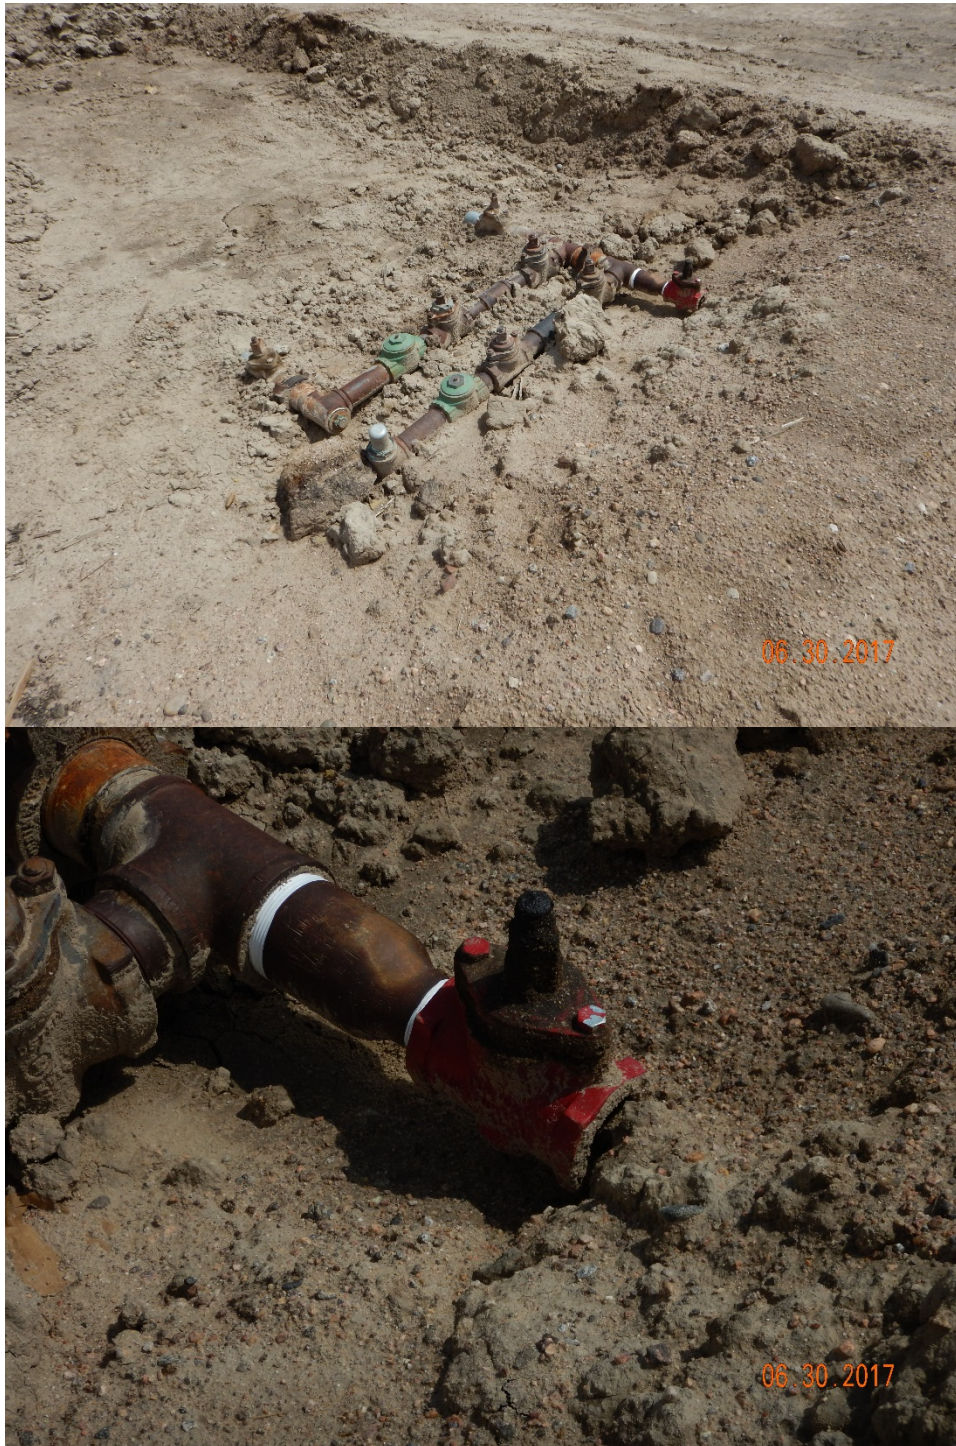
Figure 14 - Flowline manifold at SE corner of produced water tank/separator berm. Note that the red valve at SE corner is uncapped and filling with soil (bottom photo).

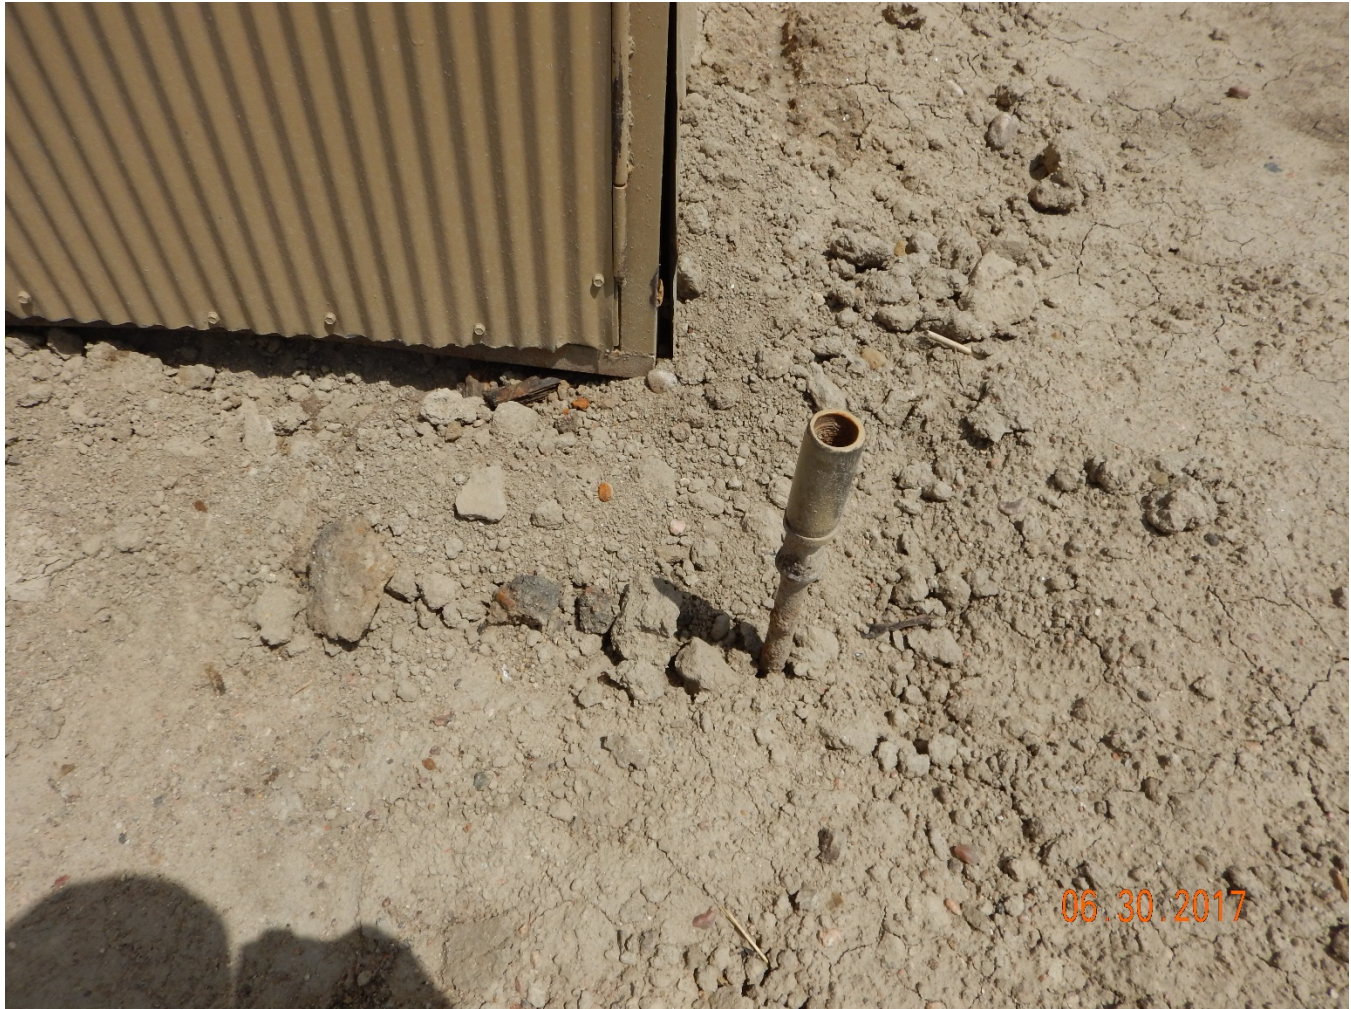
Figure 15 - Uncapped 1" flowline at SE corner of separator shed.

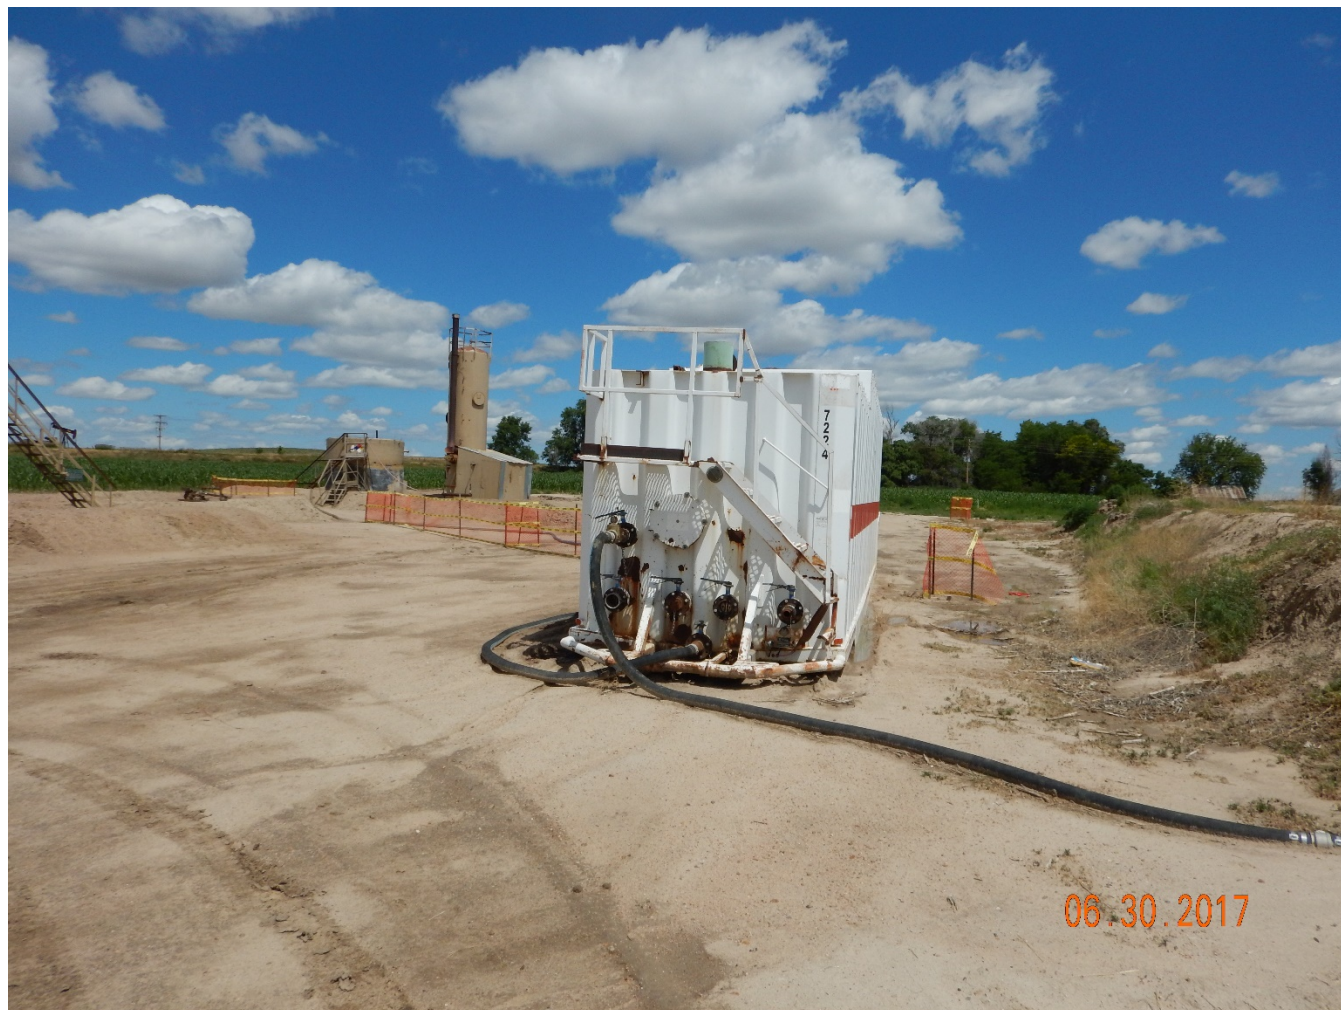
Figure 16 - Frac tank located west of produced water pit.
