COGCC Environmental Field Inspection Report Photo Attachment

Inspection Date: **June 30, 2017**

Steven J. Arauza, P.G.

**Oil & Gas Conservation
Commission**

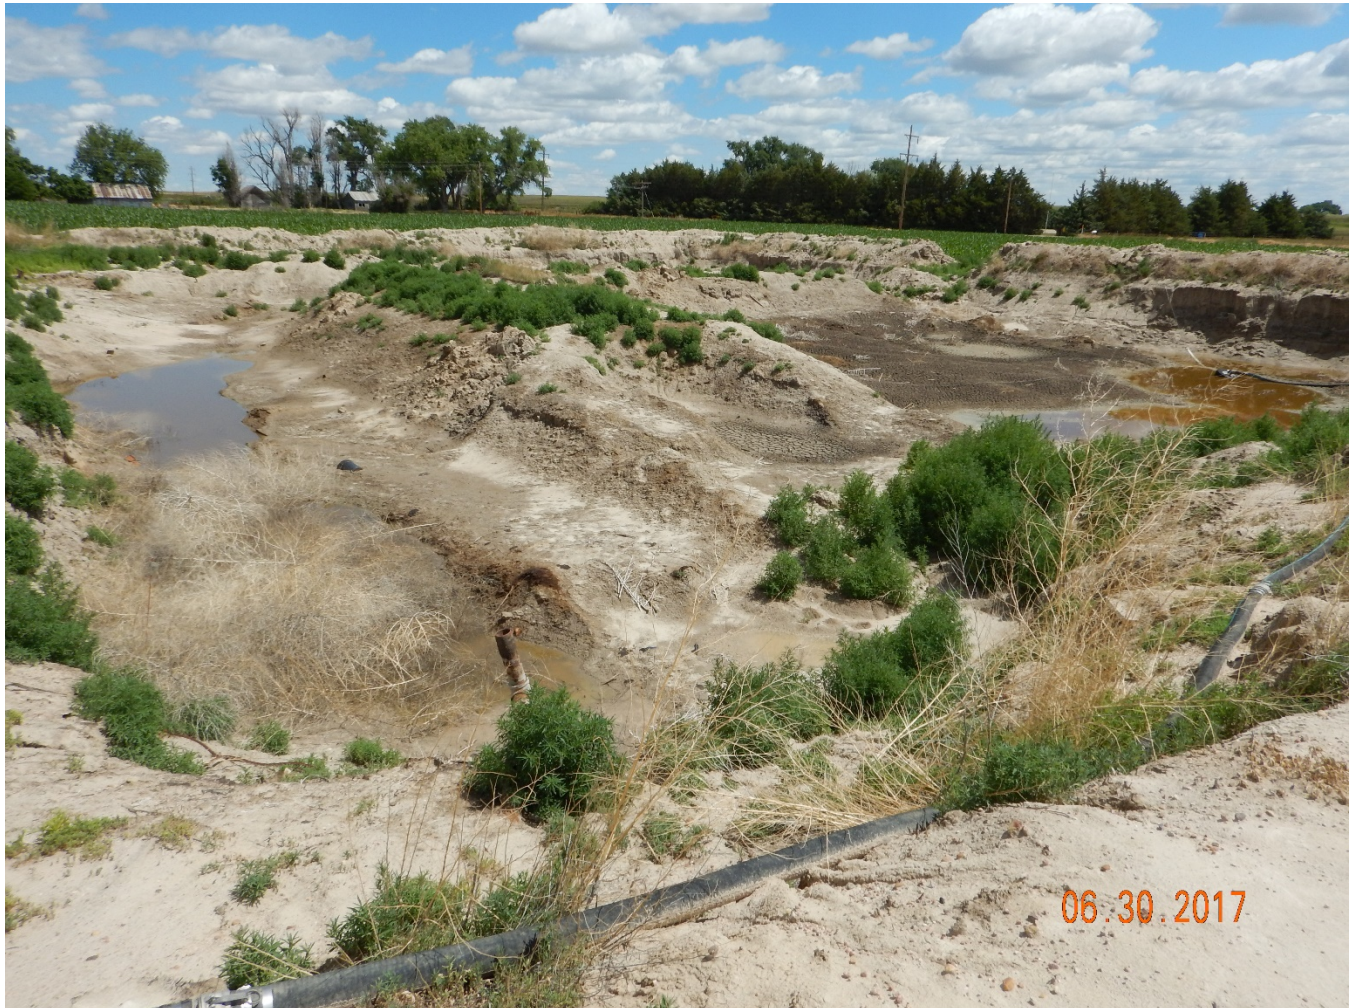
Figure 17 - View of produced water pit from SW corner. Note: oil-stained soil in SW corner (foreground) large break in east berm (background).

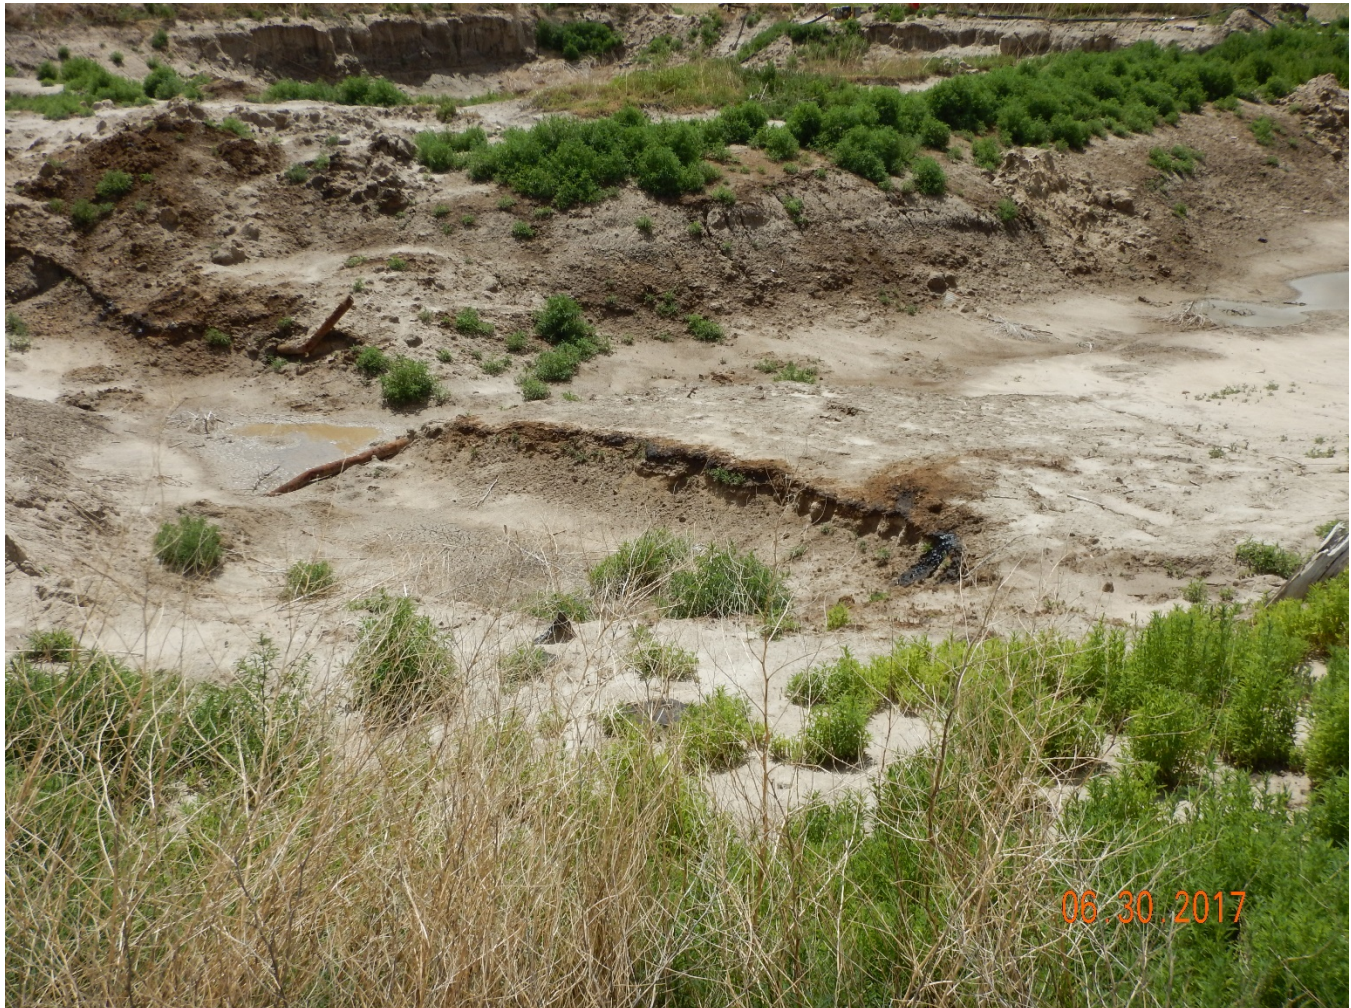
Figure 18 - Oil-stained soil and junk pipe in NW corner of produced water pit.

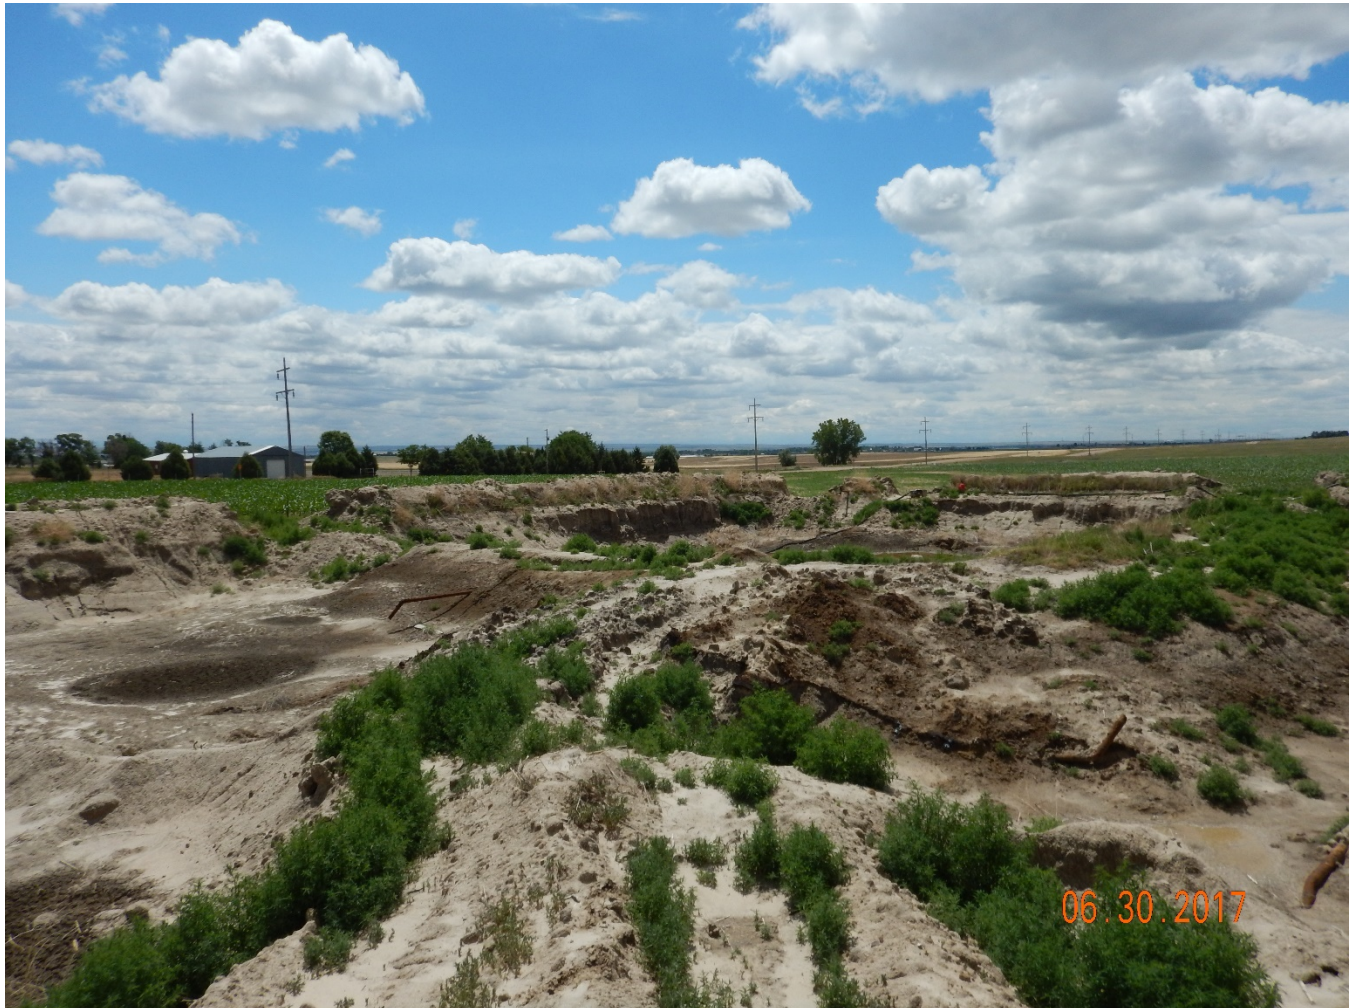
Figure 19 - View of produced water pit from NW corner. Note: oil-stained soil in foreground, junk pipe throughout pit, large gaps in berms on east and south sides (background).

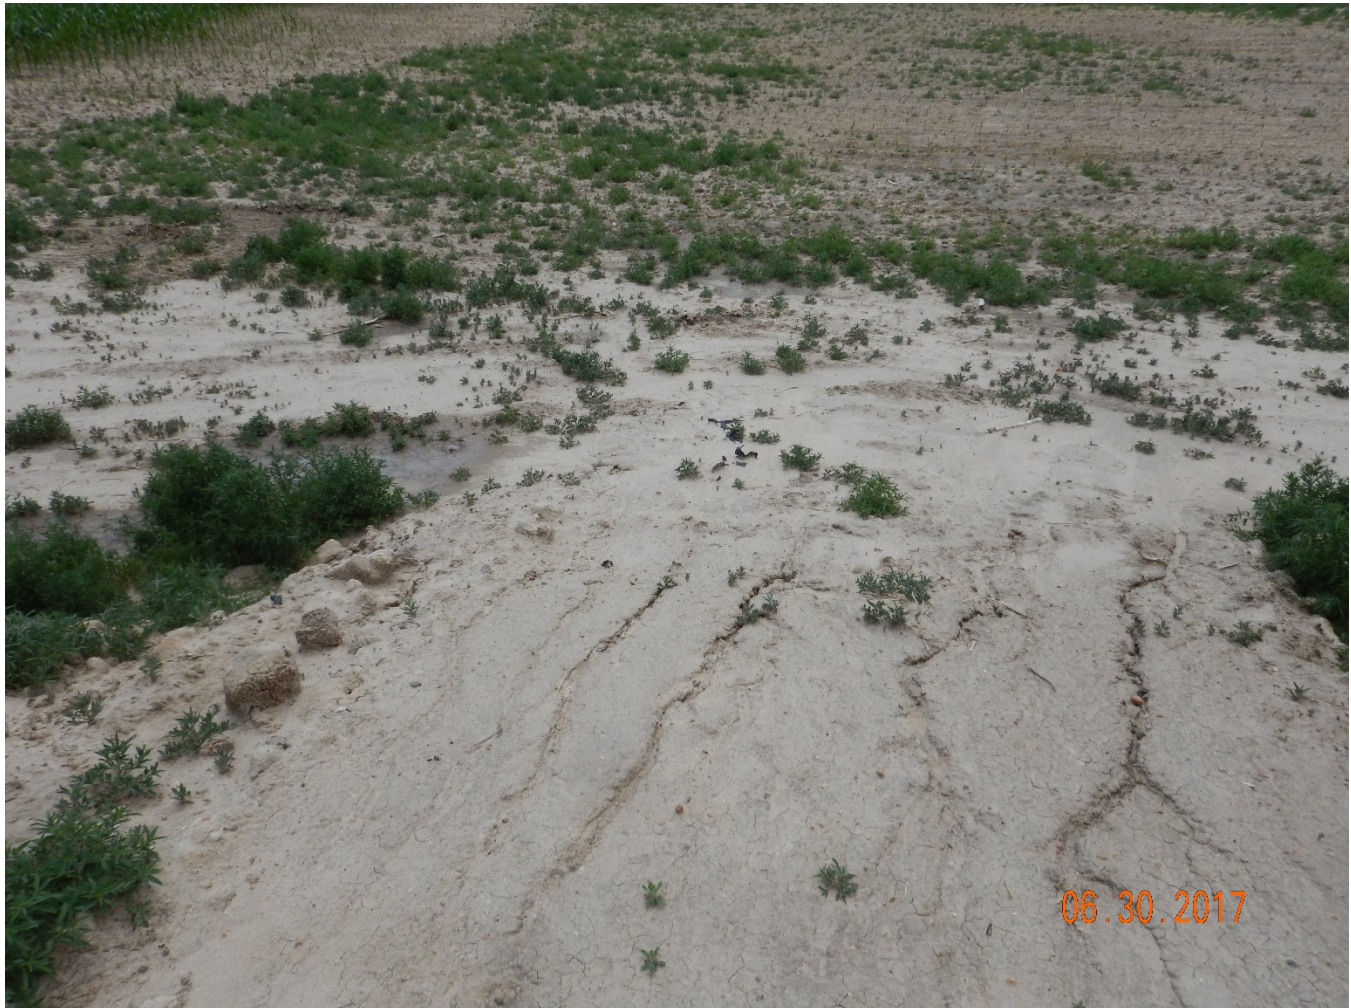
Figure 20 - Sediment transport from gap in southern pit berm into field to the south.

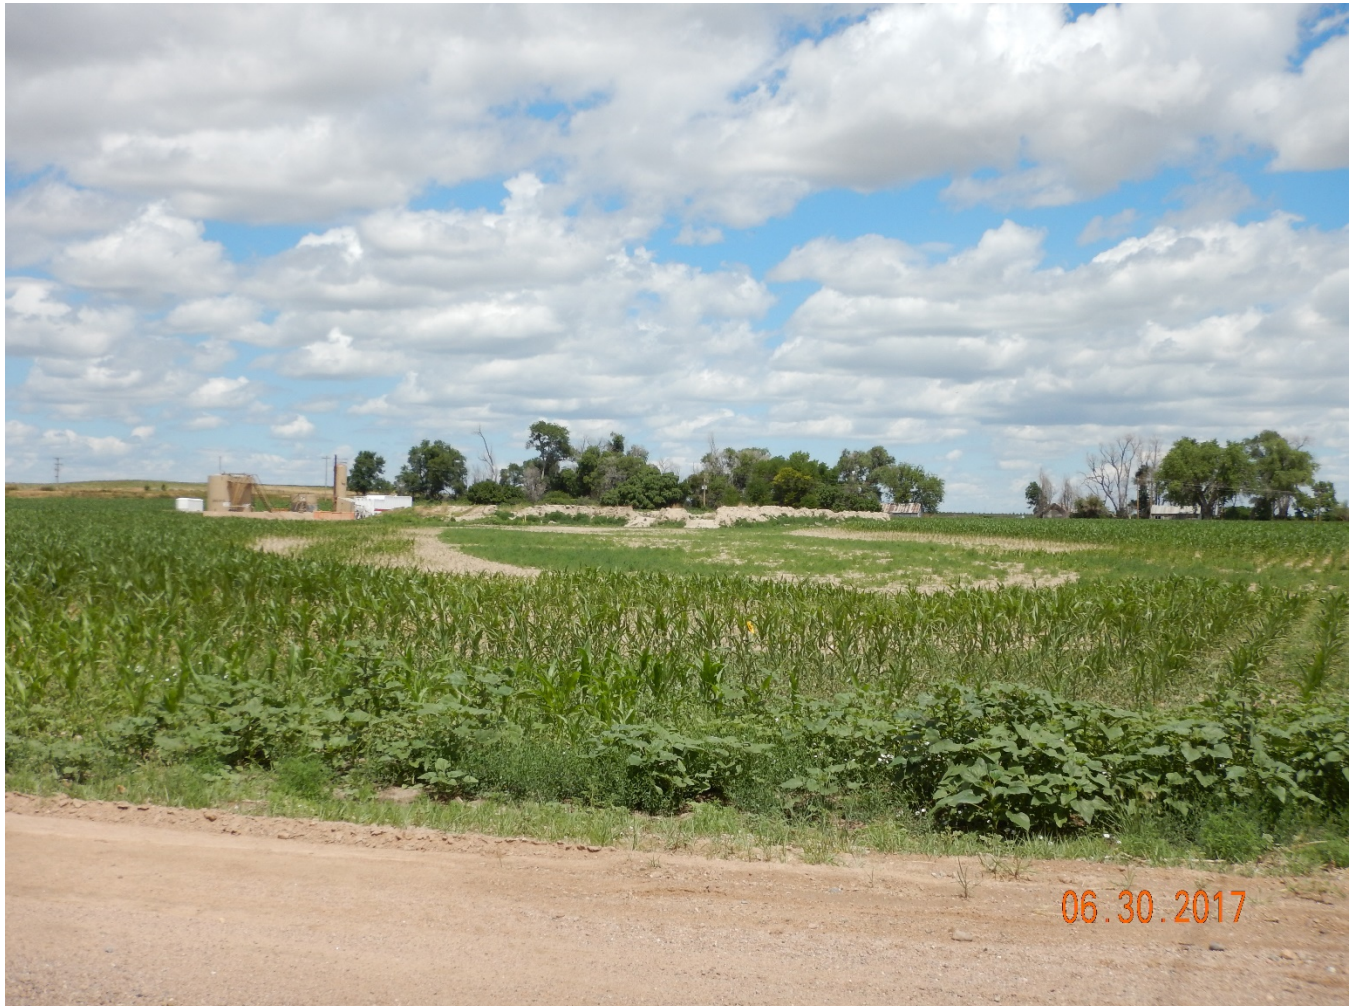
Figure 21 - View of former pit location, south of existing produced water pit. Note: impacted vegetation extends for approximately 500' SE toward the intersection of C R 32 and C R 33.
