Inspection Photos  
Location Name: USA Shaw 19  
API: 05-081-60020

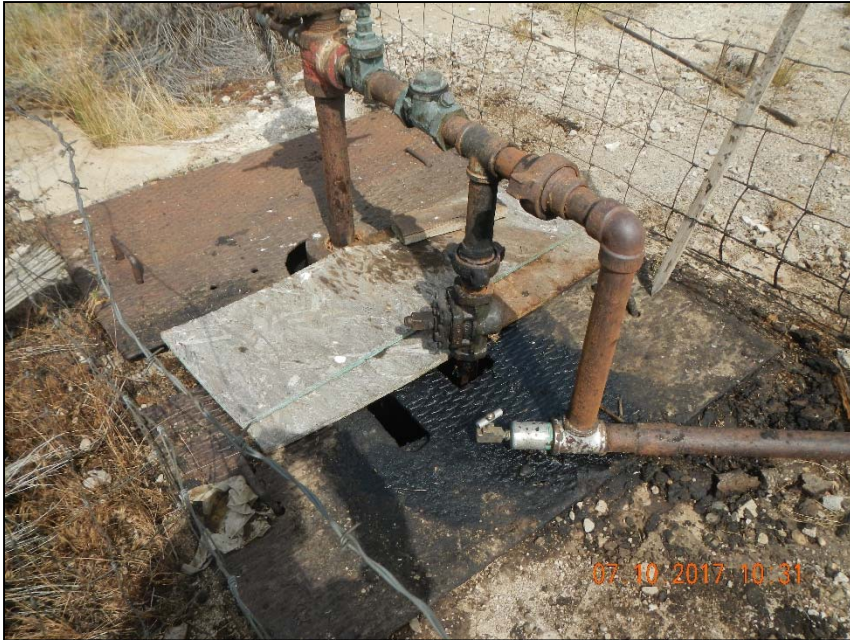
**Photo 1. Wellhead with no fluid in cellar.**

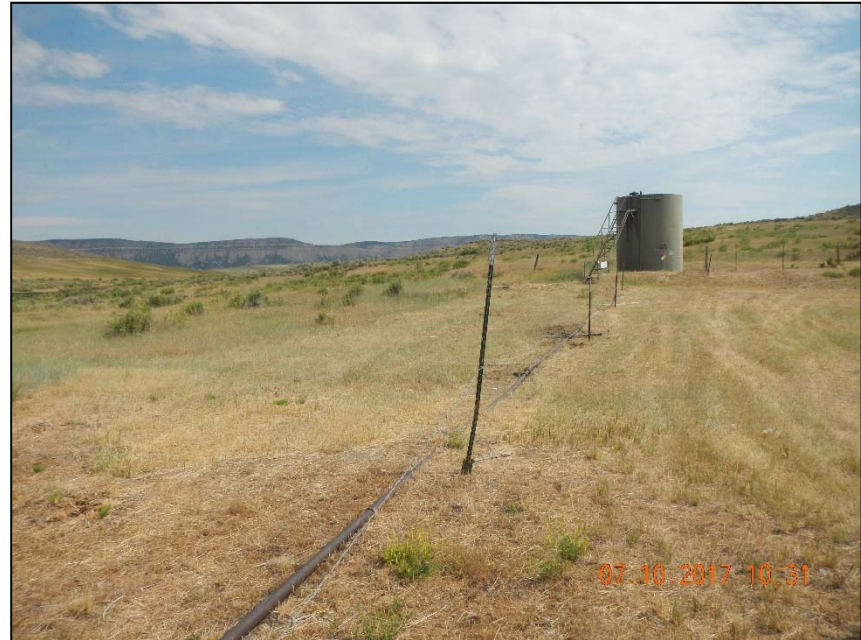
**Photo 2. Overview of flowline standing at wellhead looking to tank.**

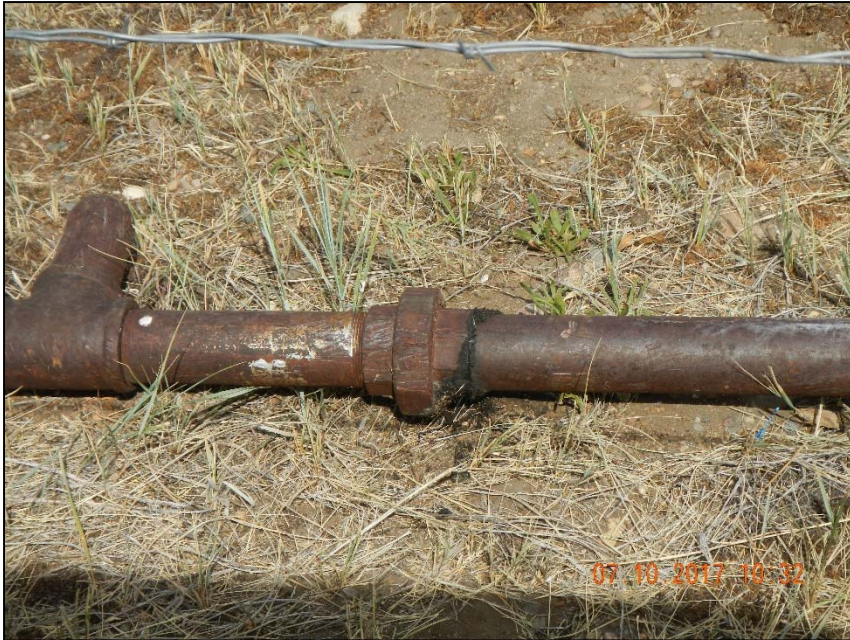
**Photo 3. Close-up of leak remaining at threads.**

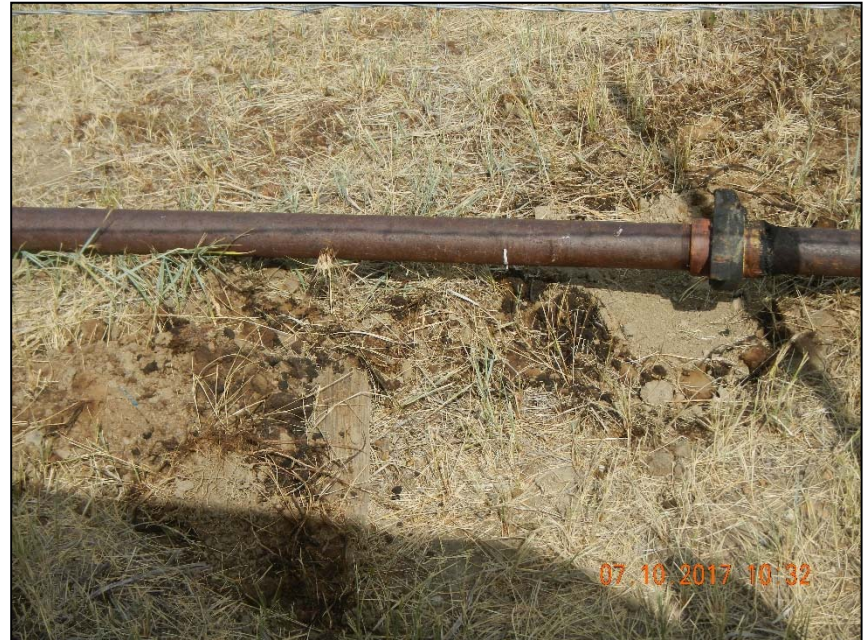
**Photo 4. Close-up of leak and clean-up efforts at threads.**

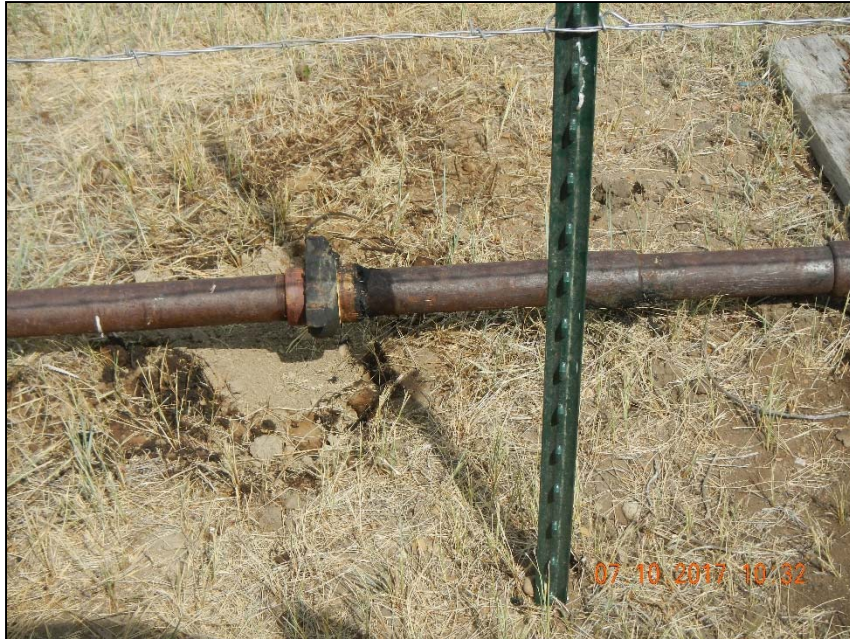
**Photo 5. Close-up of leak and clean-up efforts at threads.**

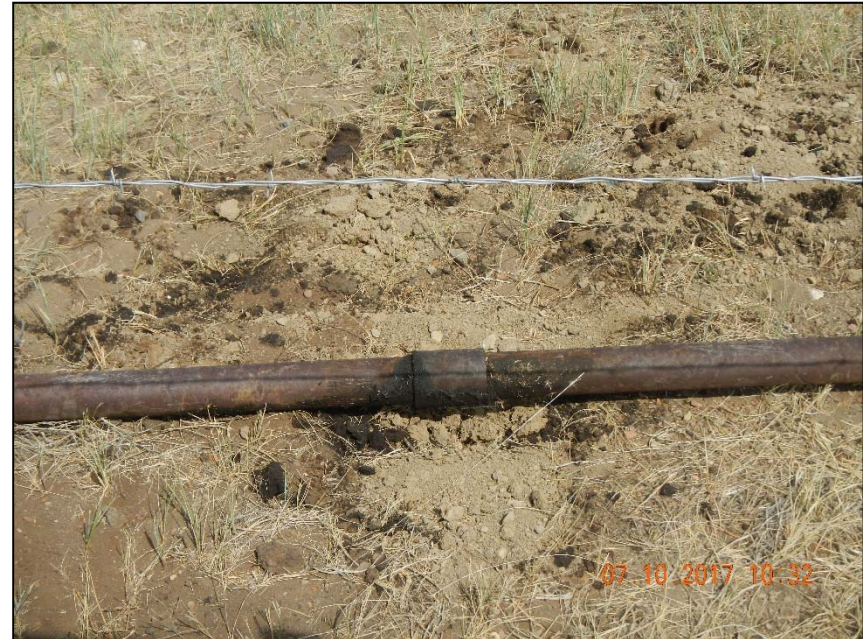
**Photo 6. Close-up of leak and clean-up efforts at threads.**

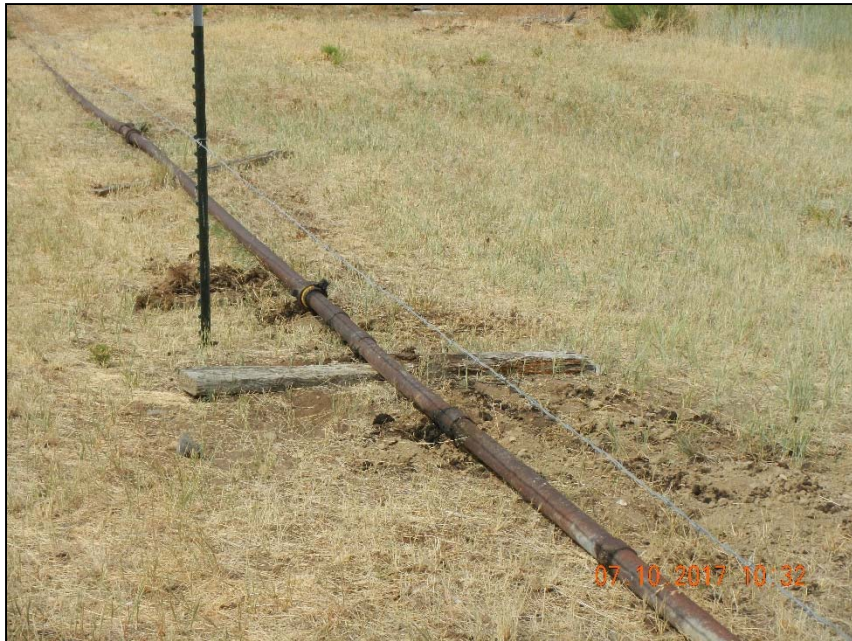
**Photo 7. Evidence of clean-up efforts.**

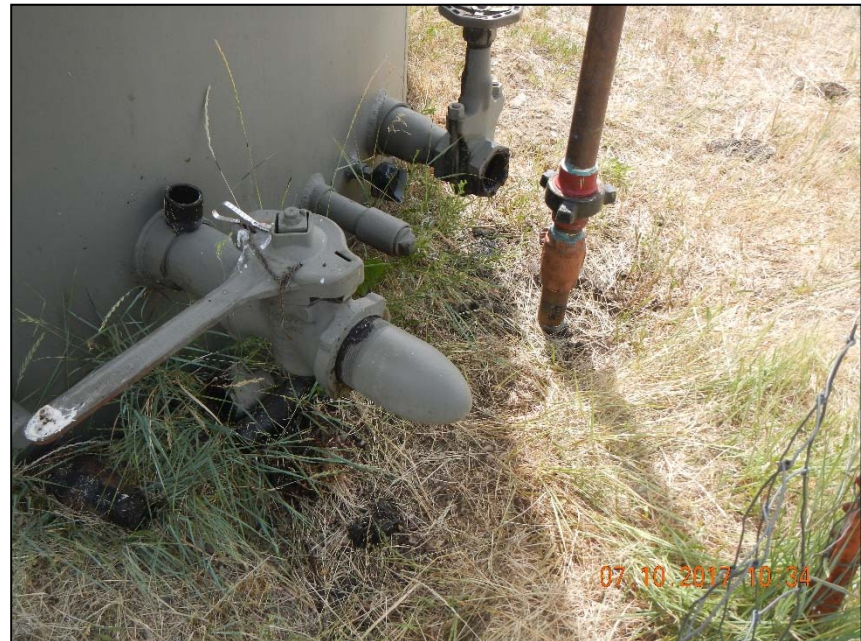
**Photo 8. Close-up of staining at tank.**
