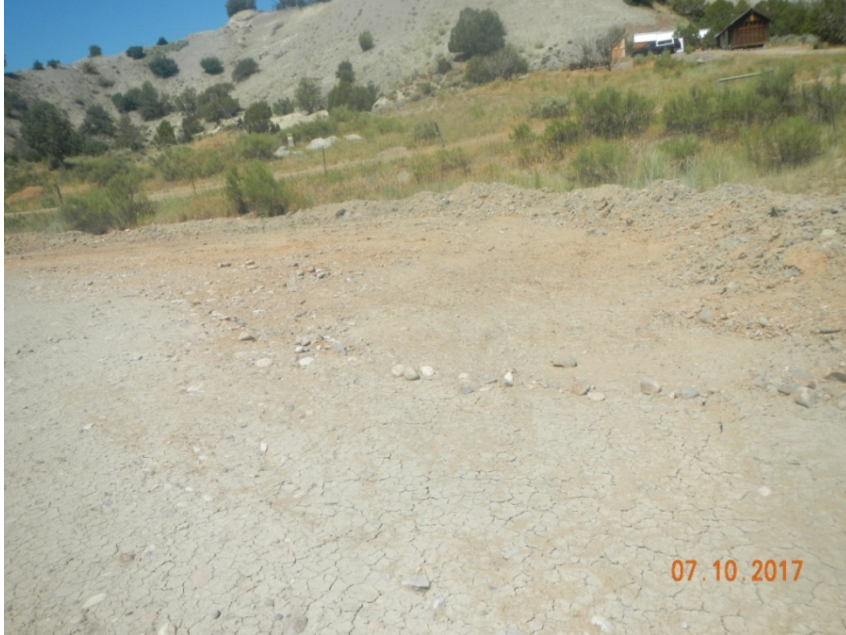
**Photo 1: View of area in the northwestern corner of the well pad that appears to have recently been reclaimed. Revegetation should be monitored here and re-seeding this fall is needed, as poor germination was observed.**

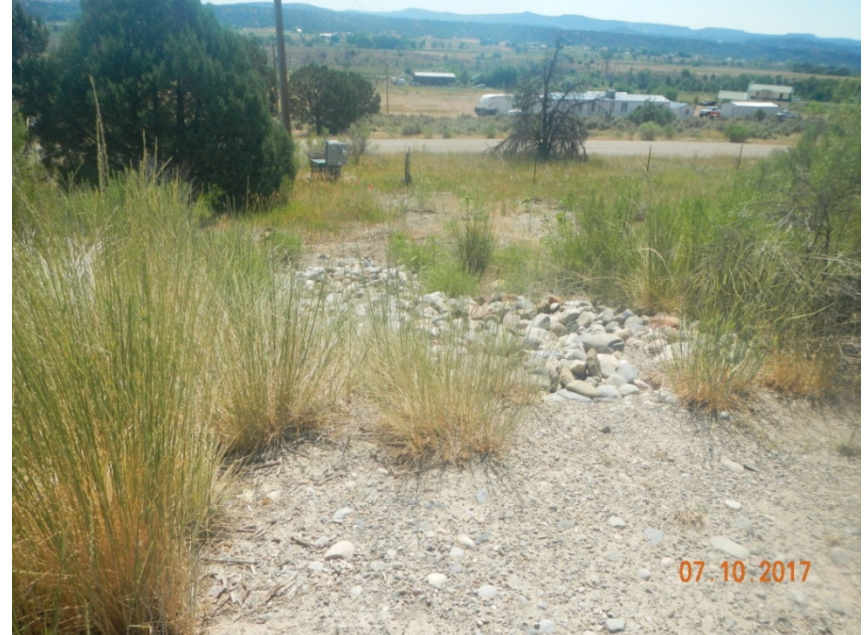
**Photo 2: View of cobble run-down installed since the December 2016 reclamation inspection. Appears to be functioning.**

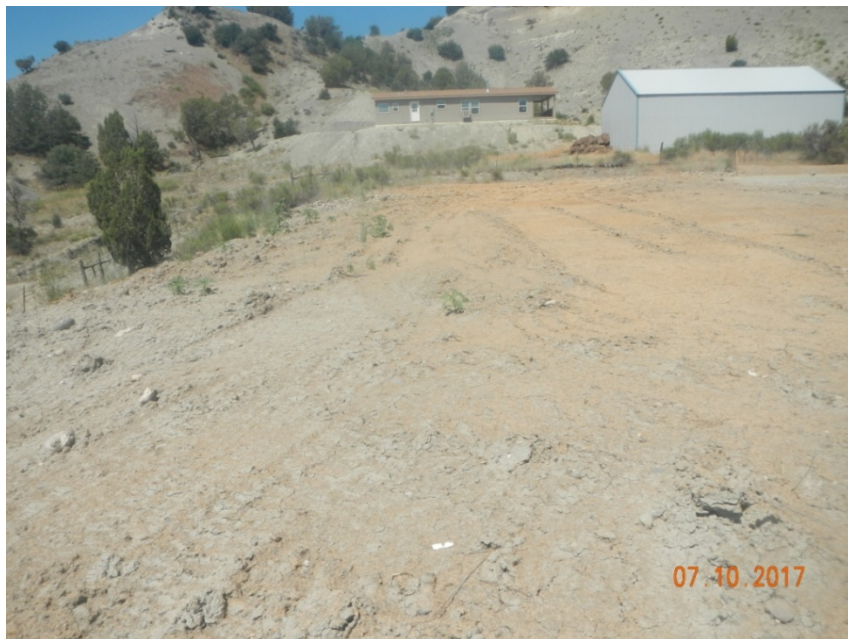
**Photo 3: View of newly reclaimed area in the southern portion of the project area. Young grass seedlings observed here.**

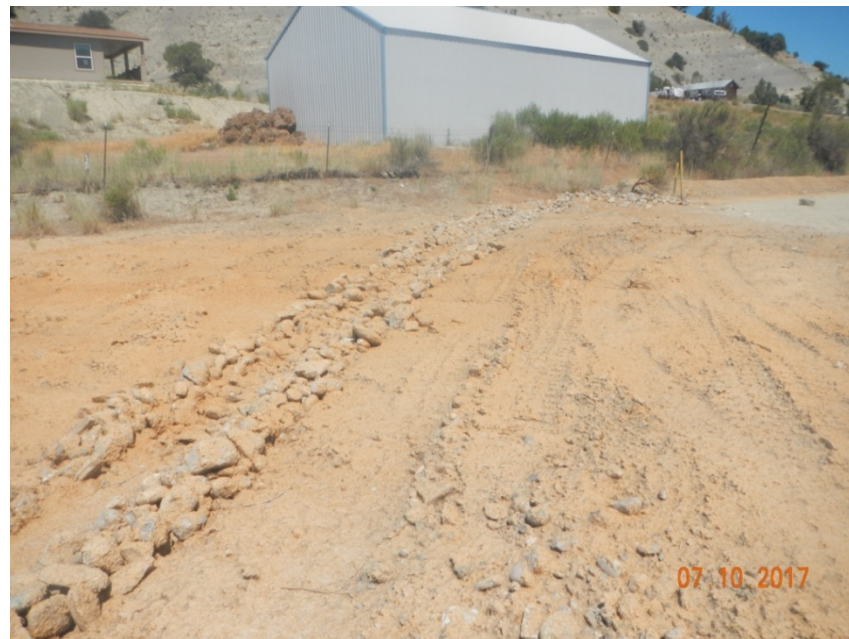
**Photo 4: View of newly installed cobble-lined diversion in the southwestern portion of the project area. Appears to be functioning.**
