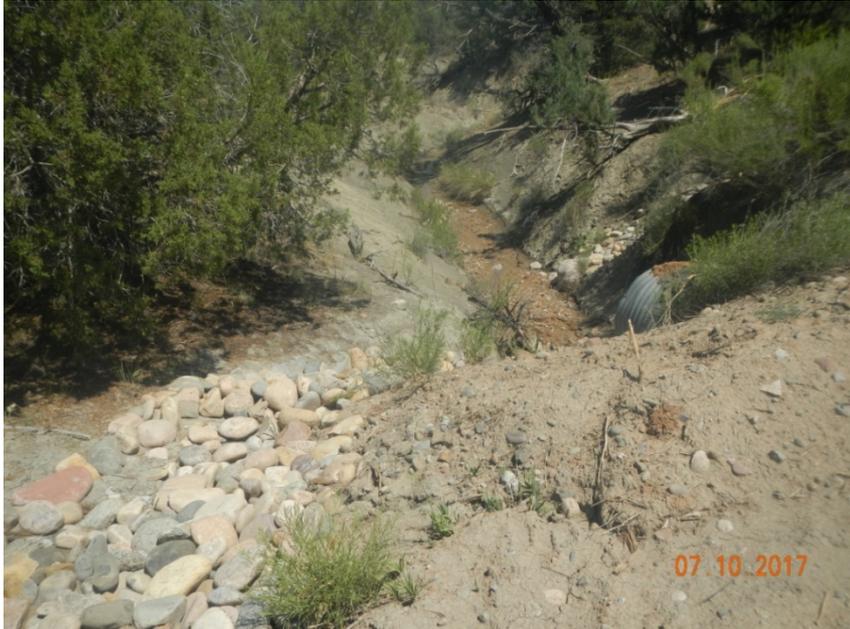
Photo 1: View of cobble run-down installed along the southern edge of culvert along access.

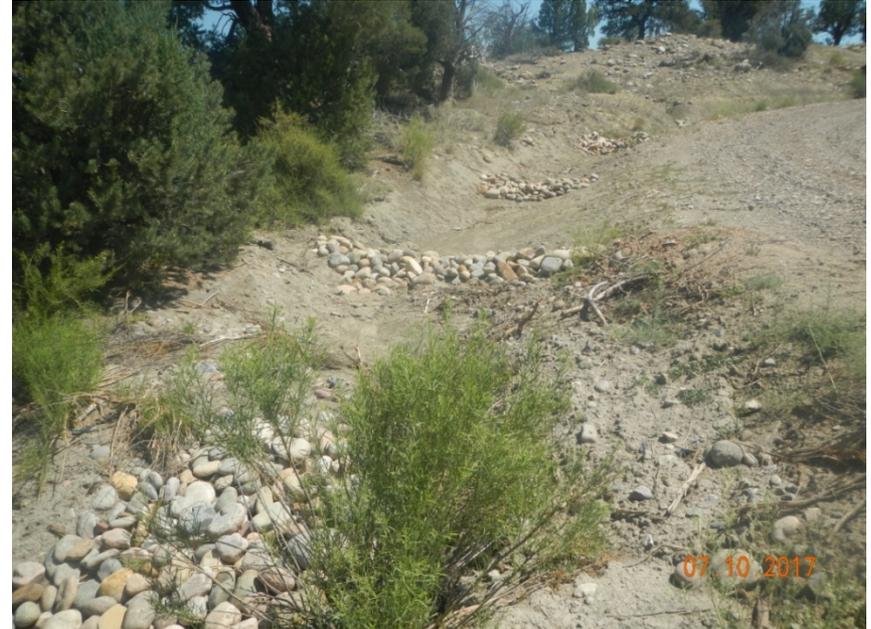
Photo 2: View of cobble run-down and check dams along roadside drainage north of culvert shown in Photo 1.

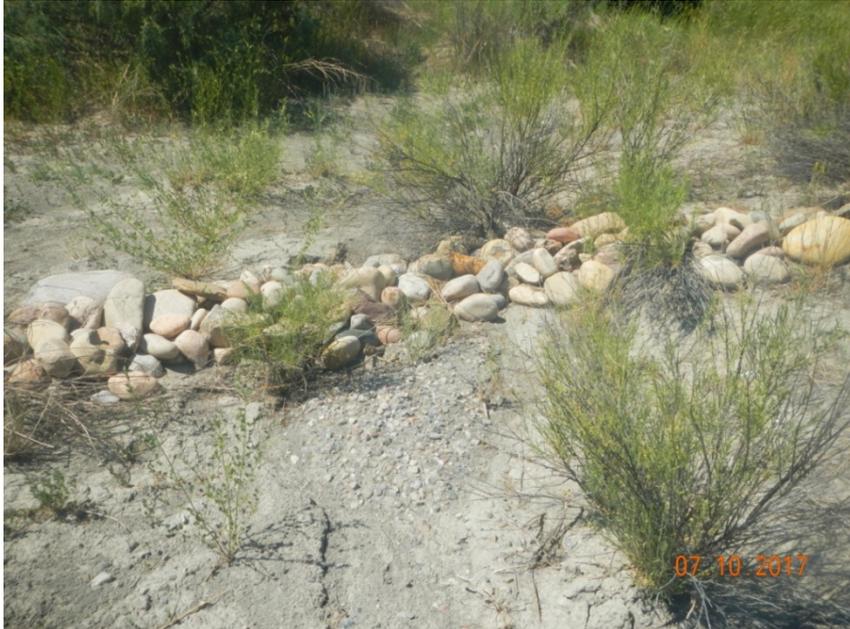
Photo 3: View cobble check dam in the southeastern portion of the project area. Appears to be installed to filter flows off of the southern portion of the well pad.

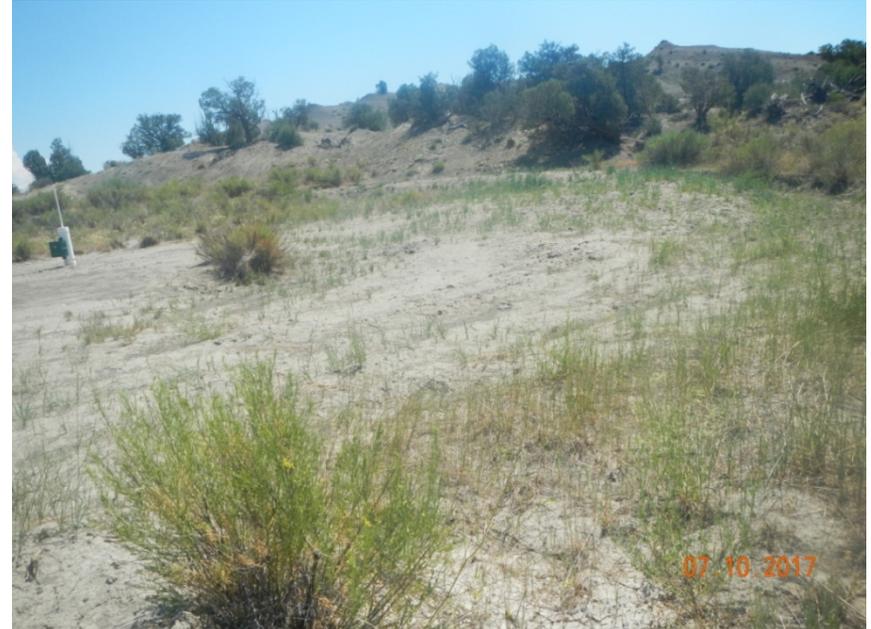
Photo 4: View of the southeastern portion of the well pad from the southern edge facing northeastward.

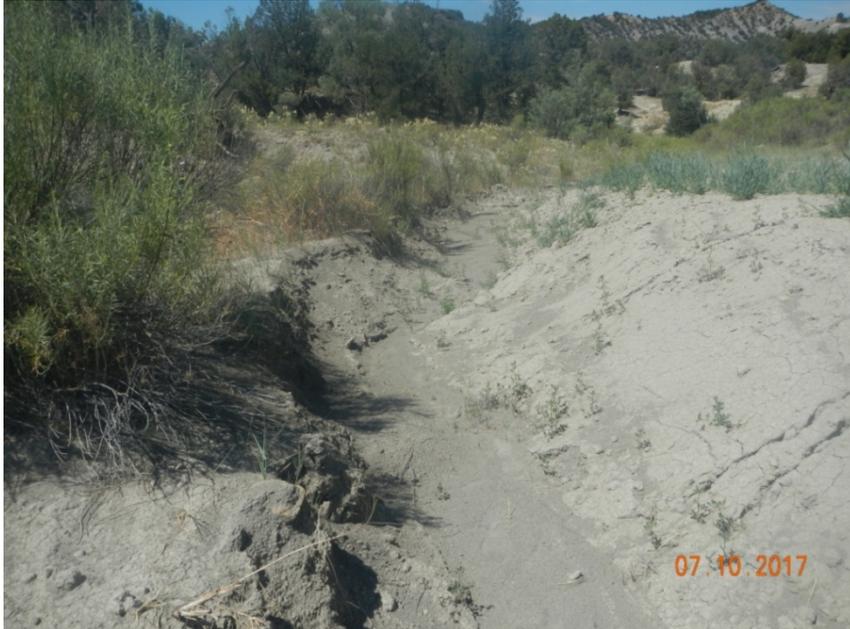
Photo 5: View of sediment filled diversion along the southeastern edge of the project area facing downstream (southwestward). Stormwater controls are needed to stabilize sediment transport in this area.

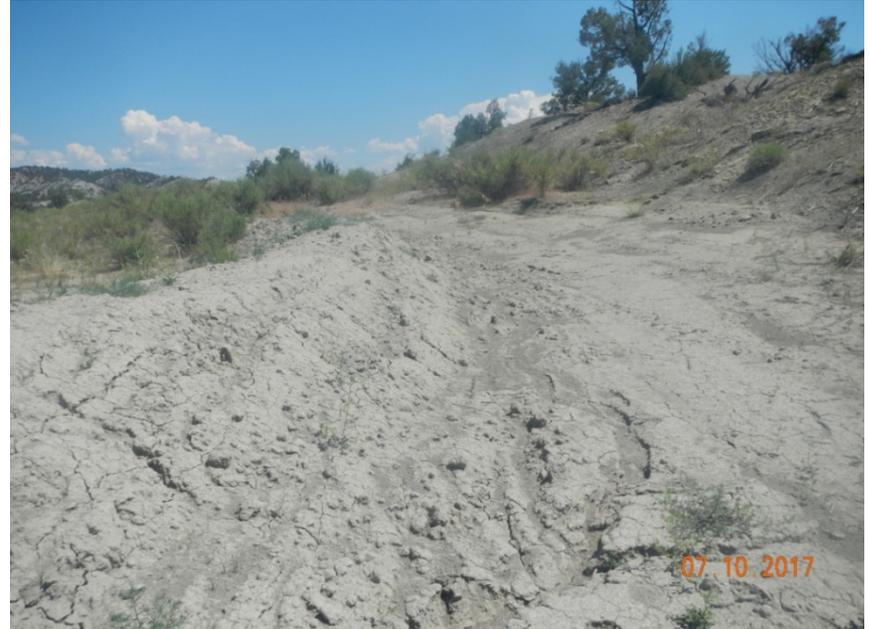
Photo 6: View of sediment filled diversion with exposed soils and no stormwater controls, facing upstream (northward). Stormwater controls are needed to stabilize sediment transport in this area.

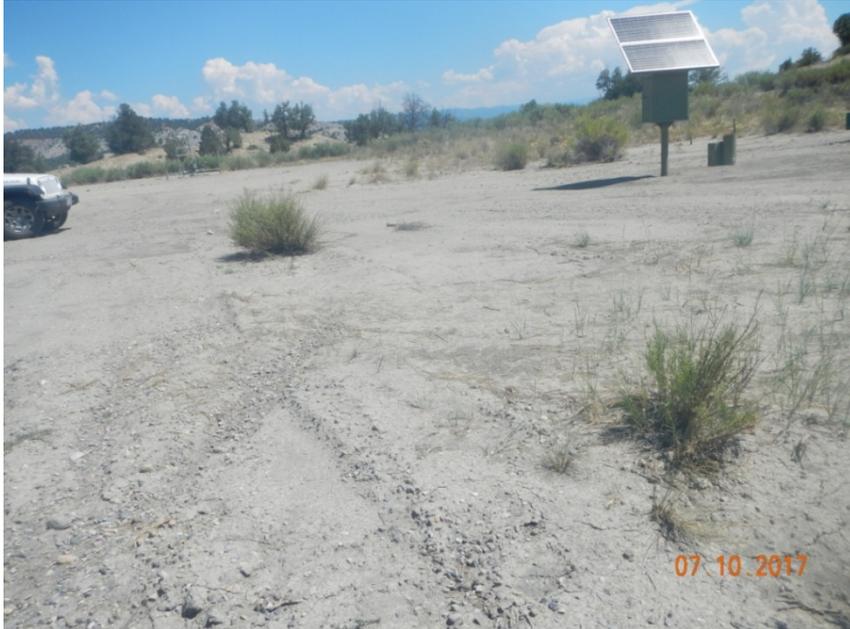
Photo 7: View of area in the southeastern portion of the project area that needs further seeding for stabilization.

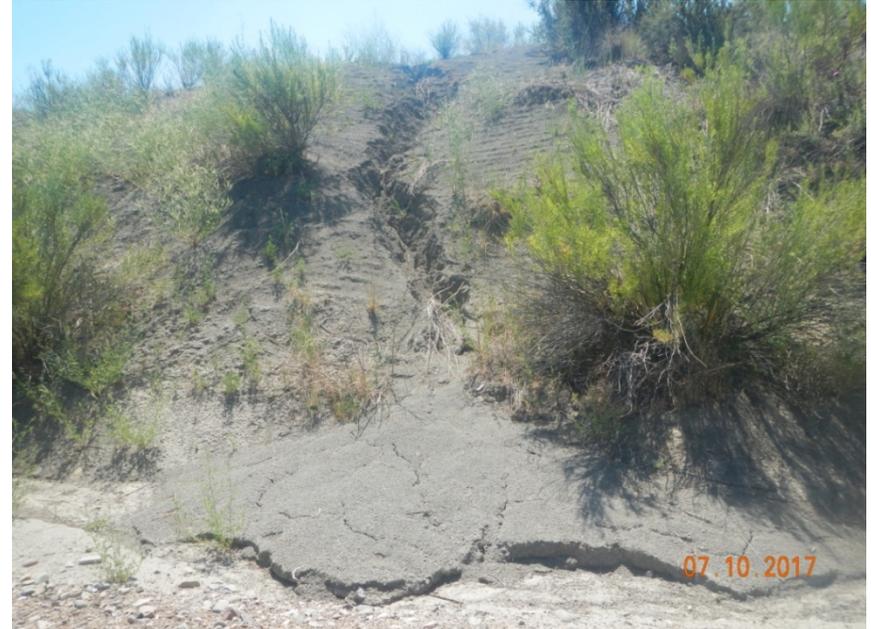
Photo 8: View of erosion in the northwestern fill slope, depositing sediment onto the access road and into the flow pattern of roadside drainage.
