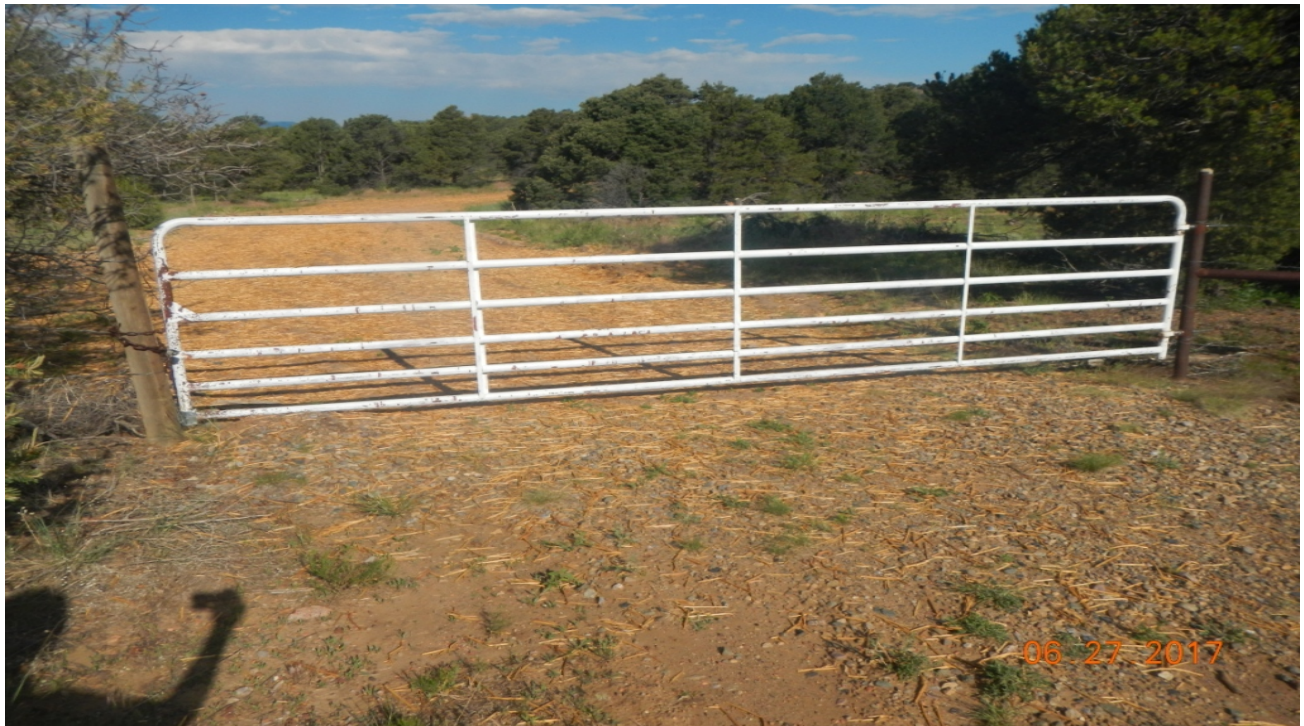
photo 1: Facing west at the beginning of the former access road.

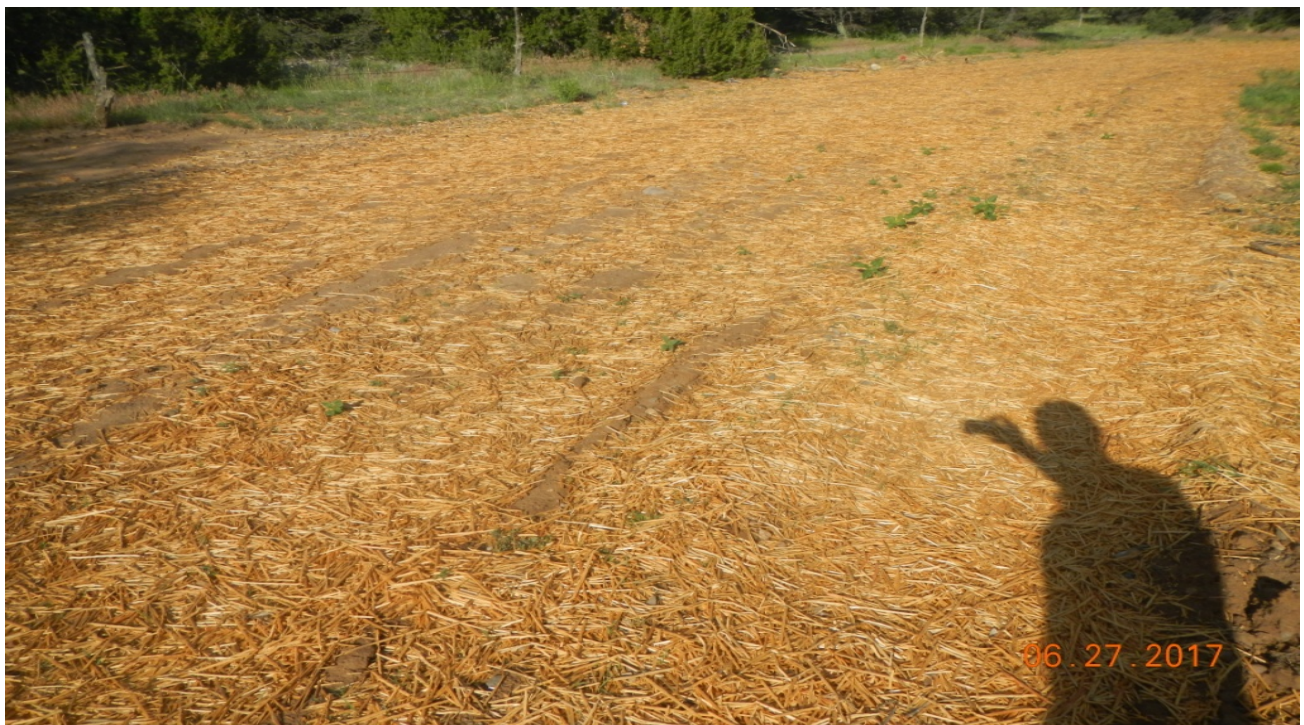
photo 2: The access road has been reclaimed since the previous inspection. There is wood mulch covering the reclaimed area.

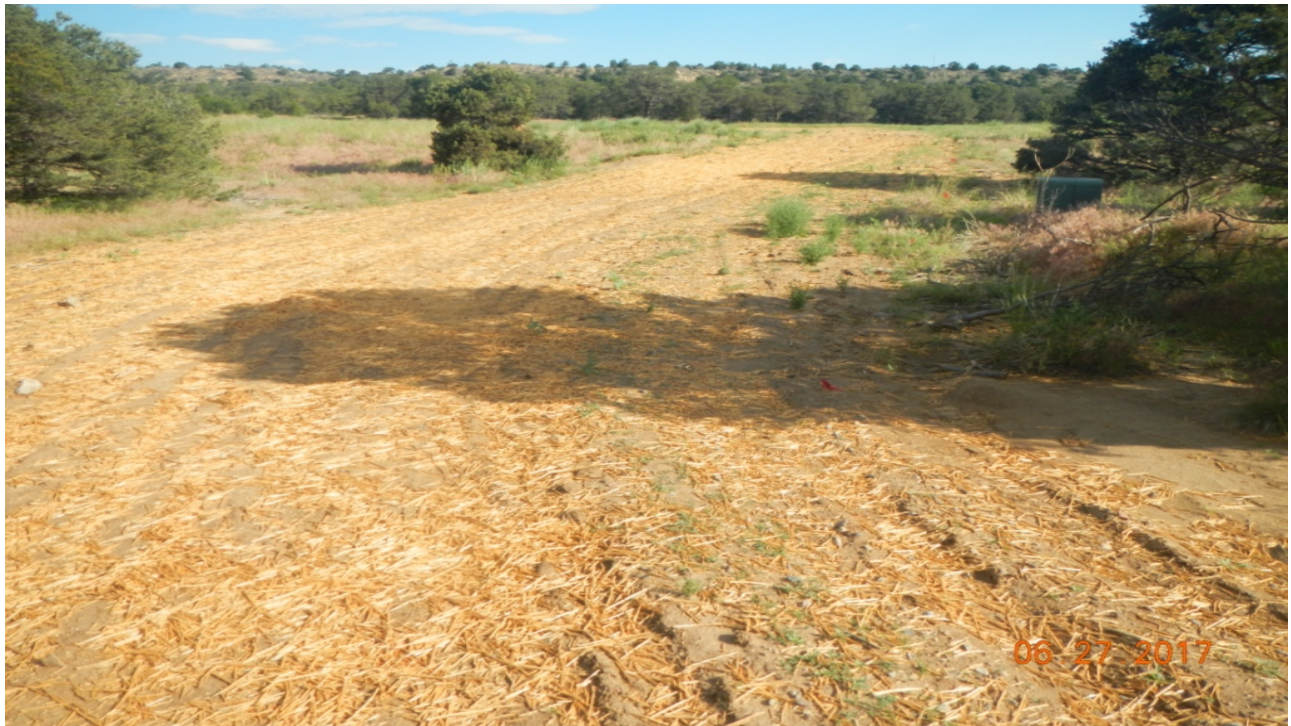
photo 3: Facing north along the reclaimed access road toward the location.

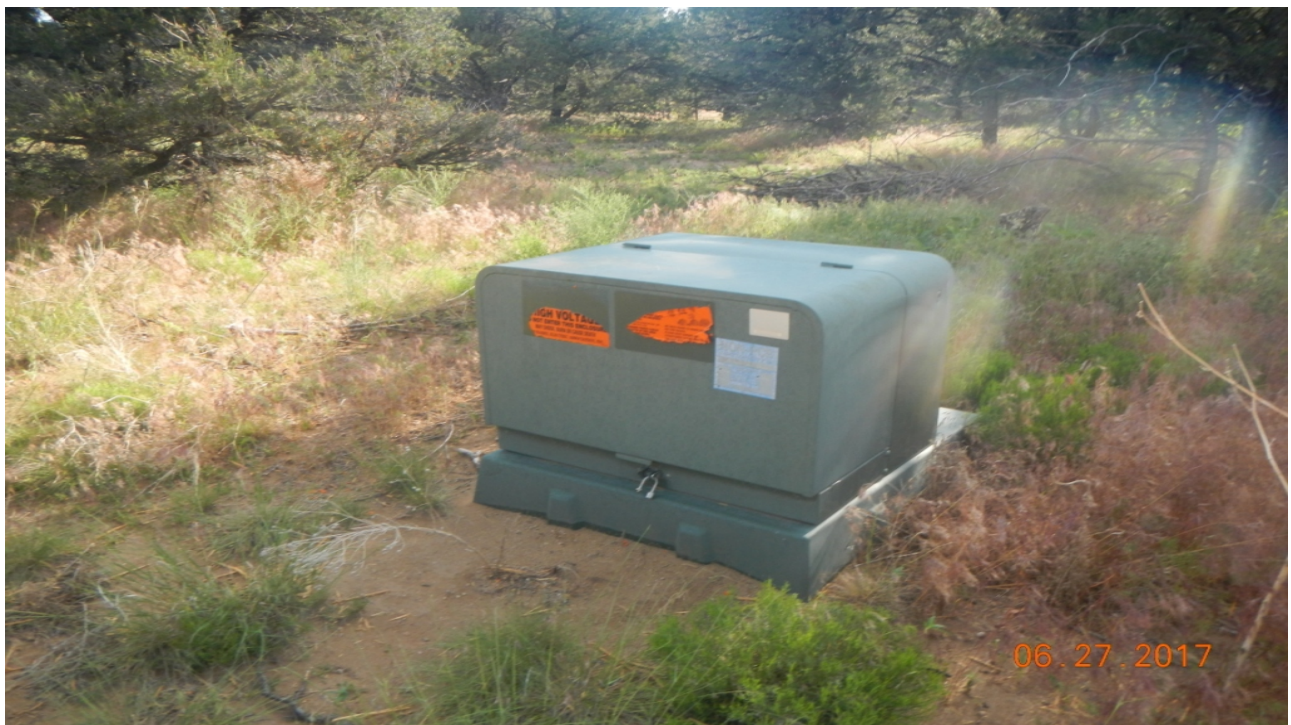
photo 4: The electric utility box remains at the east side of the reclaimed access road.

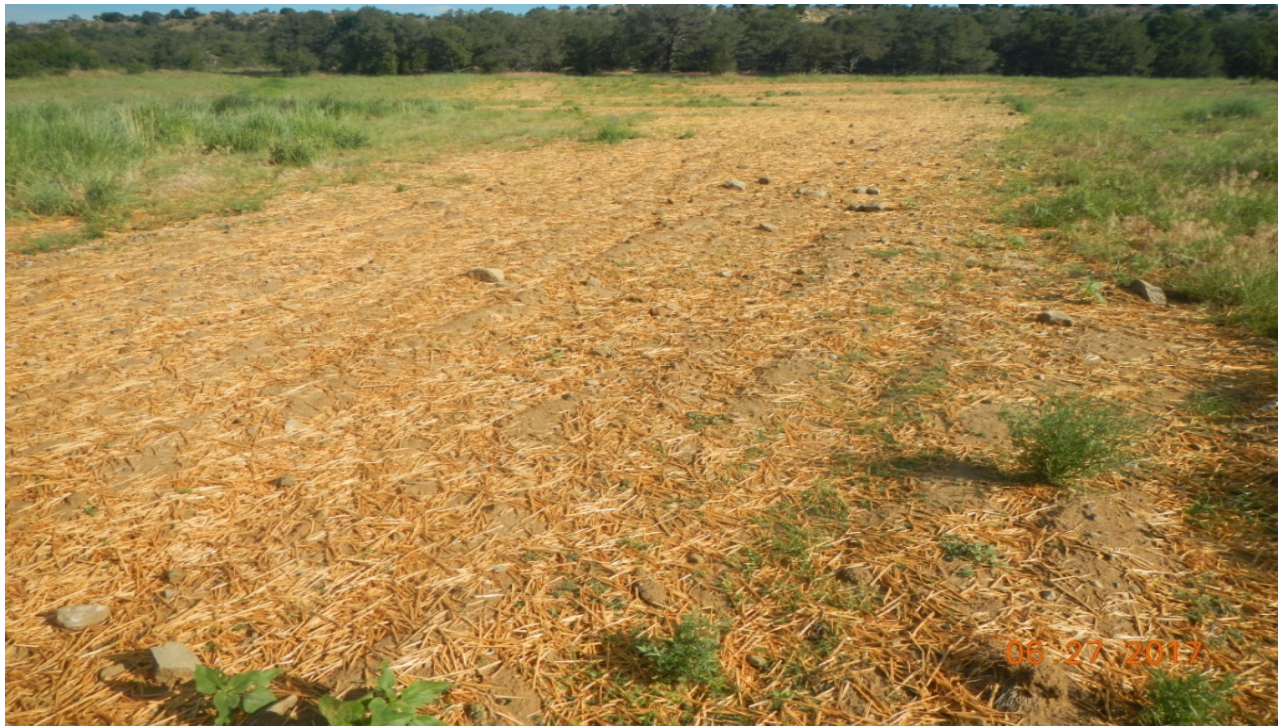
photo 5: Facing north toward the location.

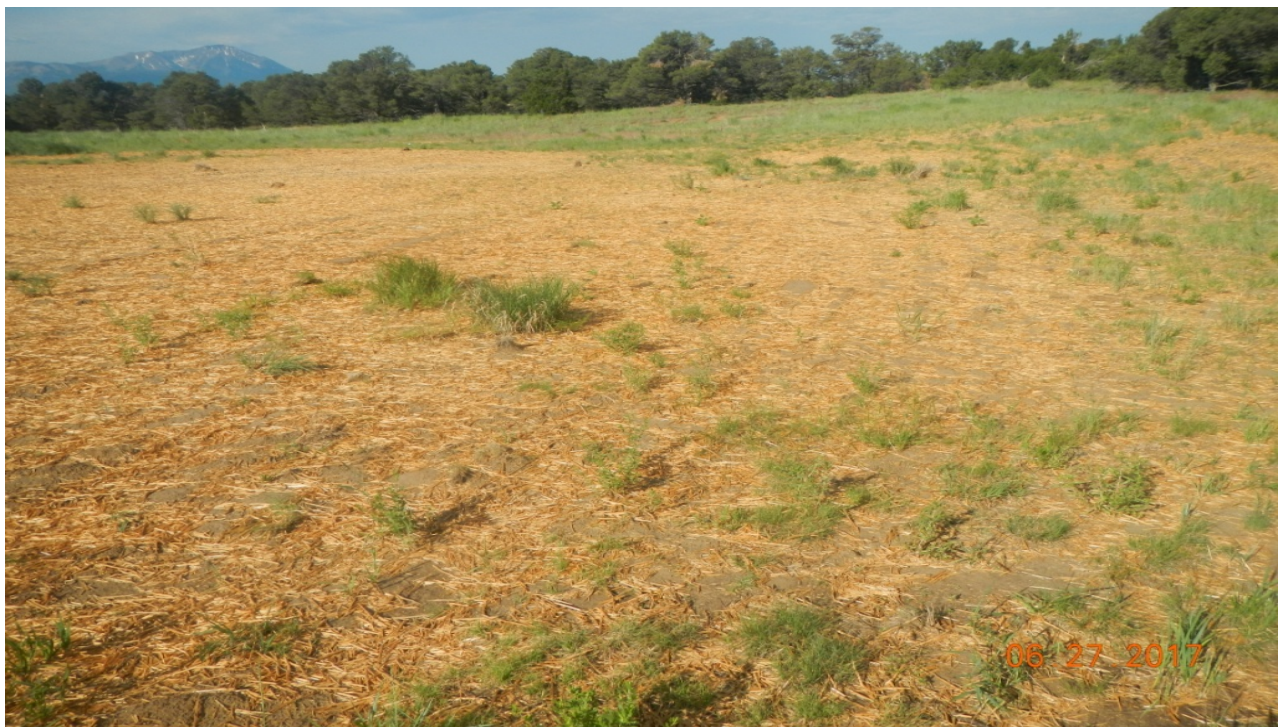
photo 6: Facing west at the location.

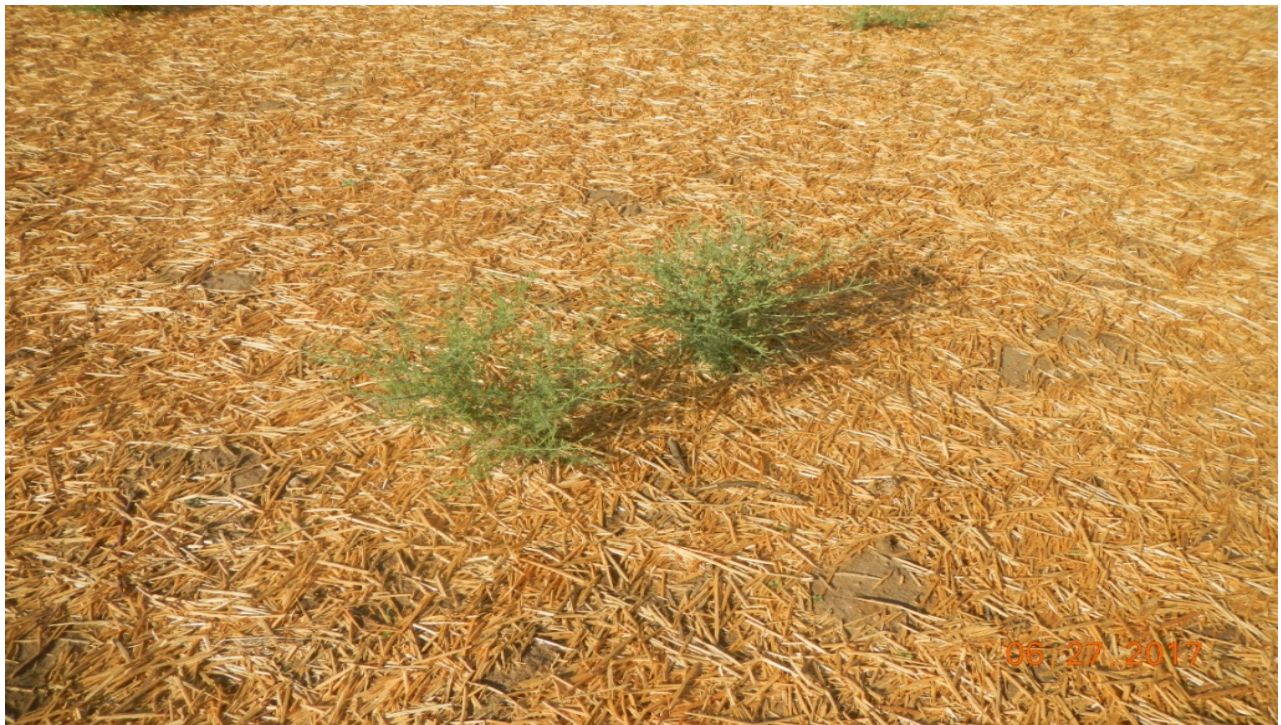
photo 8: There is List B noxious weeds (Diffuse knapweed) growing at the location.
