Reclamation and Stormwater Inspection

July 11, 2017

Operator: NOBLE ENERGY INC- #100322

Location ID: 445209

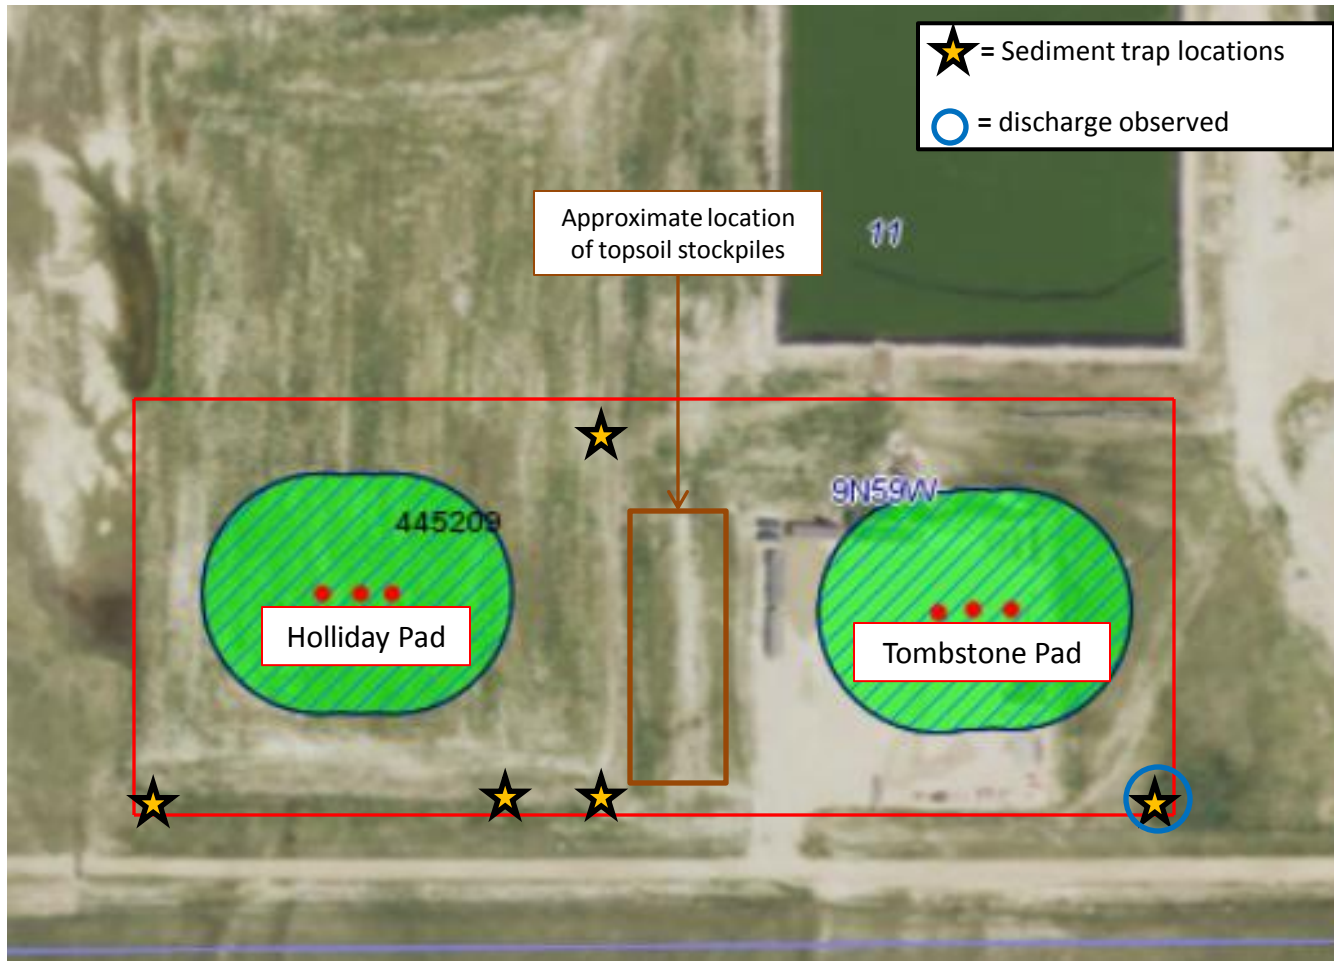
Overview of Location ID 445209 associated with the Holliday and Tombstone pads. The star indicates the approximate sediment trap locations. Perimeter of the location highlighted in red. Blue circle indicates a discharge was observed.

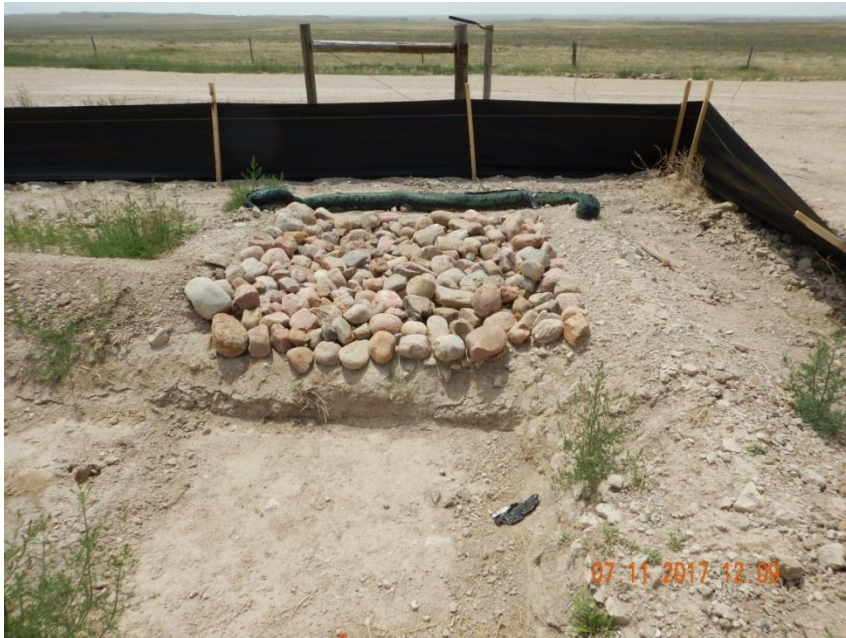
Photo 1. Photo taken from the southwest Holliday pad, facing South. Sediment trap size was measured at ~5'x4'x1.5' (width x length x depth= 30ft³) with a stabilized outlet. Silt fence BMP has not been properly installed. Silt fence is only pinned down and not buried/back-filled/compacted. Also, silt fence stakes should be installed to the outside of the silt fence, not inside of the silt fence.

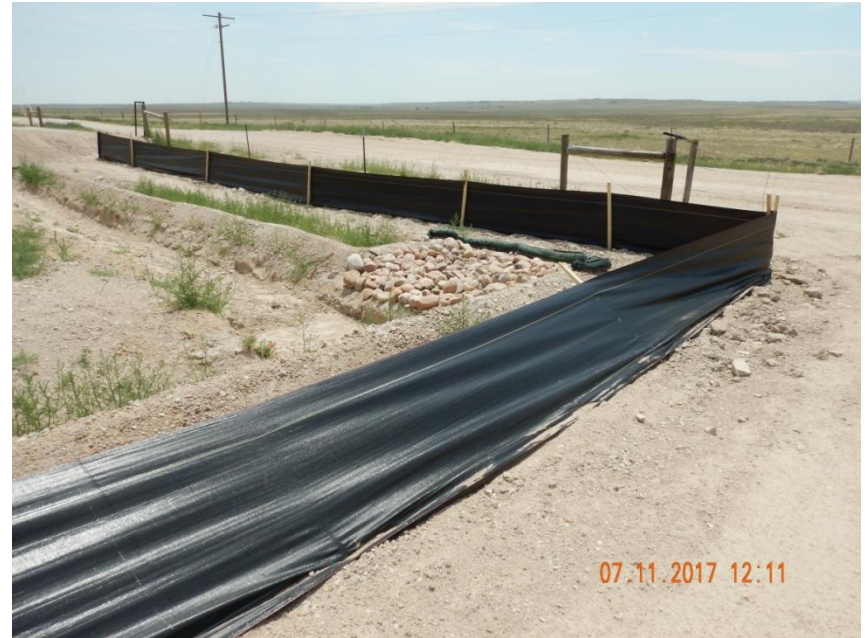
Photo 2. Photo taken from the southwest Holliday pad, facing Southeast. Silt fence BMP has not been properly installed. Silt fence is only pinned down and not buried/back-filled/compacted. Also, silt fence stakes should be installed to the outside of the silt fence, not inside of the silt fence.

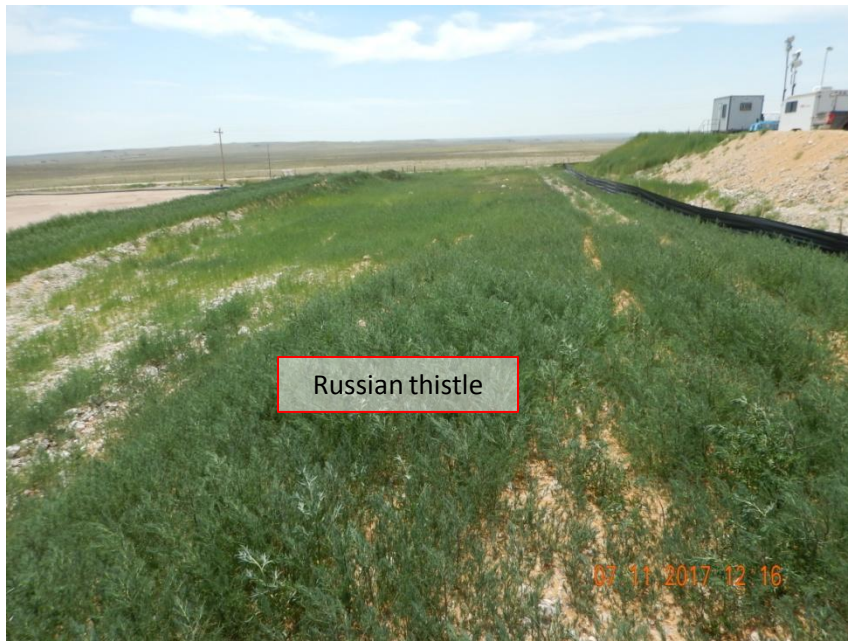
Photo 3. Photo taken between the Holliday pad and Tombstone pad on top of the topsoil stockpiles, facing South. Topsoil stockpile has predominately Russian thistle growth and Kochia growth which is not in compliance with Rule 1002.c. and Rule 1003. Hydromulch application was observed on the topsoil stockpile but is only a temporary BMP.

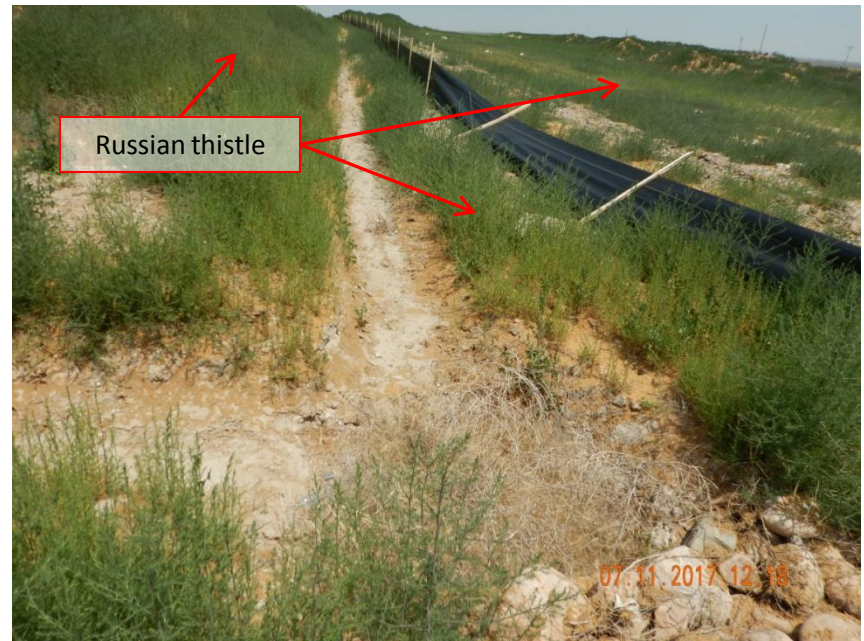
Photo 4. Photo taken from the southeast Holliday pad, facing North. Sediment trap size was measured at ~5'x4'x1.5' (width x length x depth= 30ft³) with a stabilized outlet.. Silt fence has not been properly installed. Silt fence is only pinned down and not buried/back-filled/compacted. Also, silt fence stakes should be installed to the outside of the silt fence, not inside of the silt fence. Russian thistle growth observed throughout most disturbance areas.

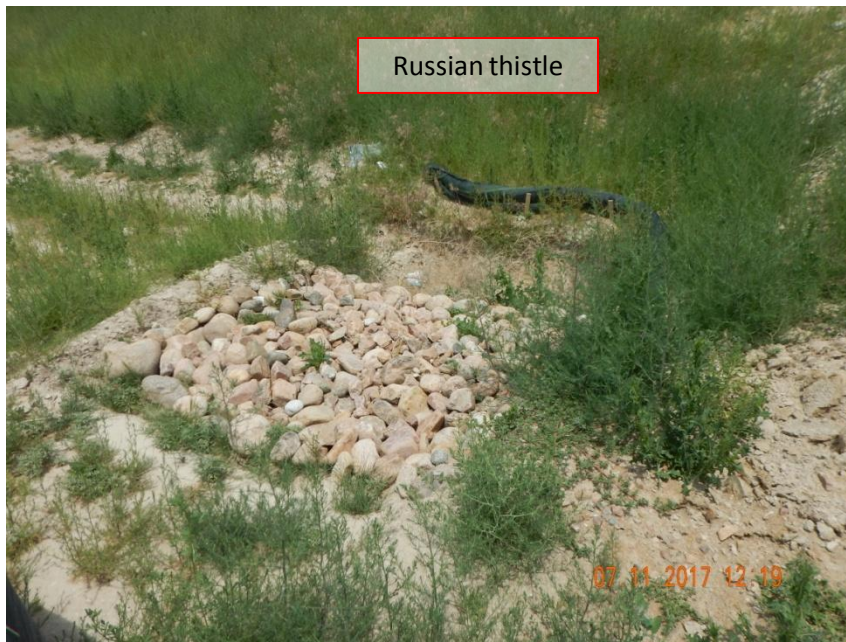
Photo 5. Photo taken from the southeastern Holliday pad, facing North. Sediment trap size was measured at ~5'x4'x1.5' (width x length x depth= 30ft³) with a stabilized outlet.

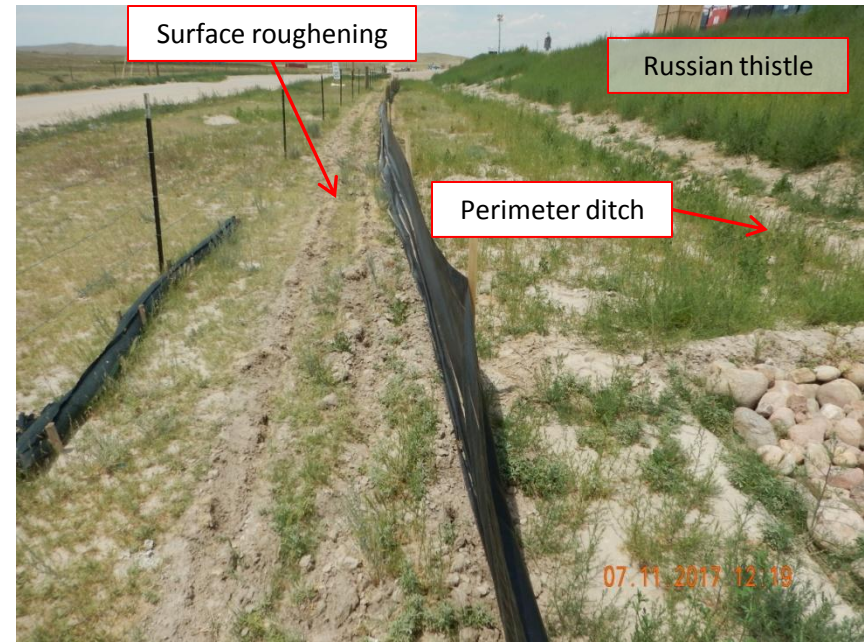
Photo 6. Photo taken from the southeastern Holliday pad, facing West. Silt fence improperly installed outside of the perimeter ditch, then surface roughening with filterxx BMP along a portion of the southeastern perimeter. Silt fence is only pinned down and not buried/back-filled/compacted. Also, silt fence stakes should be installed to the outside of the silt fence, not inside of the silt fence.

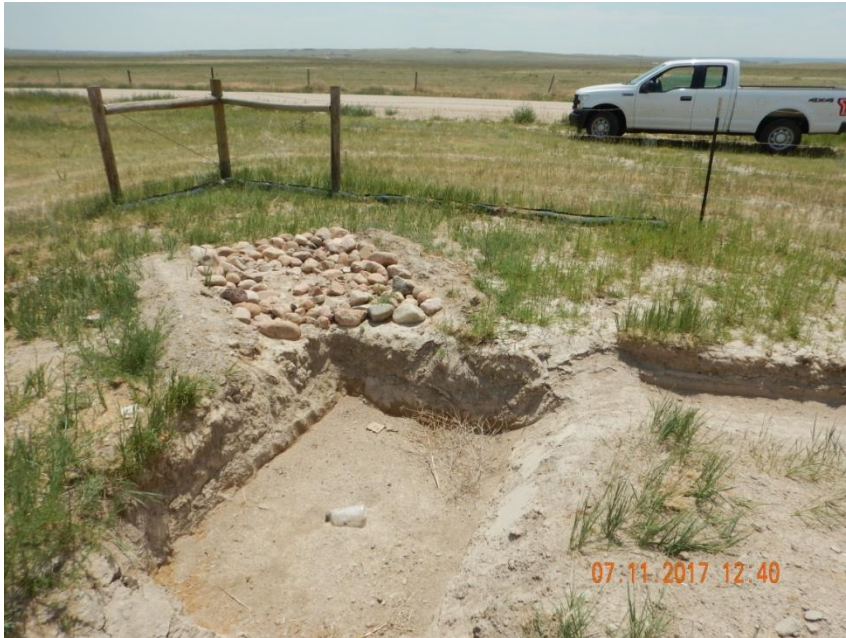
Photo 7. Photo taken from the southeast location of the Tombstone pad, facing South. Sediment trap size was measured at $\sim 7' \times 4.5' \times 2'$ (width x length x depth= 63ft³) with a stabilized outlet. Sediment discharge was observed beyond the outlet area and beyond the filtrex BMP along the corner of the fence. Refer to photos 9 & 10.

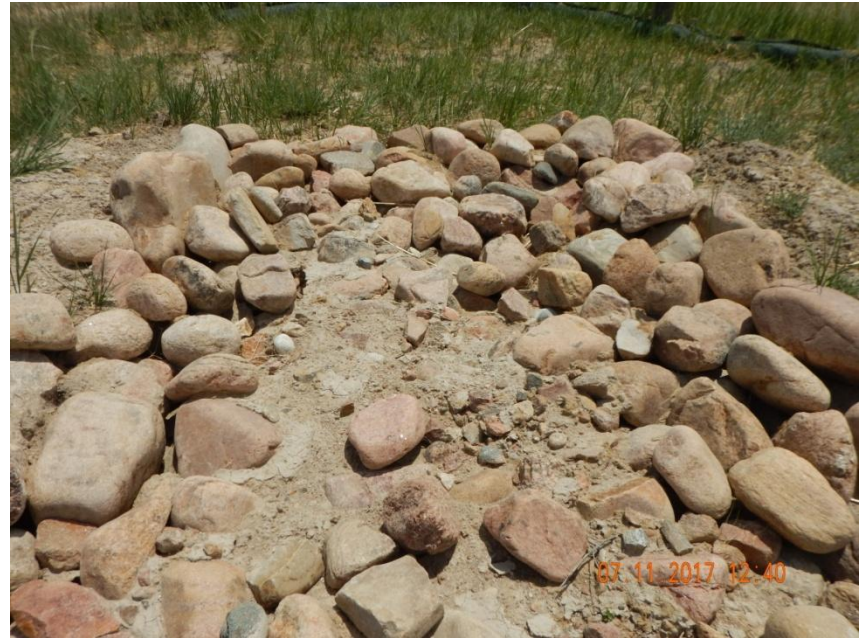
Photo 8. Close up photo taken from the outlet area of the sediment trap illustrating sediment build up which indicate the sediment trap is not built to a sufficient size.

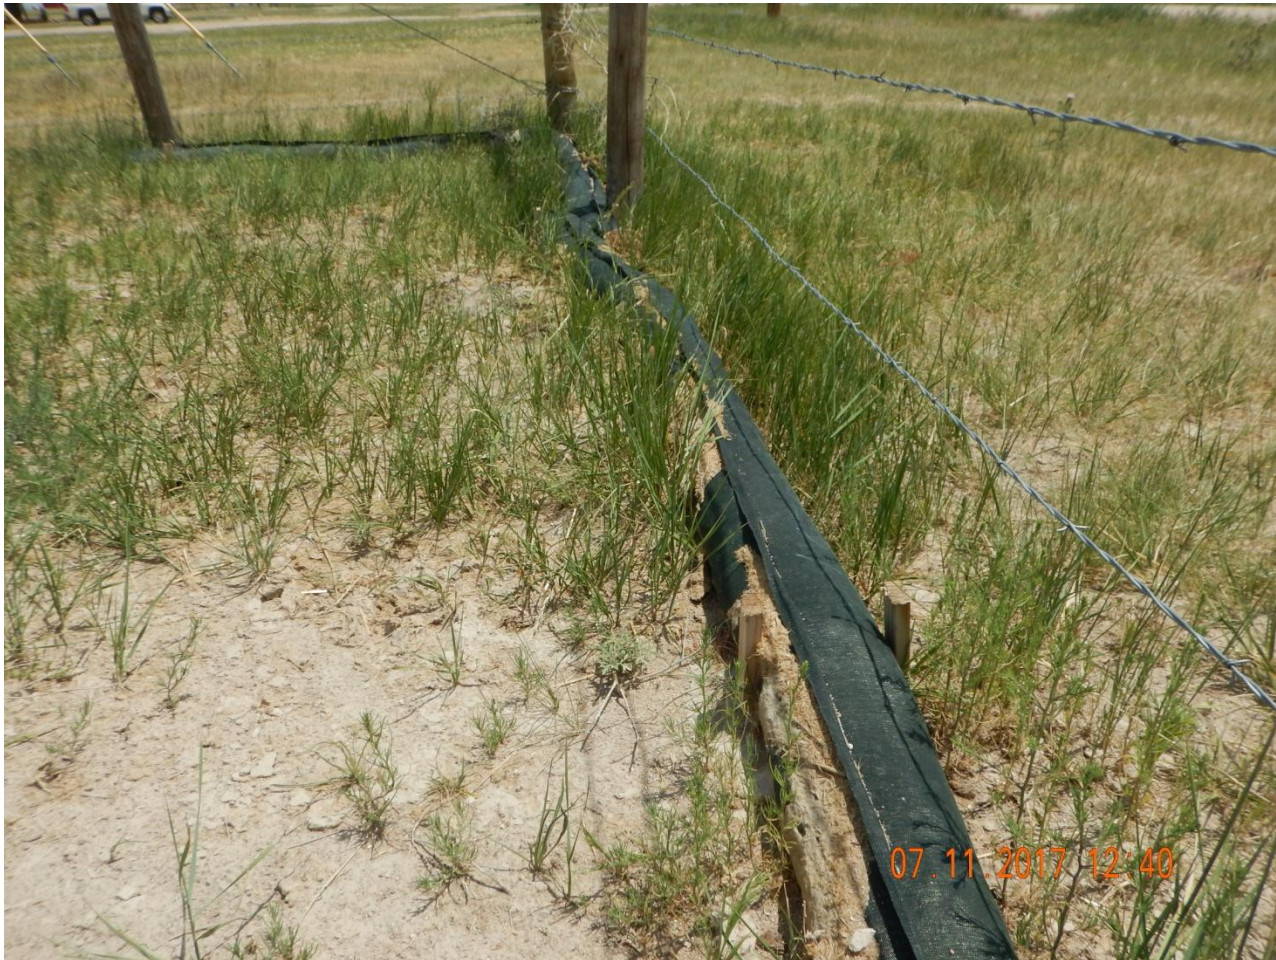
Photo 9. Close up photo taken just beyond the sediment trap at the corner of the fence, illustrating stormwater runoff appears to be washing hydromulch material and sediment off location over the filtrex BMP.

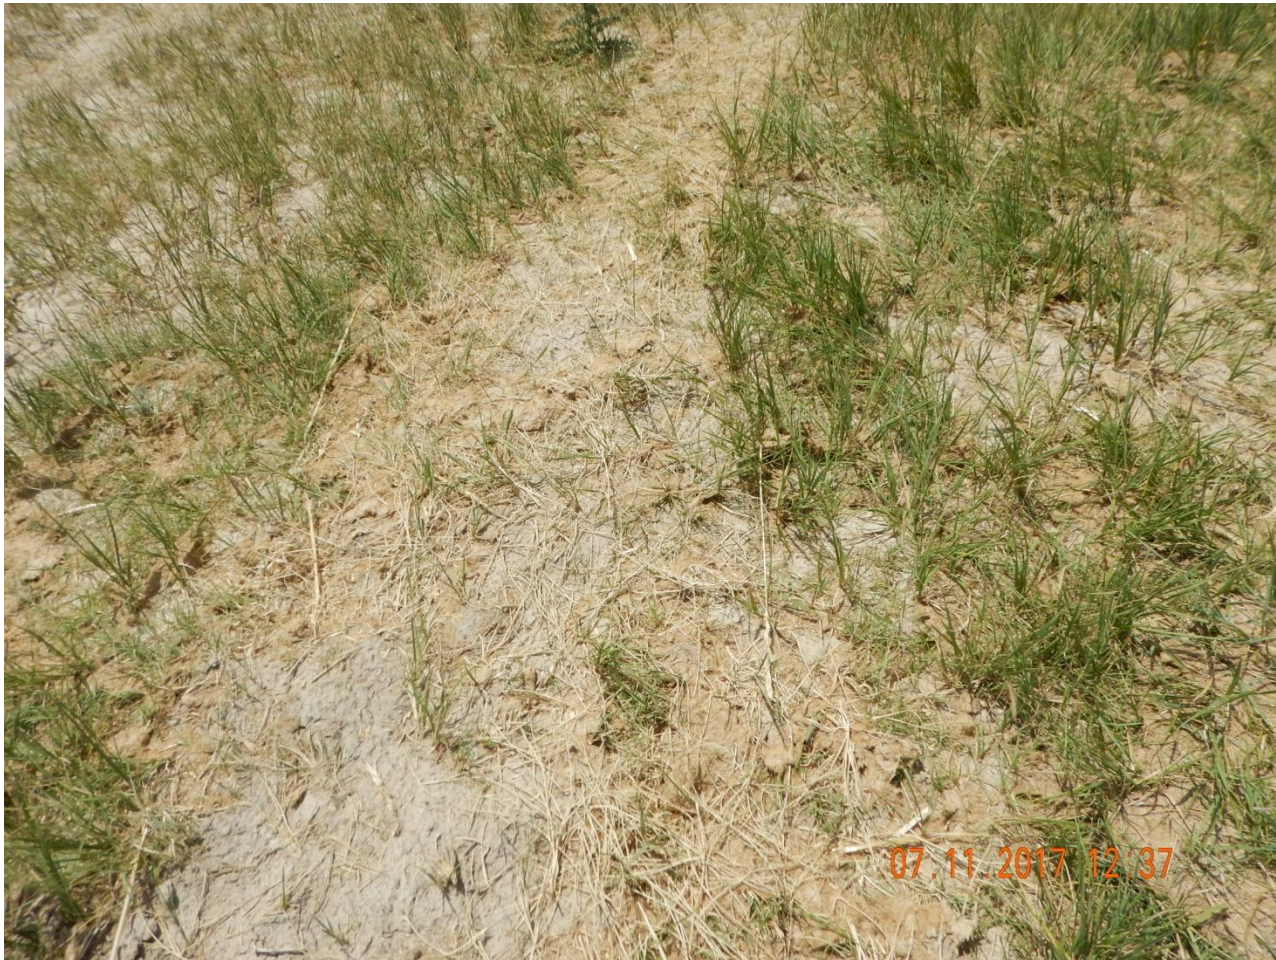
Photo 10. Close up photo taken just beyond the corner of the fence, illustrating stormwater runoff appears to be washing hydromulch material and sediment off location.

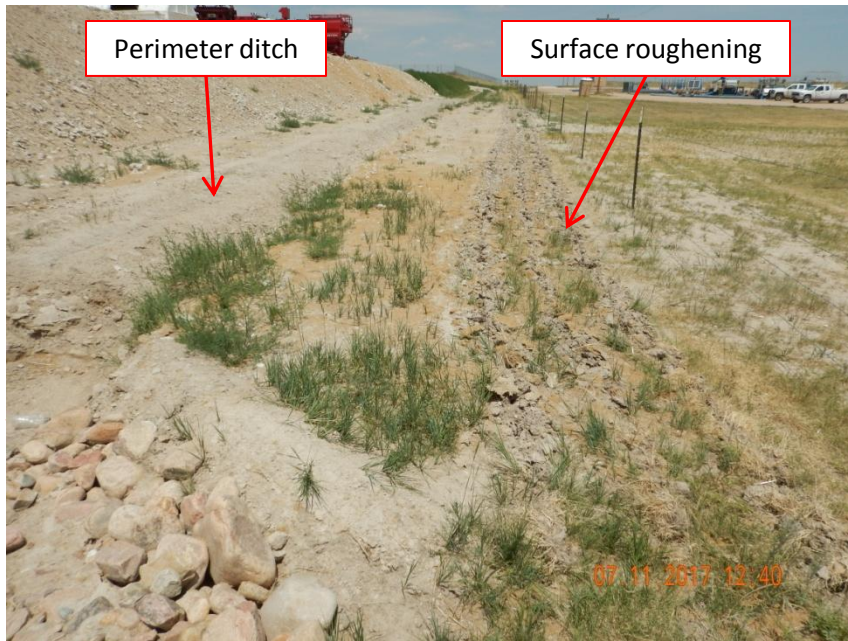
Photo 11. Photo taken from the southeast location of the Tombstone pad, facing North. Perimeter ditch with surface roughening BMP installed along the eastern perimeter. Portions of the fill slope may need additional stabilization as it appears hydromulch does not appear to be consistently observed throughout.

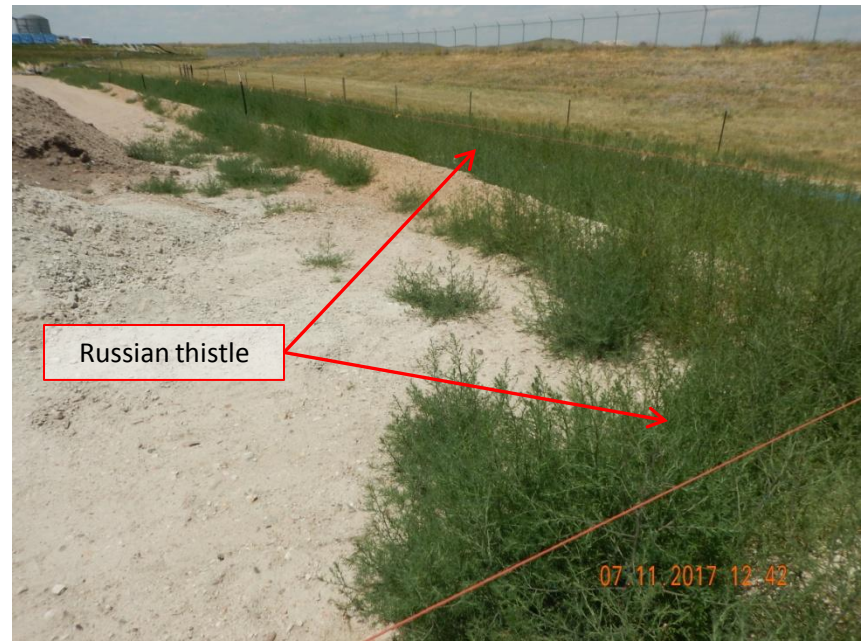
Photo 12. Photo taken from the northeast location of the Tombstone pad, facing Northwest. A berm ~18" has been constructed along the north, east and south pad perimeter, but does not appear to be properly compacted.

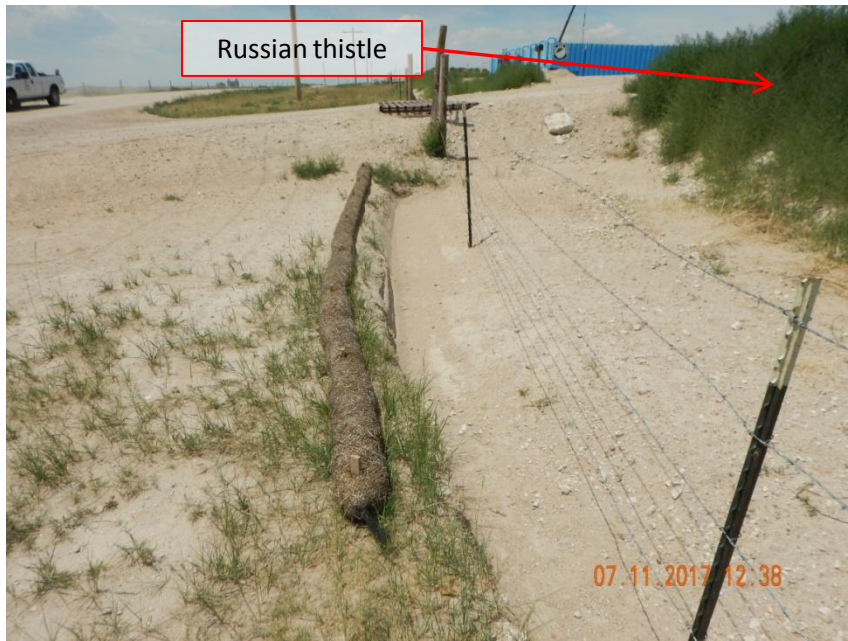
Photo 13. Photo taken from the entrance of the Tombstone pad, facing West. Straw wattle BMP does not appear to be properly installed and therefore not properly functioning.
