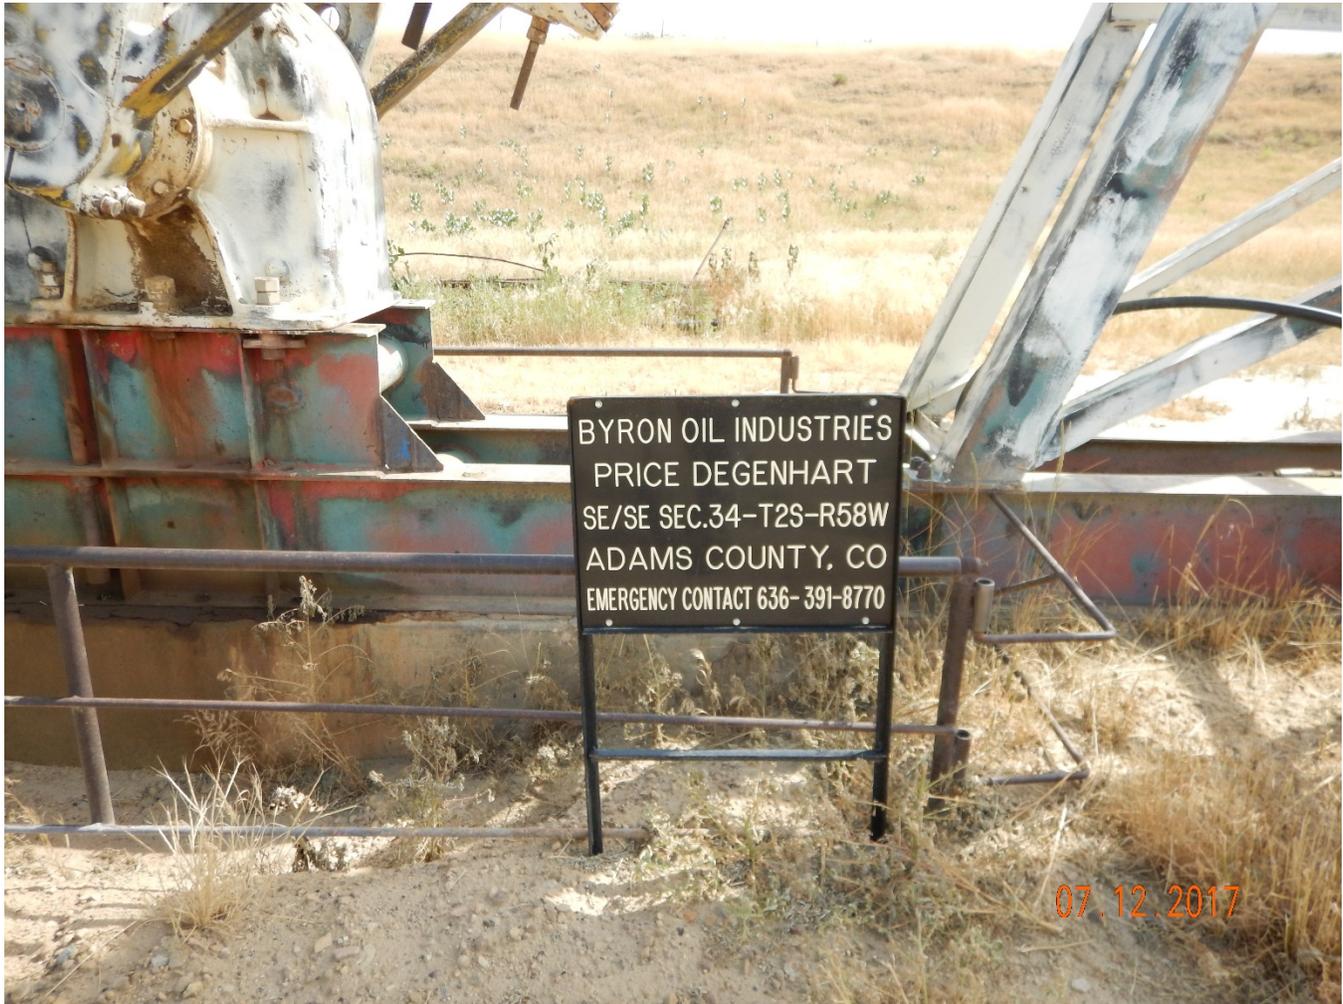
*Figure 1 - Well sign at pump jack.*

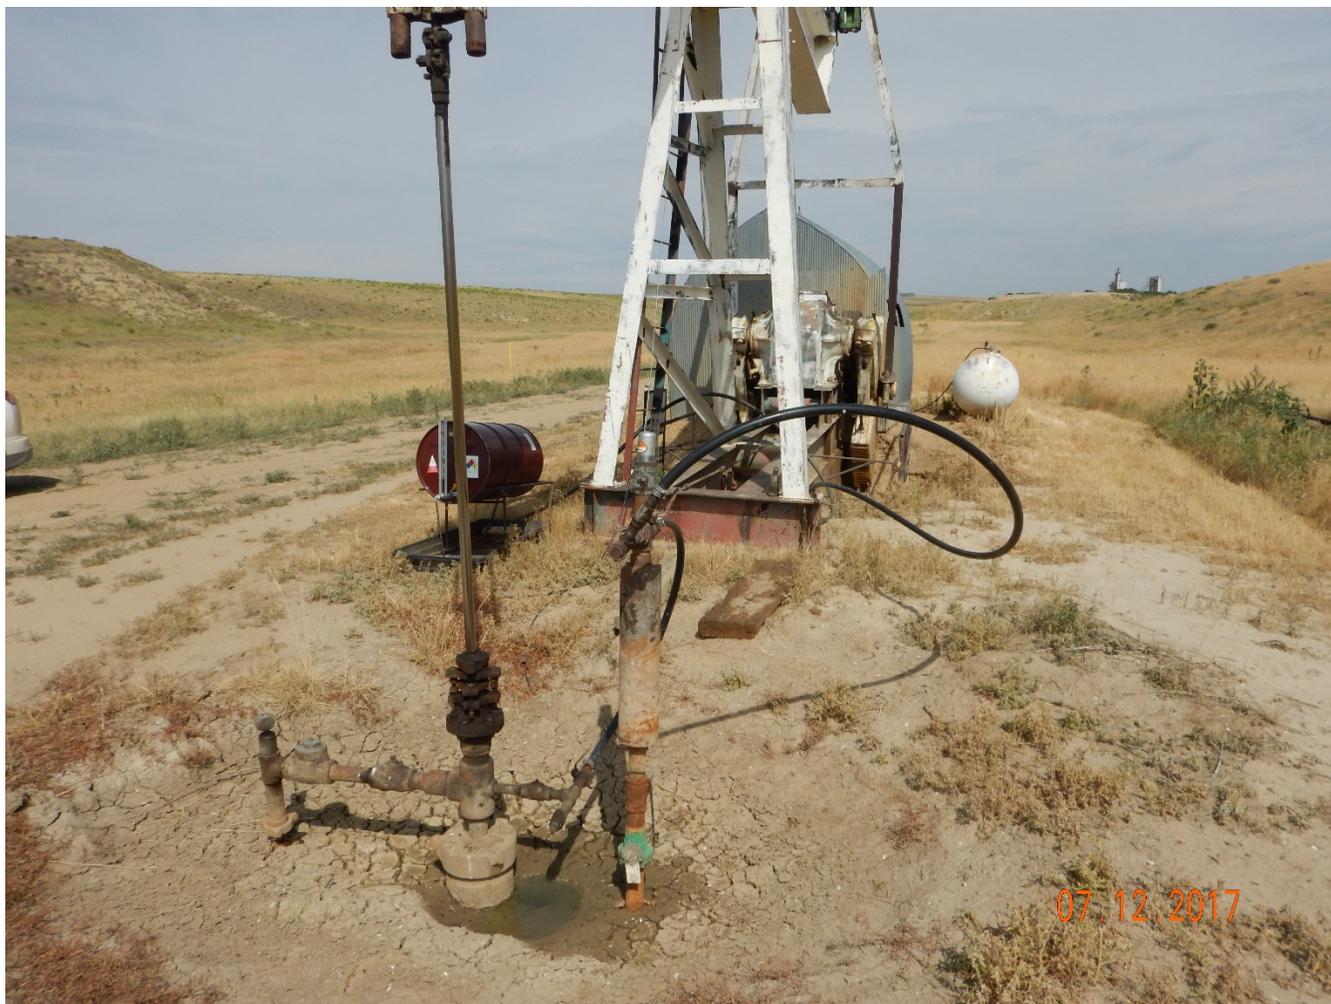
*Figure 2 - Wellhead, pumping unit, 55-gallon storage drum, and propane tank. Note: wellhead remains surrounded by water.*

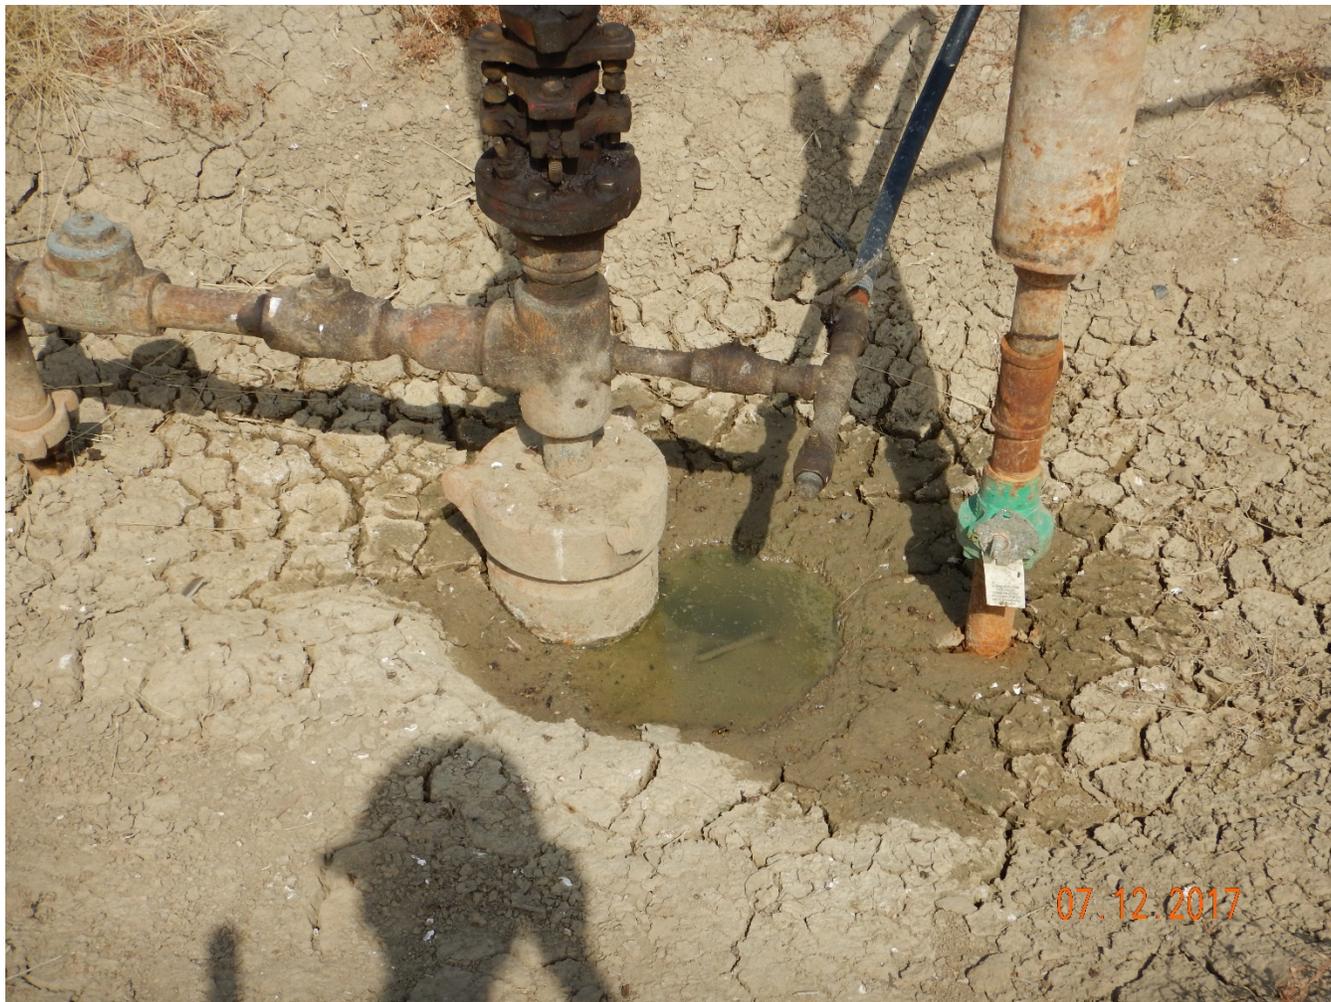
*Figure 3 - Puddle surrounding wellhead. A steady release of bubbles into puddle was observed at wellhead, indicating possible integrity issue. An audible gas leak was also observed coming from 1" line on east side of wellhead.*

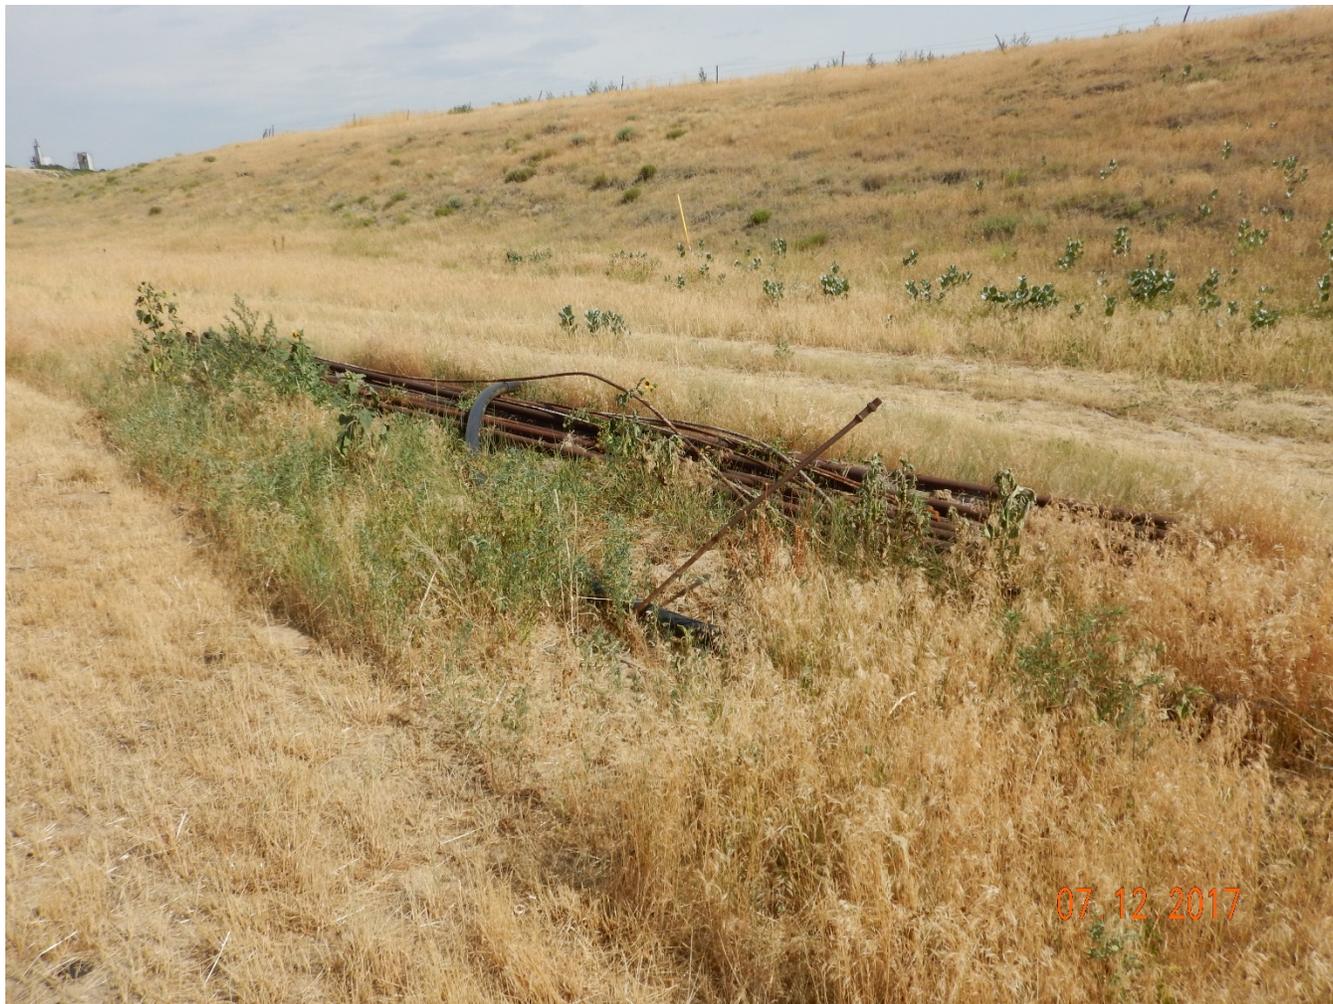
*Figure 4 - Unused equipment remaining at wellhead.*

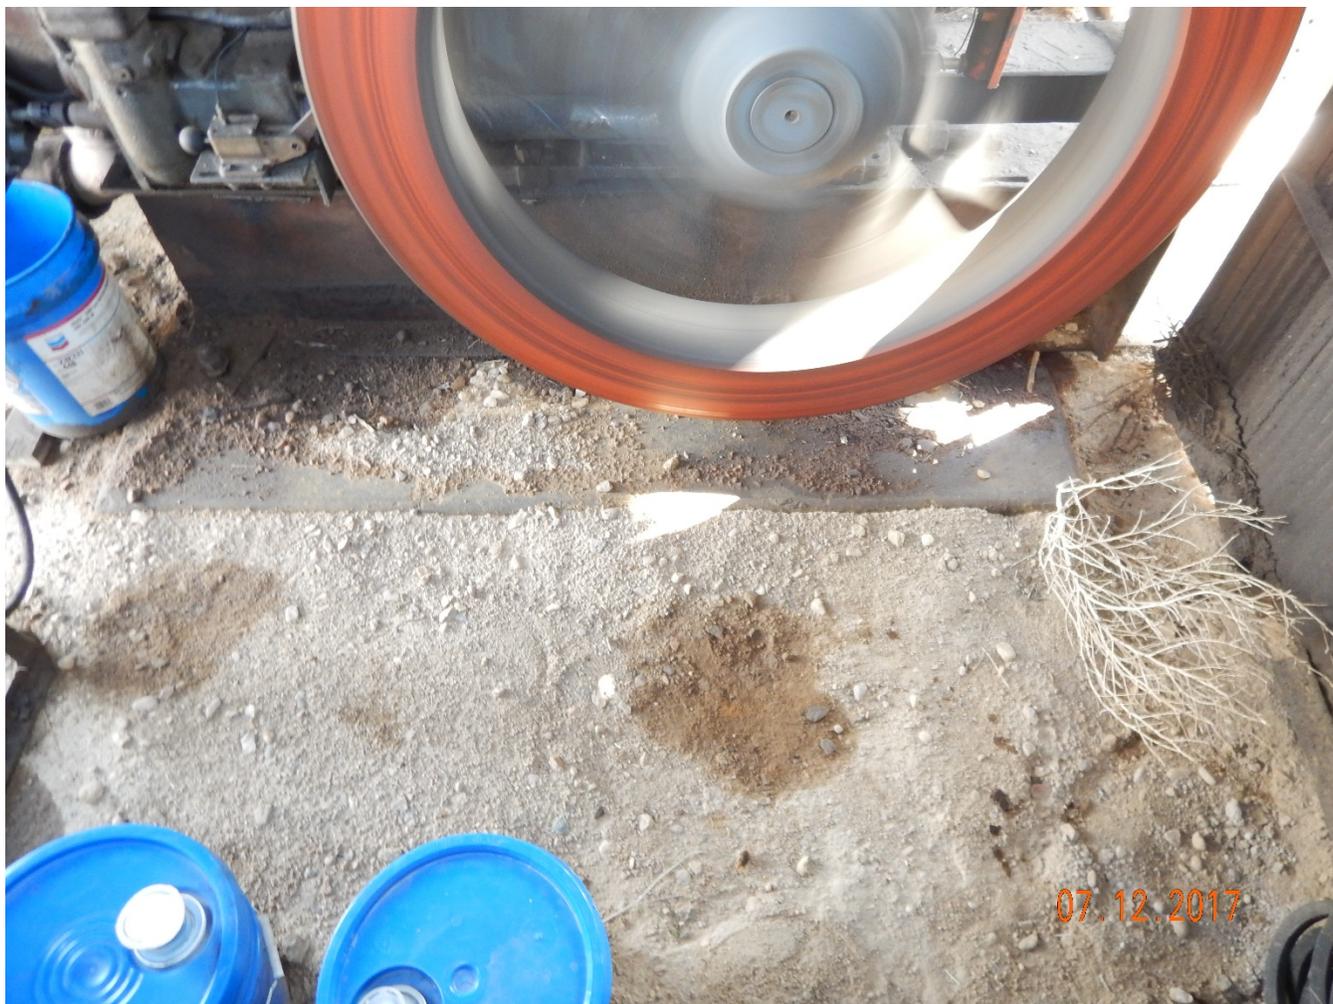
*Figure 5 - Lube oil staining observed at prime mover.*

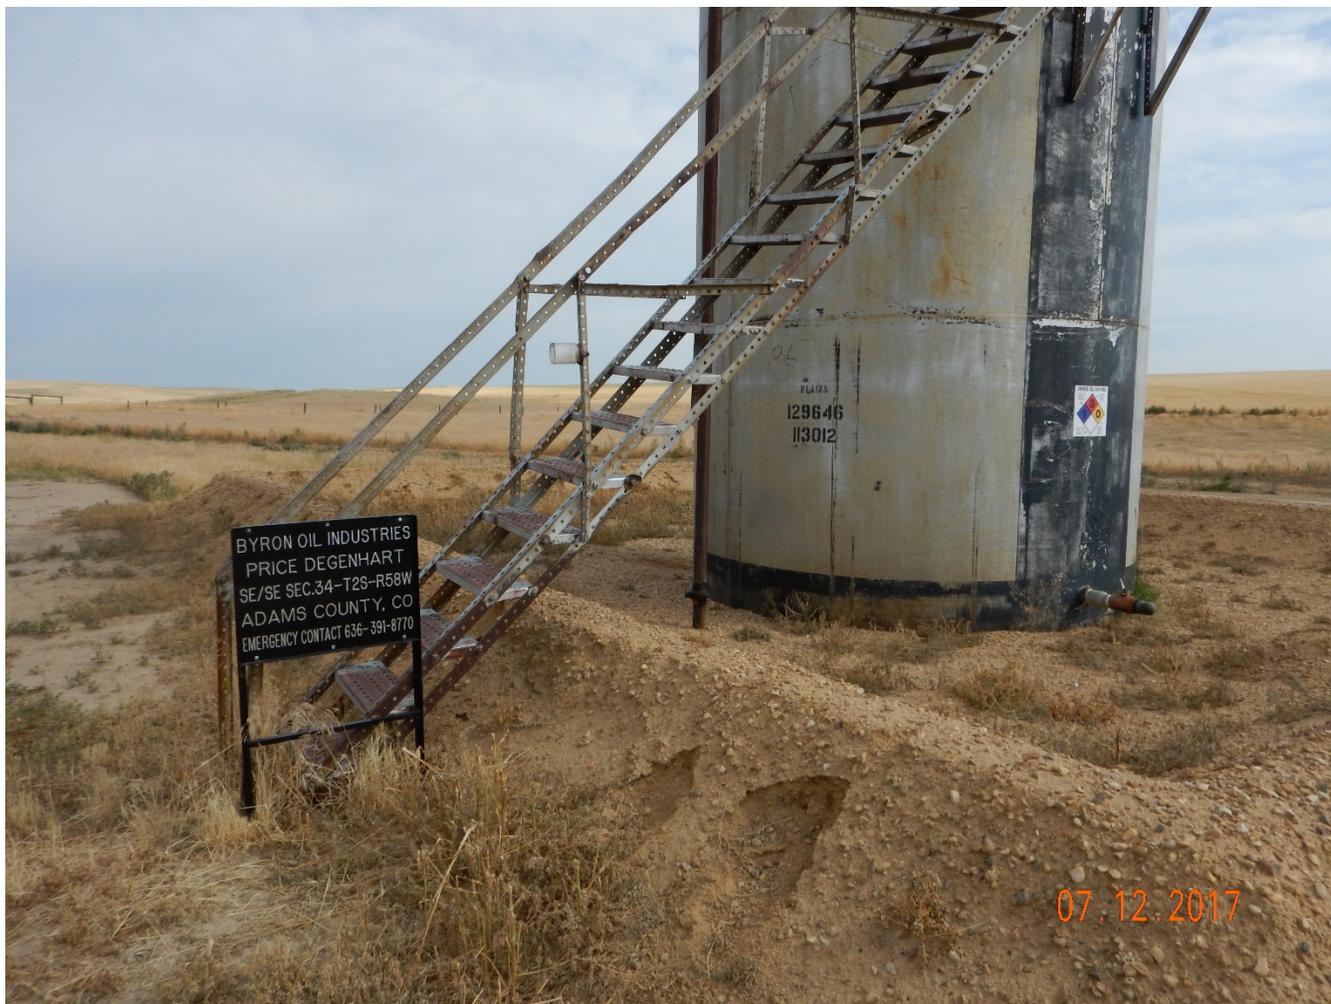
*Figure 6 - Tank Battery sign and crude oil AST. Note: weeds have been addressed, but berm is eroded.*

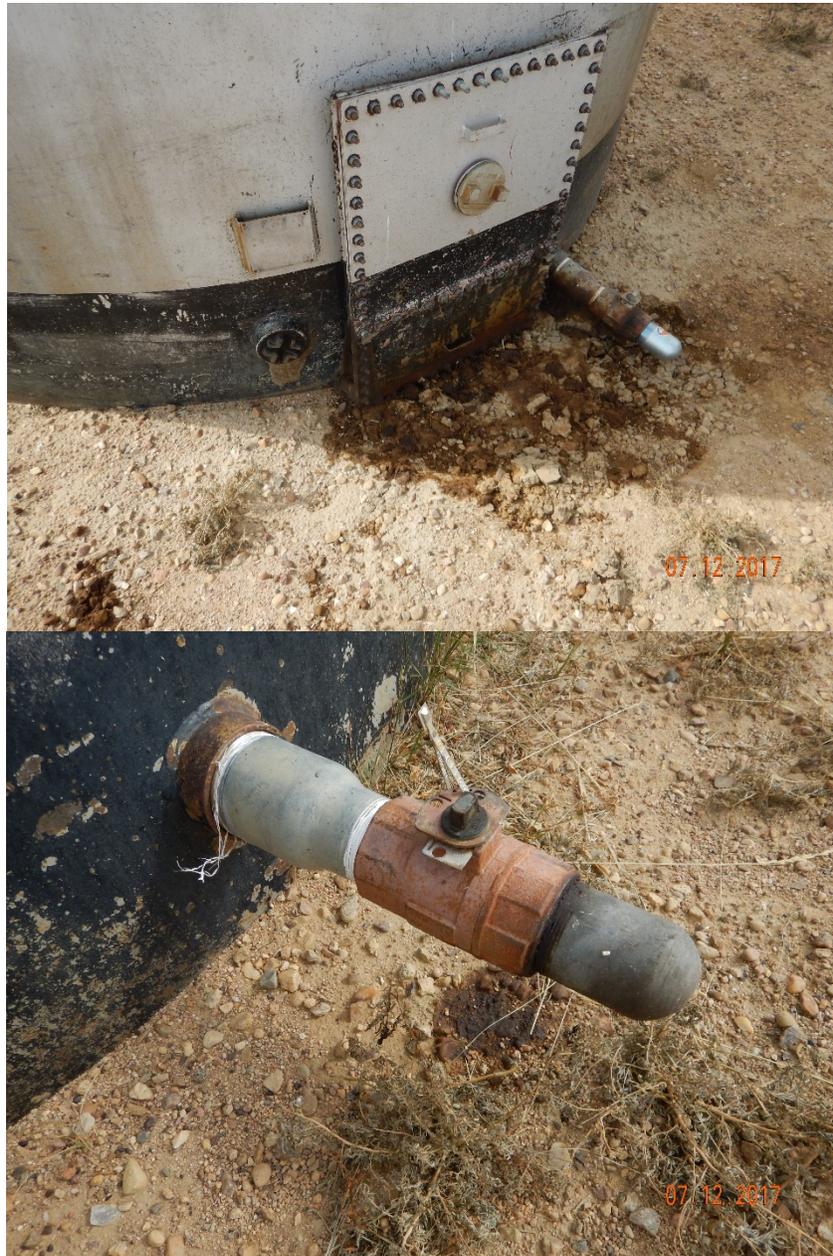
*Figure 7 - Oil-stained soil (oily waste) beneath valves on north and south sides of crude oil AST.*

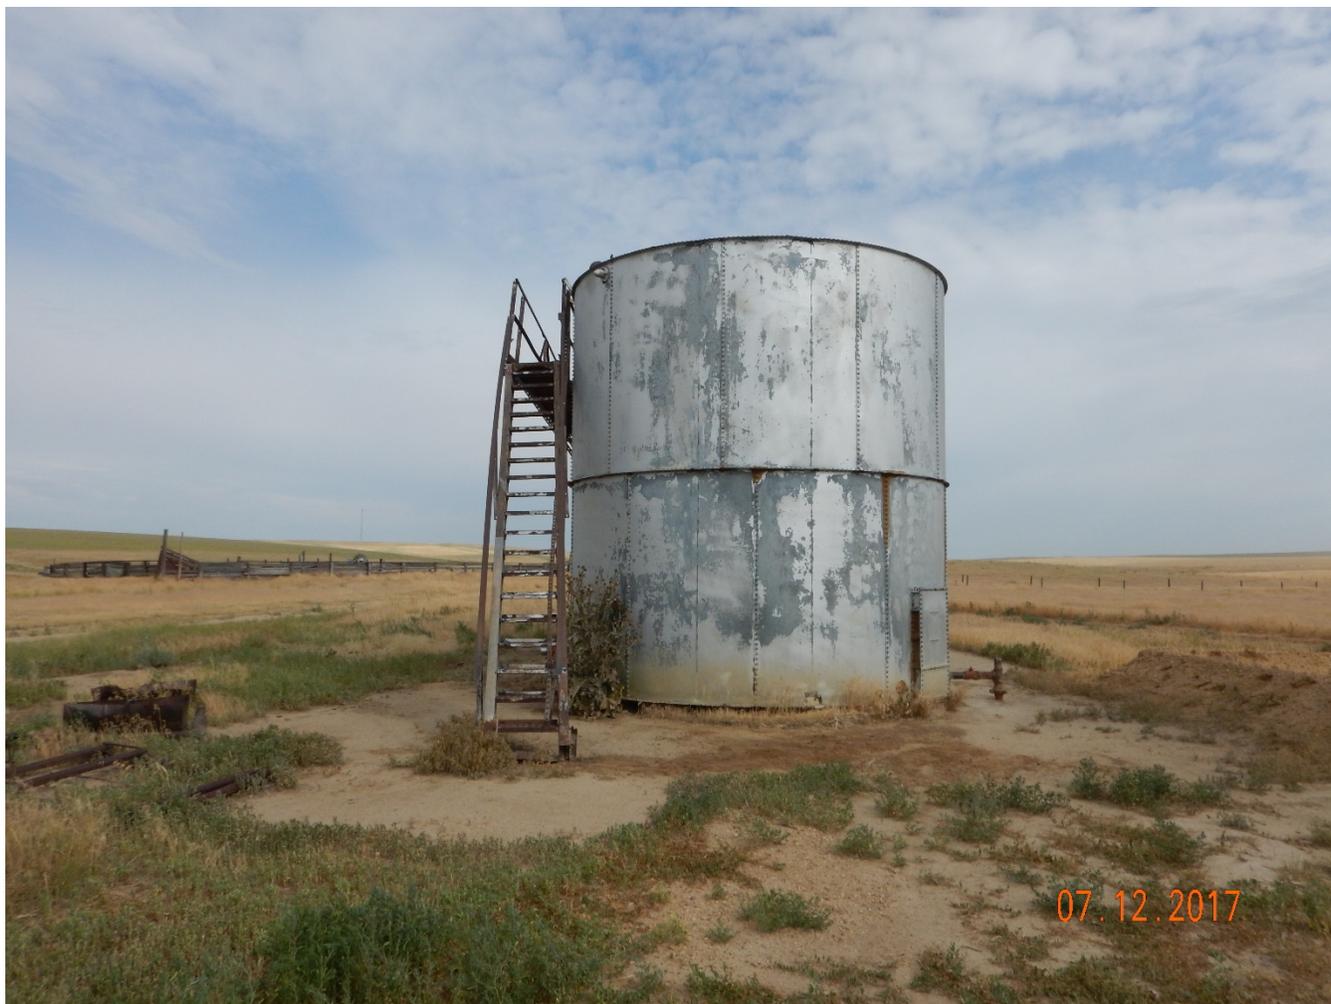
*Figure 8 - View of unidentified, steel panel ASTs from the south. Operator confirmed that these tanks are inoperable and thereby subject to Rule 603.f for removal of unused equipment. Note asphaltic material (oily waste) immediately south of tank (in foreground) and tanks lack secondary containment.*

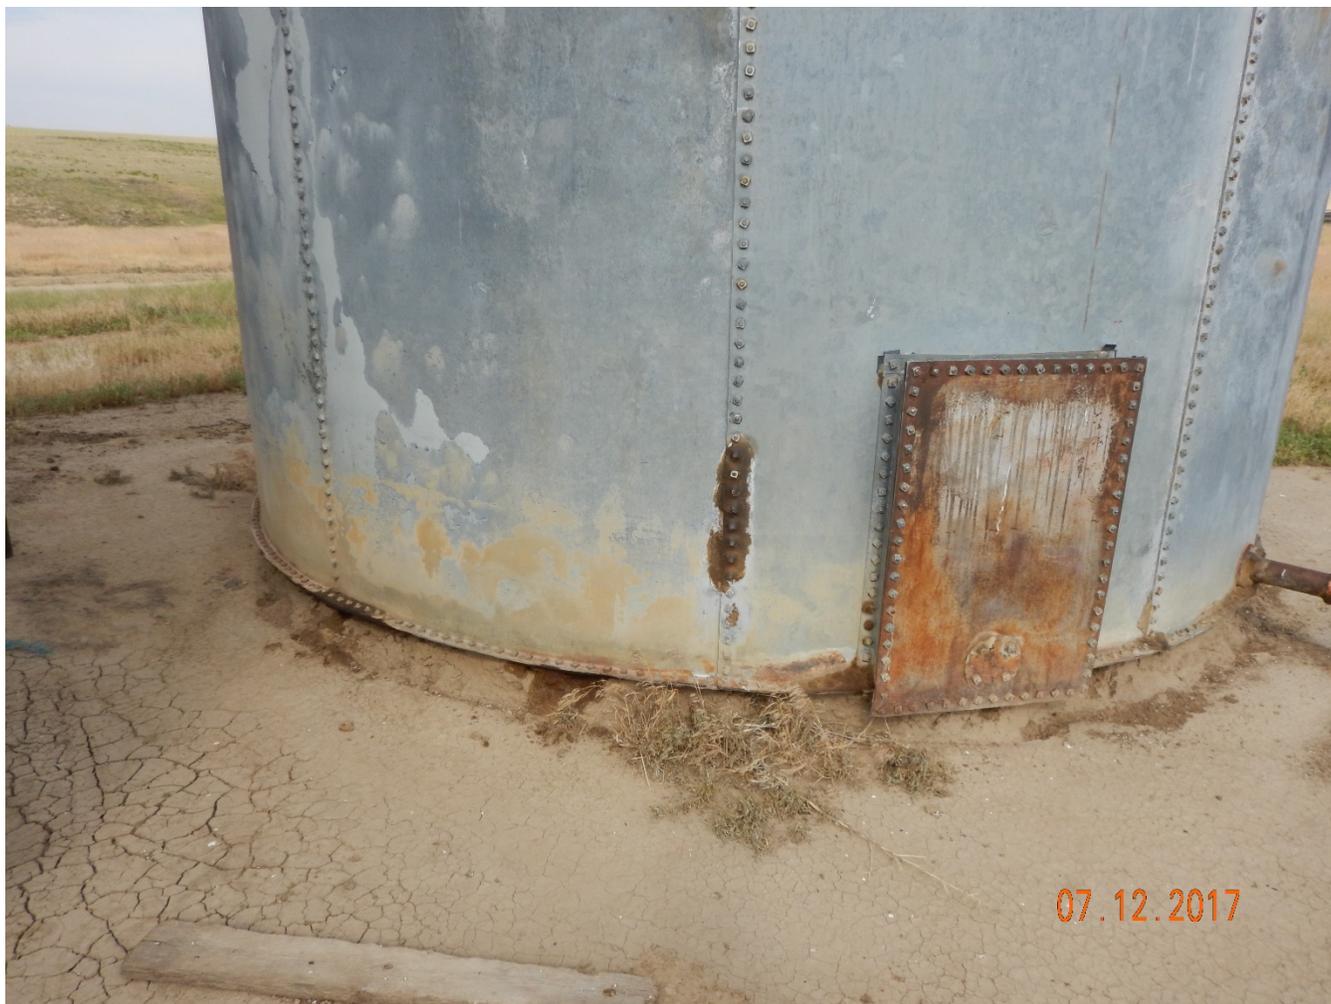
*Figure 9 - Historical accumulation of oily waste beneath tanks and seeping from tank bolts. Tanks likely contain tank bottoms.*

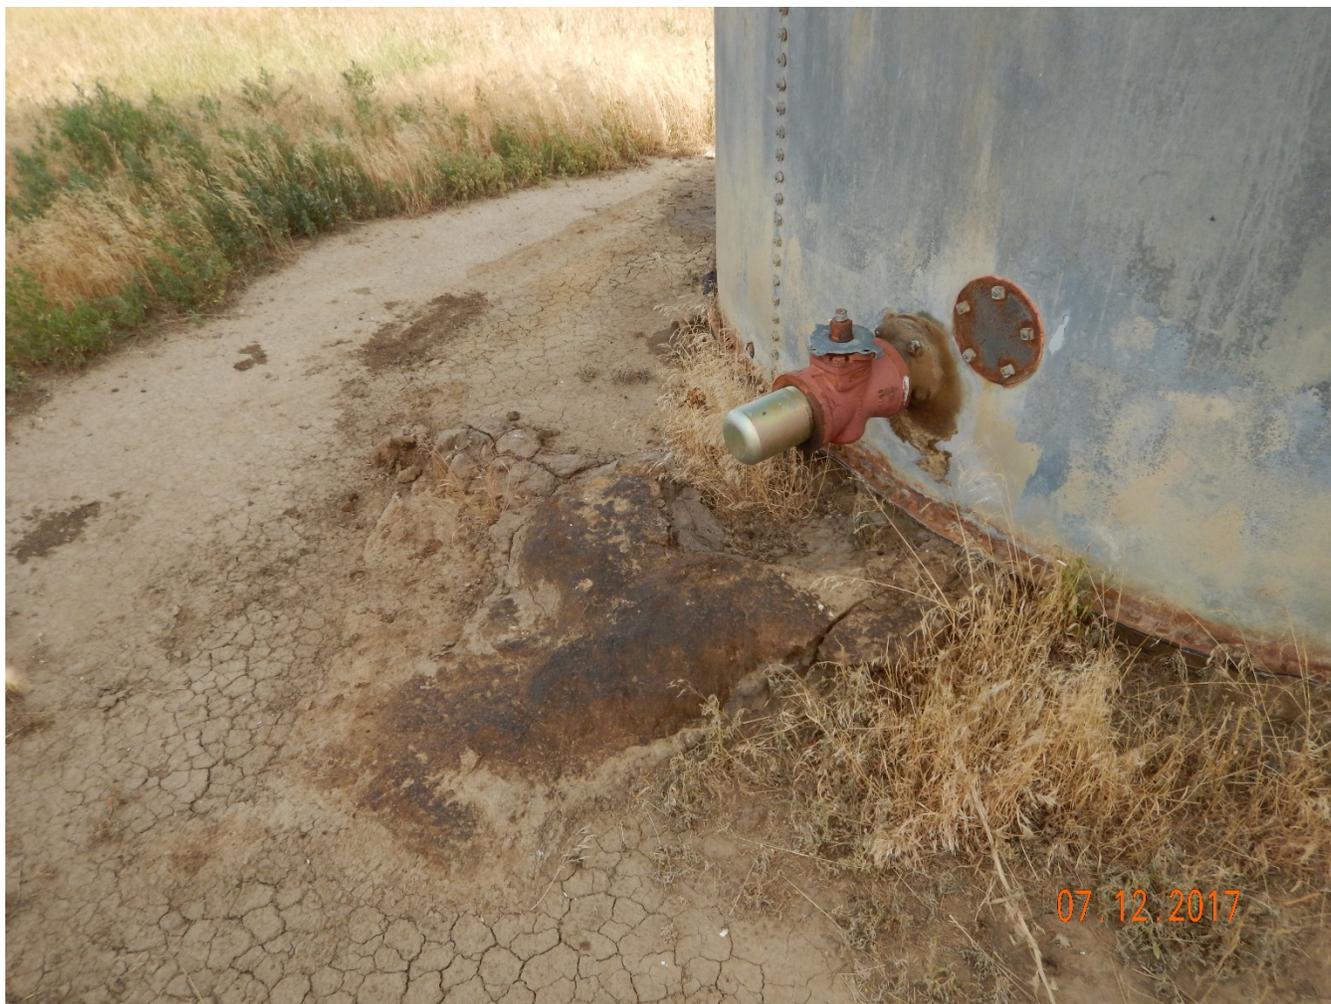
*Figure 10 – Accumulation of oily waste beneath valve on west side of northern panel tank.*

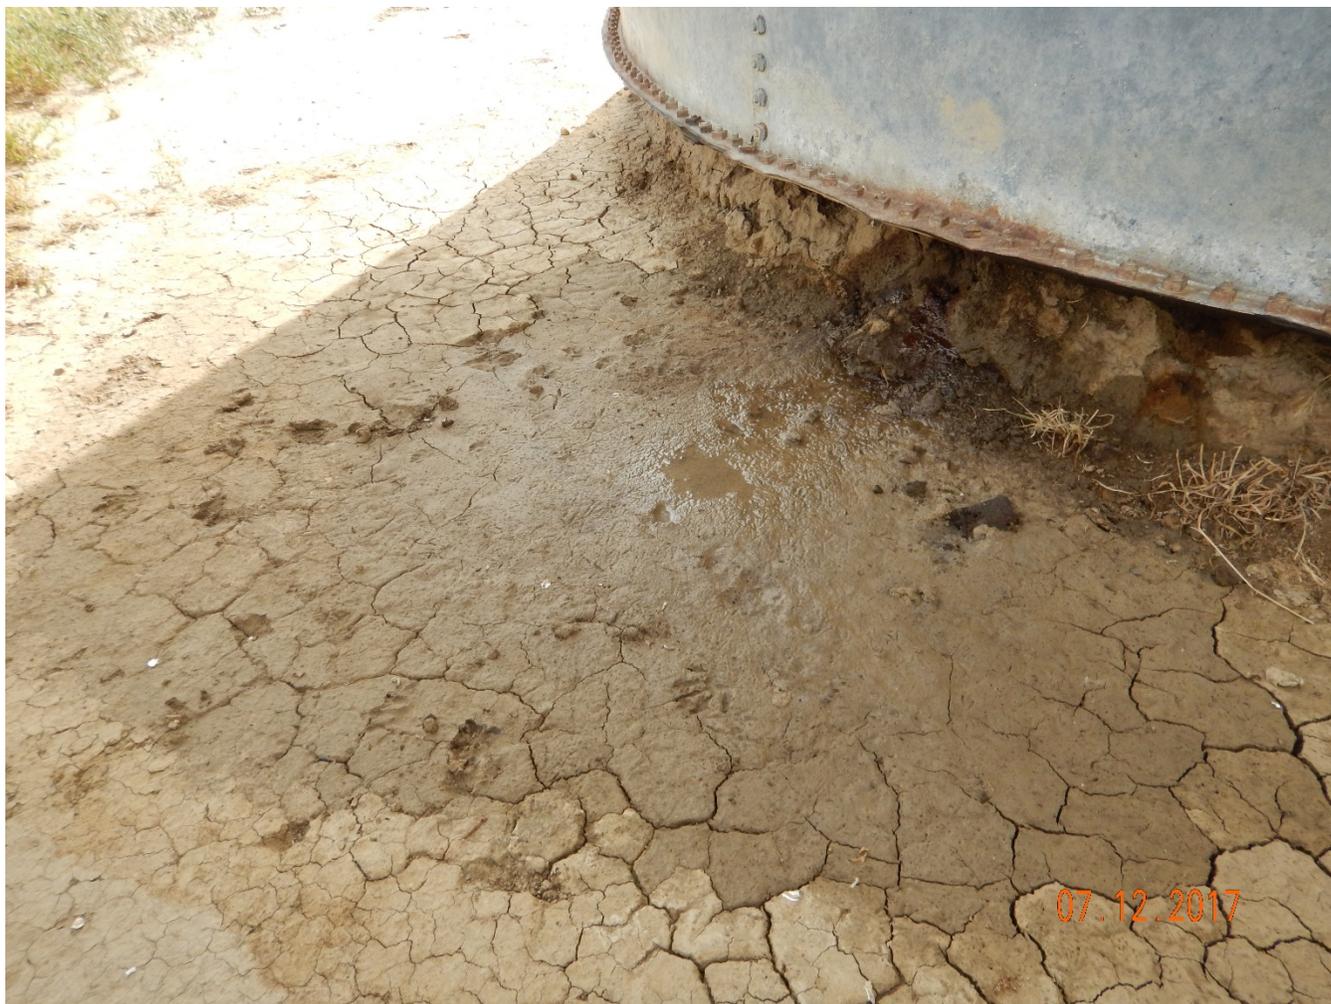
*Figure 11 - Puddle was observed on north side of northern steel panel tank. Water was observed dripping from tank into puddle. A contractor on site was notified of this issue during the field inspection and a follow-up call was made to the operator the following day.*

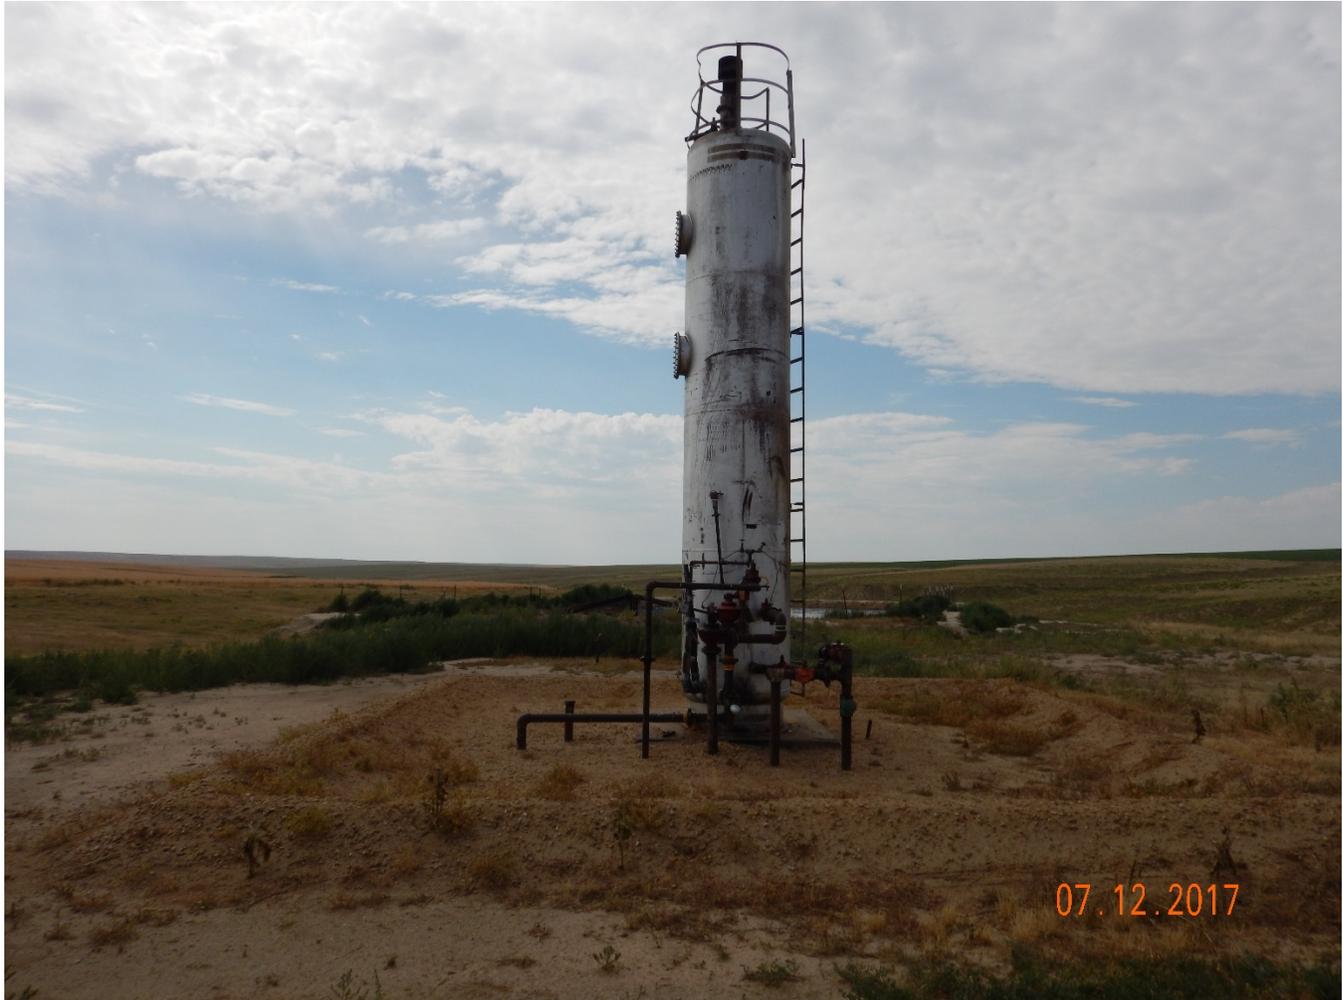
*Figure 12 - Vertical heater treater with earthen berm and adequate bird protection.*

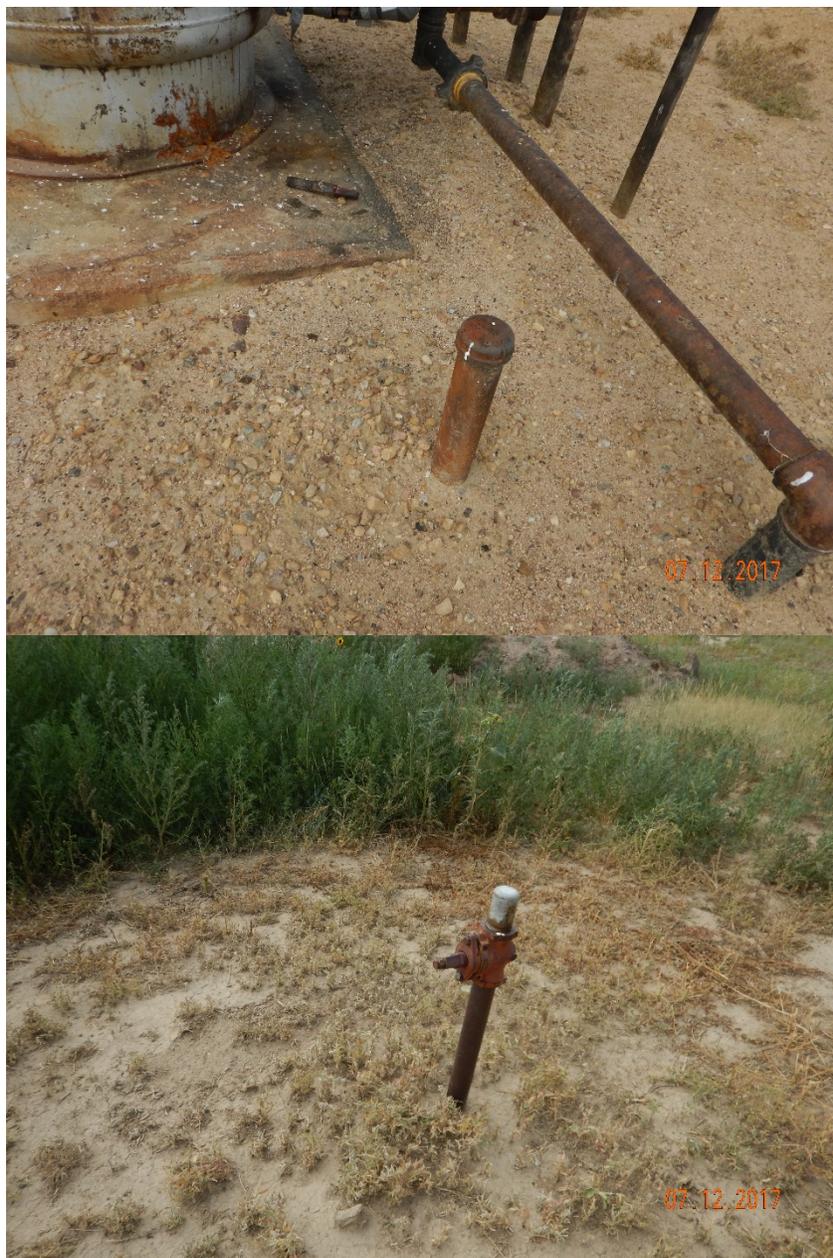
*Figure 13 - Abandoned flowline risers at heater treater (top) and south of heater treater (bottom) had not been marked or tagged to comply with 2017 Flowline NTO as of inspection date.*

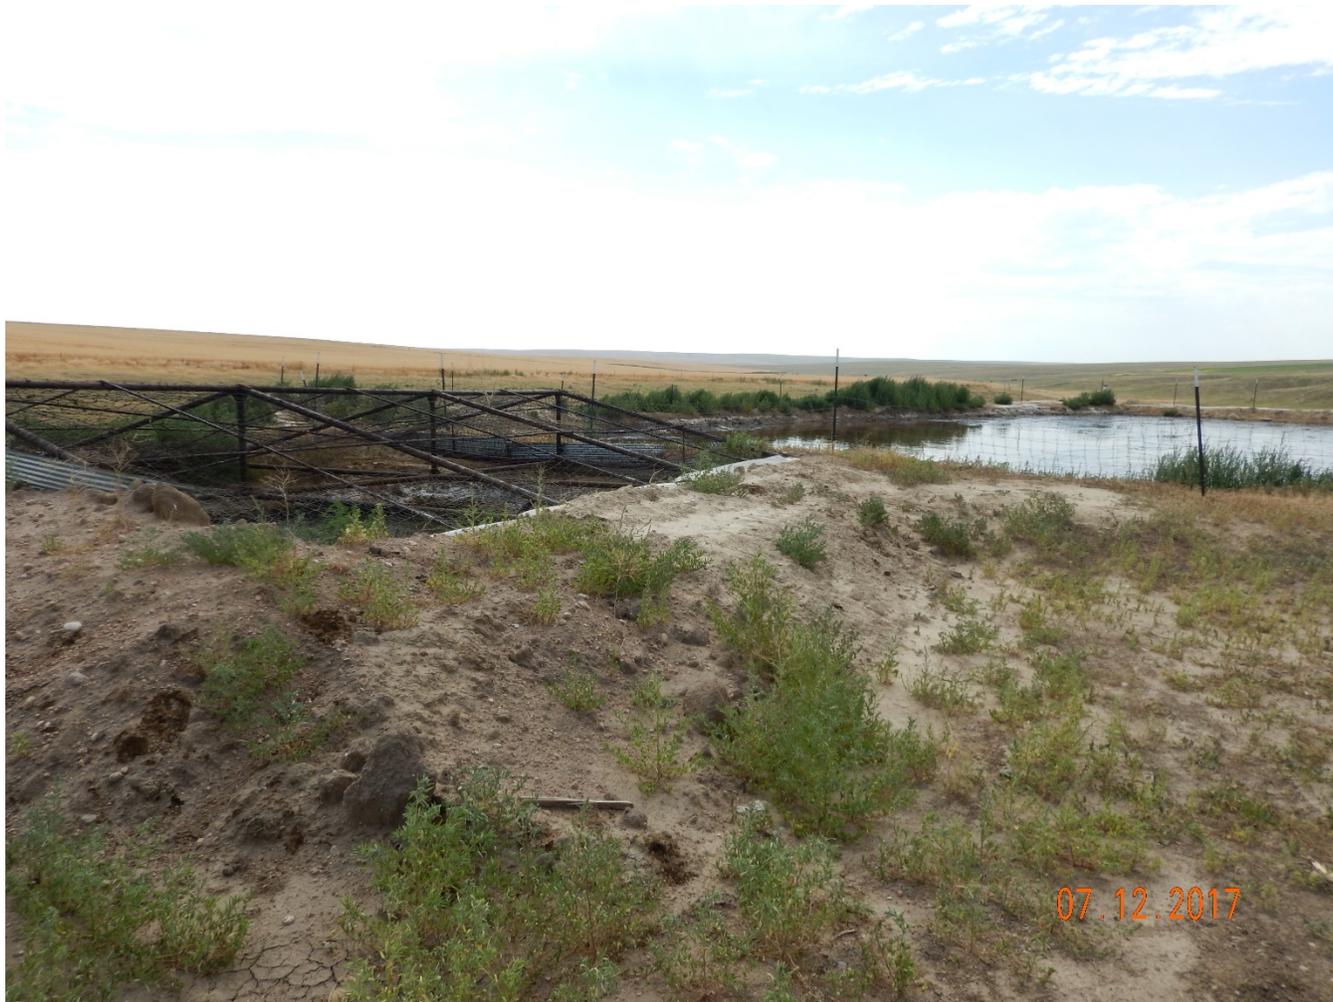
*Figure 14 - Price-Degenhart I pit complex. Netted, unlined skim pit in foreground (left) with unlined produced water pit in background (right).*

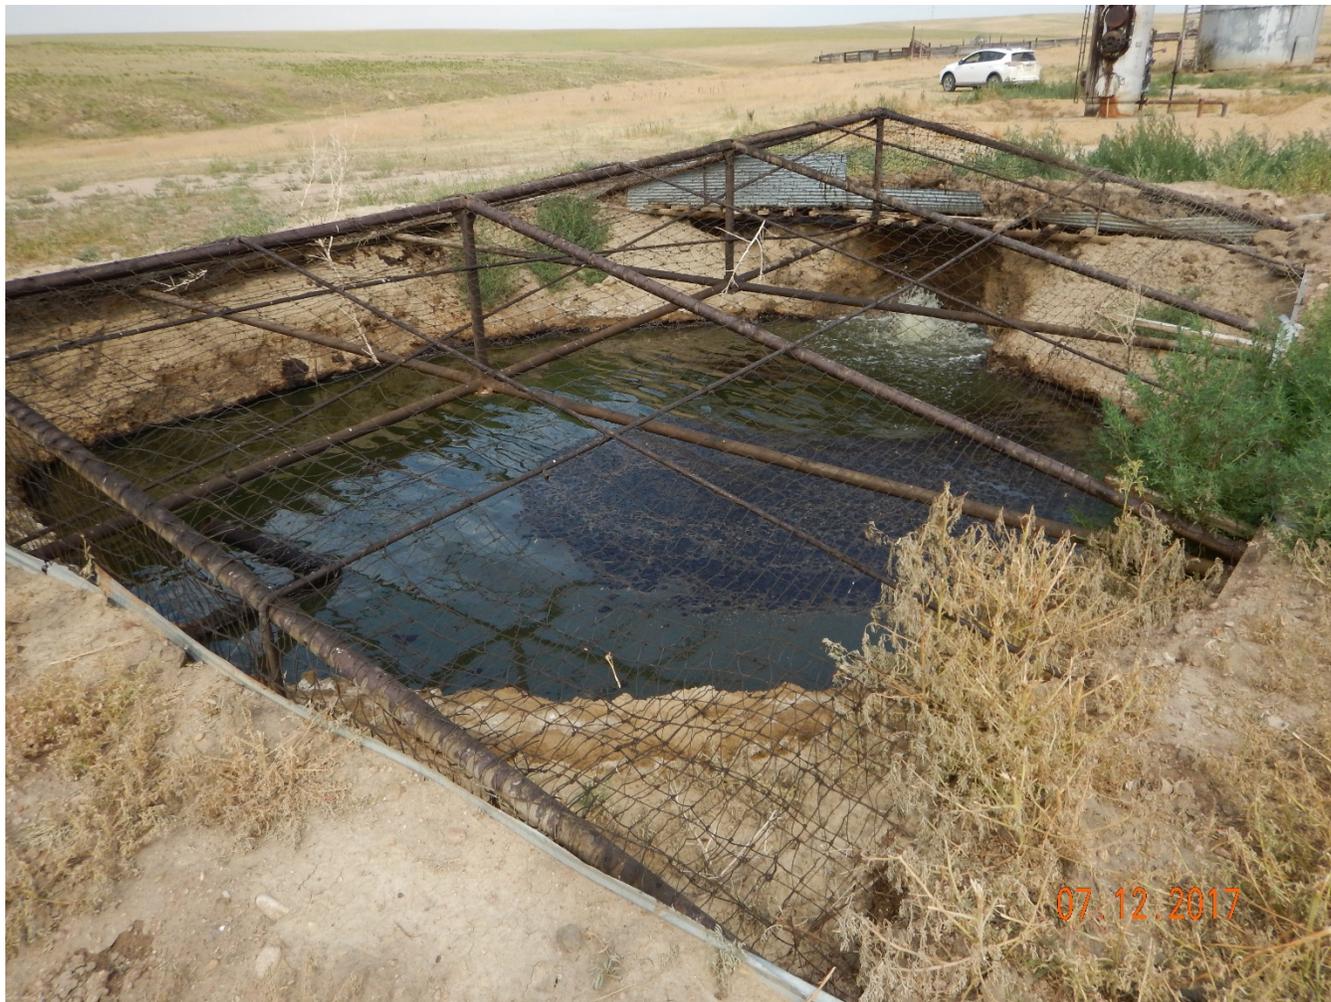
*Figure 15 – View of unlined skim pit, COGCC Facility ID #104647, from SE corner. Note oil remaining on pit and berms. Continued operation of an unlined skim pit is a violation of Rule 904.a.(4), presence of oil on the pit is a violation of Rule 902.c and Rule 323.*

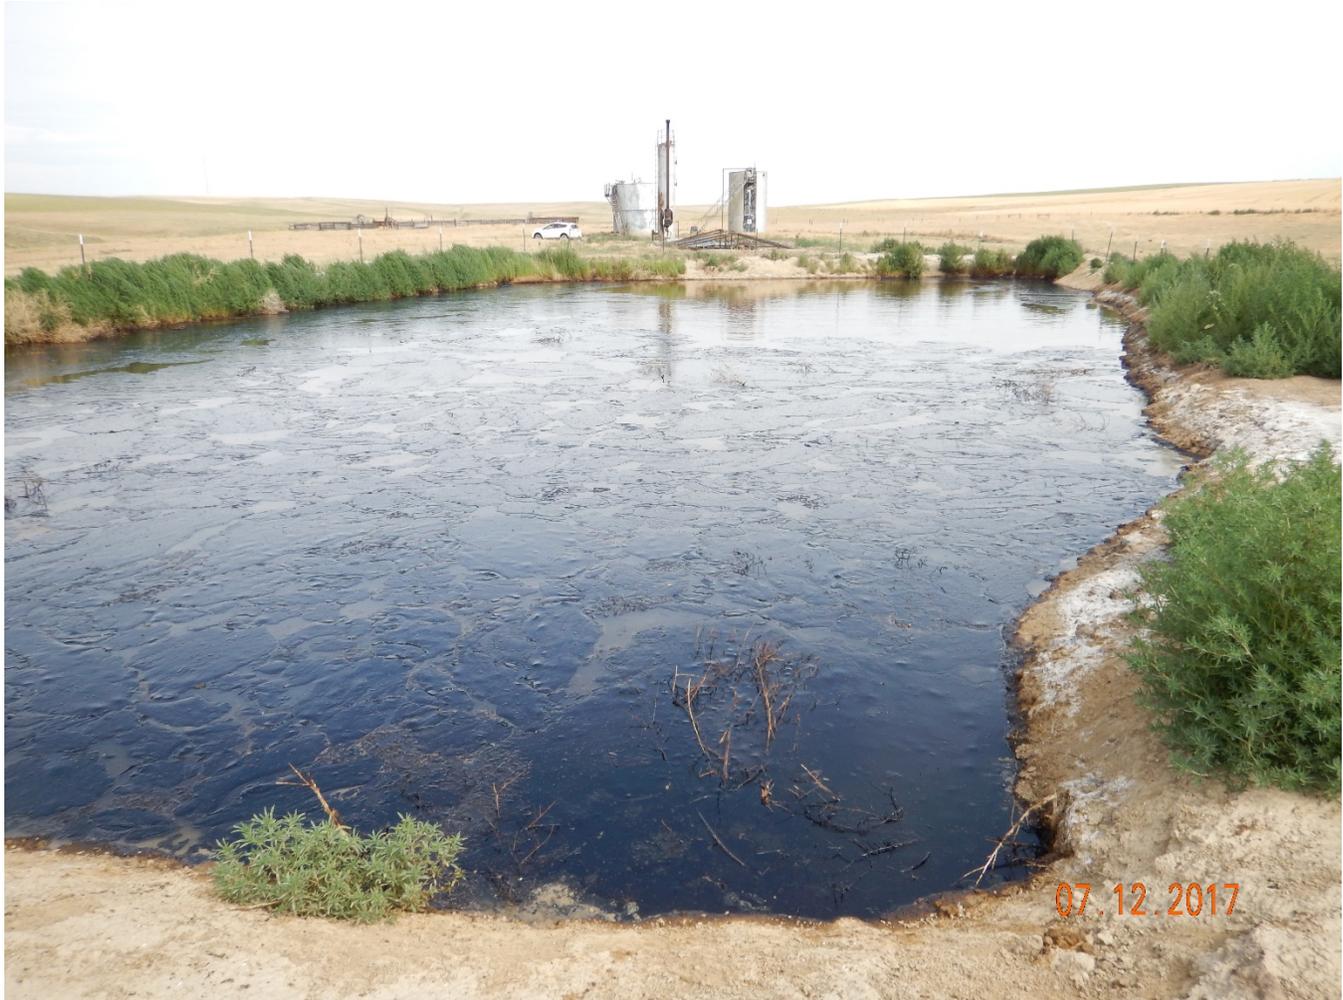
*Figure 16 - View of unlined produced water pit, COGCC Facility ID #114378, from SE corner. Note: weeds growing into berms and continued presence of oil on pit, in violation of Rule 902.c and Rule 323.*

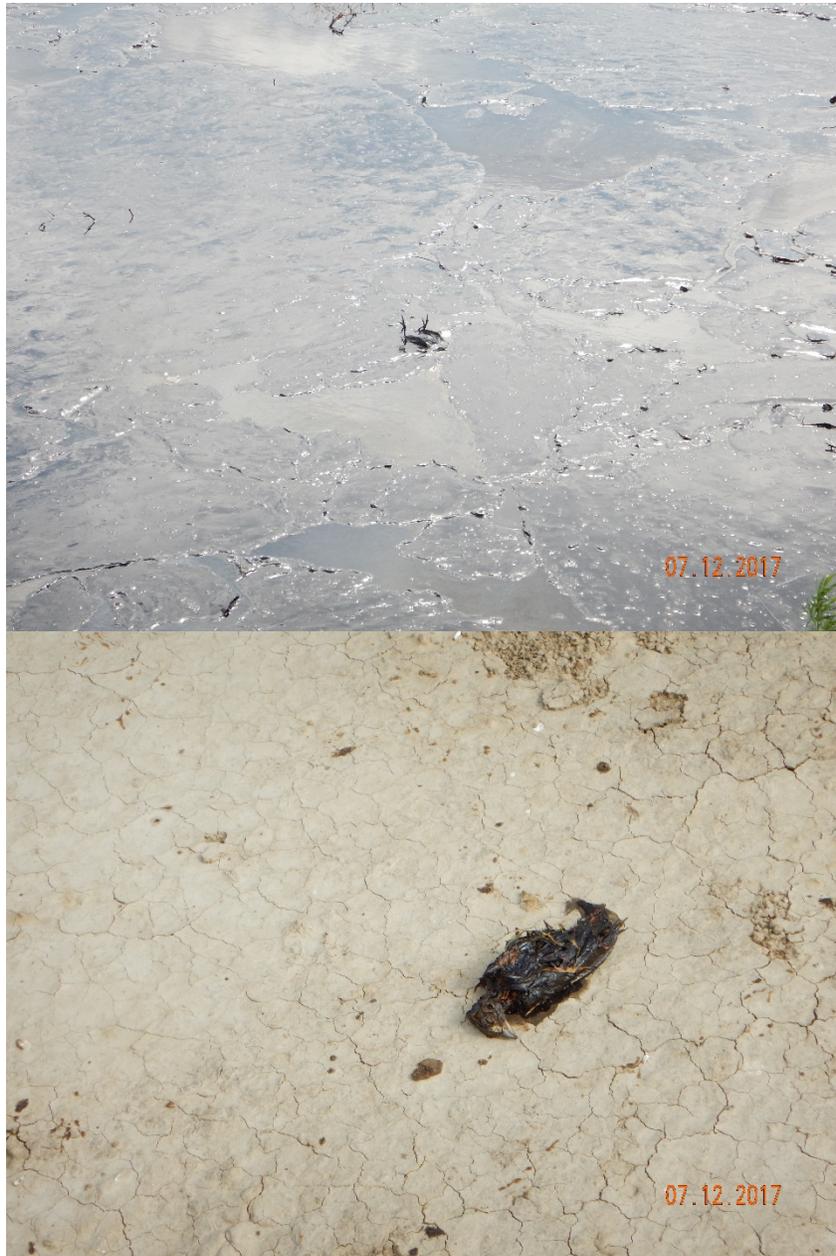
*Figure 17 - Dead birds observed in and around produced water pit.*
