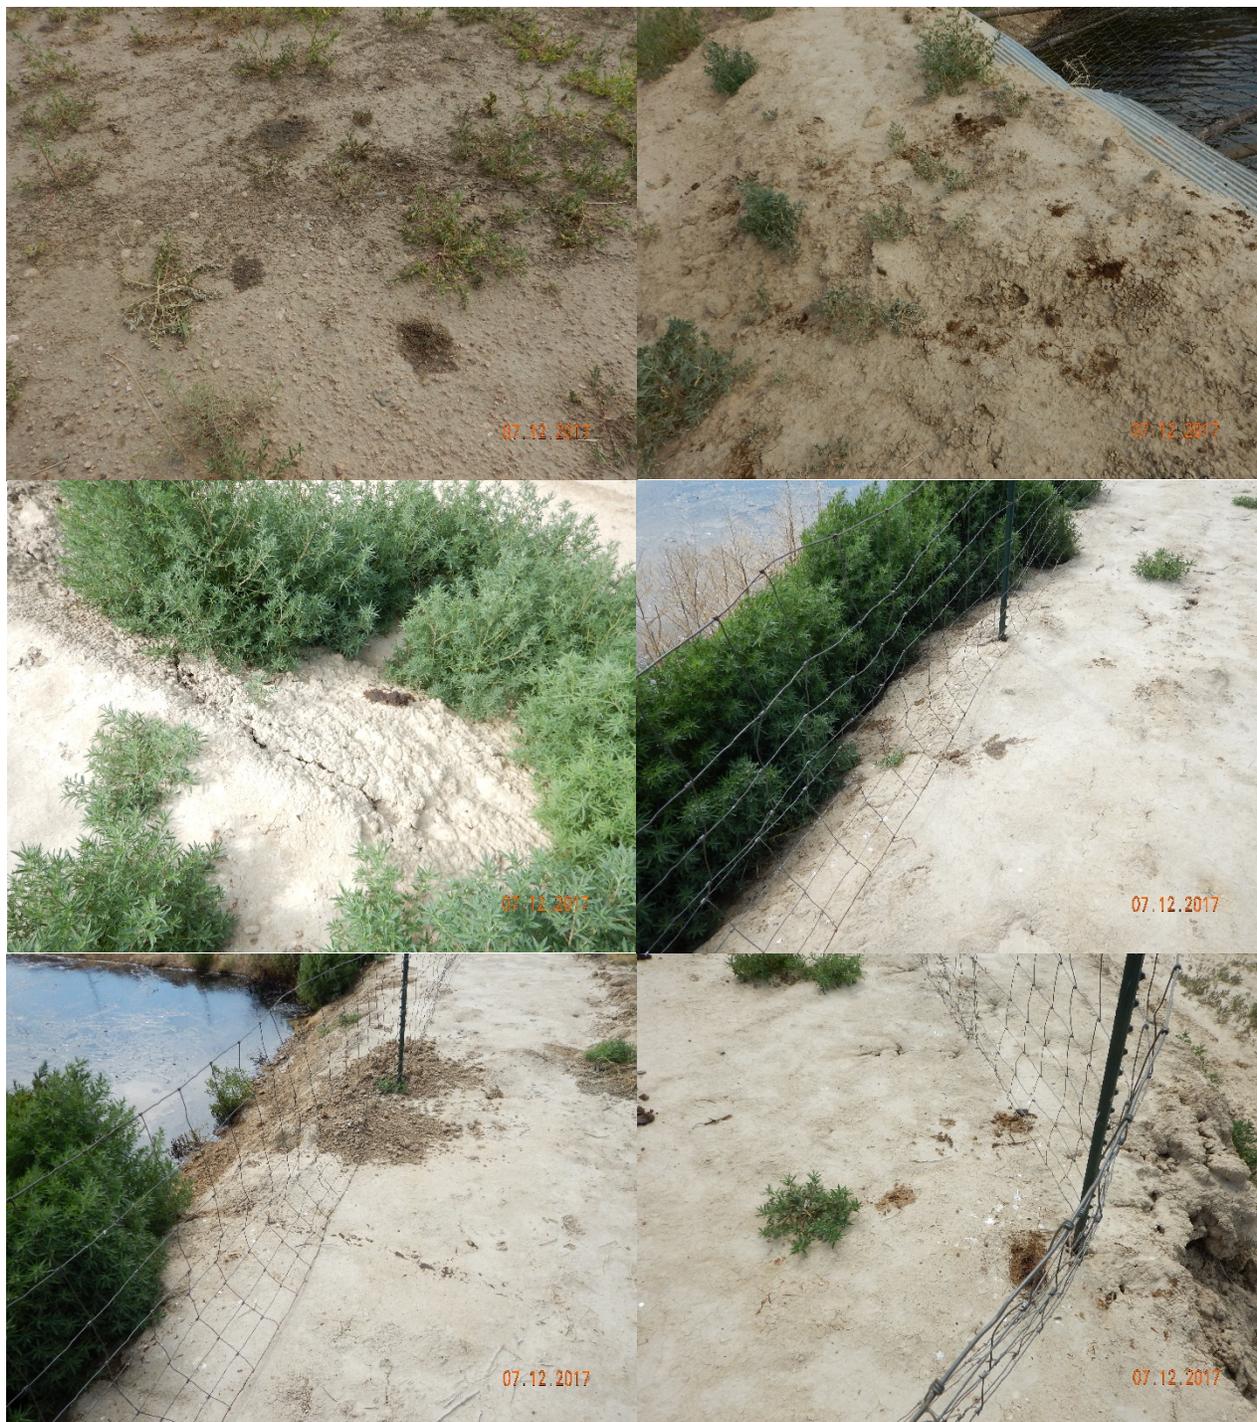
*Figure 18 - Localized, oil-stained soil observed along western berms of both pits (likely the result of attempts to remove oil from pits in response to 6/22/2017 FIR).*

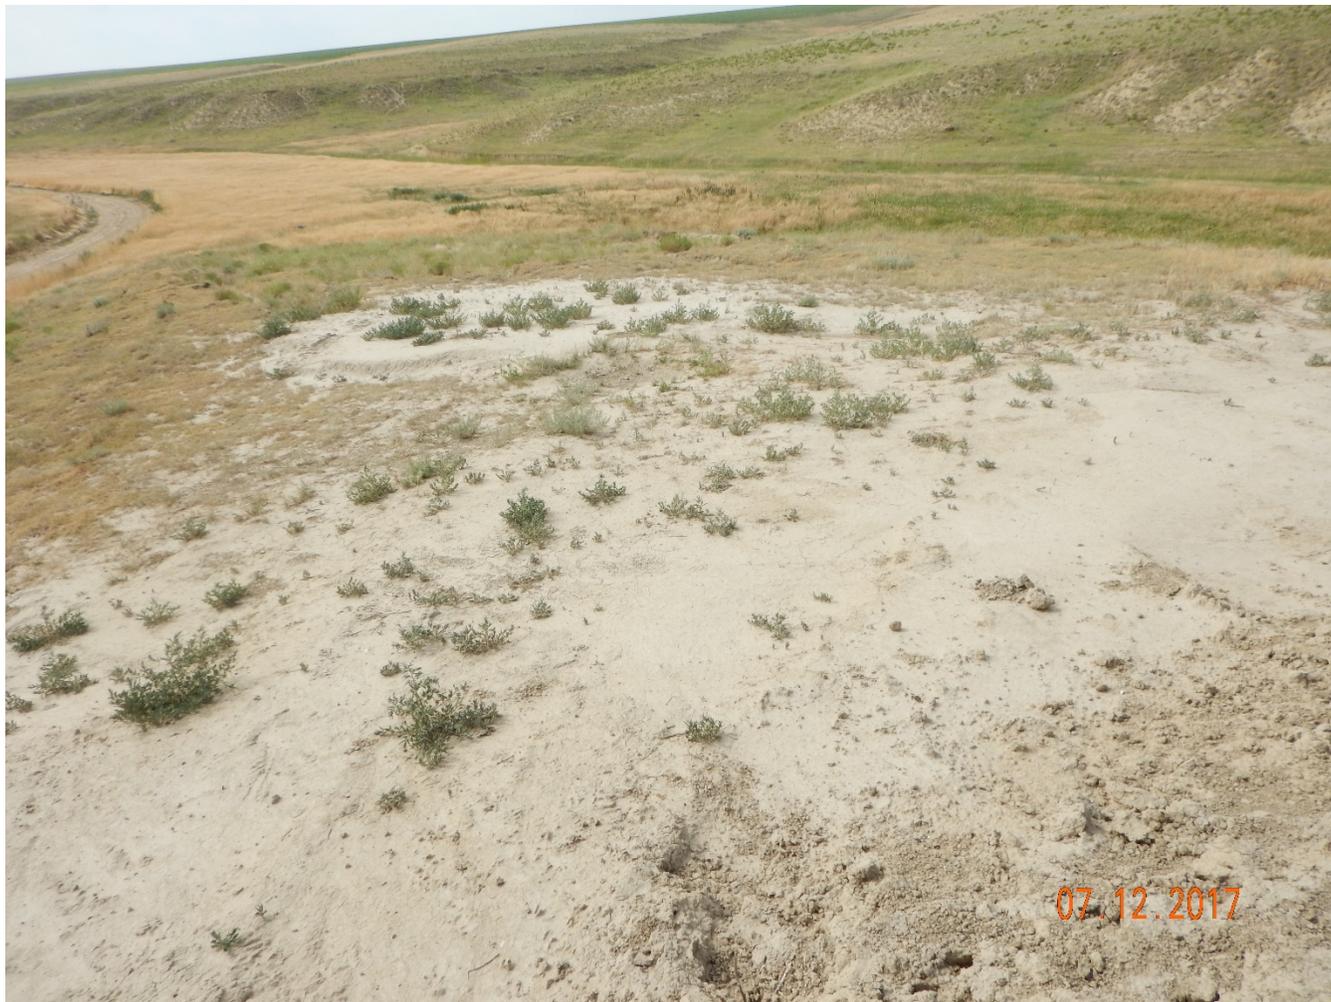
*Figure 19 - Evidence of erosion, sediment migration, and possible impacted vegetation to south of produced water pit.*

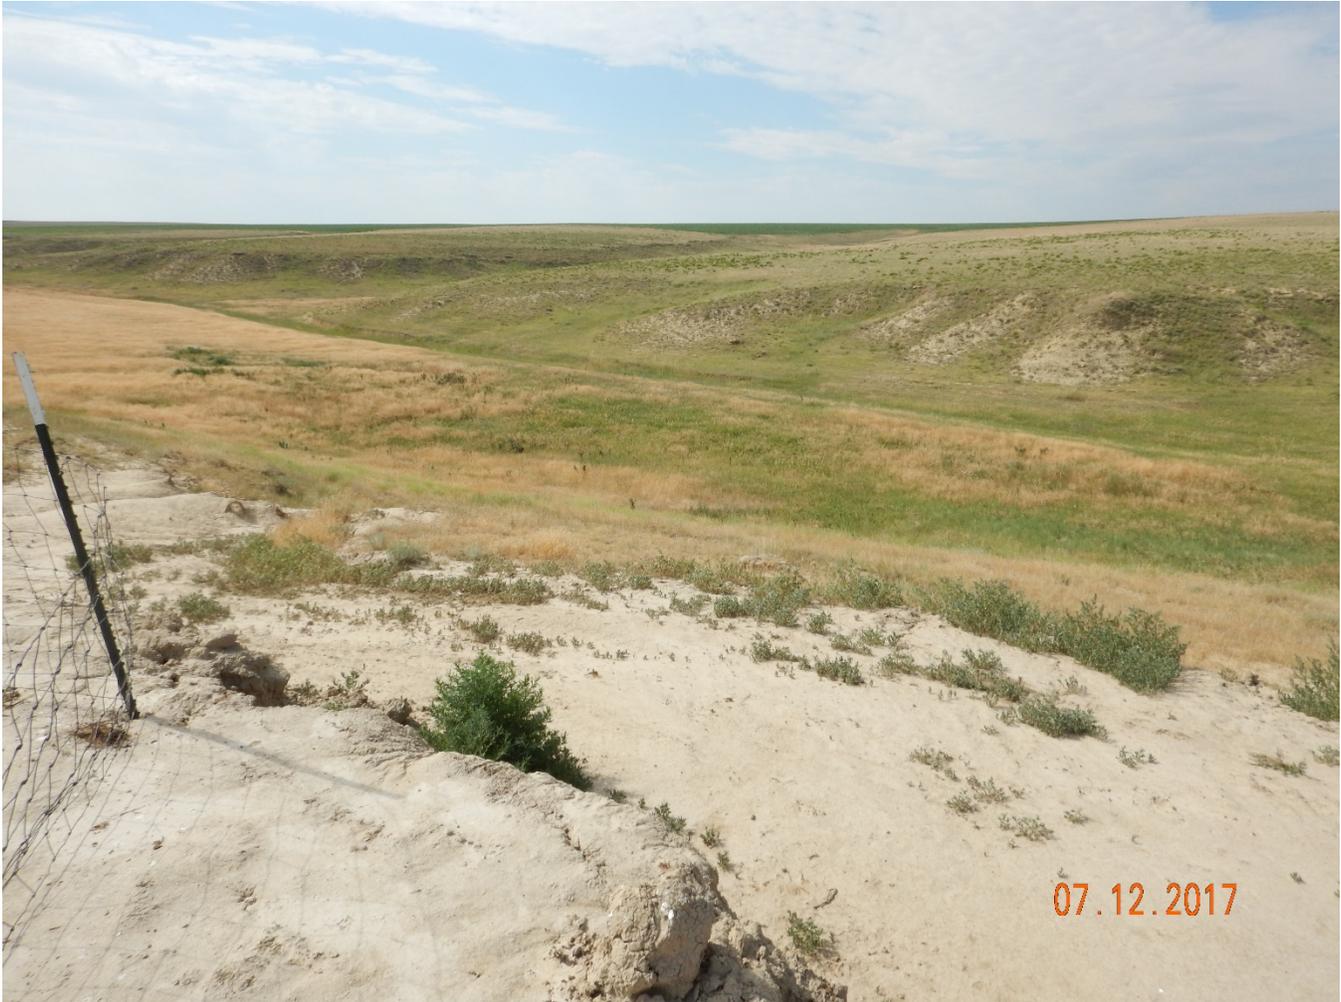
*Figure 20 - Evidence of erosion, sediment migration, and possible impacted vegetation to southwest of produced water pit.*
