Inspection Photos

Location Number: 450561

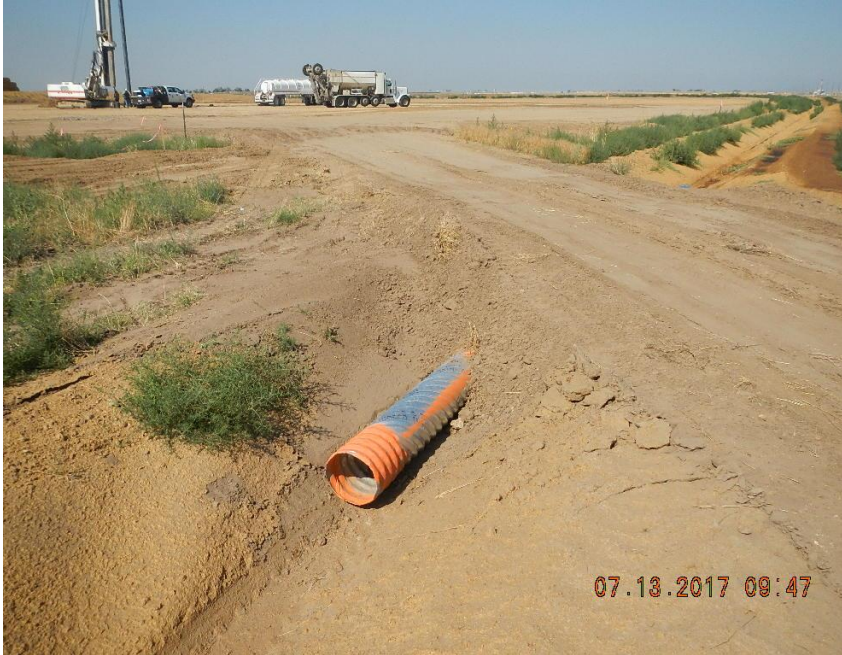
Photo 1 Culvert at entrance from north

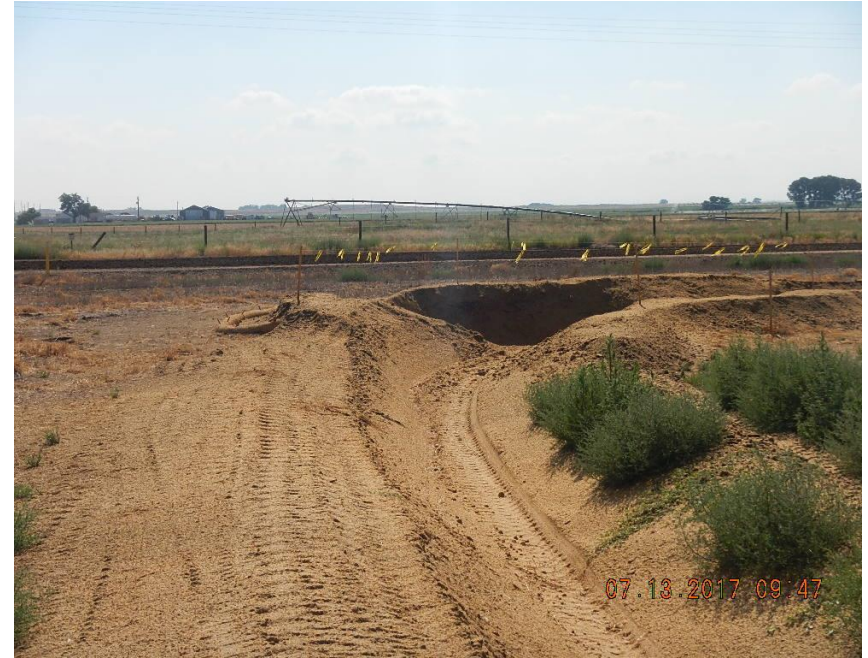
Photo 2 Stormwater detention on northeast corner from northwest

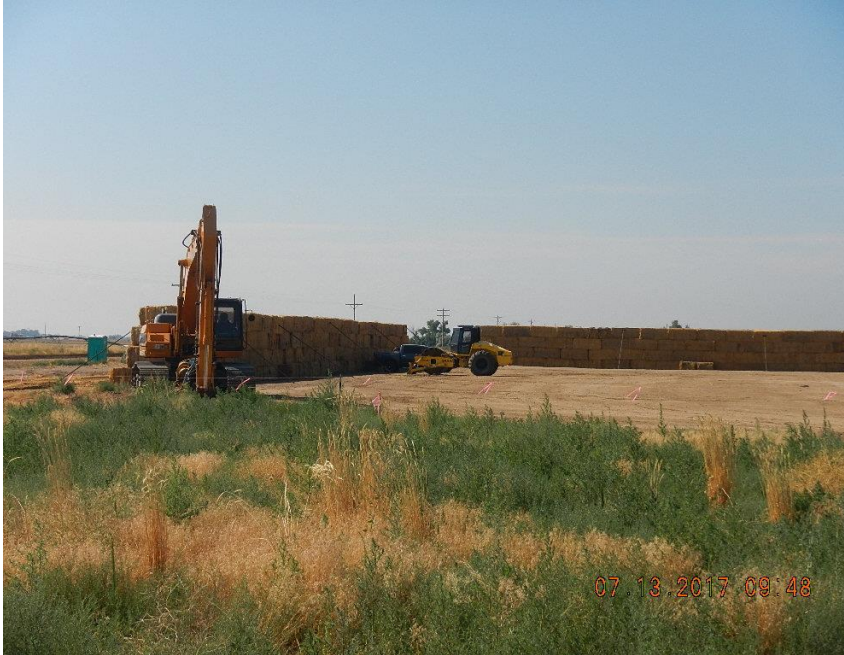
Photo 3 Sound mitigation bales on south and southeast corner of location.

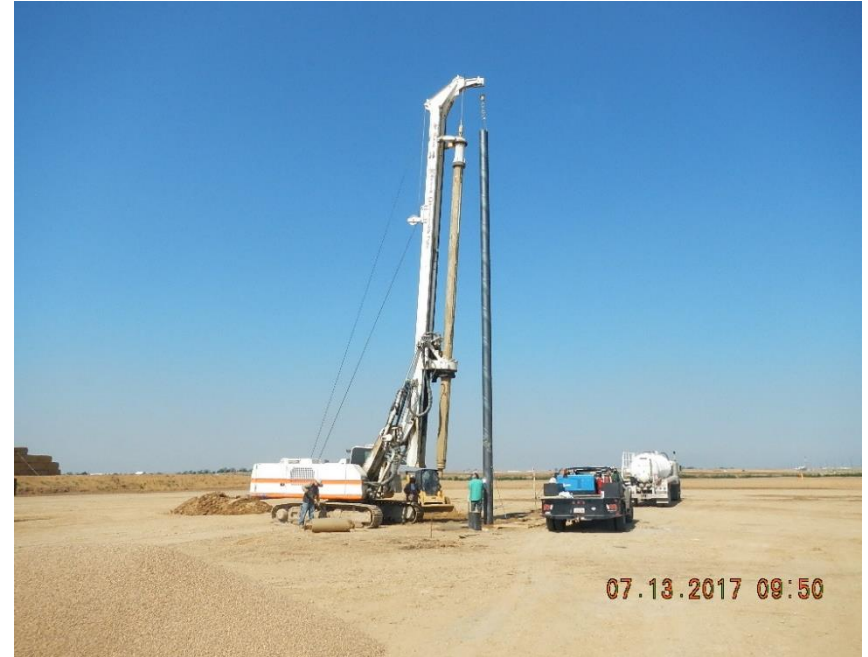
**Photo 4 Pete Martin R-12 rig
Welding of rat hole casing underway from east.**
