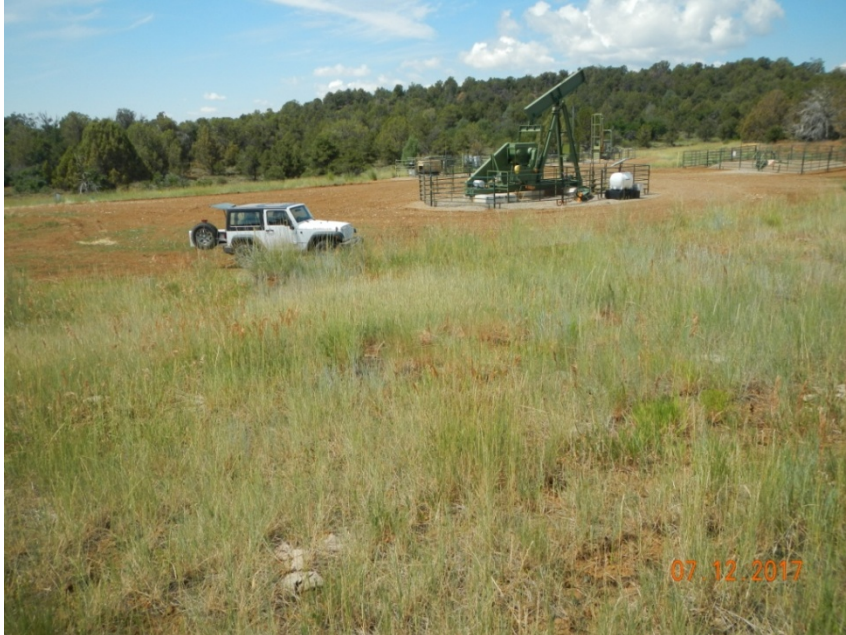
Photo 1: View from the northeastern portion of the project area facing center.

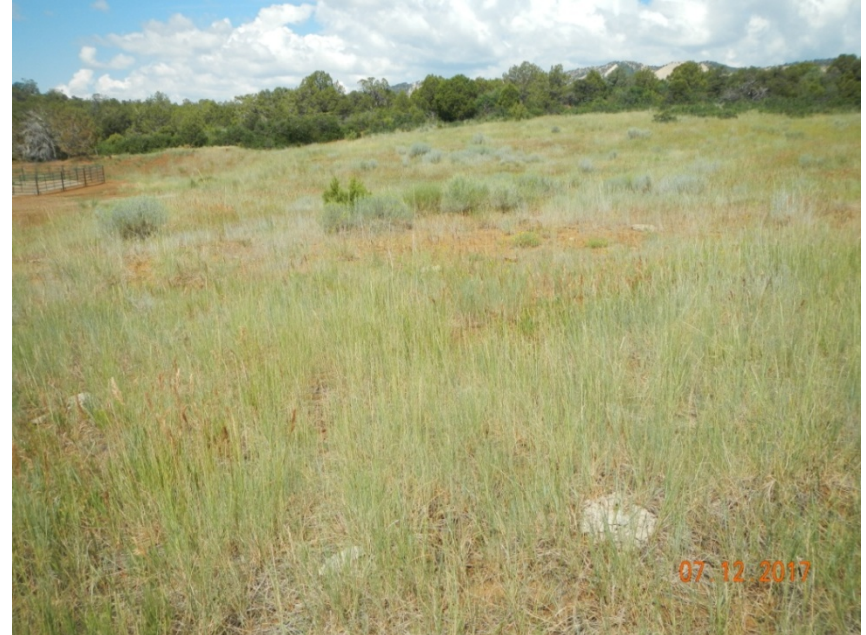
Photo 2: View of the northern portion of the project area from the northeastern corner facing westward.

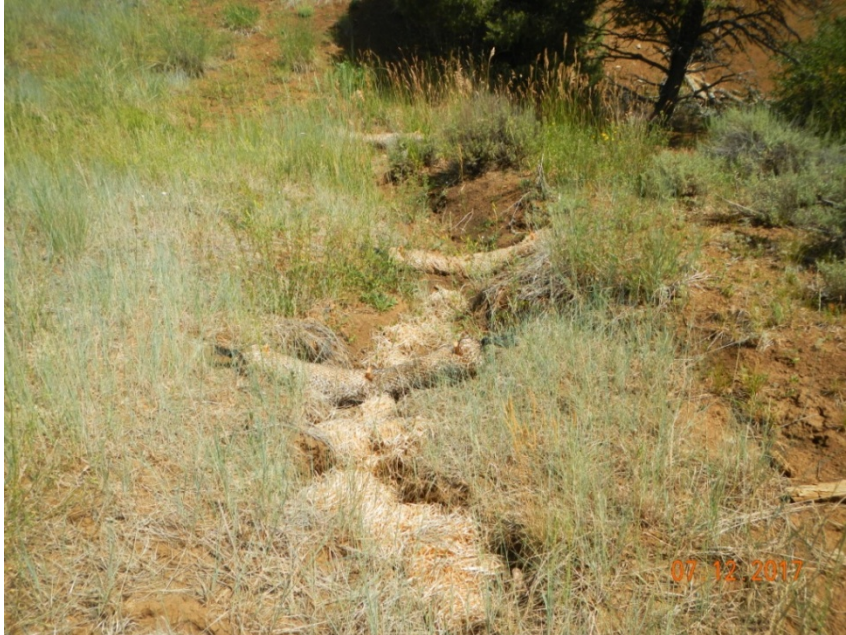
Photo 3: View of new stormwater controls installed in head-cut area at culvert outlet.

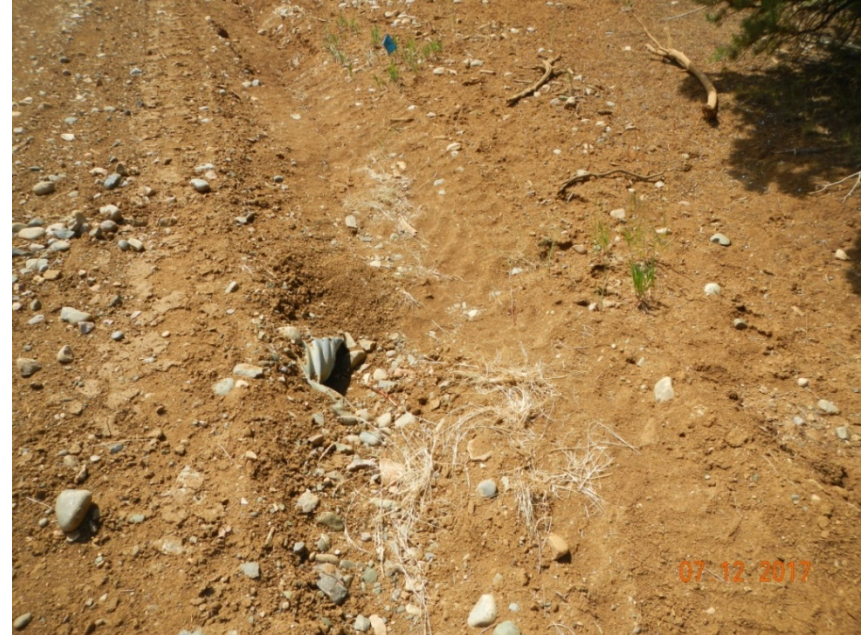
Photo 4: View of damaged culvert inlet at the well pad entrance.
