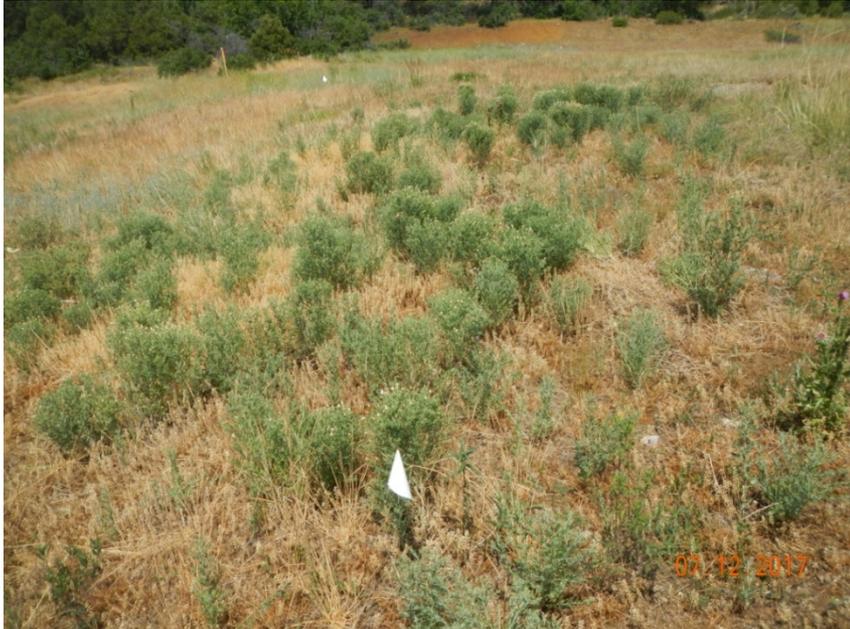
Photo 1: View of Russian knapweed plants growing within the southern portion of the project area.

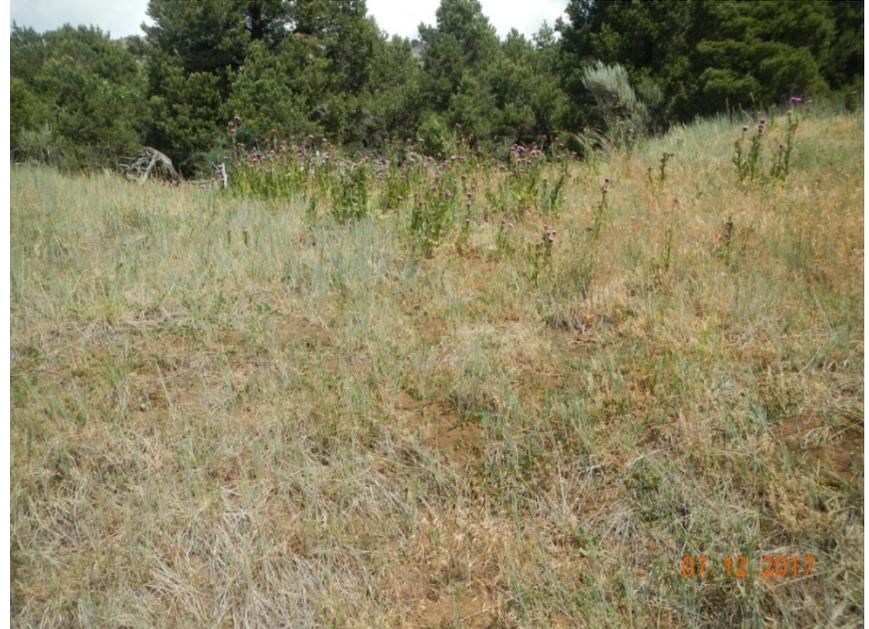
Photo 2: View of musk thistles within the northwestern corner of the project area.

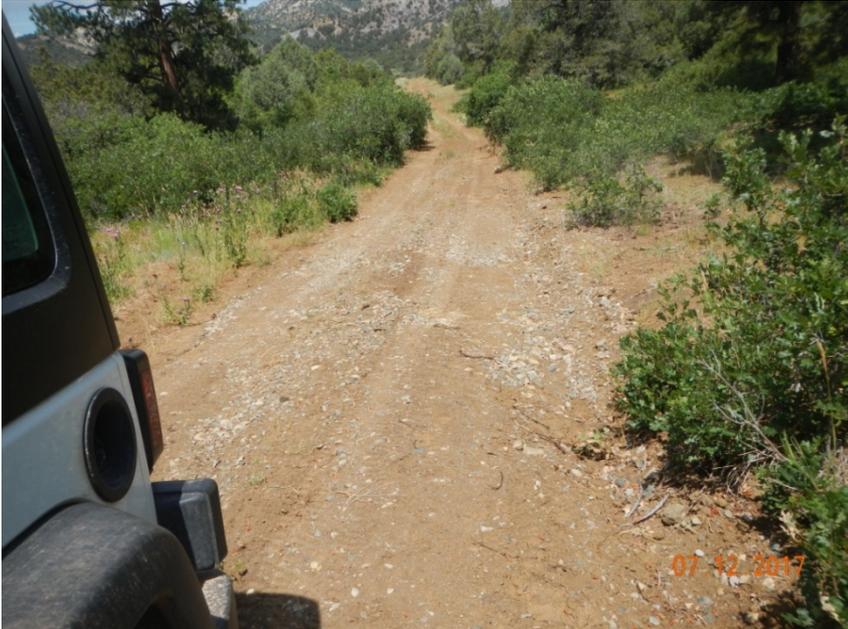
Photo 3: View of area of access road that was recently repaired.

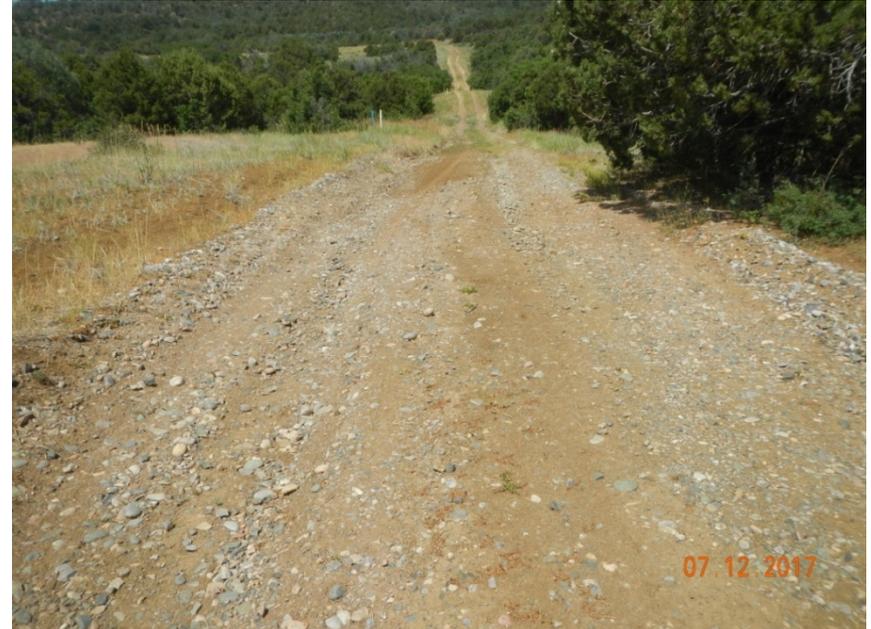
Photo 4: Another view of the repaired access road.
