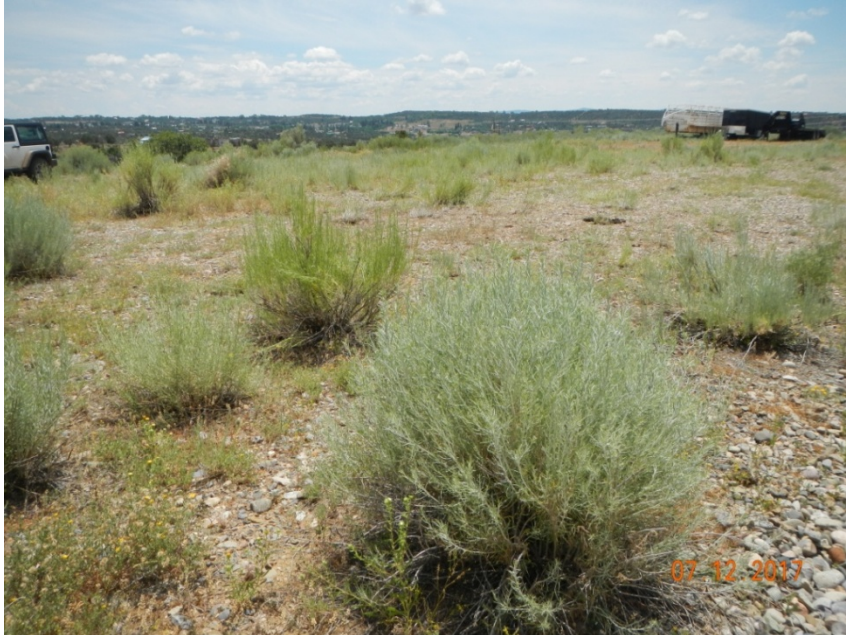
Photo 1: View of the well pad from the northwestern corner facing center. Graveled surface is becoming vegetated with rubber rabbitbrush and volunteer grasses and forbs.

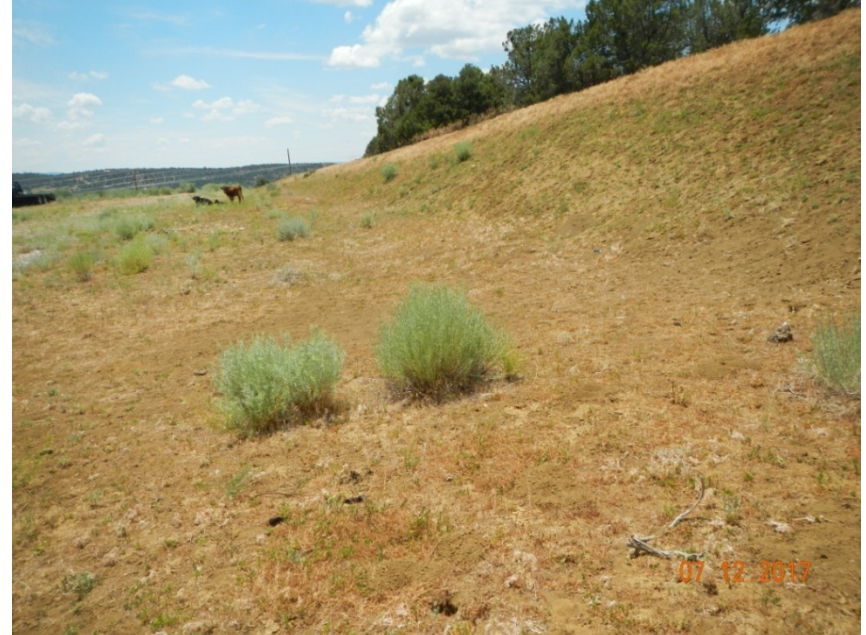
Photo 2: View of the western portion of the project area from the northwestern corner facing southward.

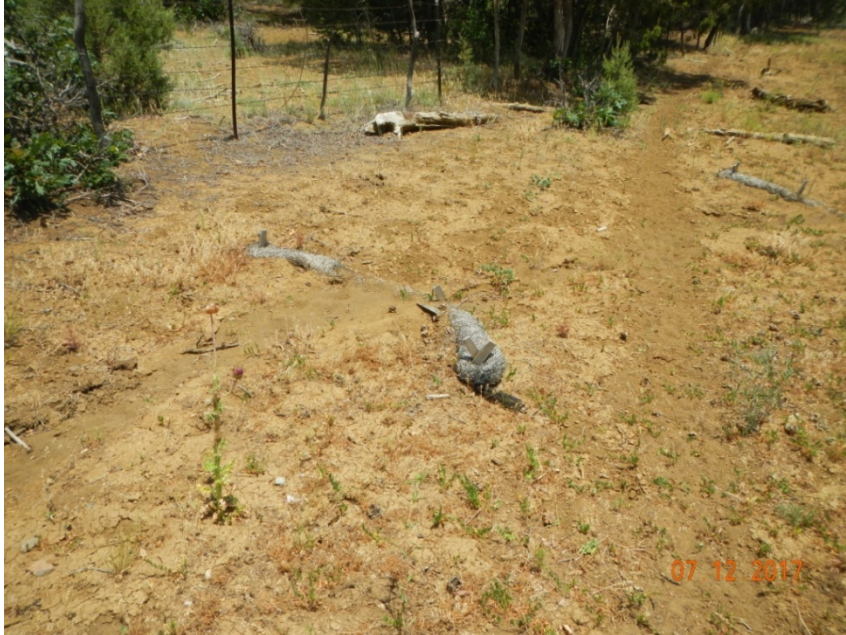
Photo 3: View of wattle that is no longer functioning within the northeastern corner of the project area. Permanent BMPs need to be installed to prevent erosion in this area.

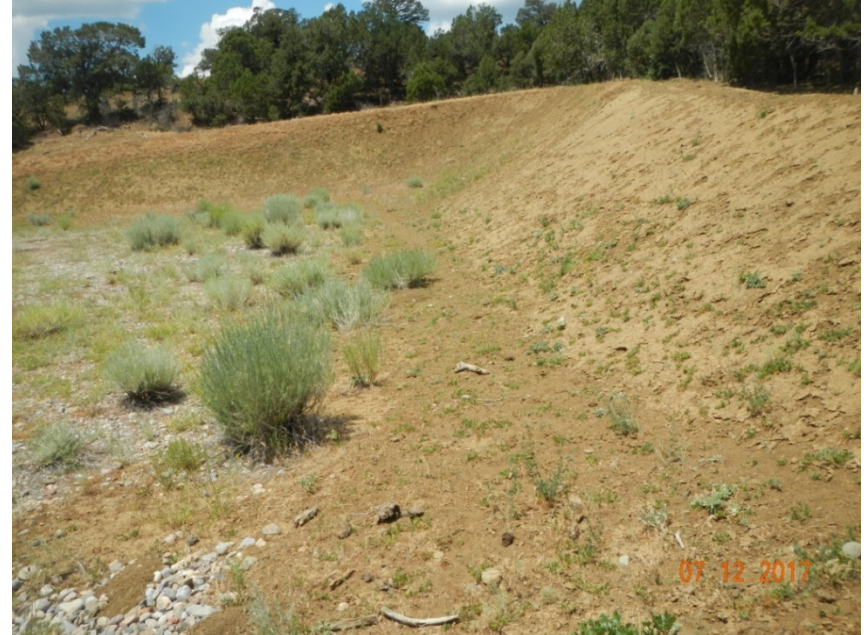
Photo 4: View of the northern and western cut-slopes from the northeastern corner facing westward. Exposed slopes need to be better stabilized with vegetation.

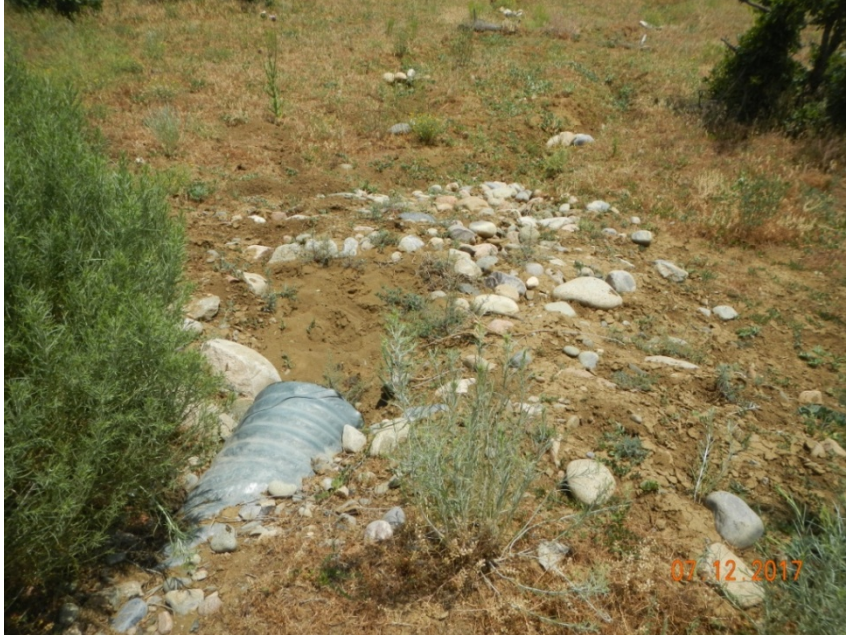
Photo 5: View of culvert outlet near the entrance to the well pad. Sediment is accumulating here and cobble BMP is not sufficient stormwater control for this area.

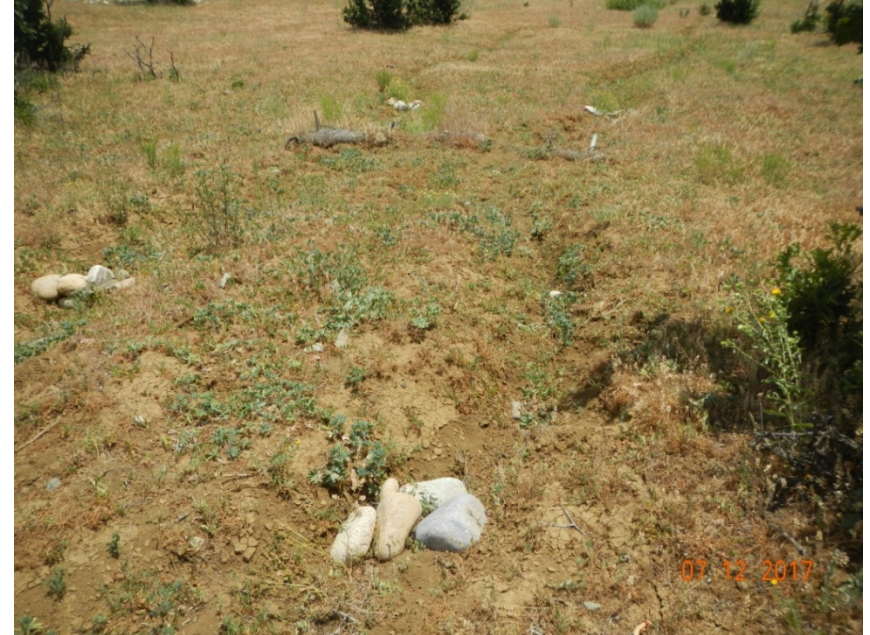
Photo 6: View of erosional channels that formed downstream of culvert shown in Photo 5. Cobble and wattle are not sufficient stormwater controls for this area. Permanent erosion controls need to be installed before the variance will be passed.

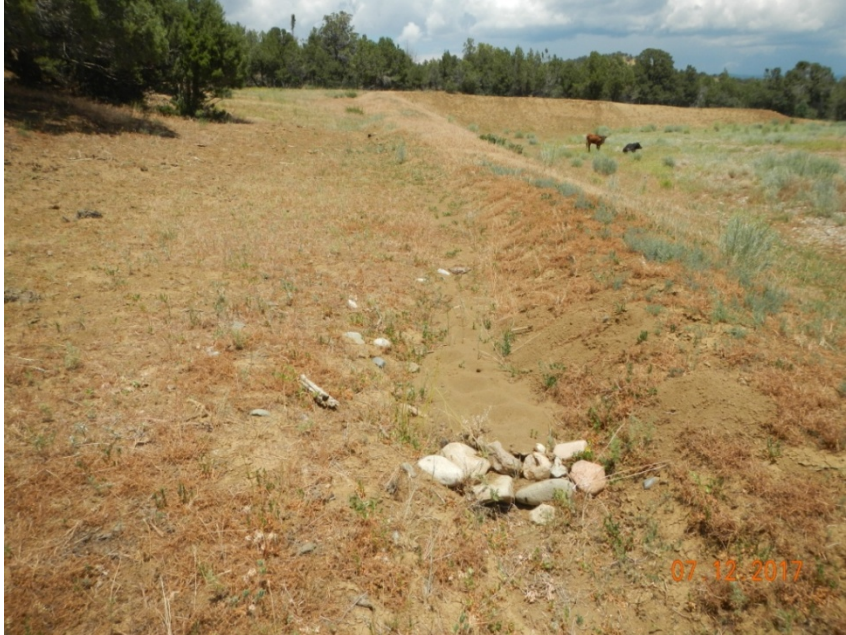
Photo 7: View of diversion channel in the western portion of the project area. Cobble check dam is full of sediment and will soon be eroding around the sides. This needs to be maintained, and expanded to provide longer term erosion control.
