Inspection Photos

Operator: EXTRACTION OIL & GAS INC - 10459

Location ID: 323581

Inspection Doc. Number: 682502467

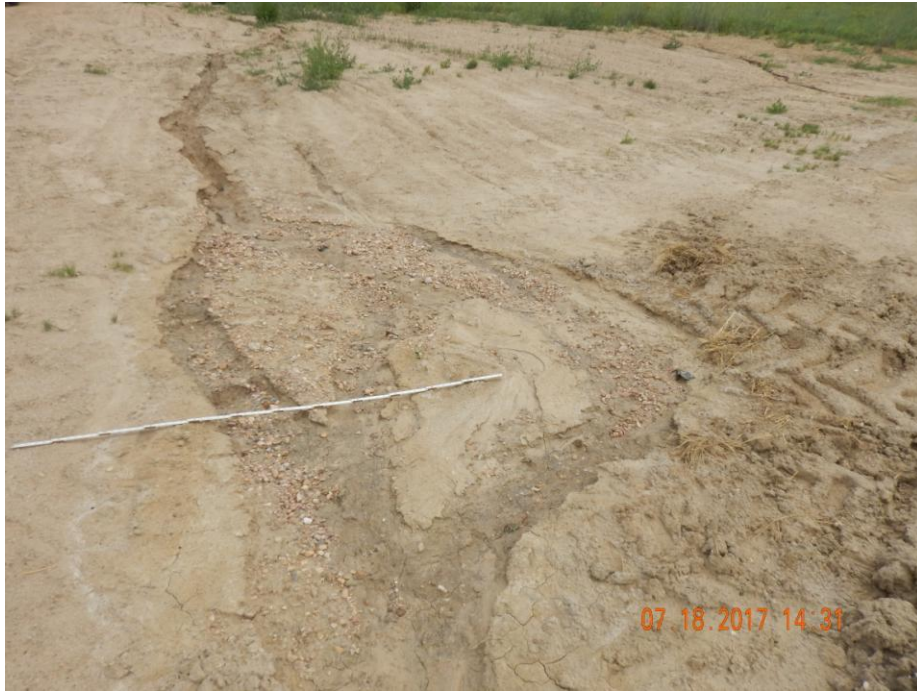
Photo 1: Photo taken from the southwest end of the location, facing southeast. Photo shows stormwater erosion occurring throughout the reclamation / remediation area. 6 foot measuring stick for reference. Location appears to have had a seeding attempted, however location was not seeding along the contour of the slope. This has facilitated erosion on the location.

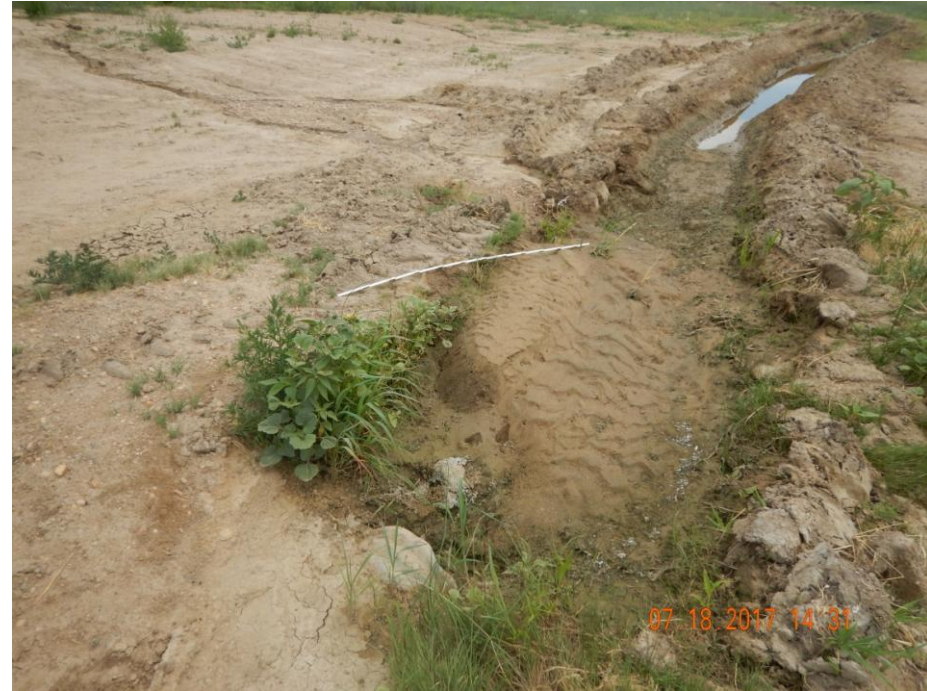
Photo 2: Photo taken from the southwest end of the location, facing southeast. Photo shows sediment laden stormwater runoff from the location has deposited into an irrigation ditch on the west end of the location. 6 foot measuring stick for reference.

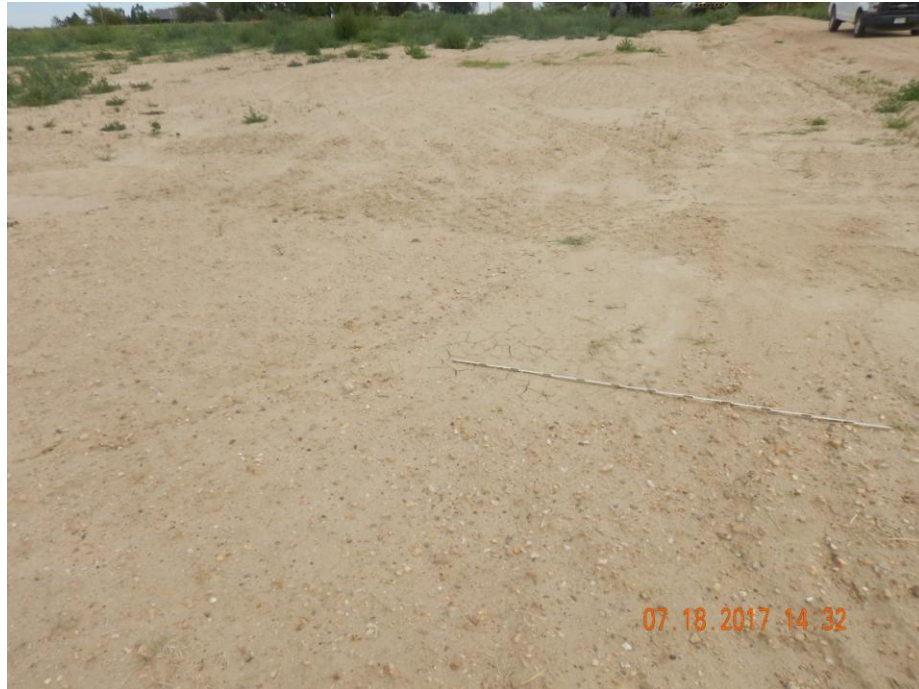
Photo 3: Photo taken from the southwest end of the location, facing east. Photo shows stormwater erosion occurring throughout the reclamation / remediation area. 6 foot measuring stick for reference. Location appears to have had a seeding attempted, however location was not seeding along the contour of the slope. This has facilitated erosion on the location.

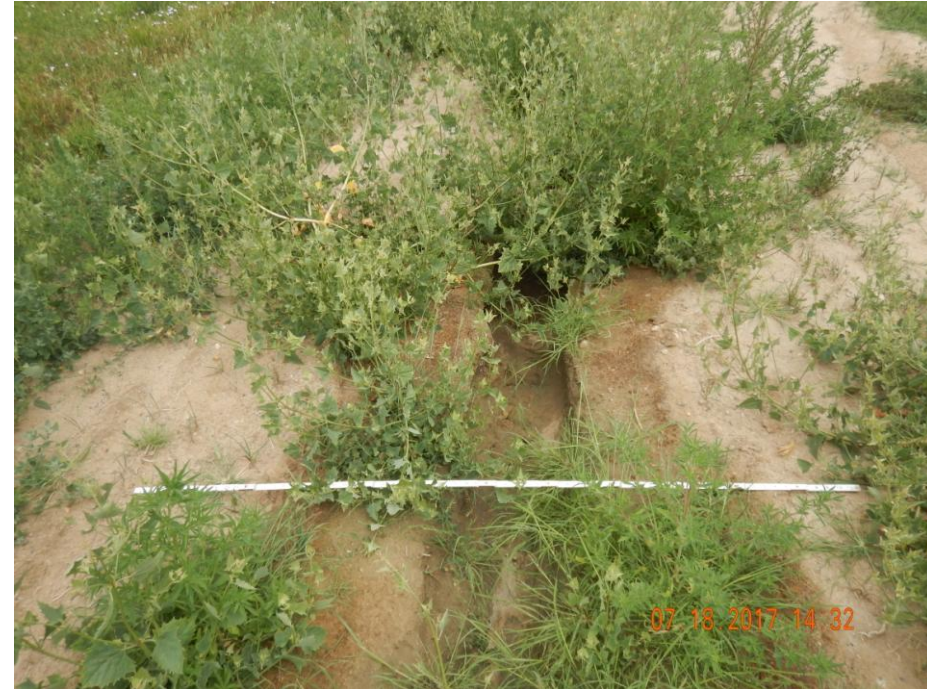
Photo 4: Photo taken from the north end of the location. Photo shows stormwater erosion occurring throughout the reclamation / remediation area. 6 foot measuring stick for reference. Location appears to have had a seeding attempted, however location was not seeding along the contour of the slope. This has facilitated erosion on the location.

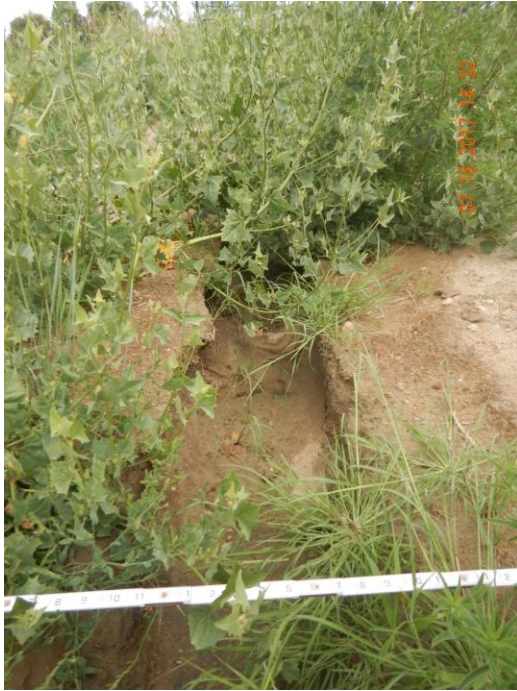
Photo 5: Photo taken from the north end of the location. Photo shows stormwater erosion occurring throughout the reclamation / remediation area. 6 foot measuring stick for reference. Location appears to have had a seeding attempted, however location was not seeding along the contour of the slope. This has facilitated erosion on the location.

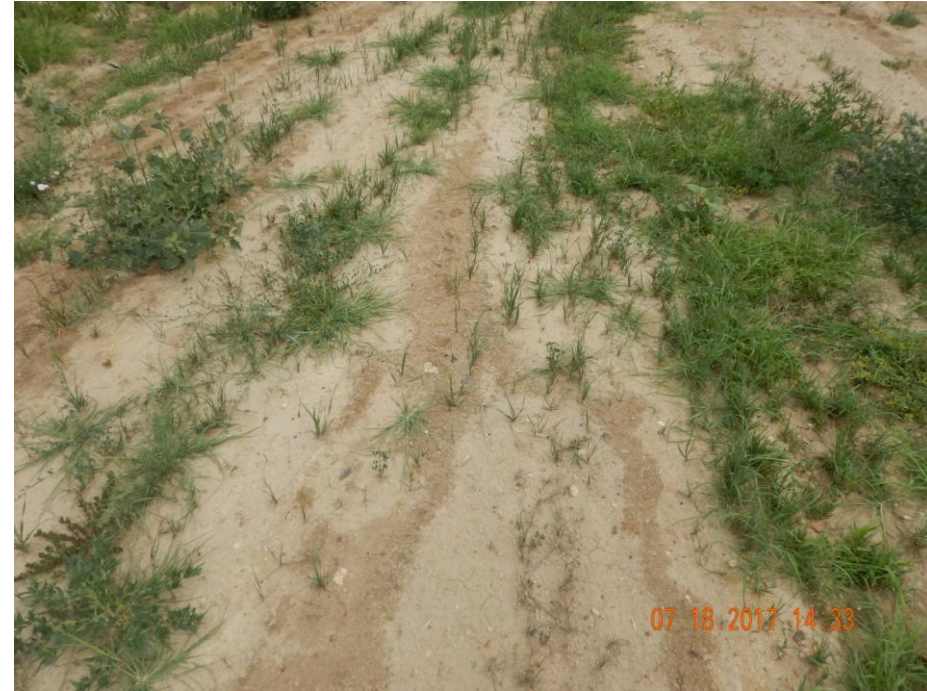
Photo 6: Photo taken from the north end of the location. Photo shows vegetative growth (likely) from a seeding. Appears location had been reseeded, however evidence of germination is scarce with the majority of the location predominantly exposed soil. Also, location was not seeding along the contour of the slope, which has facilitated erosion on the location.

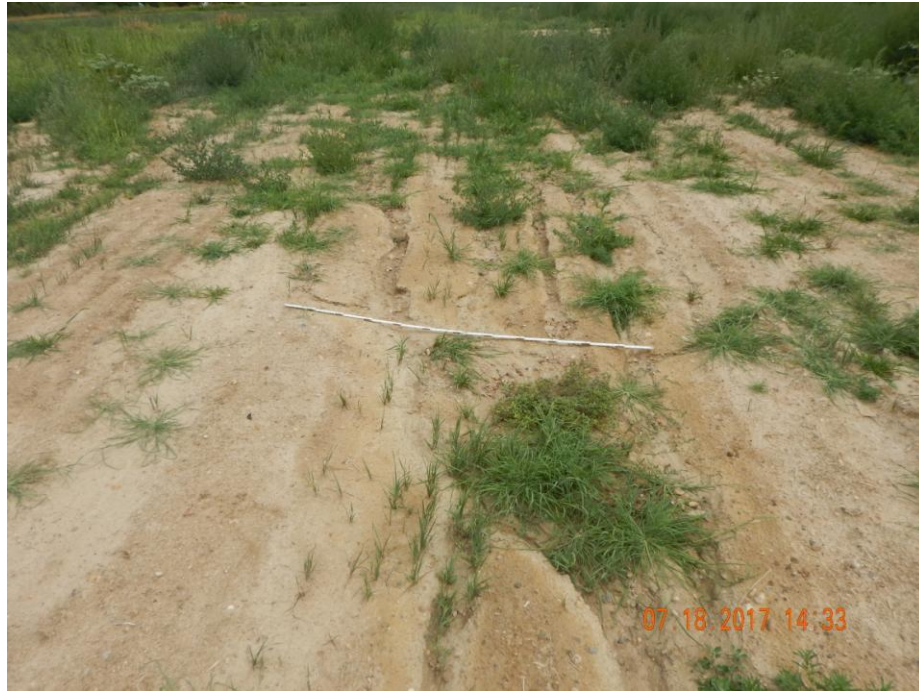
Photo 7: Photo taken from the north end of the location. Photo shows stormwater erosion occurring throughout the reclamation / remediation area. 6 foot measuring stick for reference. Location appears to have had a seeding attempted, however location was not seeding along the contour of the slope. This has facilitated erosion on the location.

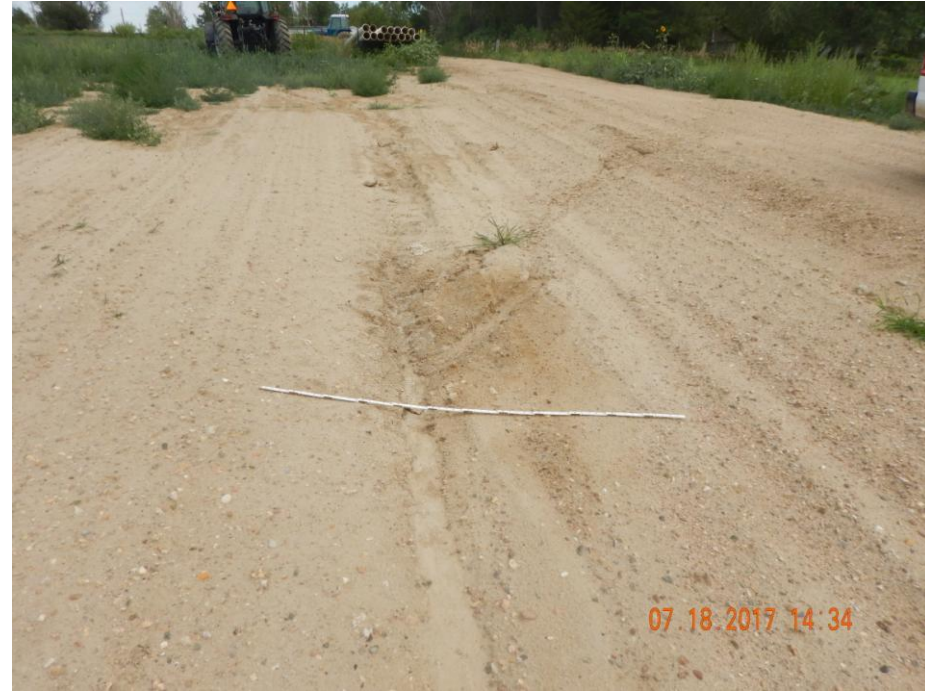
Photo 8: Photo taken from the north end of the location. Photo shows stormwater erosion occurring throughout the reclamation / remediation area. 6 foot measuring stick for reference. Location appears to have had a seeding attempted, however location was not seeding along the contour of the slope. This has facilitated erosion on the location.
