Inspection Photos
Location Name: Walker 12-2
API: 05-081-07079

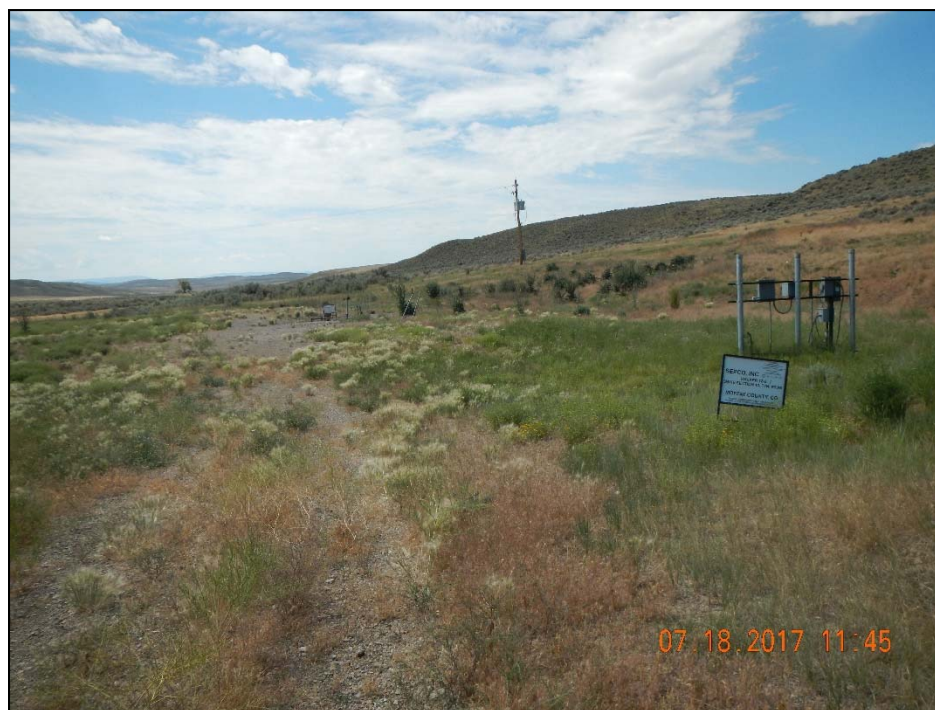
Photo 1. Overview of location taken at entrance facing south.

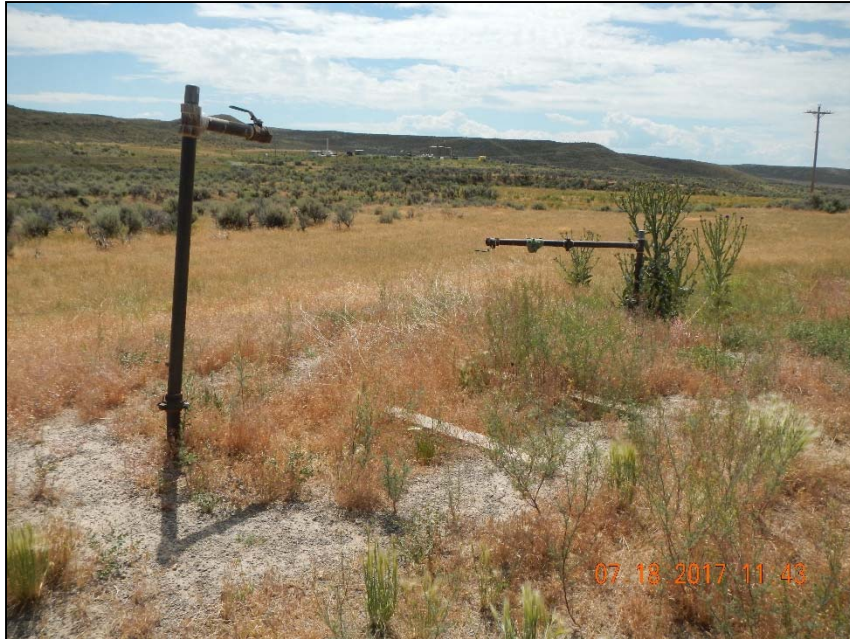
Photo 2. Unused 2" steel riser on left, unused 3" steel riser on right. Noxious weeds visible adjacent to 3" riser.

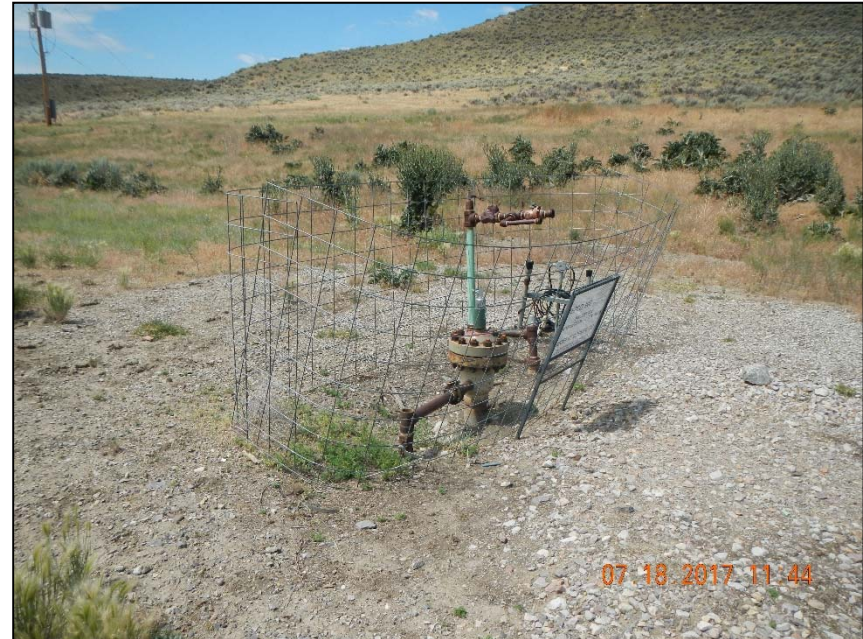
Photo 3. Unused 2" steel riser at wellhead.
