Inspection Photos  
Location Name: Walker 12-1  
API: 05-081-07044

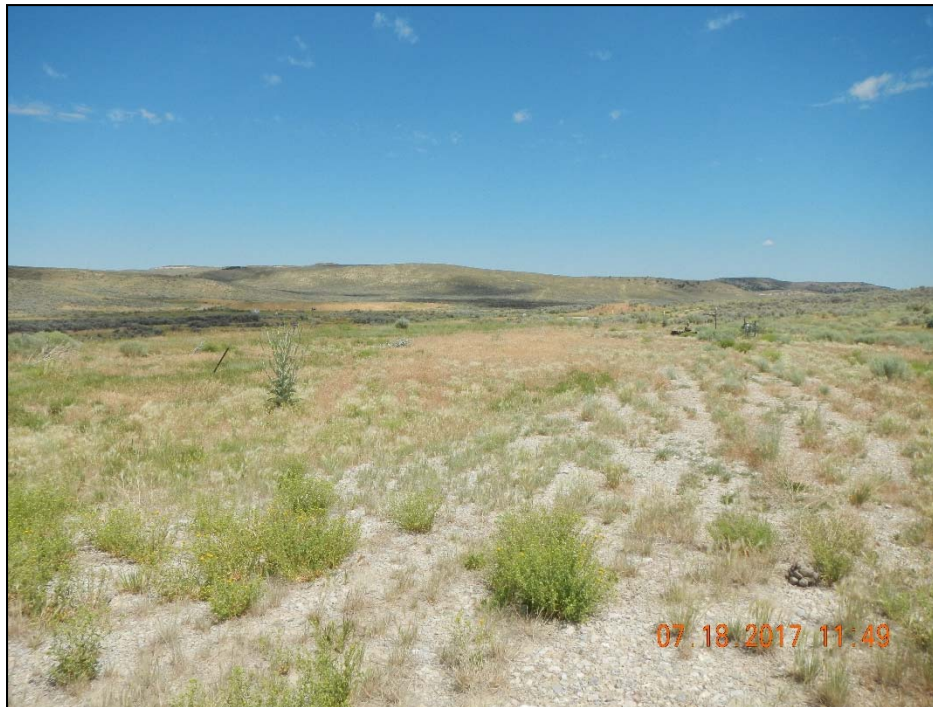
**Photo 1. Overview of location taken at entrance facing northwest.**

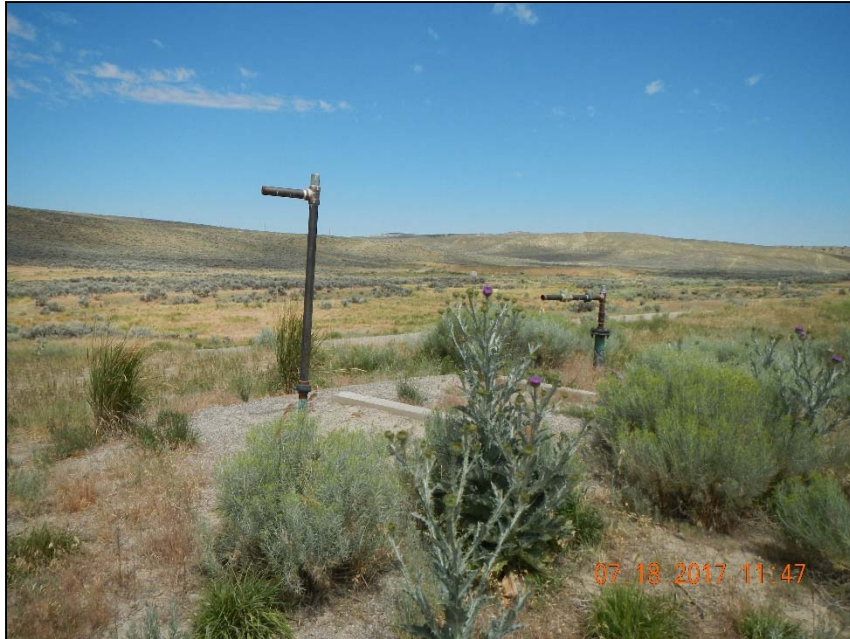
**Photo 2. Unused 2" steel riser on left, unused 3" steel riser on right. Noxious weeds in foreground.**

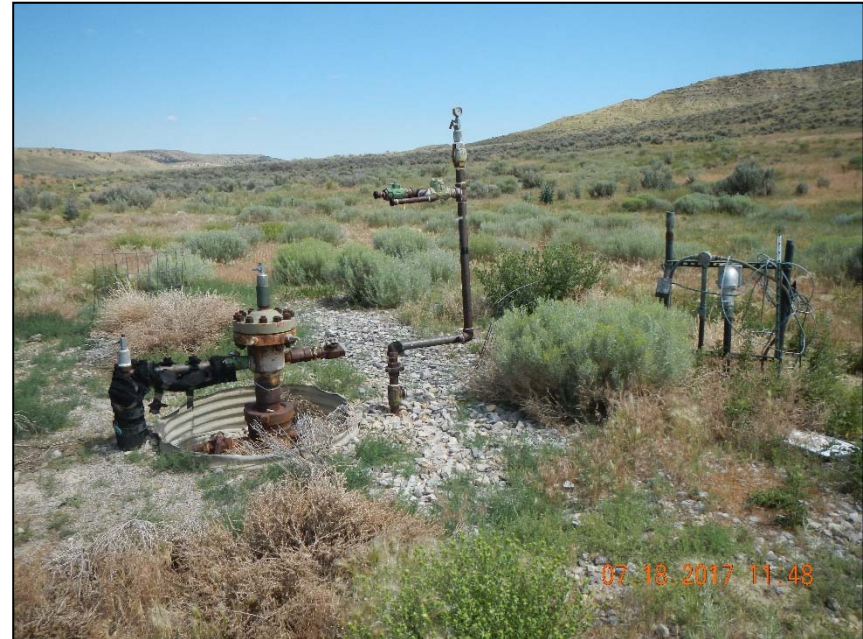
**Photo 3. Unused 2" steel riser at wellhead.**
