**Inspection Photos**  
**Location Name: DOC Powell #30-14-11**  
**API: 05-123-19447**

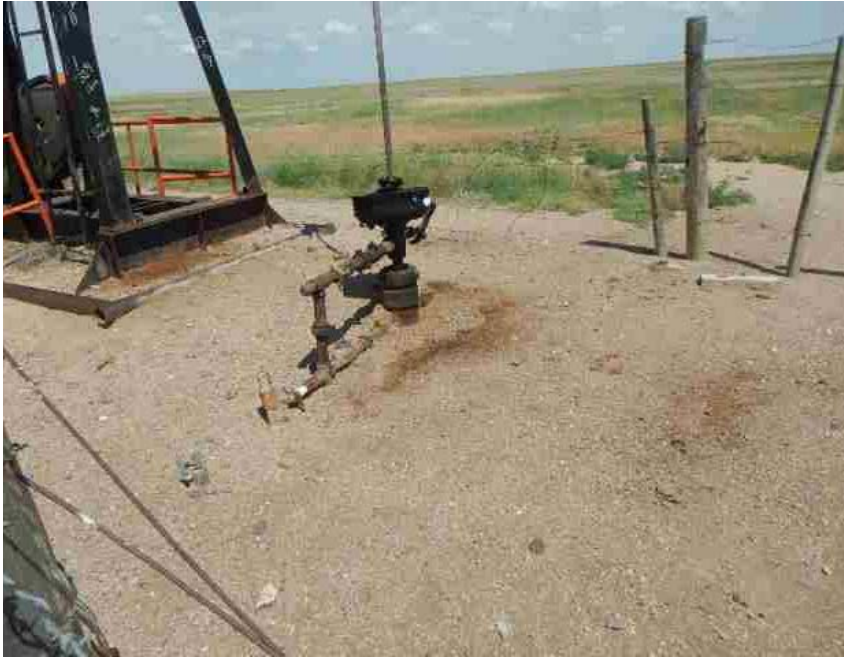
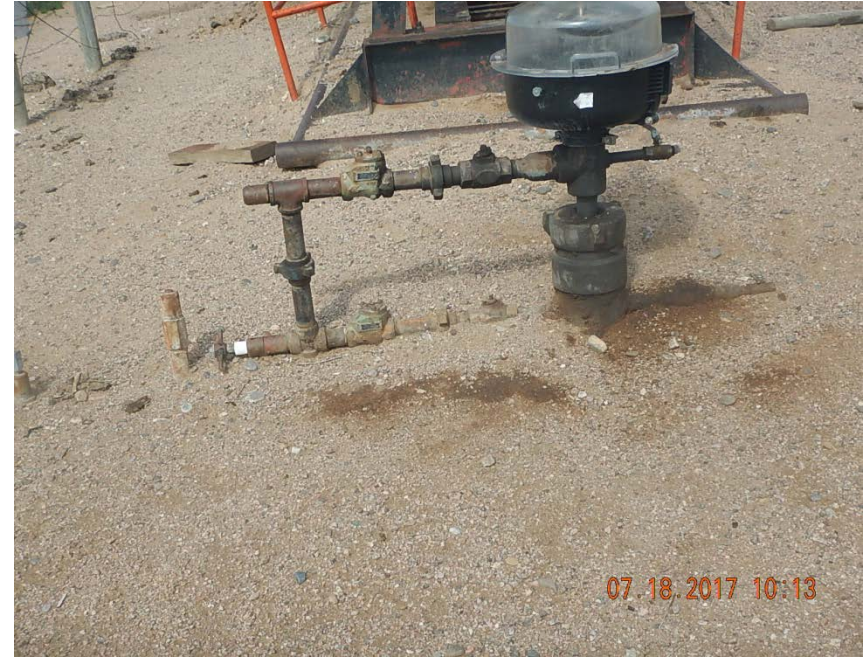
**Photo 1: Stained soil at wellhead. One unused riser at wellhead.**

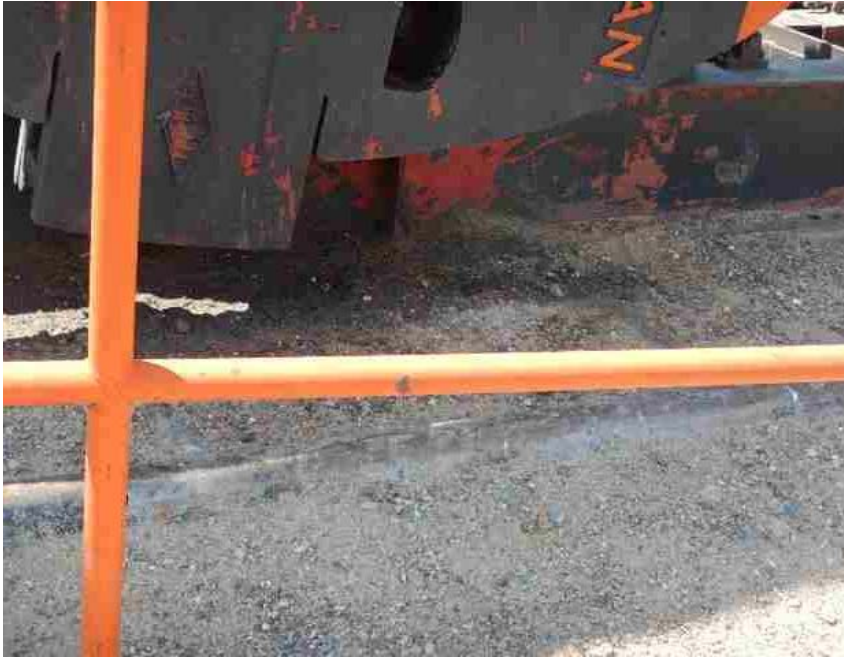
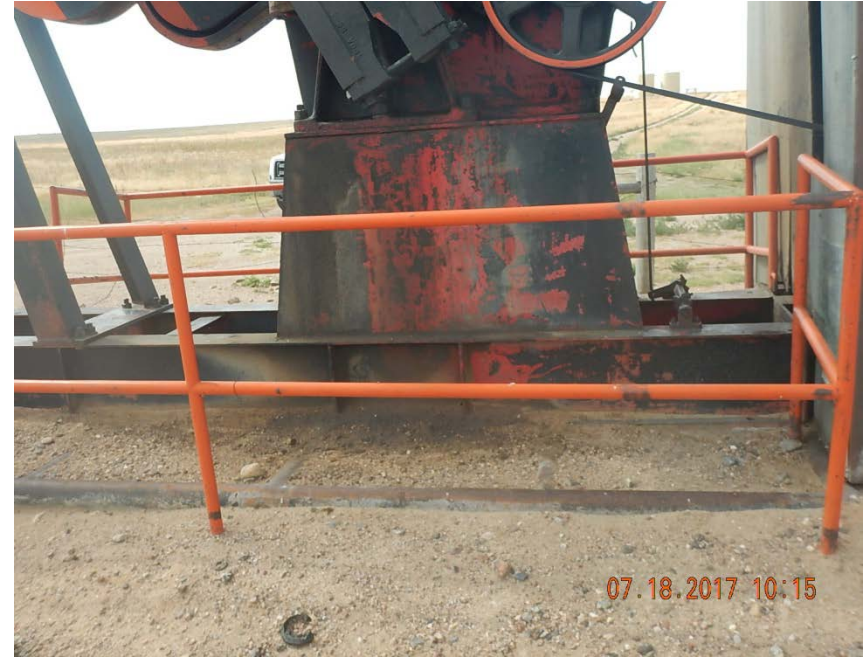
**Photo 2: Stained soil at pump jack**

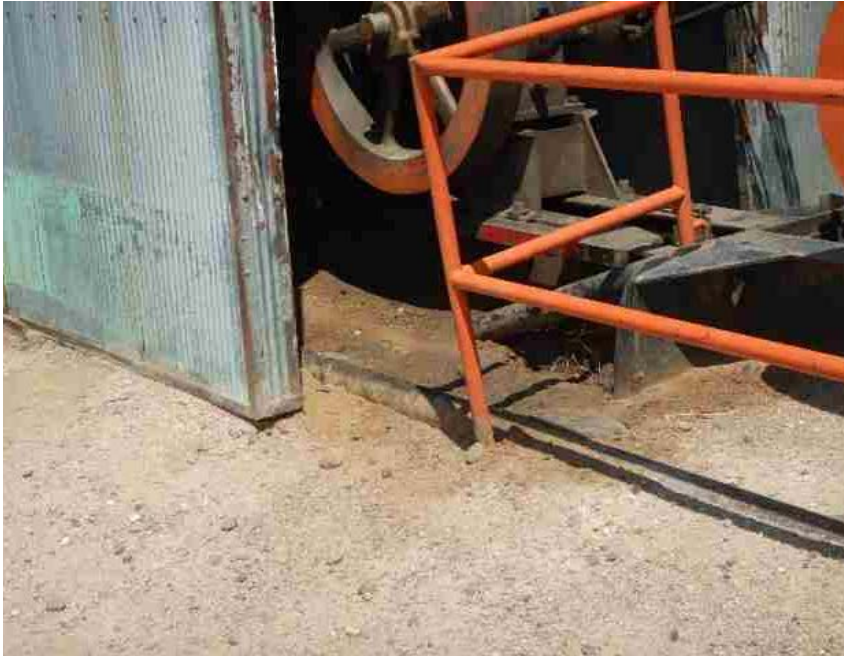
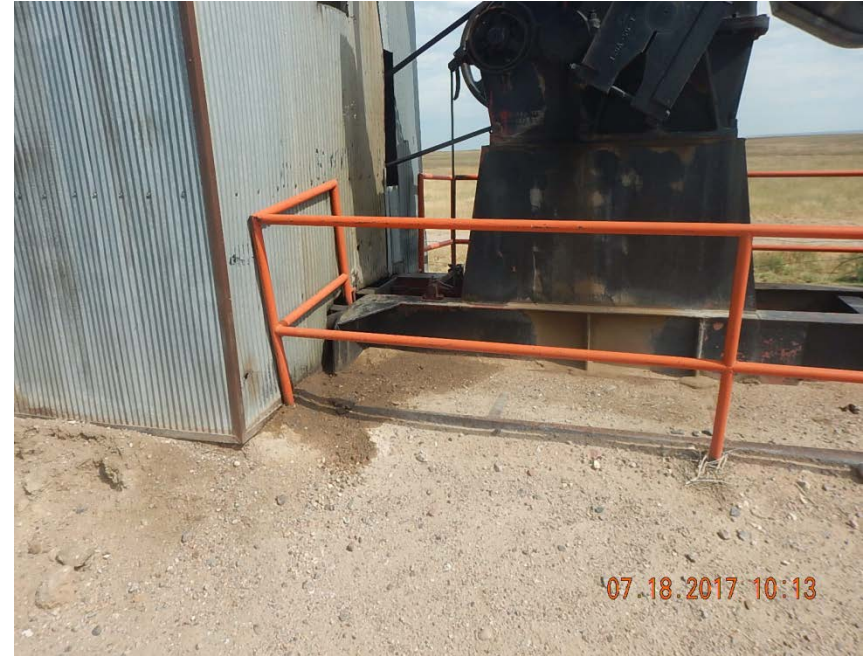
**Photo 3: Stained soil at pump jack and engine**

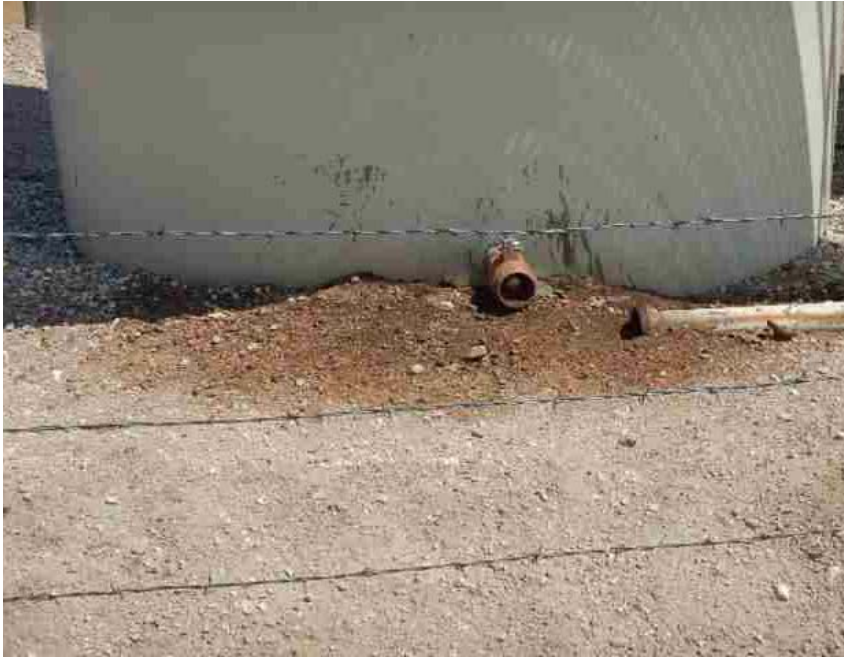
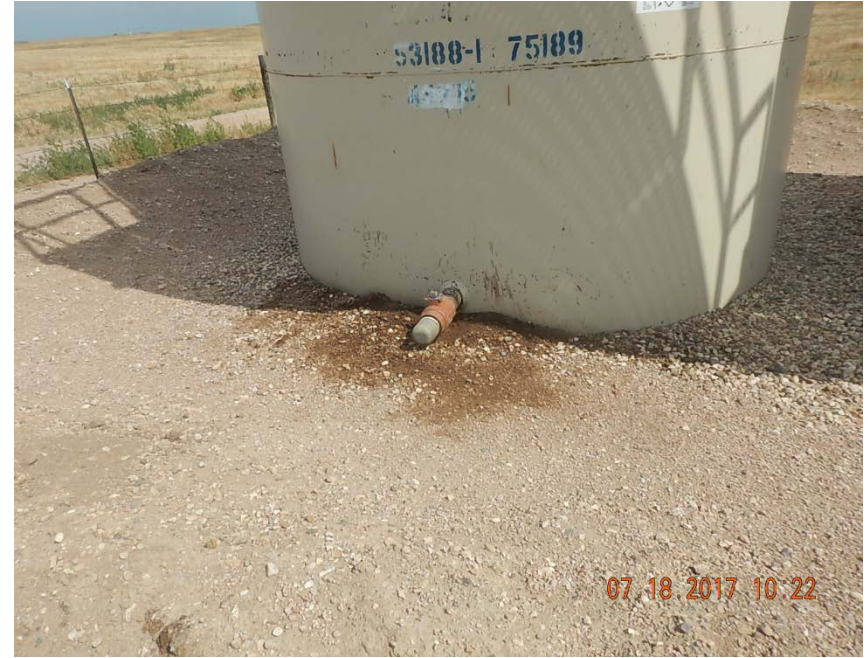
**Photo 4: Stained soil at tank**

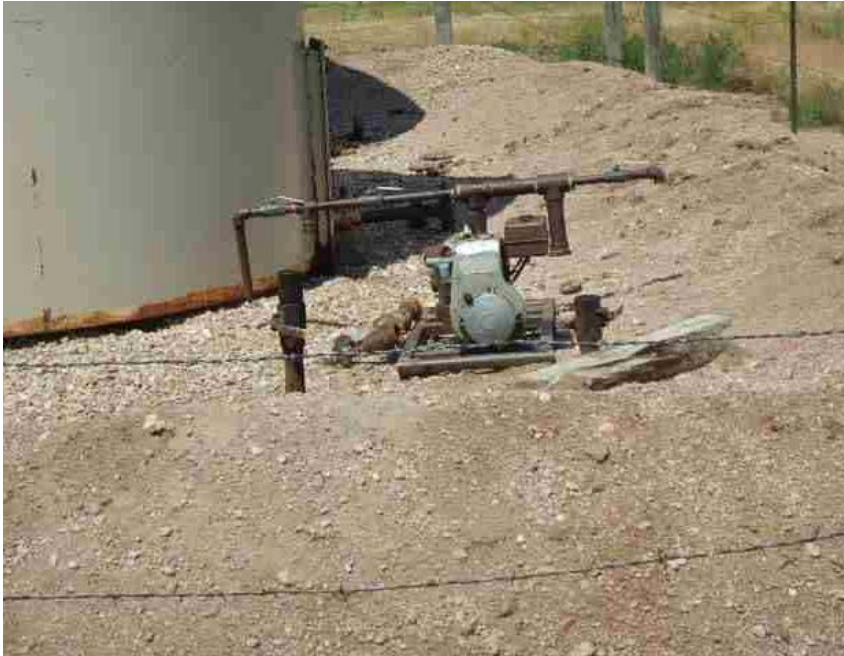
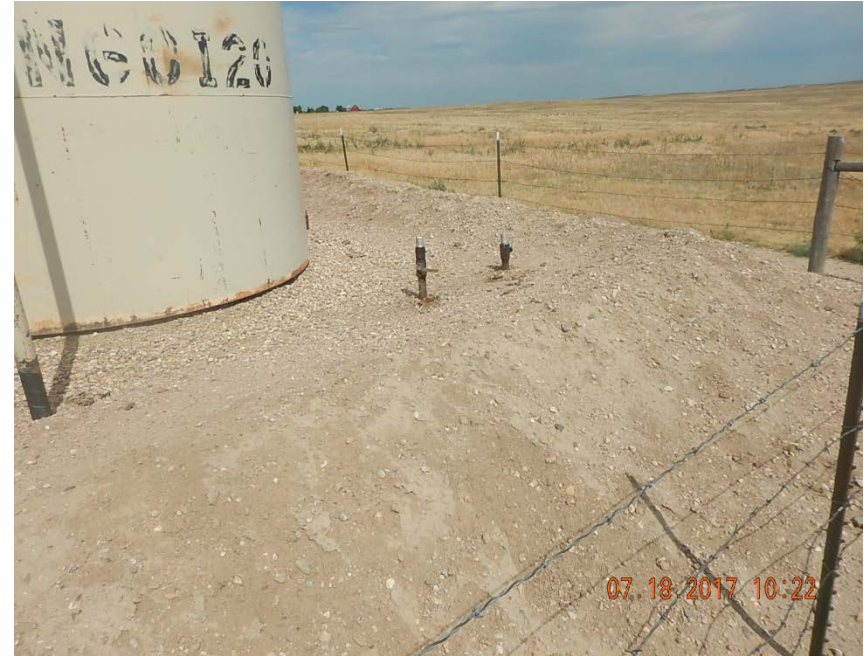
**Photo 5: Unused pump removed. Two unused risers.**

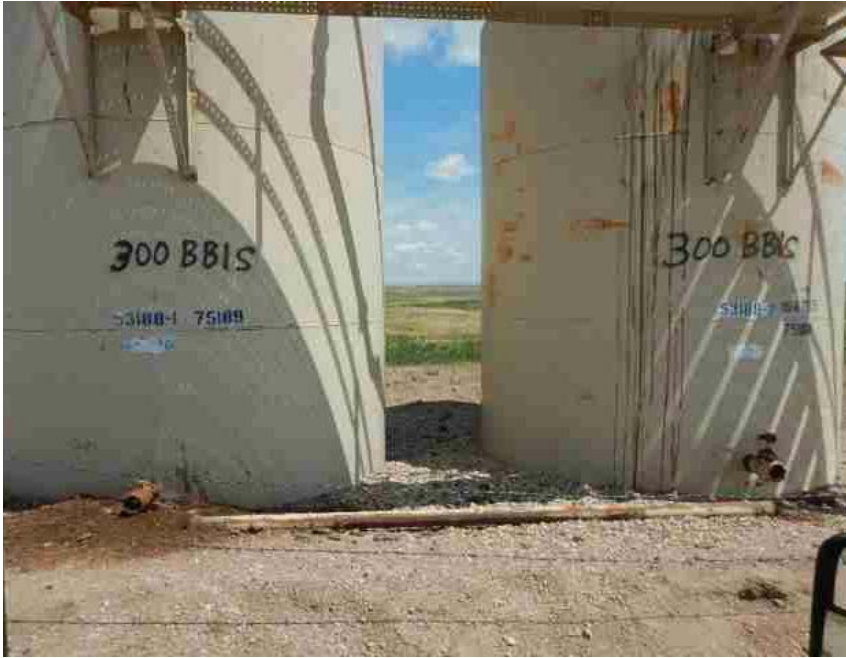
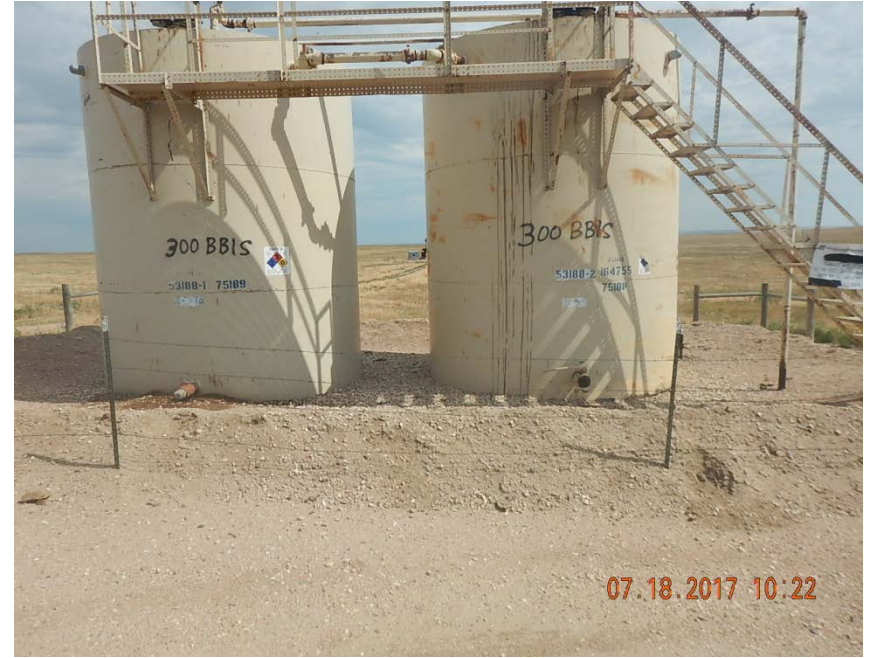
Photo 6: Damaged placard on east tank, tanks are placarded

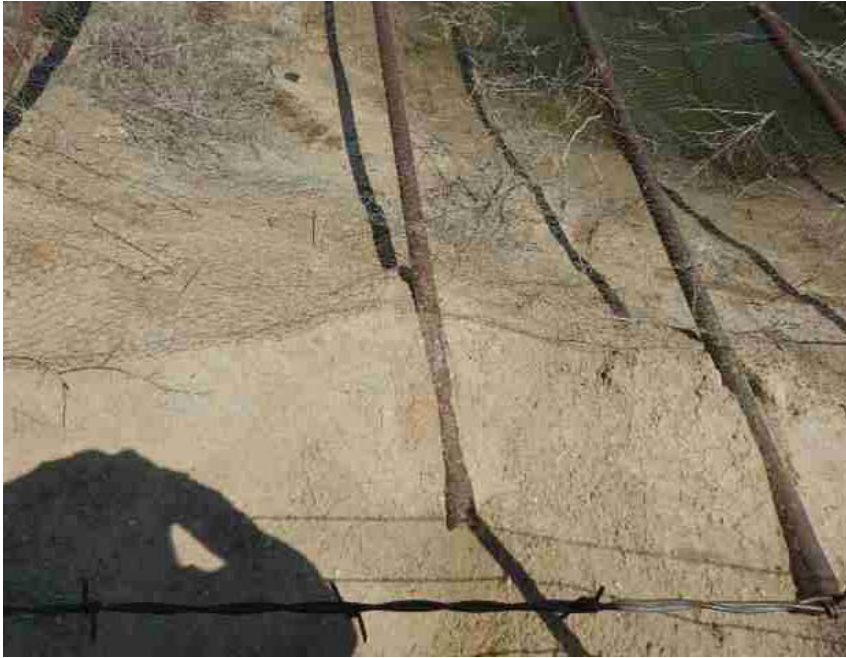
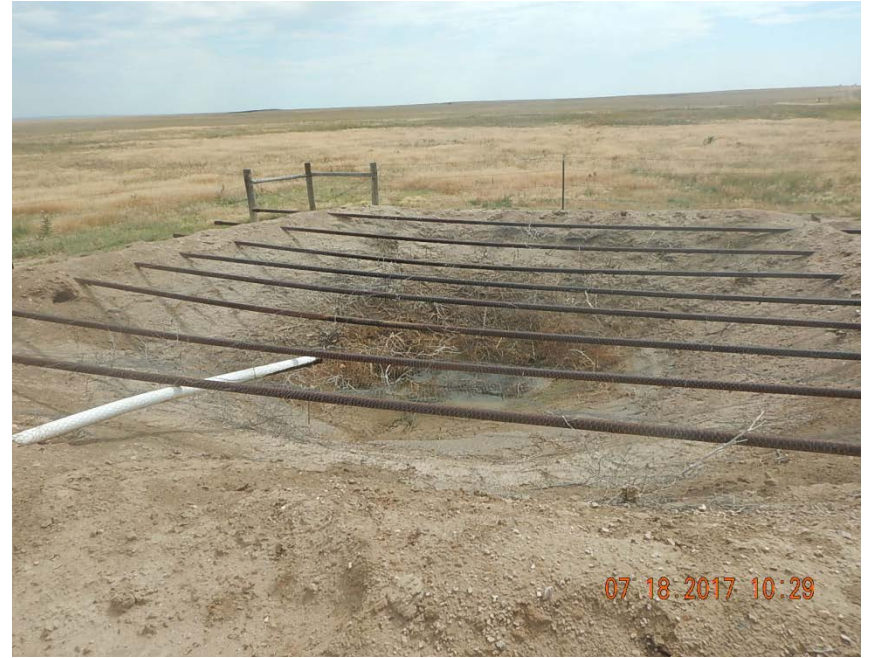
**Photo 7: Mesh repaired**

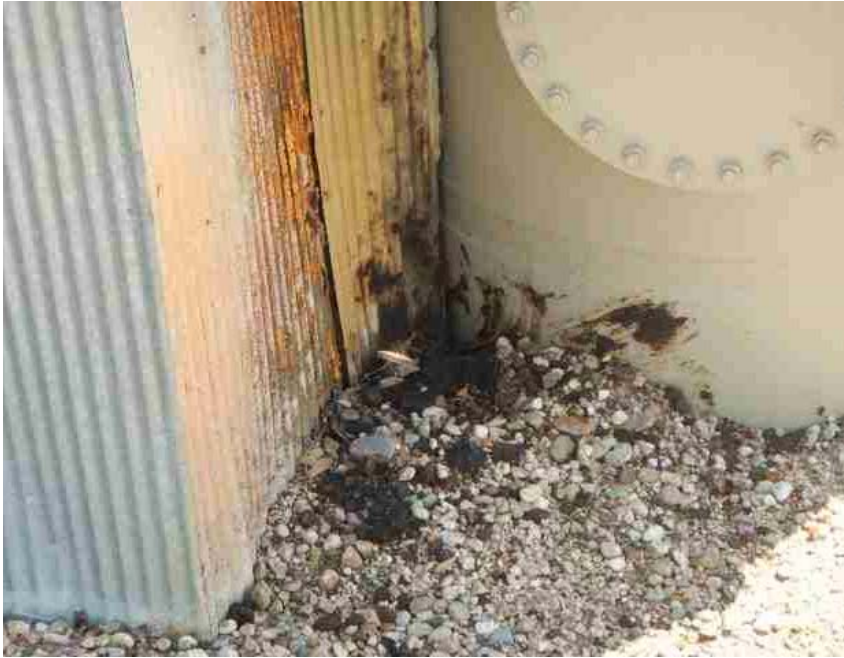
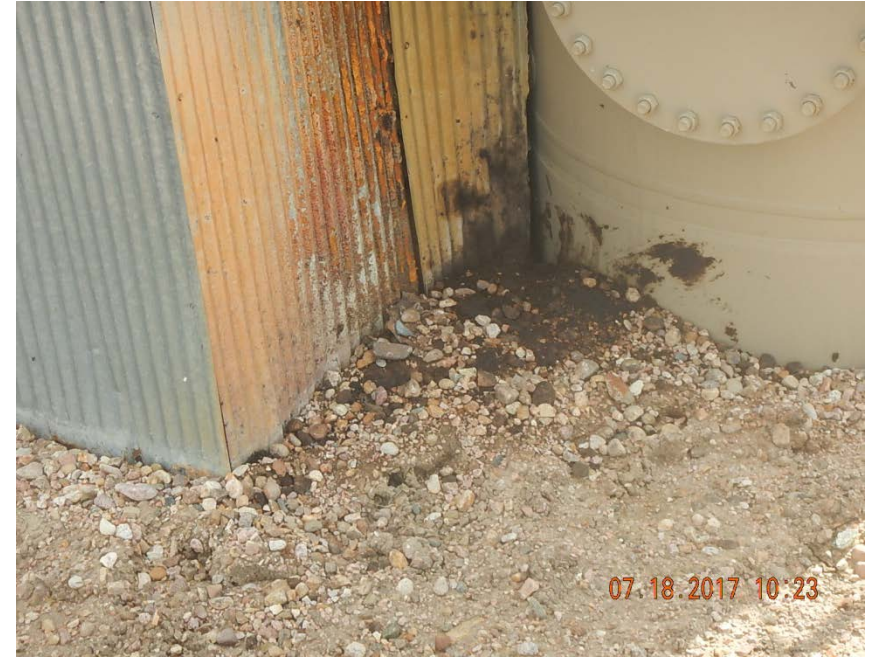
**Photo 8: Stained soil around treater**

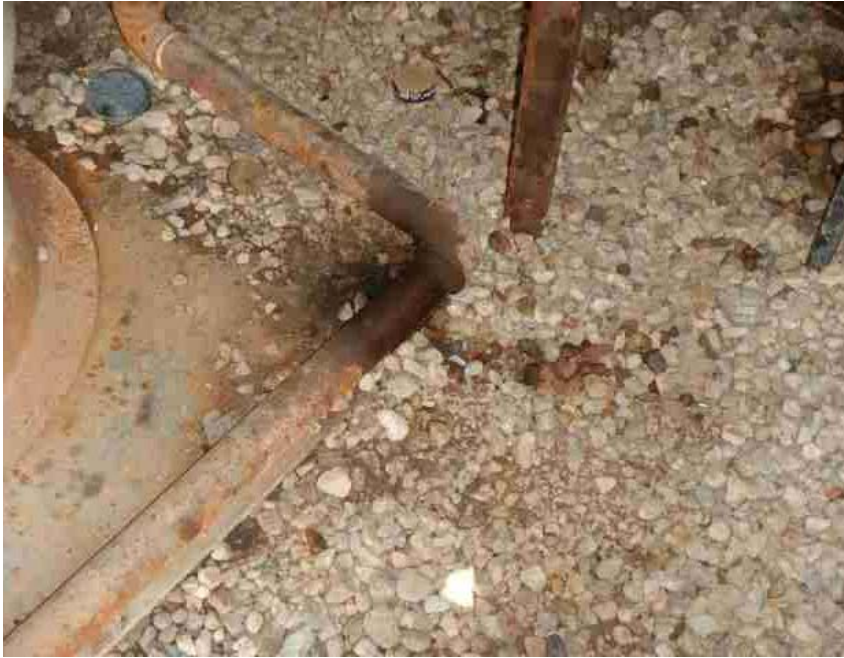
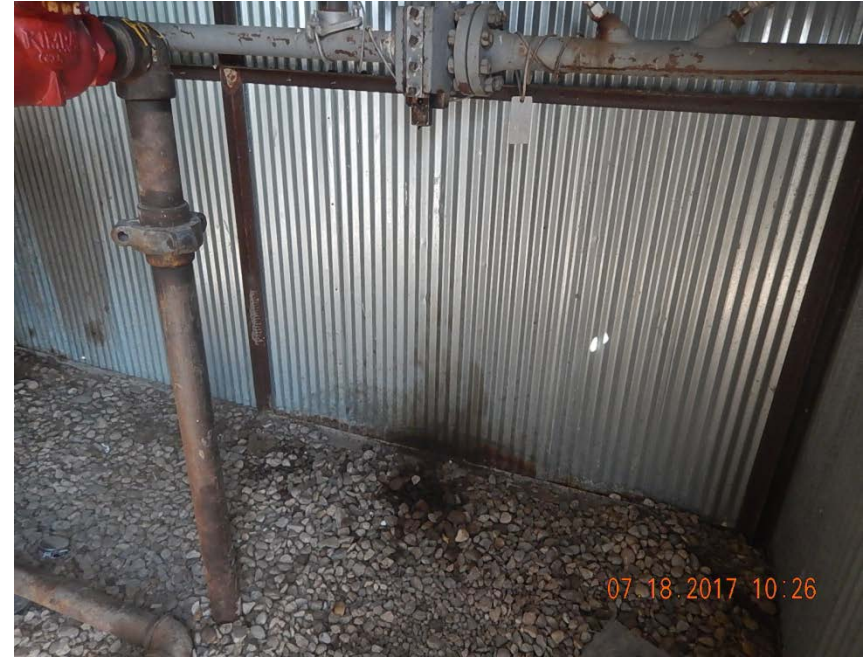
**Photo 9: Stained soil in treater house**

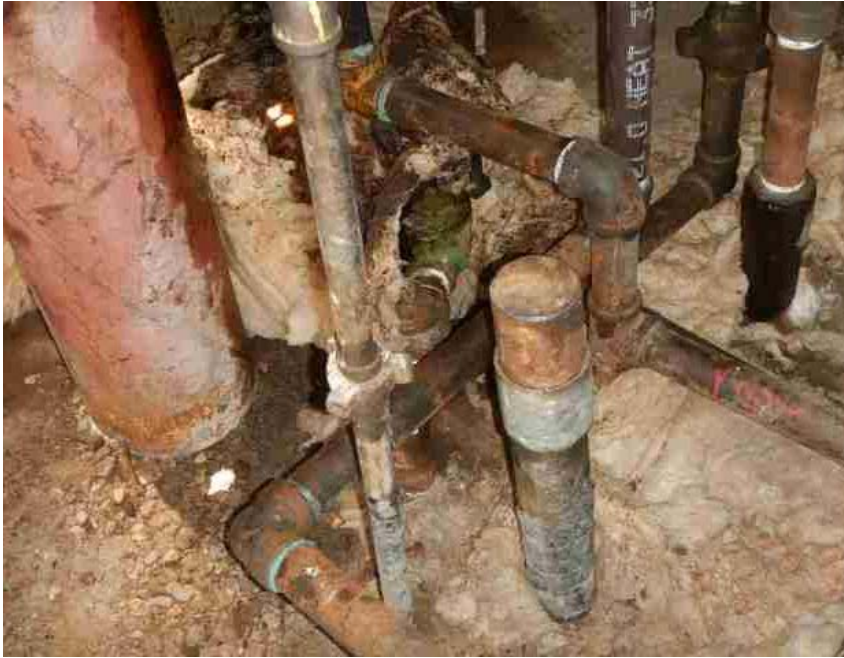
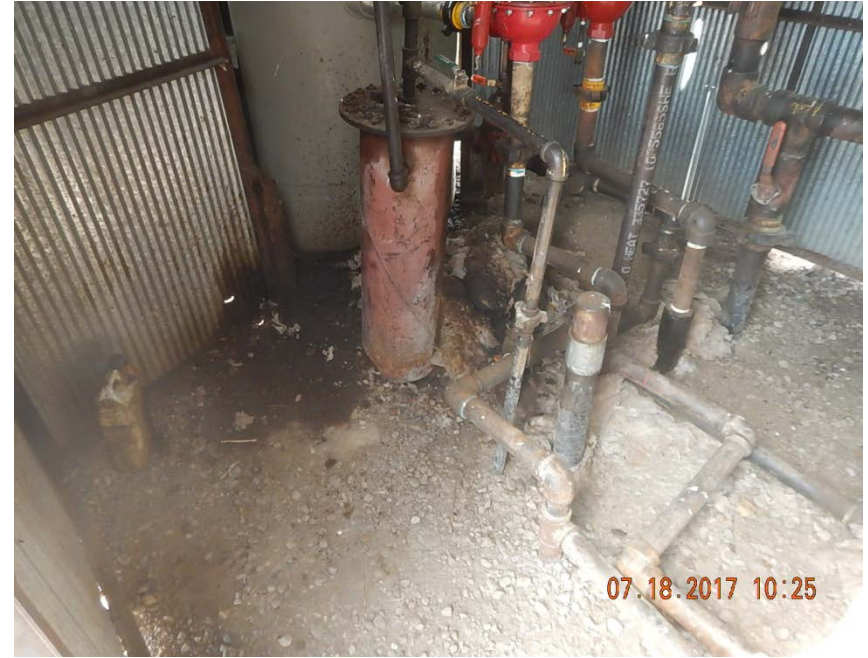
**Photo 10: Stained soil in treater house**

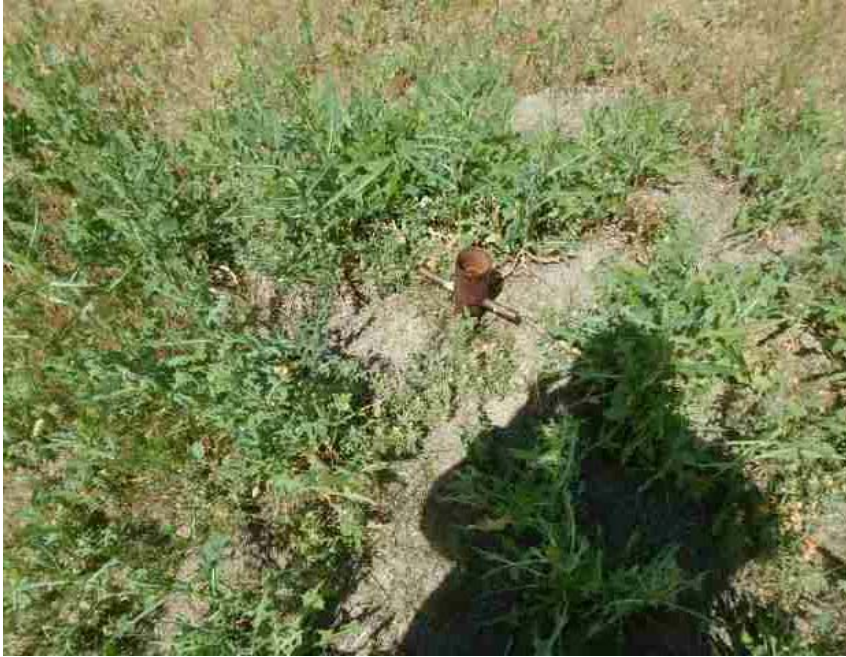
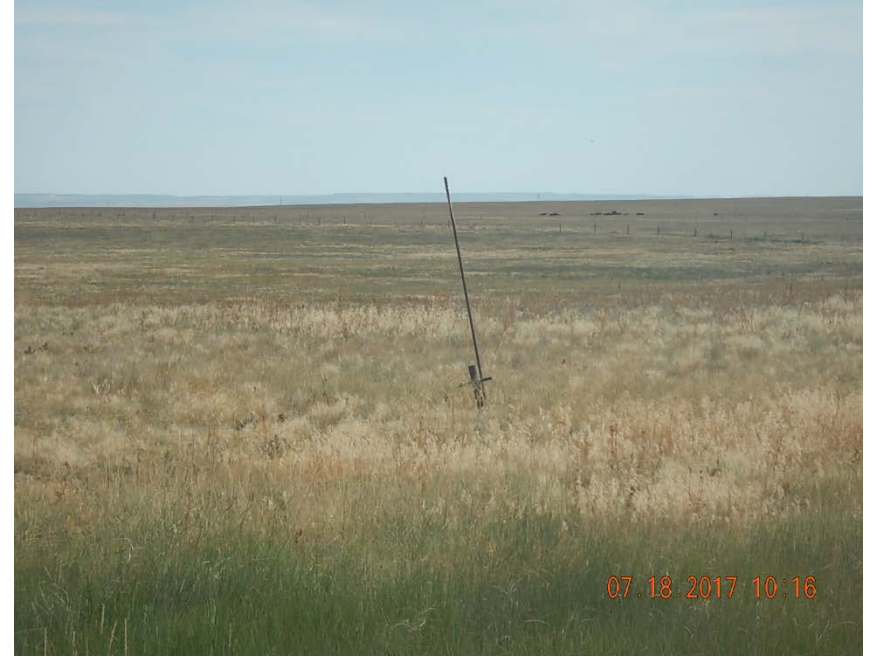
**Photo 11: Deadman marked**

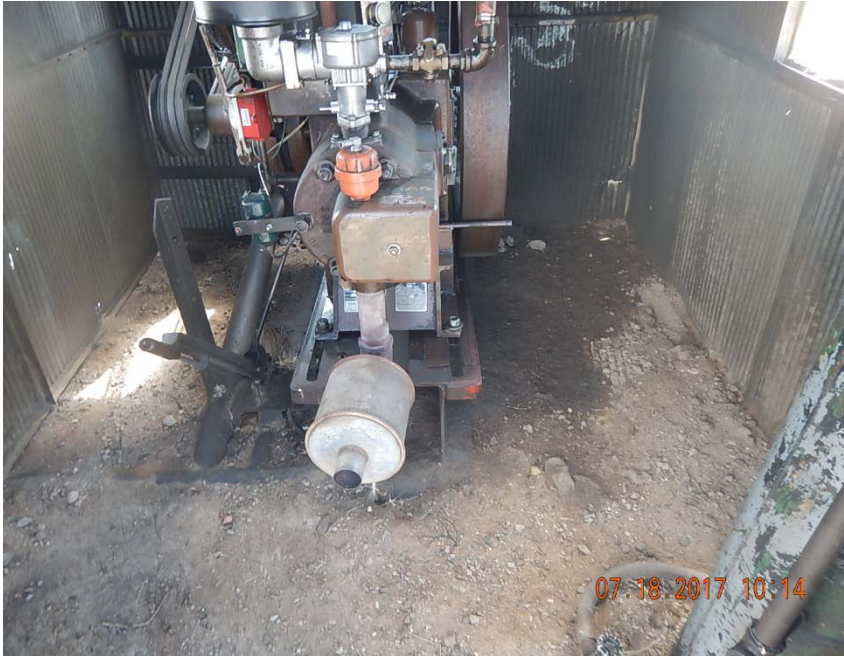
**Photo 12: Stained soil at engine**

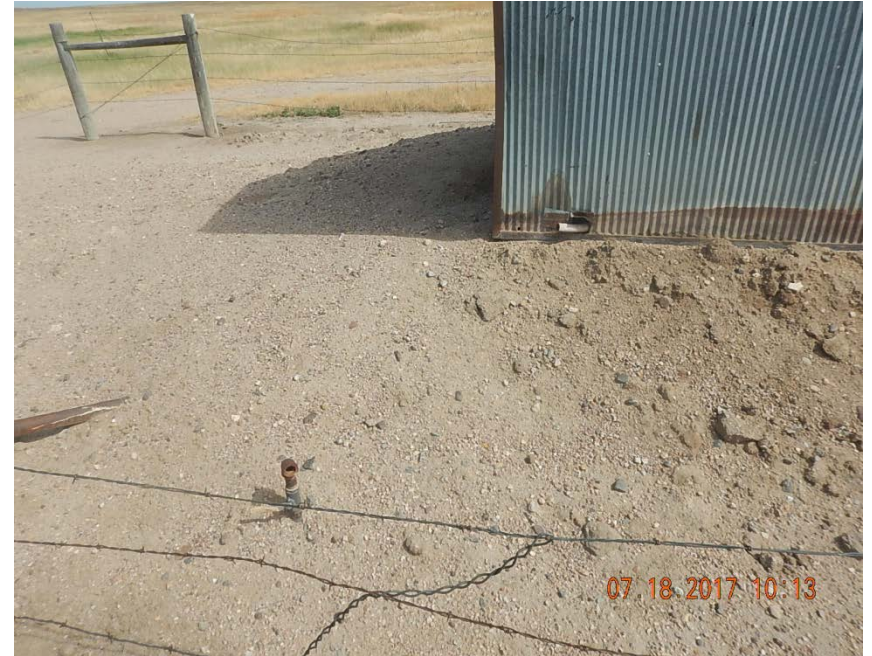
**Photo 13: Unused riser at pump jack**

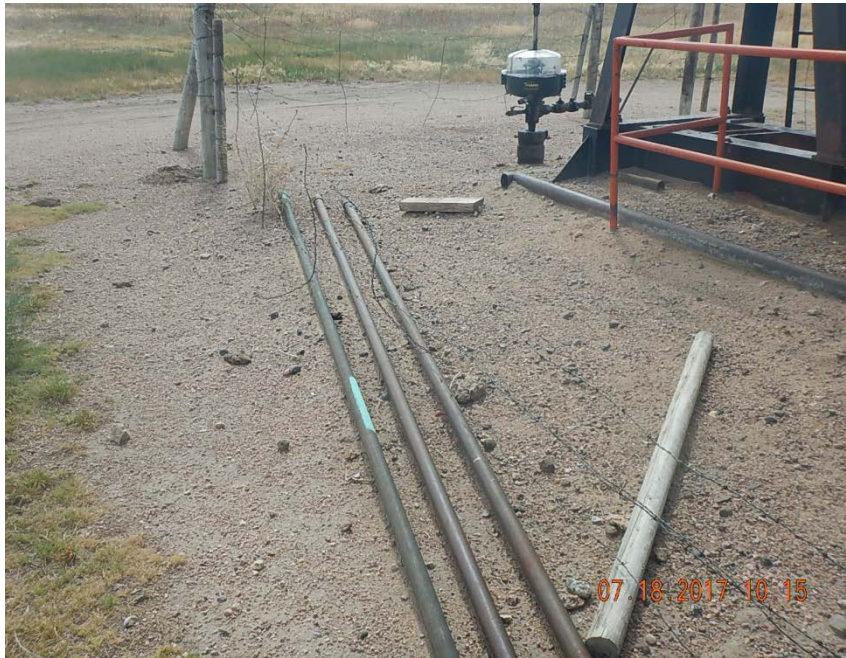
Photo 14: Unused equipment at pump jack.

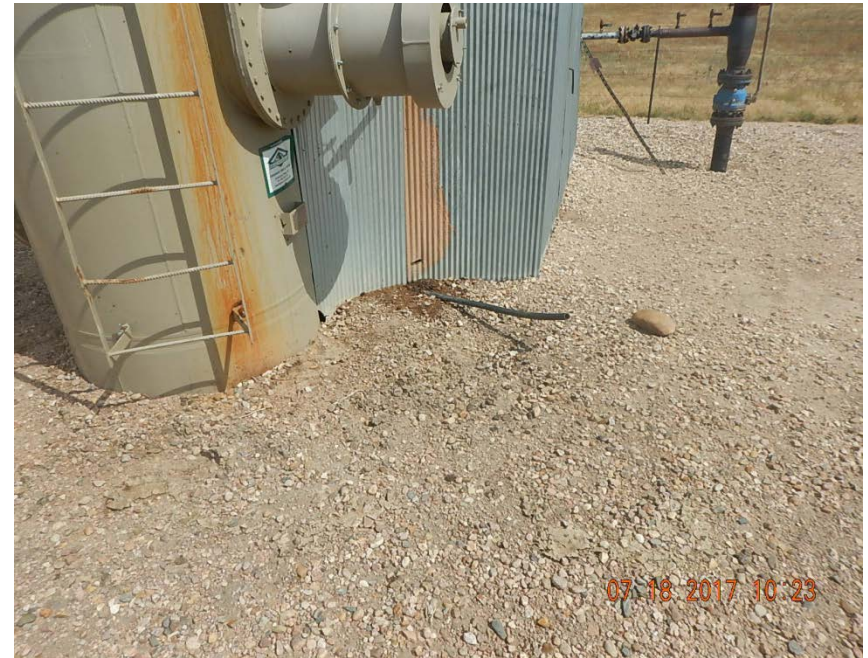
Photo 15: Stained soil at treater house

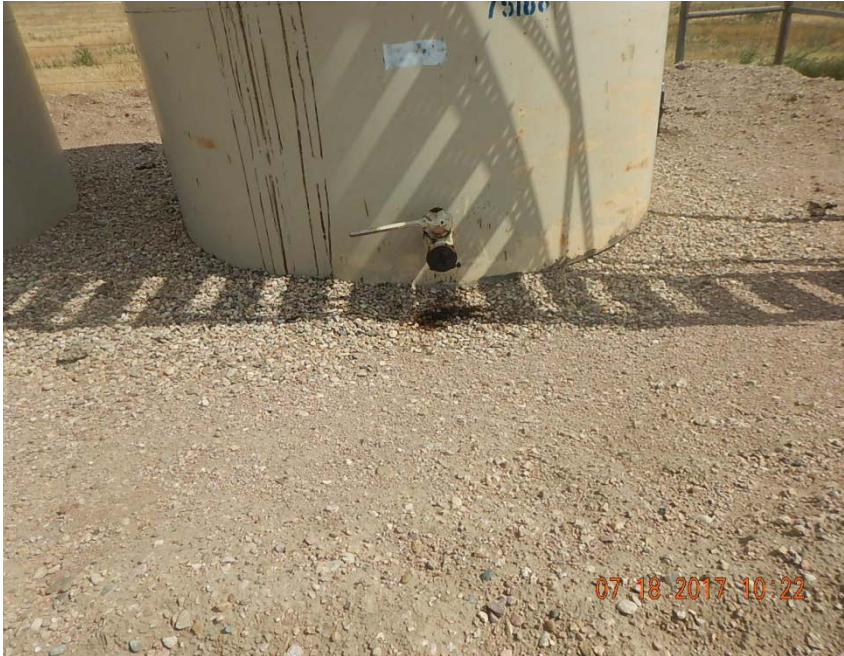
**Photo 16: Stained soil at loadout valve**
