**Inspection Photos**  
**Location Name: Showers #32-5-7**  
**API: 05-123-19441**

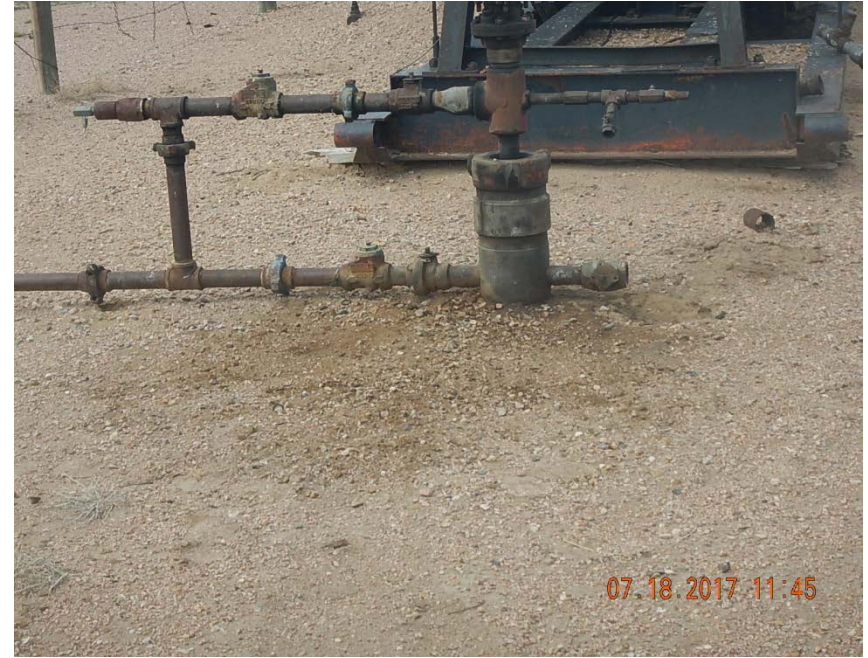
**Photo 1: Stained soil at wellhead, no bradenhead at surface**

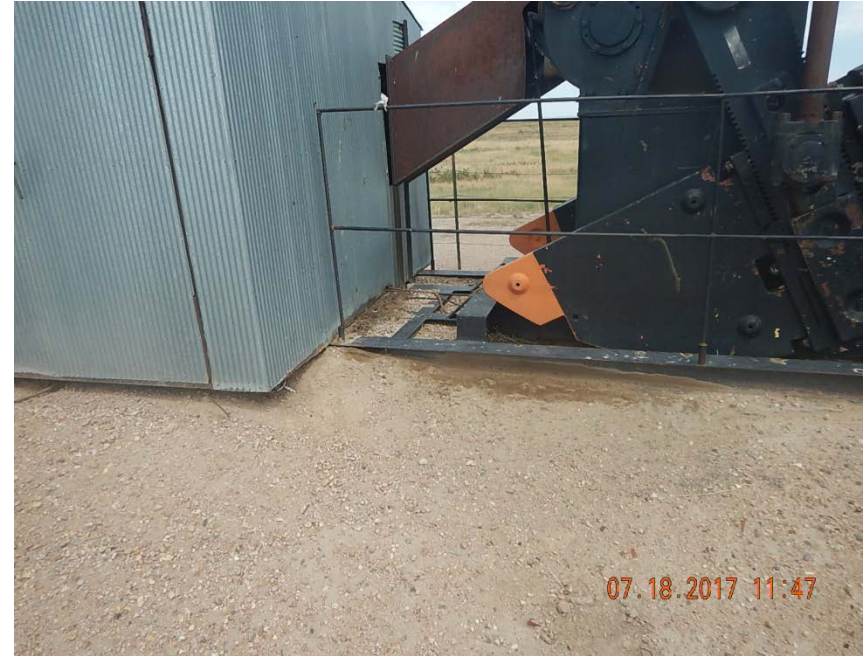
**Photo 2: Stained soil at pump jack**

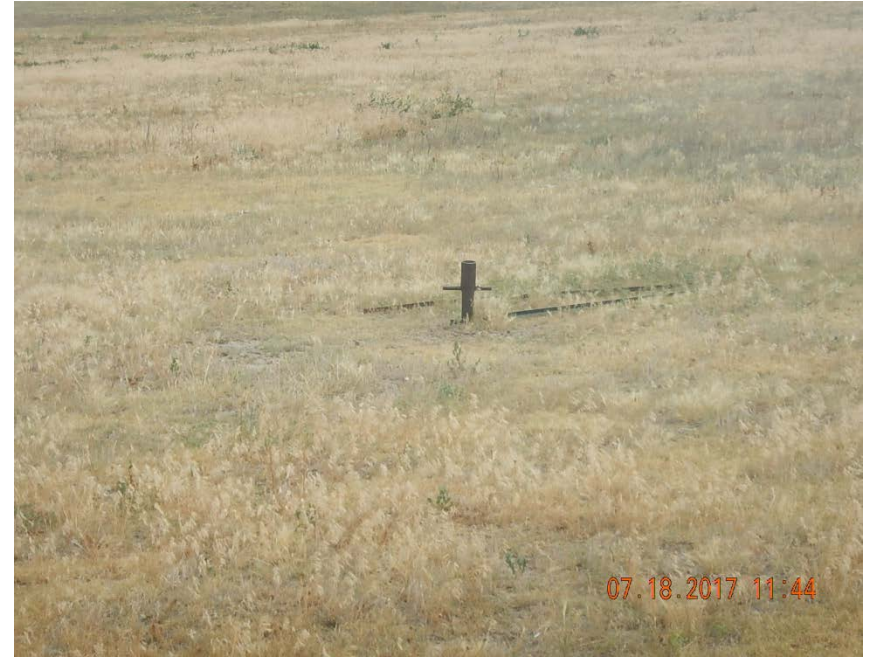
**Photo 3: Deadman markings in disrepair**

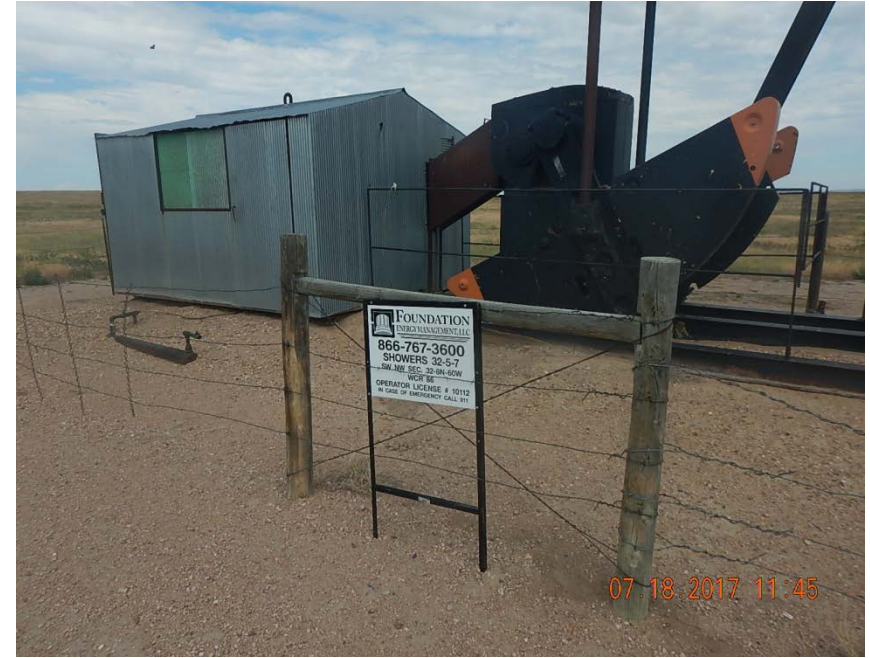
**Photo 4: Wellhead sign**
