Inspection Photos
Location Name: Hill #31-9-11
API: 05-123-19627

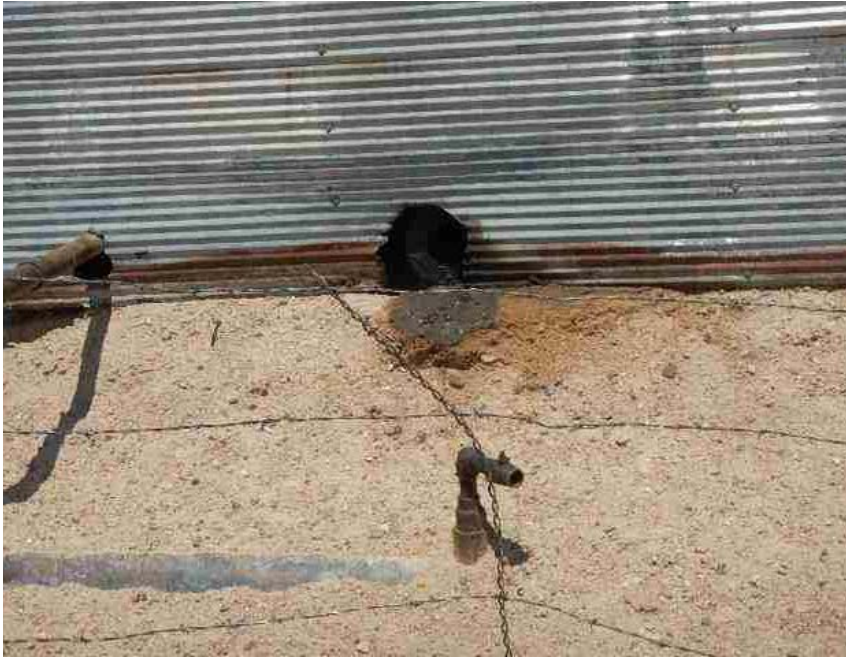
Photo from prior inspection for comparison

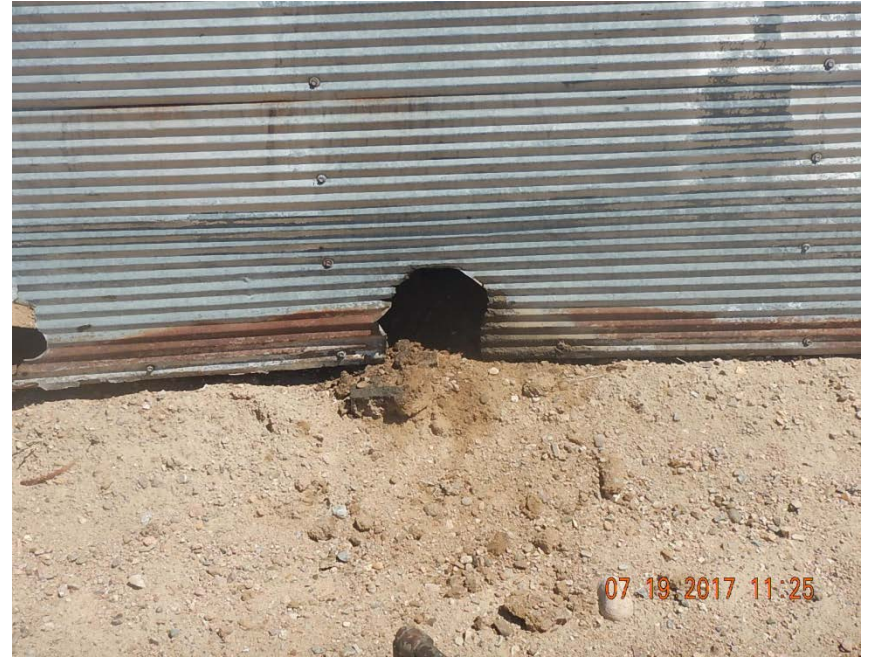
Photo 1: Stained soil at engine house

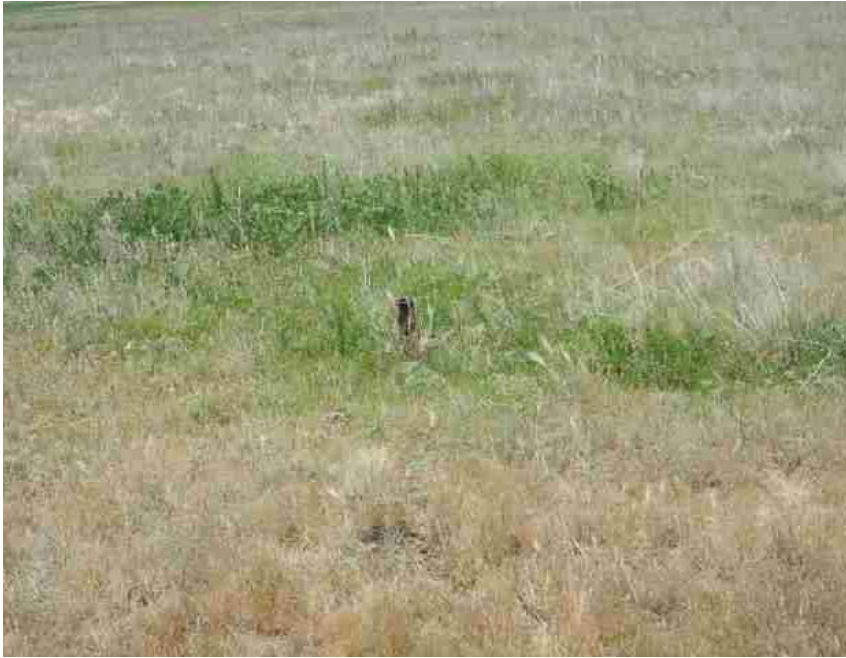
Photo from prior inspection for comparison

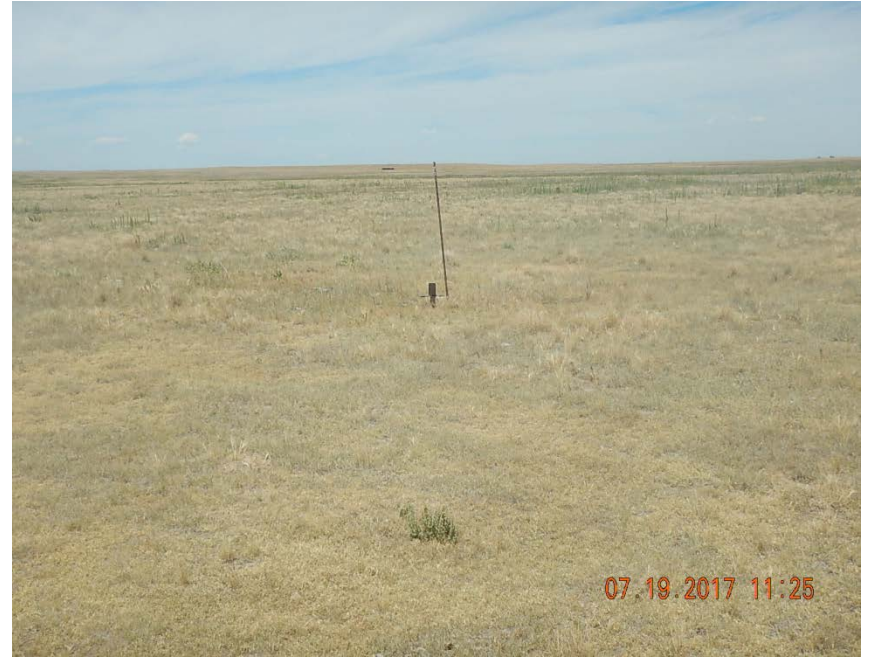
Photo 2: Deadman marked

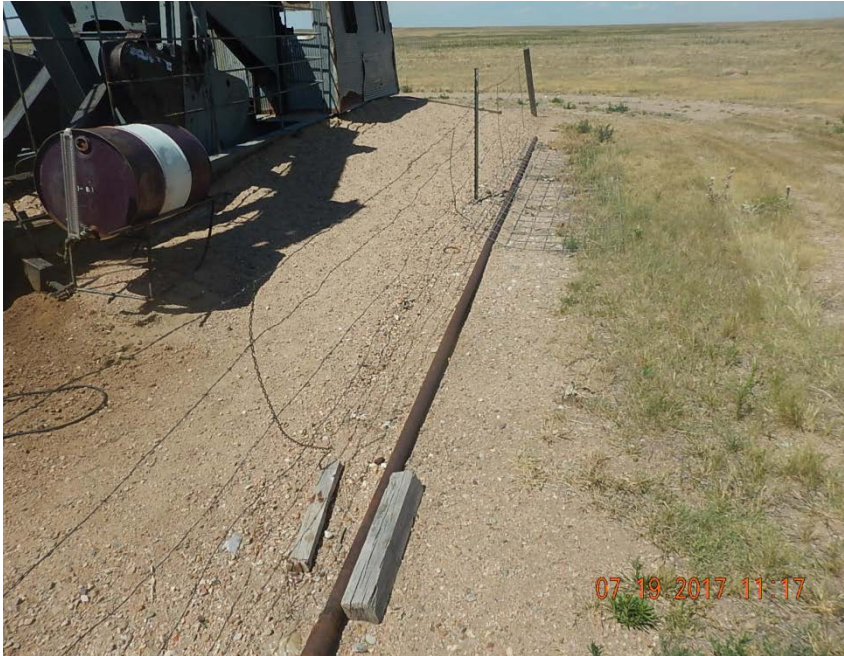
Photo 3: Unused equipment by pump jack.

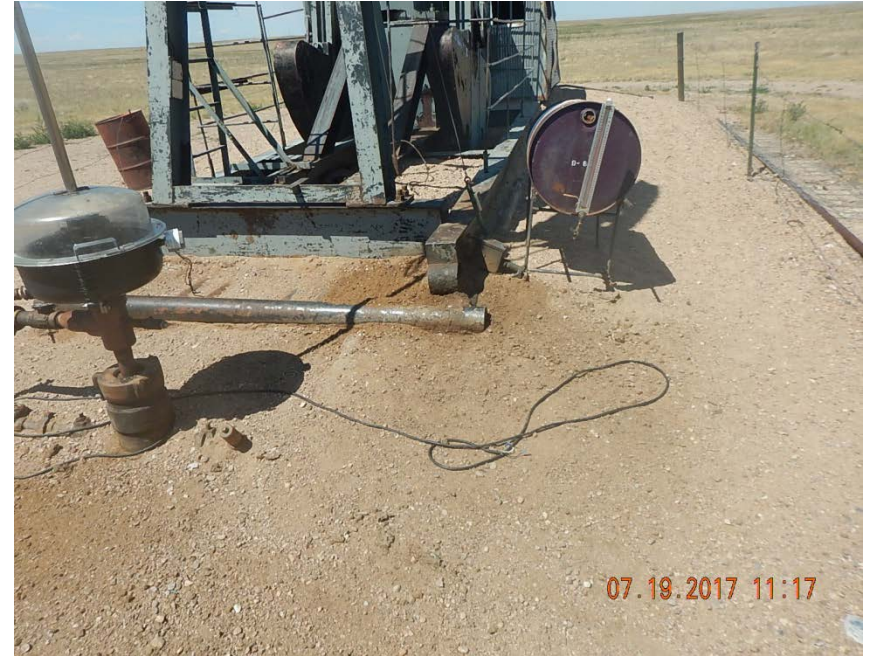
Photo 4: Stained soil at pump jack

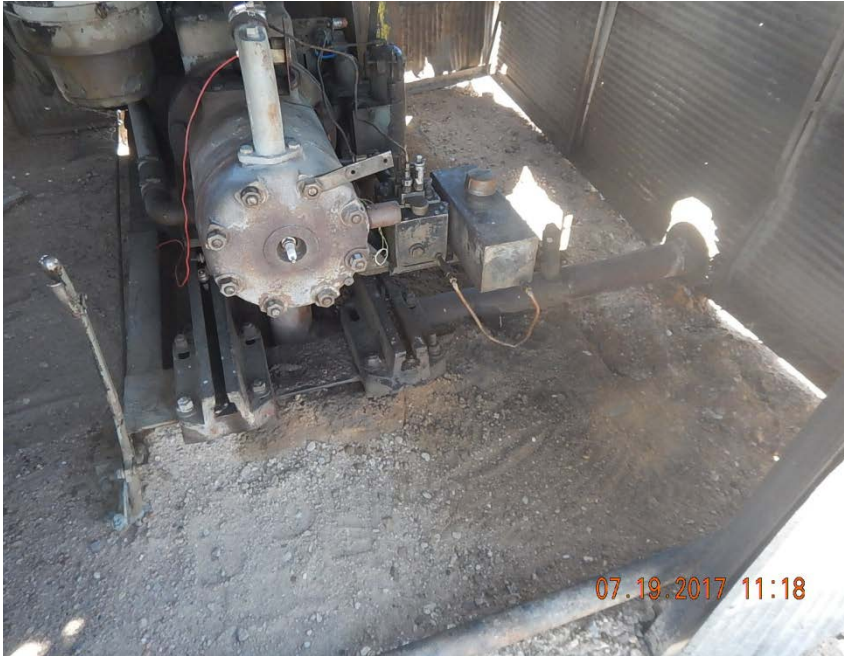
Photo 5: Stained soil in engine house
