Inspection Photos
Location Name: Hill #31-15-8
API: 05-123-19368

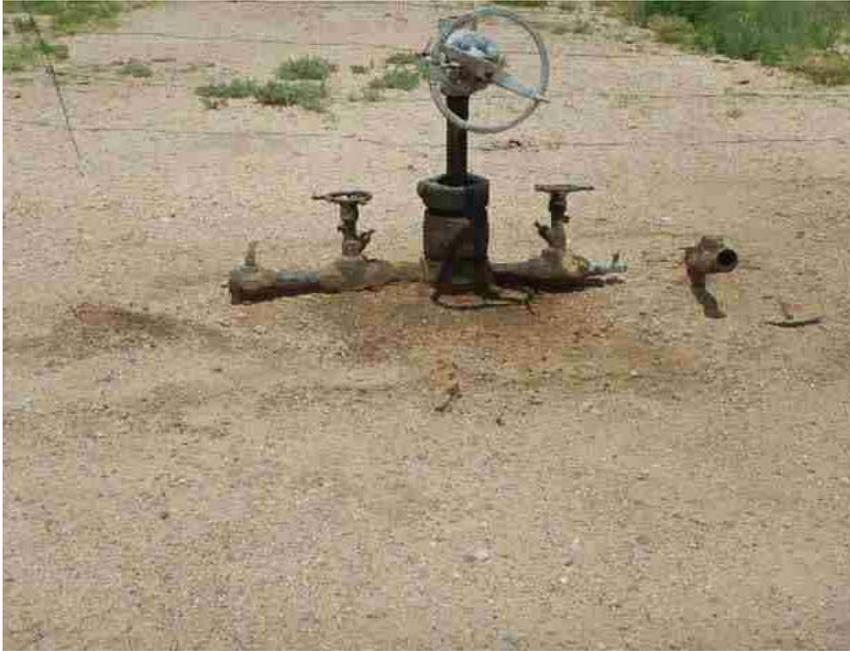
Photo 1: Stained soil at wellhead

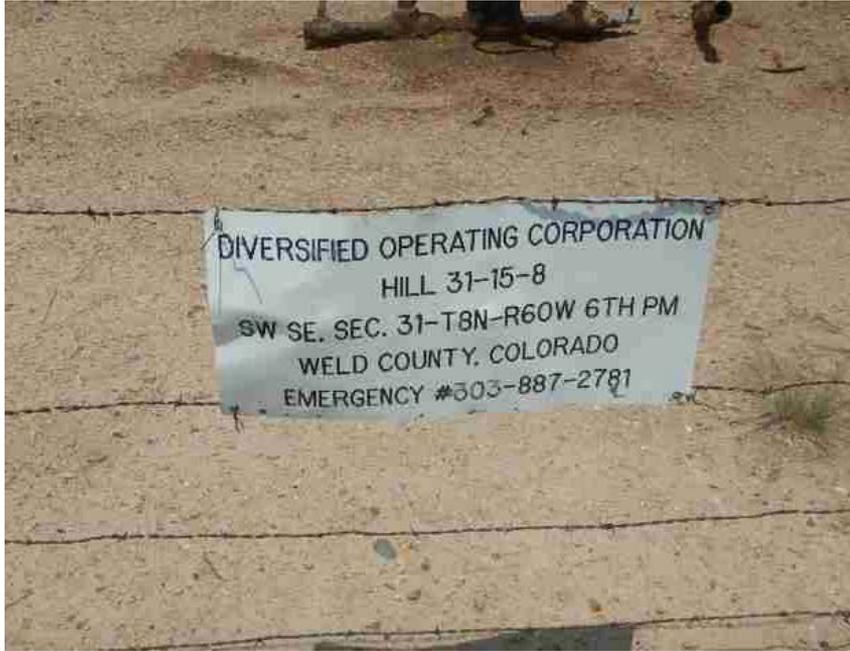
Photo 2: Wellhead sign is for prior operator

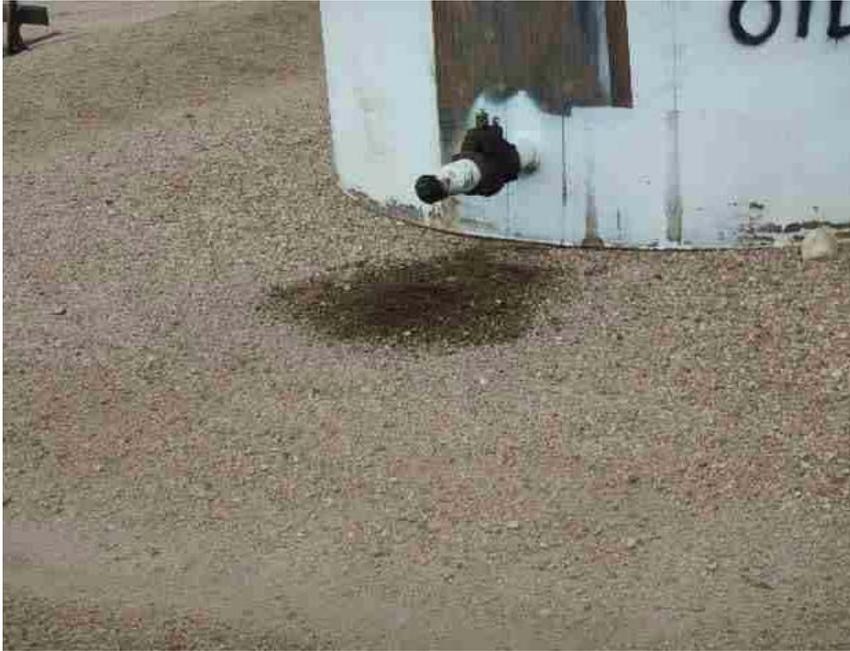
Photo 3: Stained soil at crude oil loadouts. E tank (right) is actively leaking

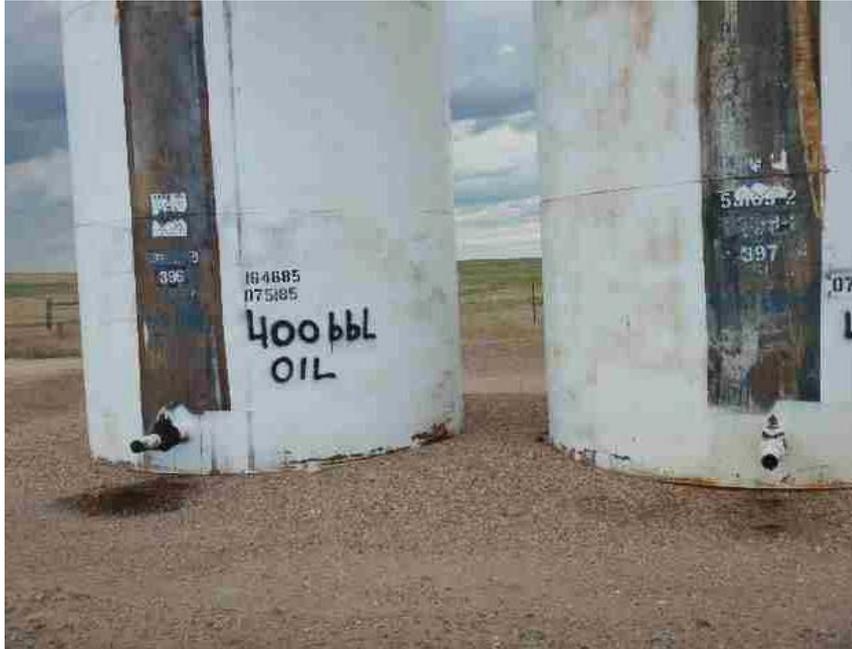
Photo 4: Damaged placards on crude oil tanks

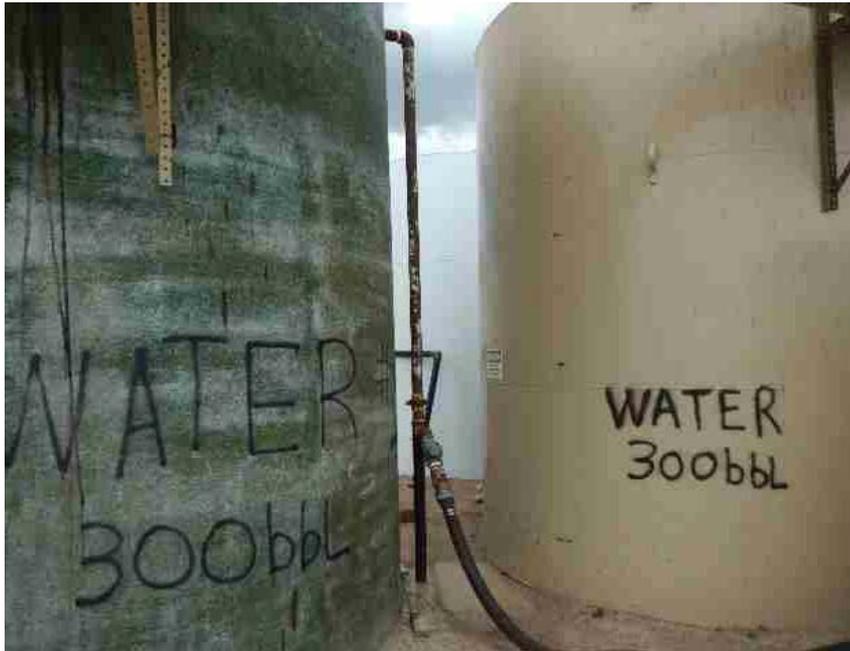
Photo 5: W tank (left) lacking placarding, E tank (right) now placarded

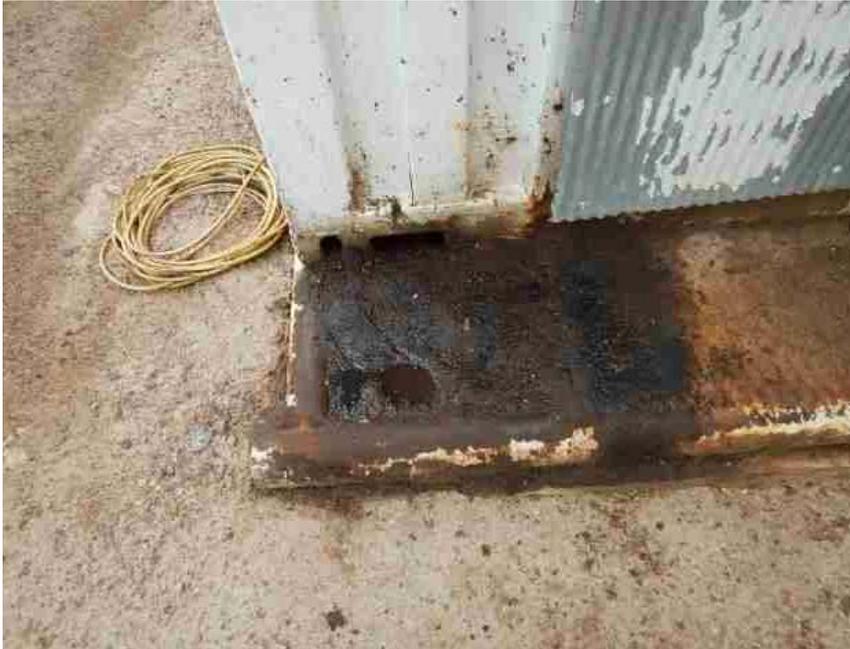
Photo 6: Stained soil at SE corner of pumphouse

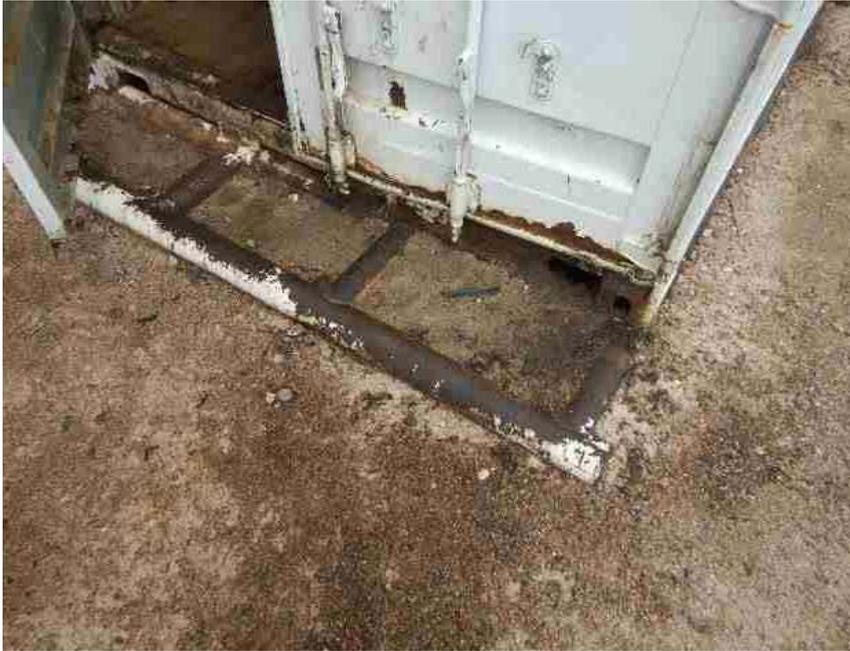
Stained soil at SW corner of pumphouse, unused equipment

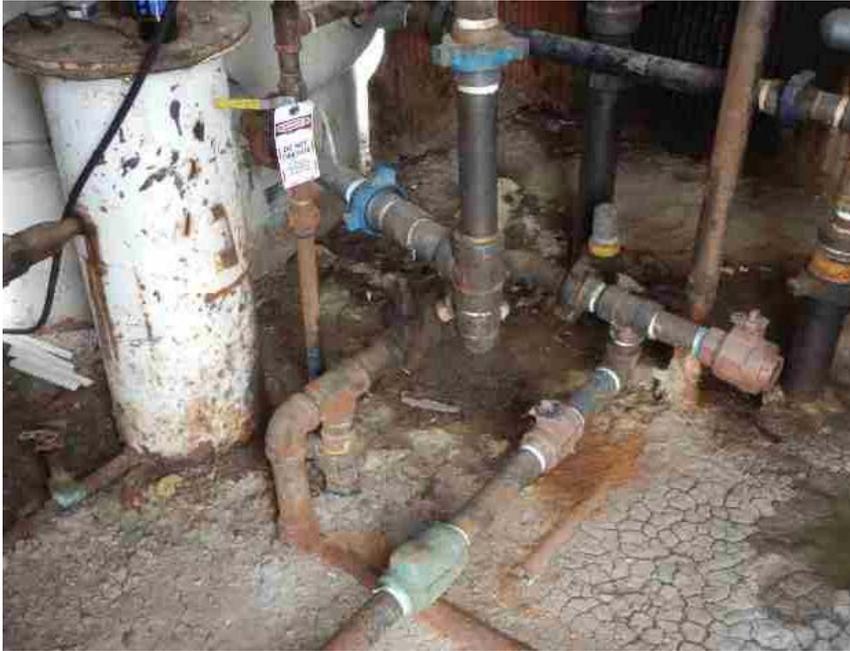
Photo 8: Stained soil in treater house

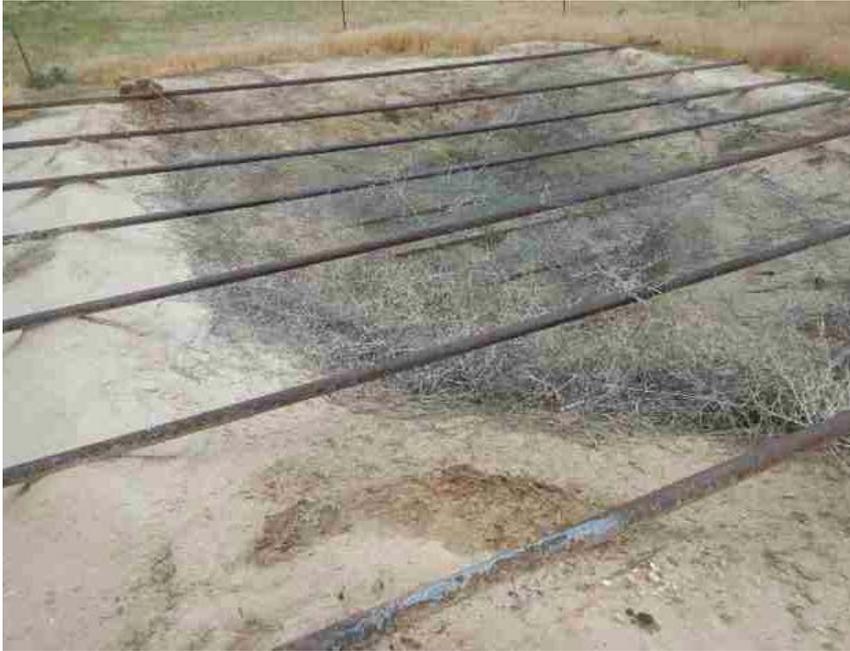
Photo 9: Gaps in netting on pit

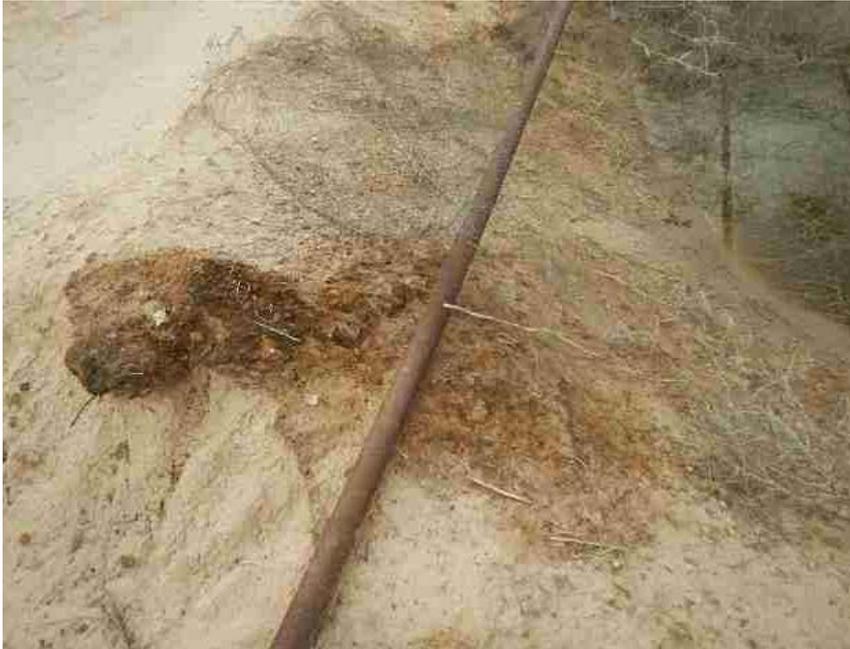
Photo 10: Stained soil at NE corner remediated

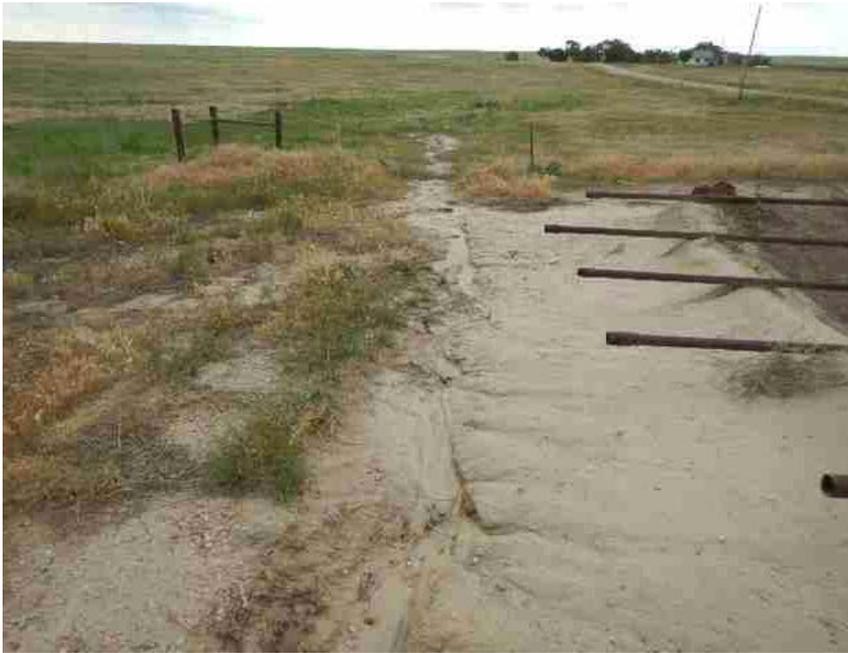
Photo 11: Stormwater erosion on N side of pit. Waddles put in place at NE corner of facility

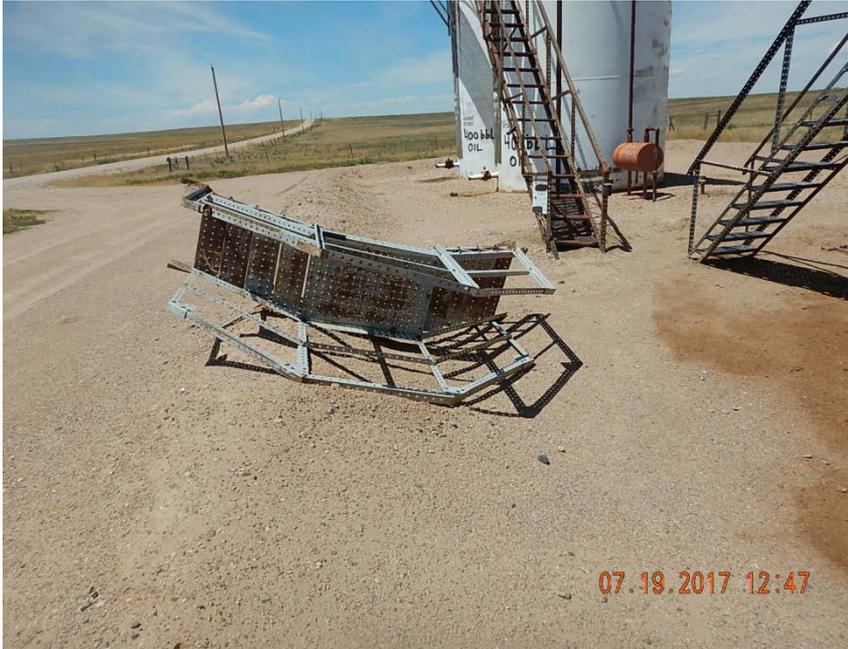
Photo 12: Unused equipment at tank battery

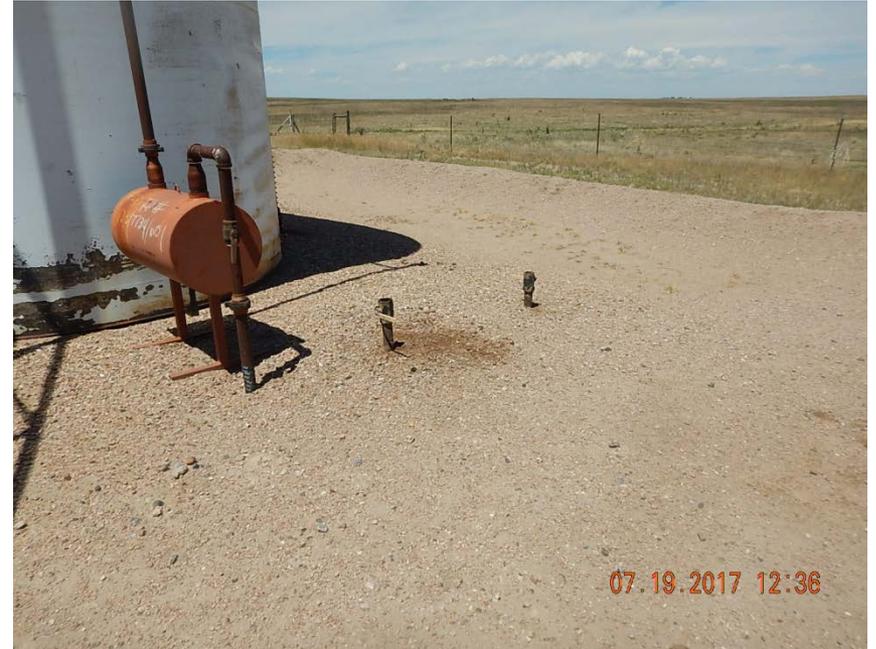
Photo 13: Riser at tank battery

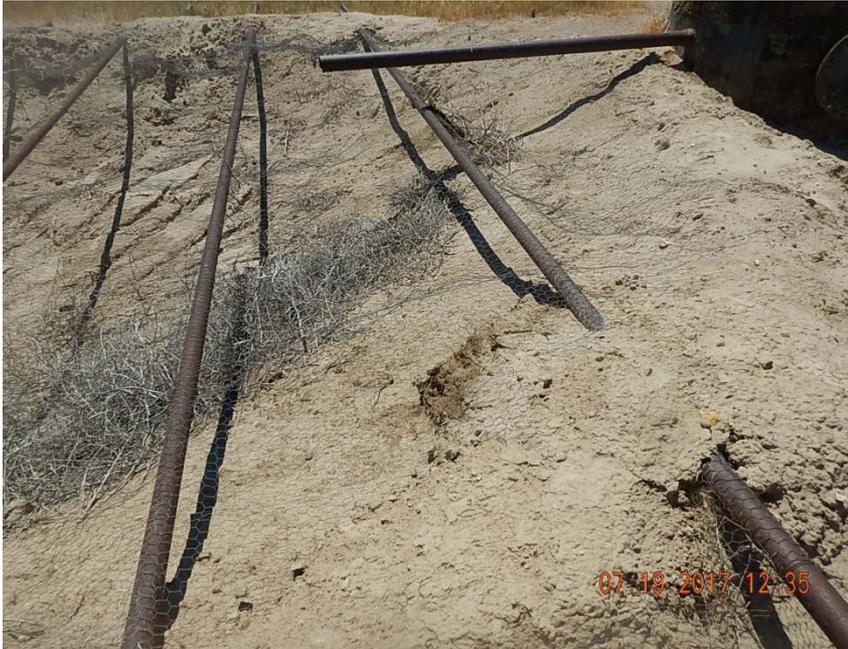
Photo 14: Stained soil at NW corner of pit

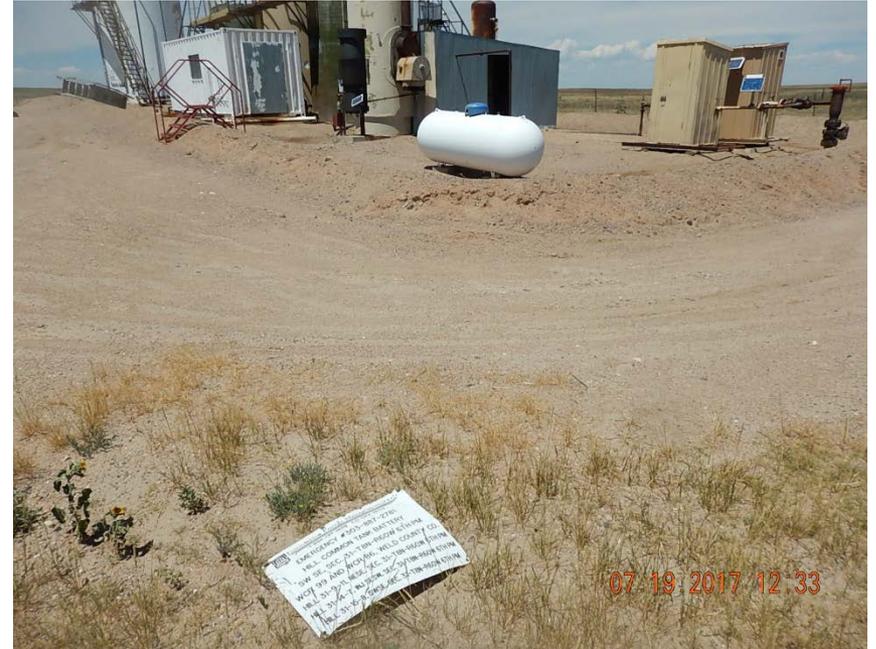
Photo 15: Detached battery sign

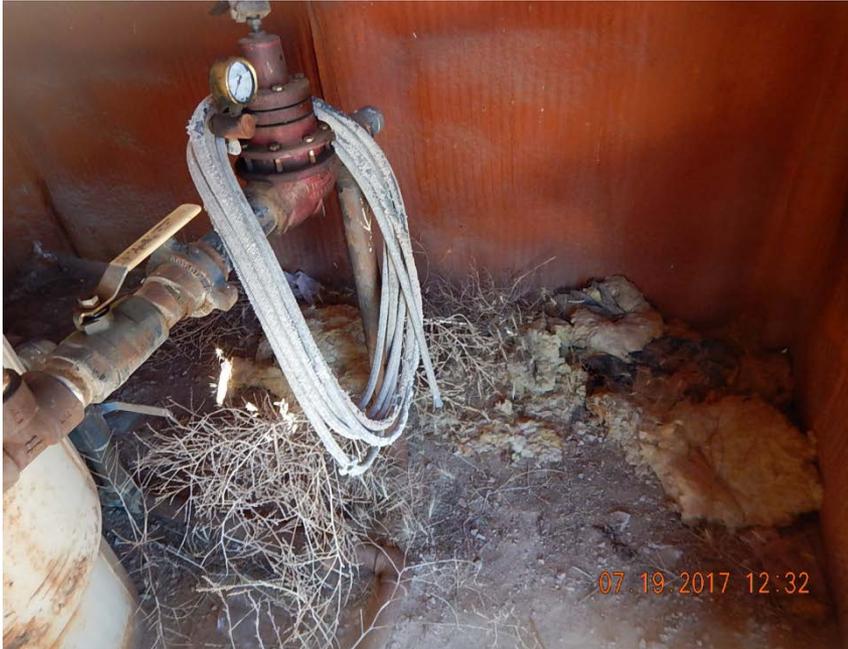
Photo 16: Debris in treater house

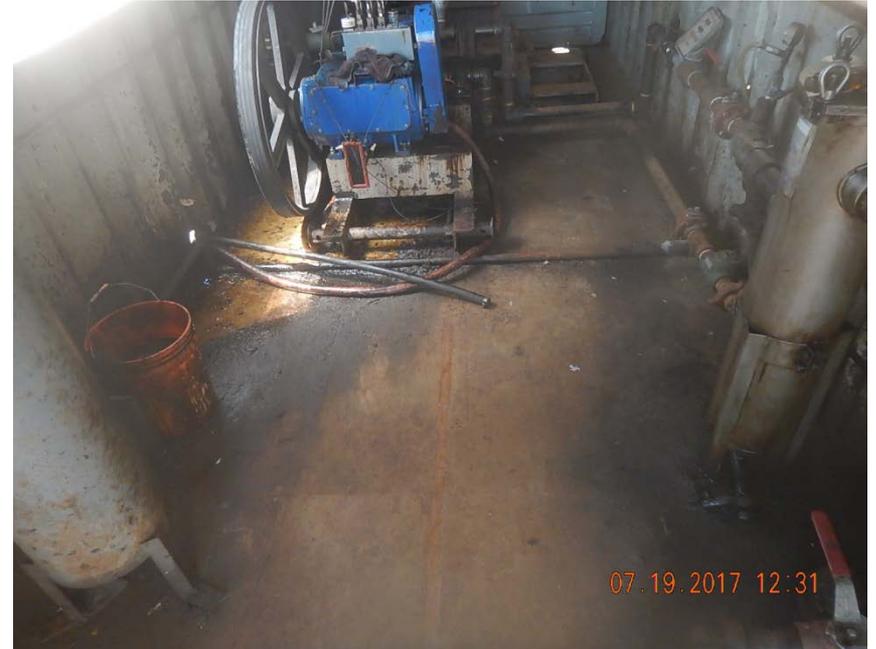
Photo 17: Oil, waste in pumphouse

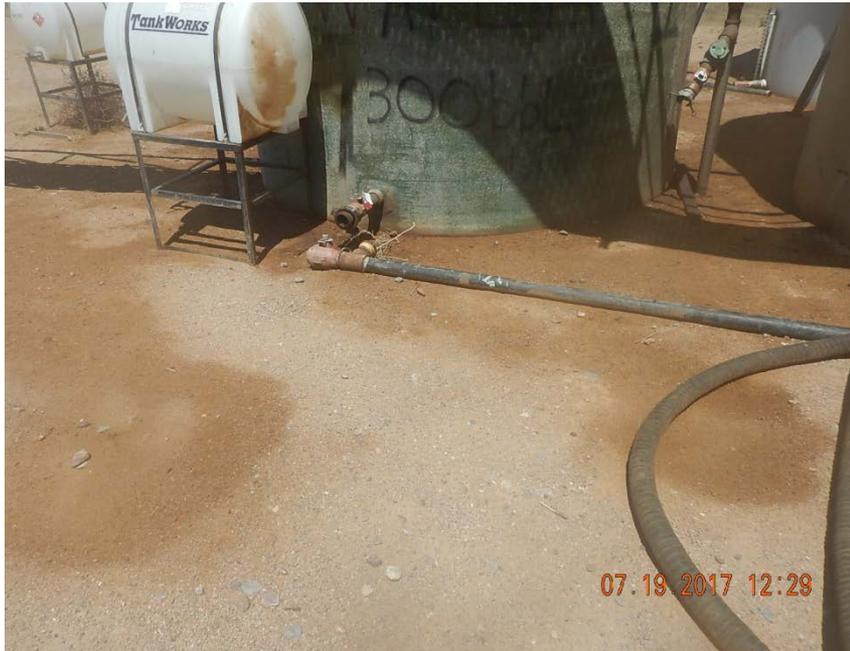
Photo 18: Stained soil around produced water tank

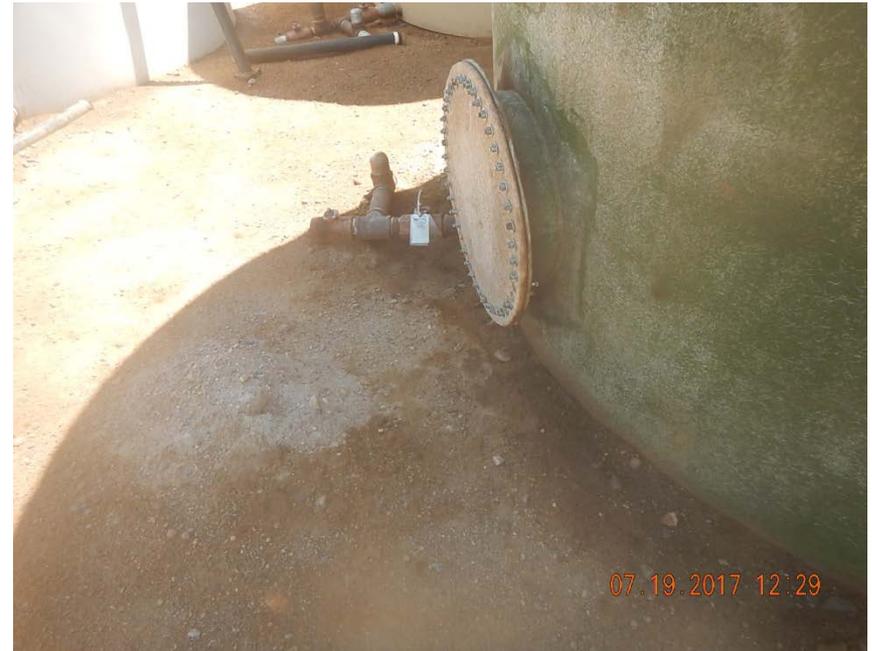
Photo 19: Stained soil around produced water tank
