Inspection Photos
Location Name: Hill #6-1
API: 05-123-20169

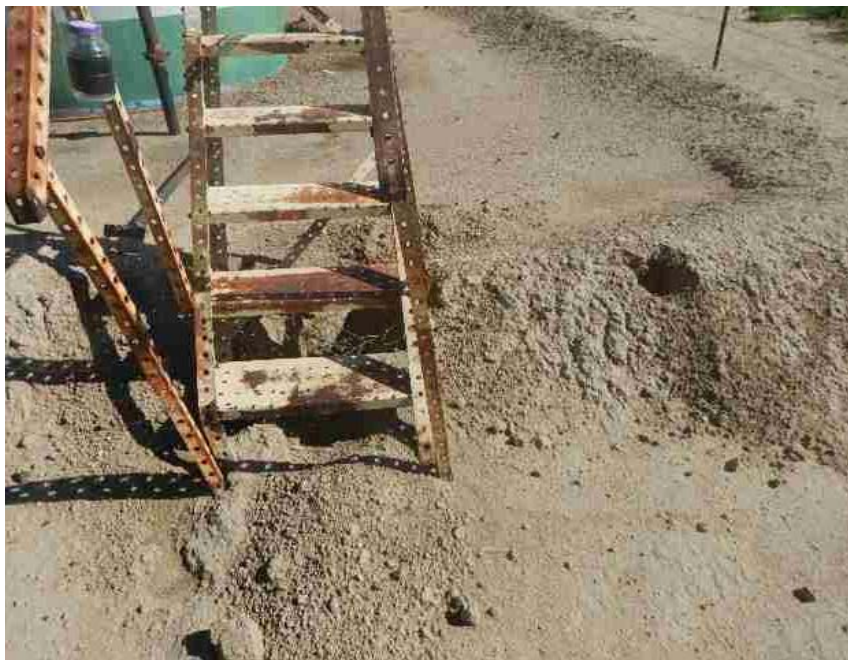
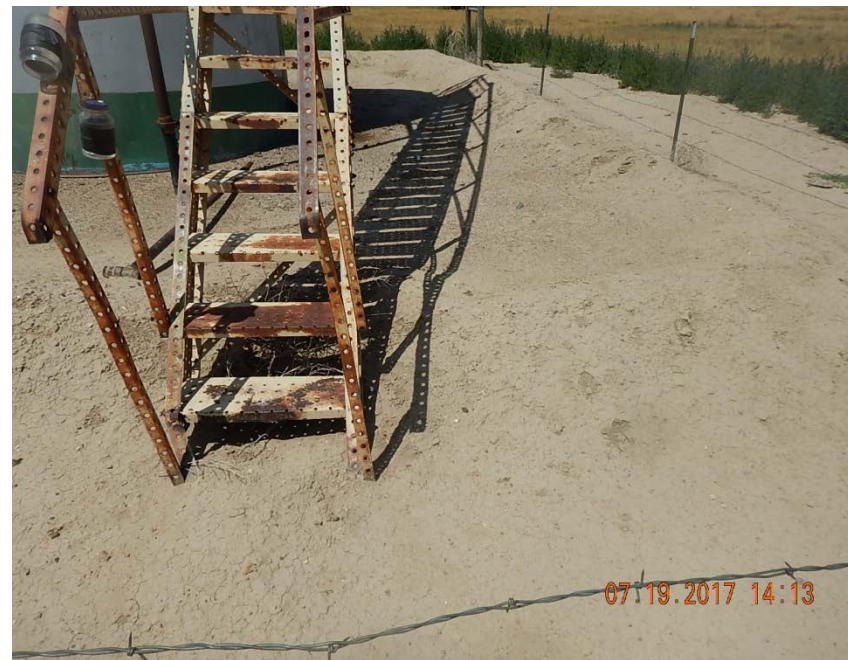
Photo 1: Berms repaired

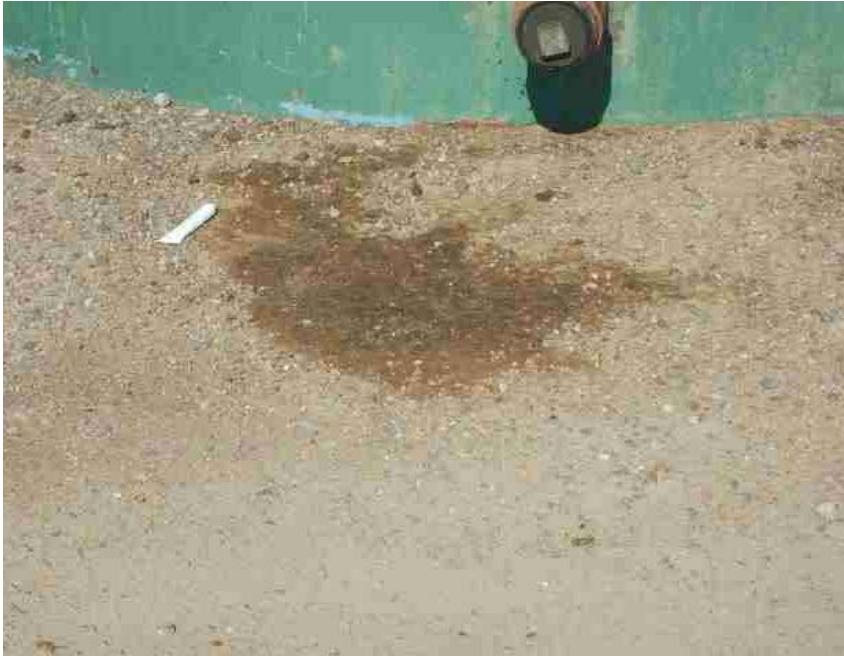
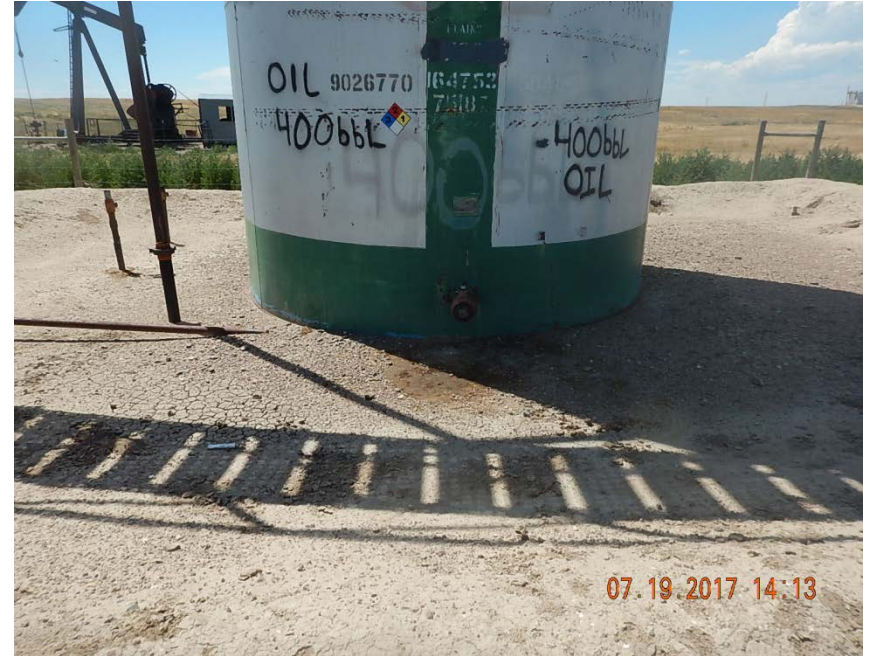
Photo 2: Stained soil at truck loadout

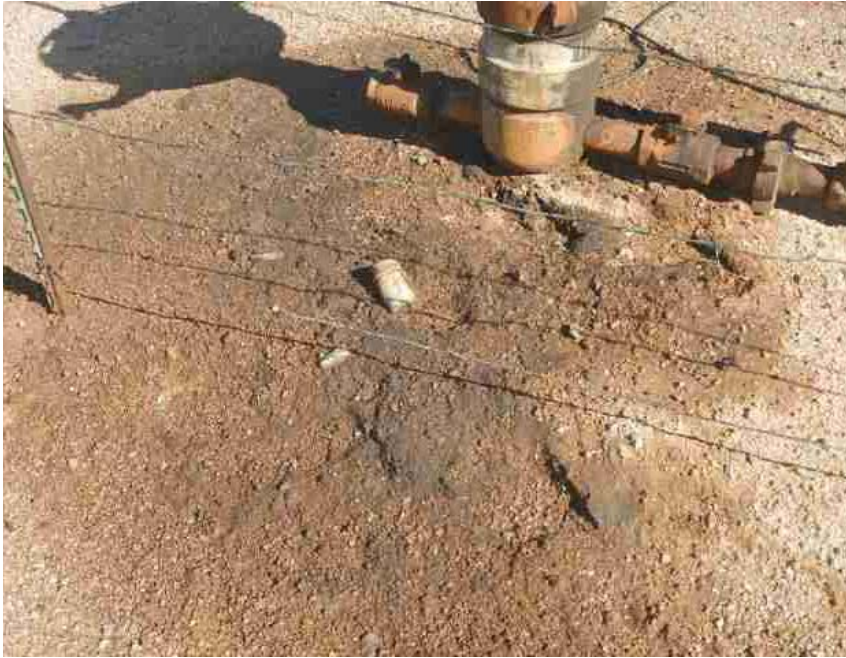
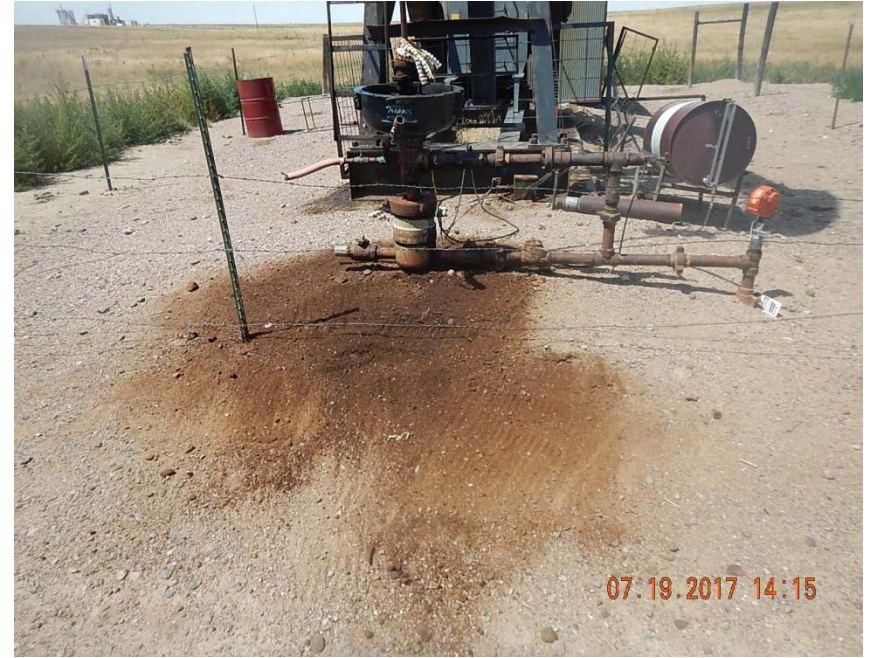
Photo 2: Stained soil at wellhead. Bradenhead not plumbed to surface.

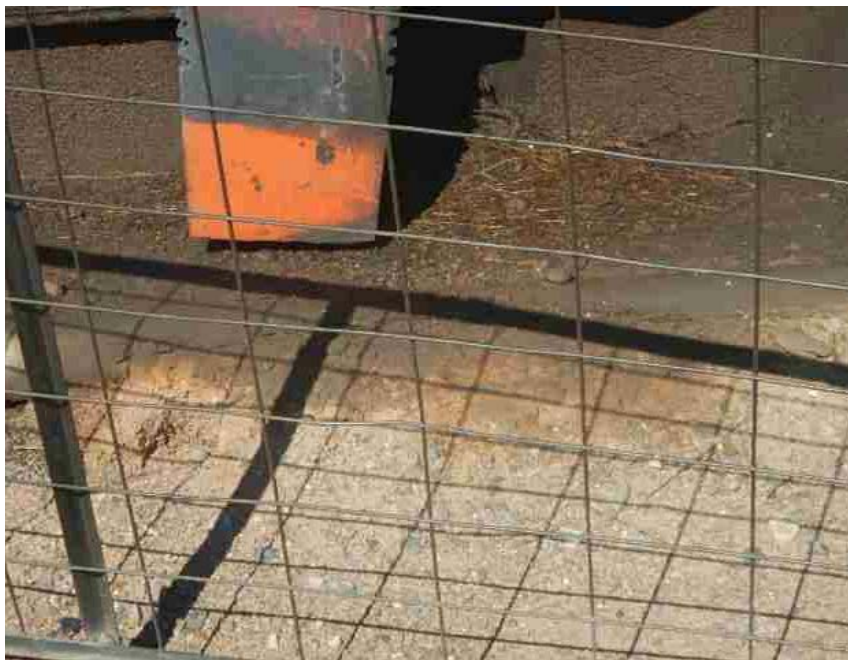
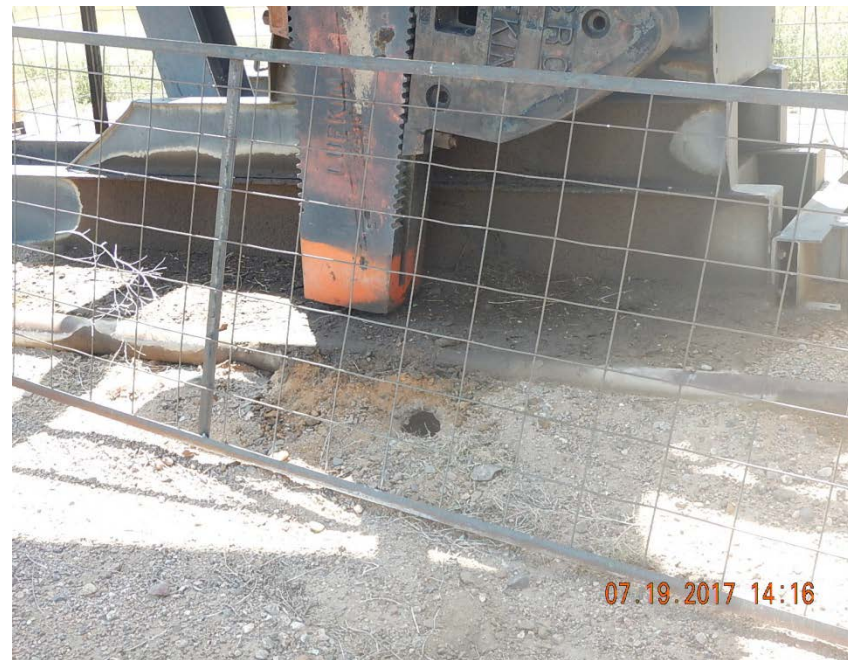
Photo 4: Stained soil at pump jack

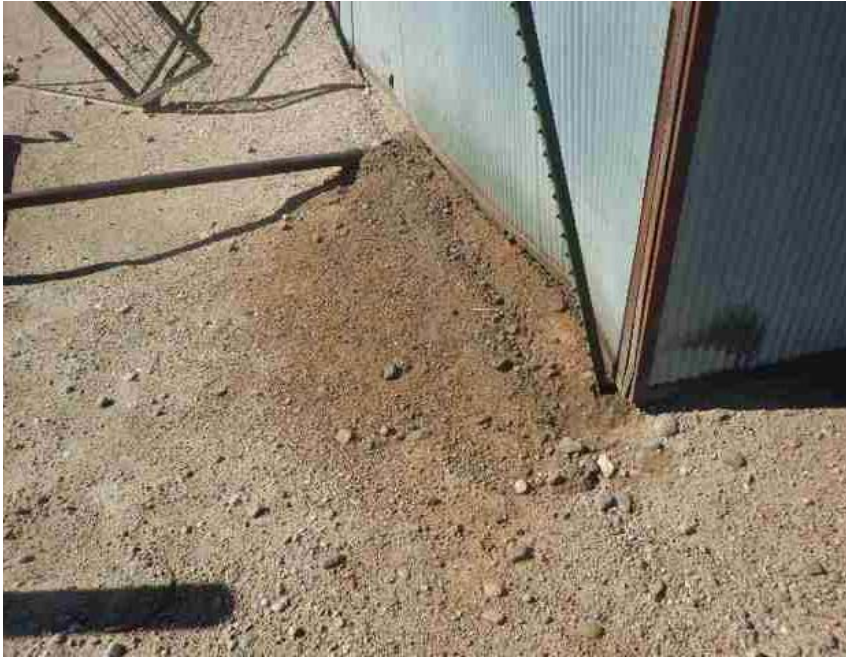
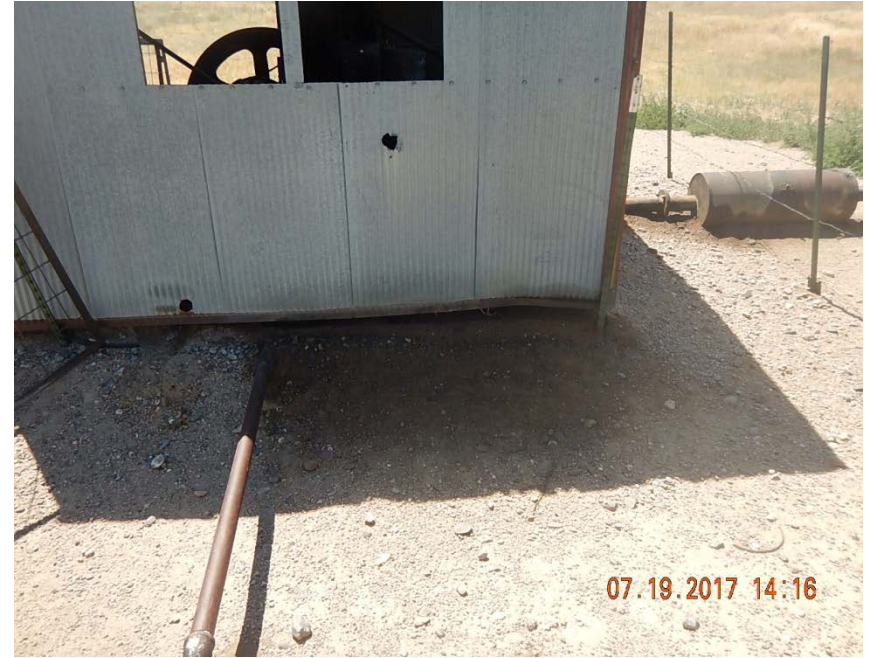
Photo 5: Stained soil at engine housing

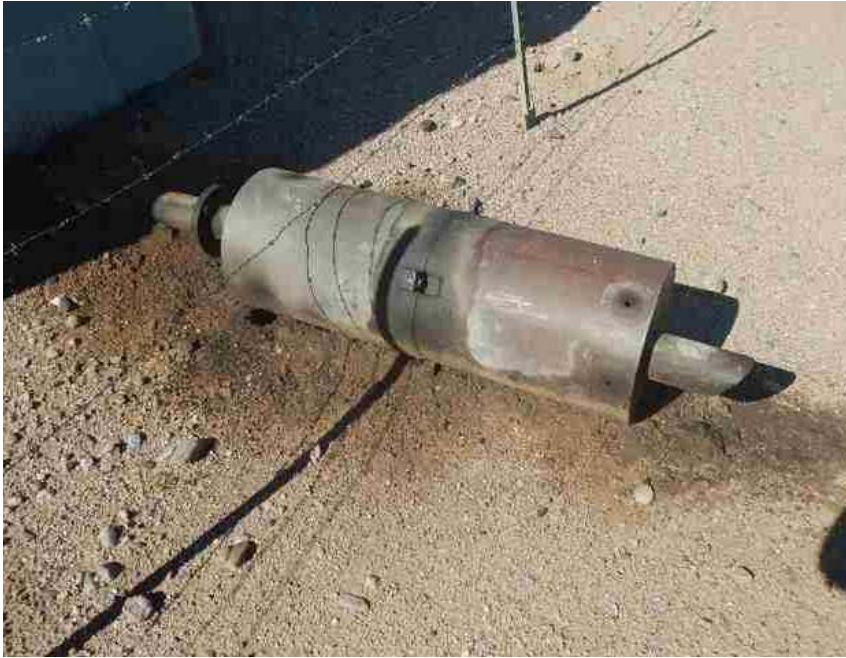
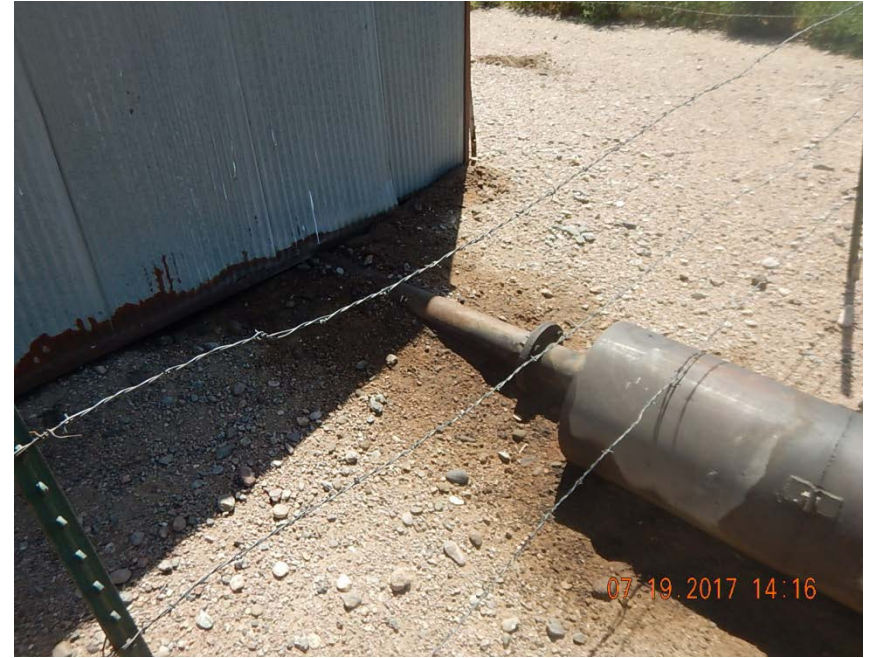
Photo 6: Stained soil at engine exhaust

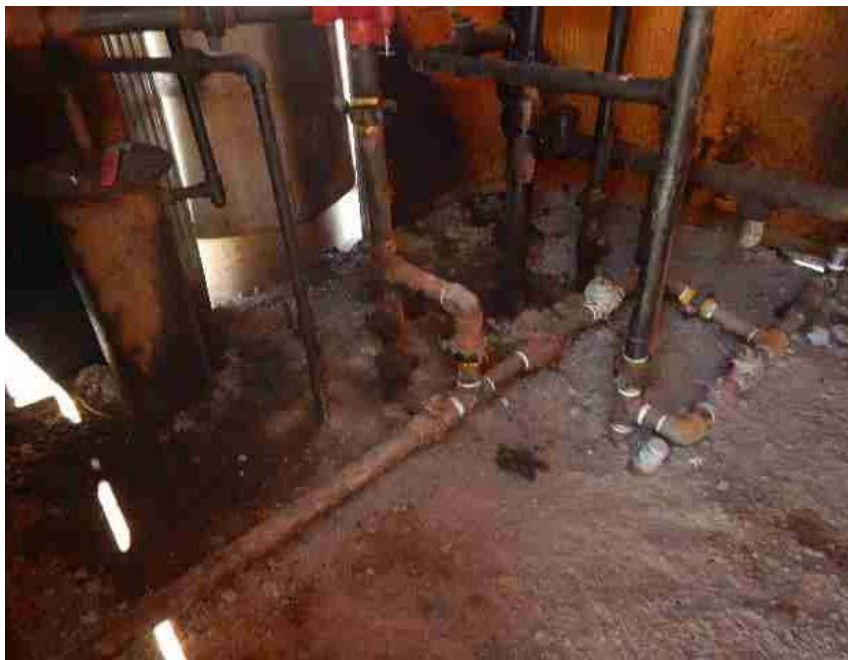
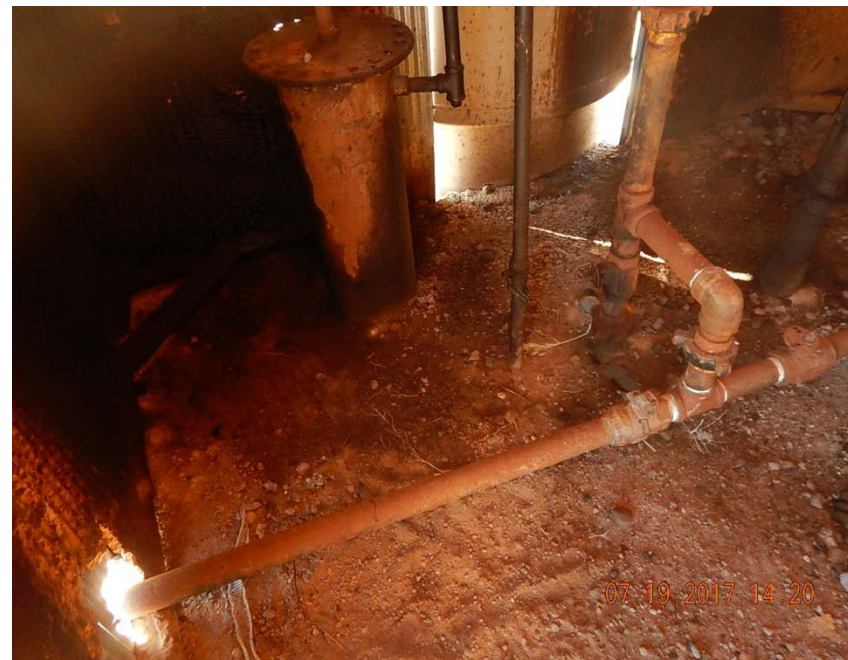
Photo 7: Stained soil in treater house

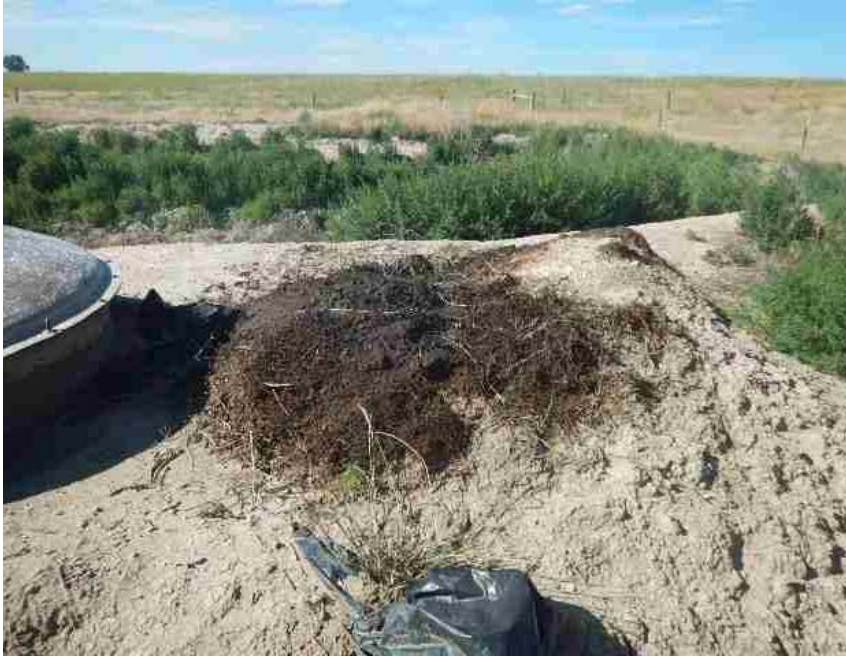
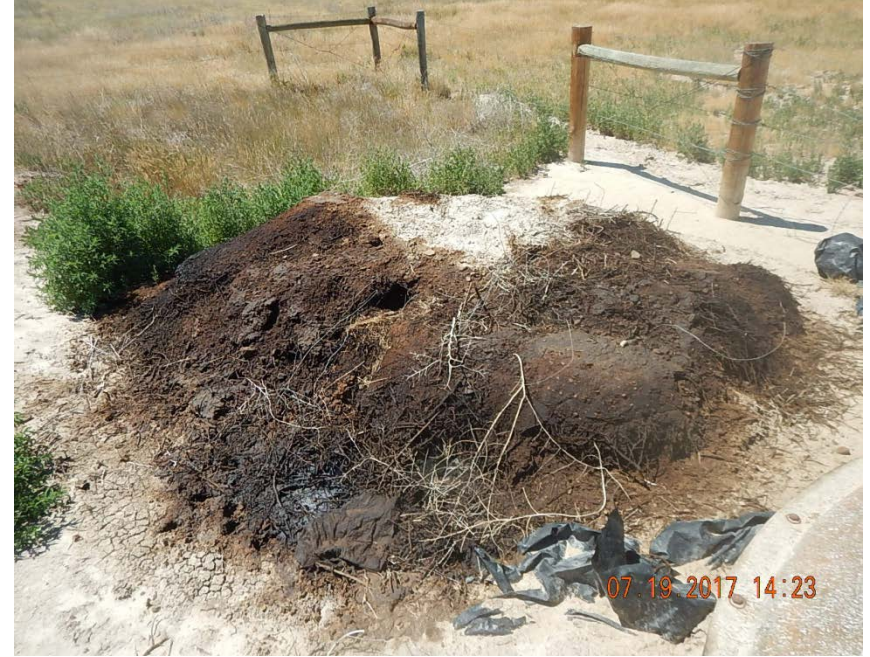
Photo 8: Stained soil by skim

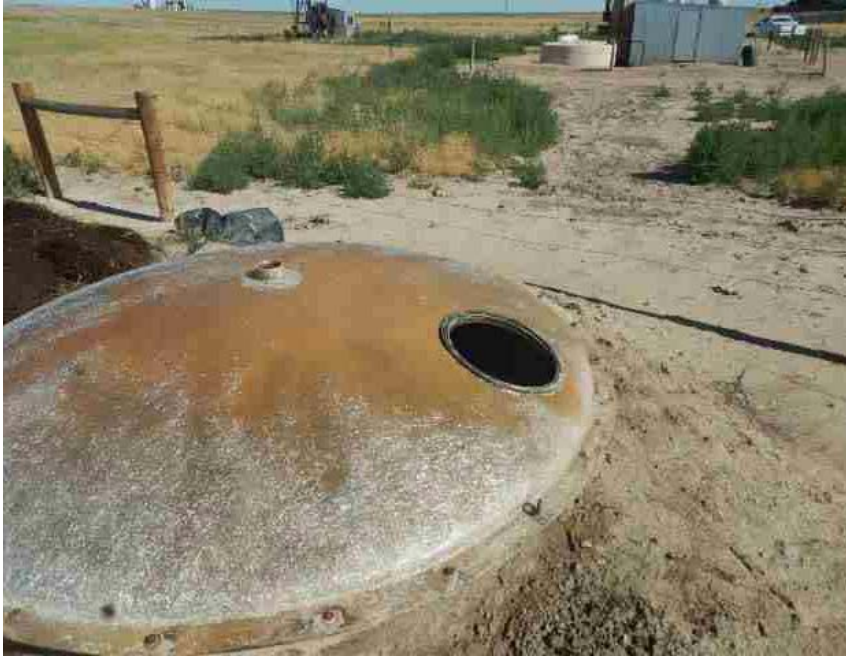
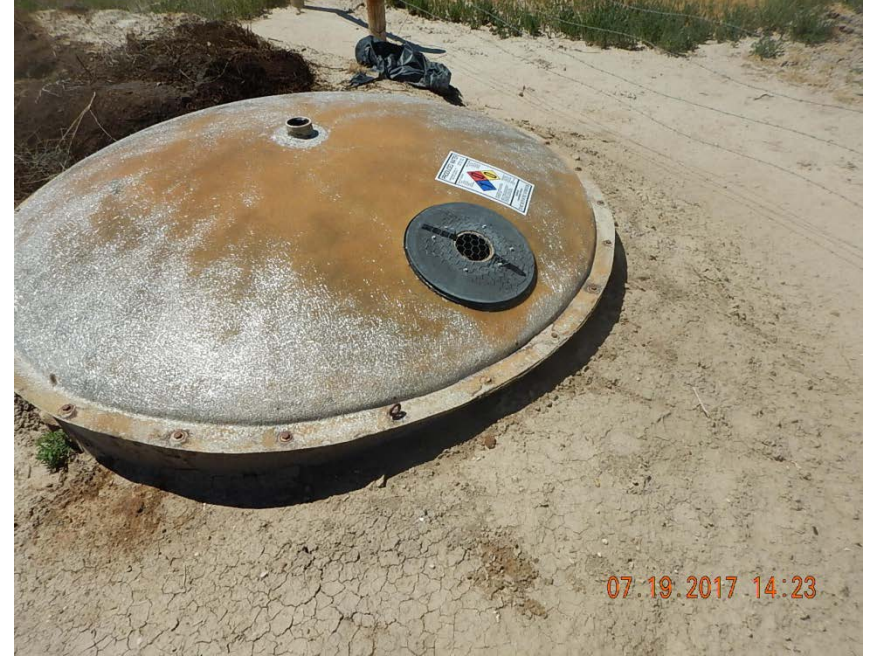
Photo 9: Skim covered

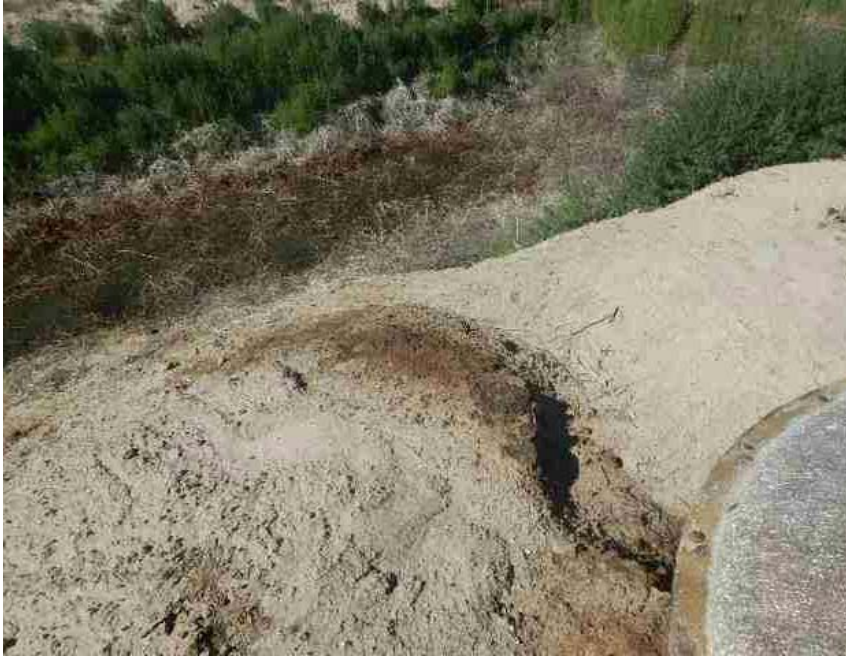
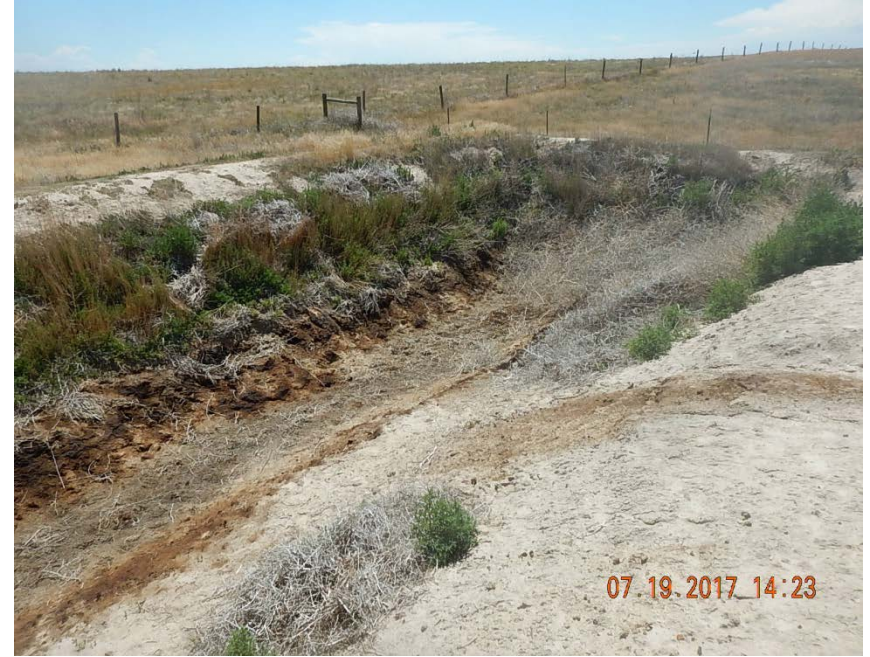
Photo 10: Stained soil in pit

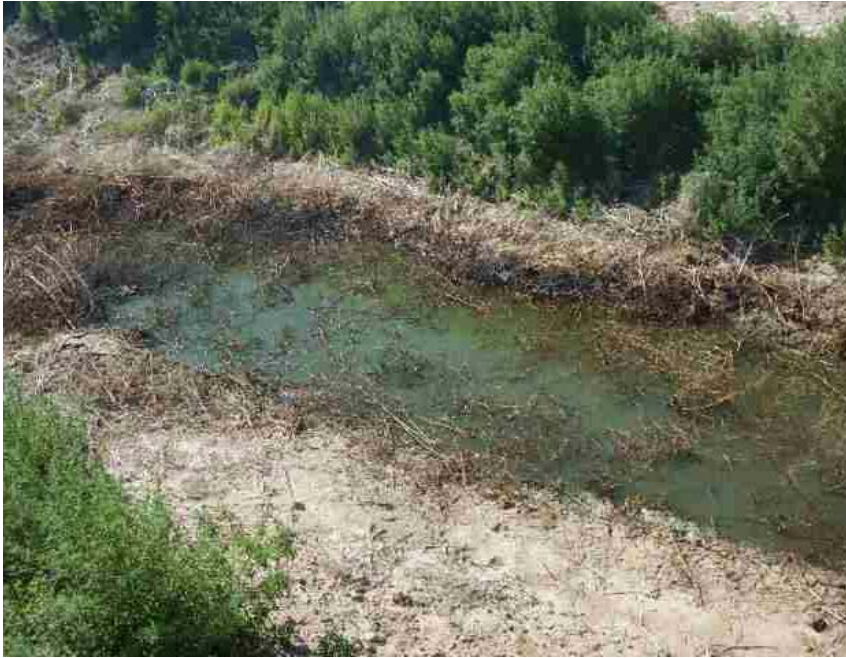
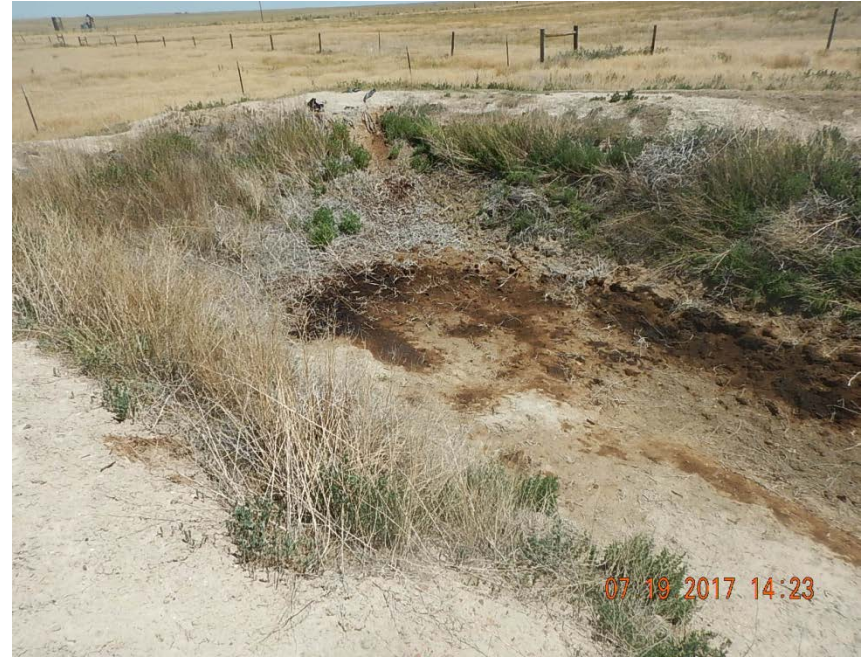
Photo 11: Stained soil in pit

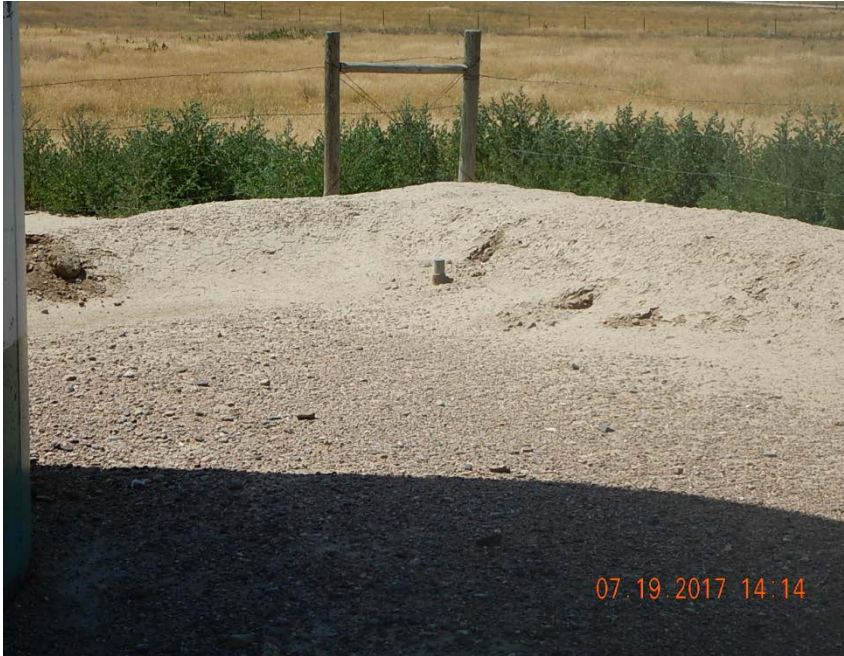
Photo 13: Riser at NW corner of crude oil battery

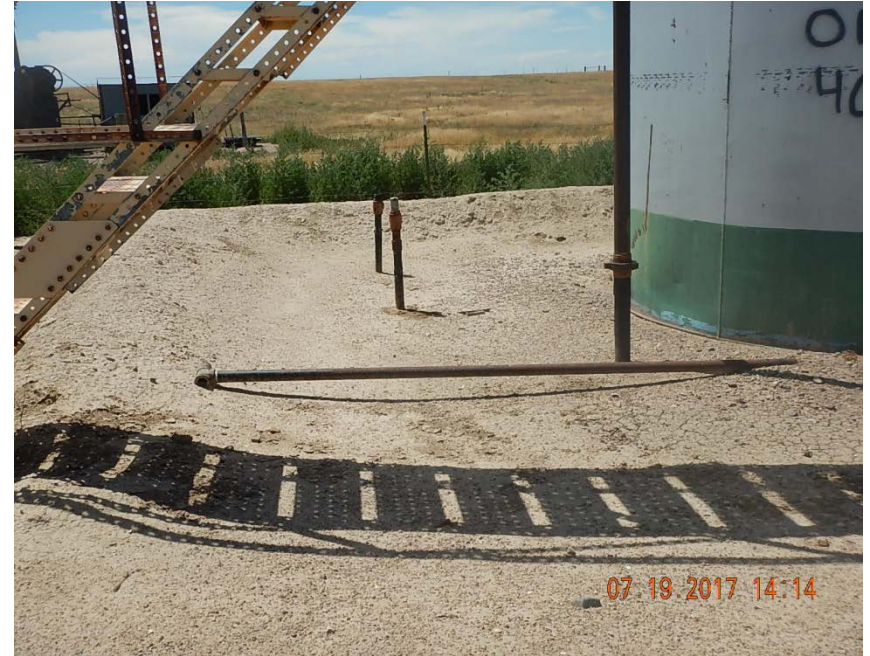
Photo 14: Unused pipe, risers at SW corner of tank

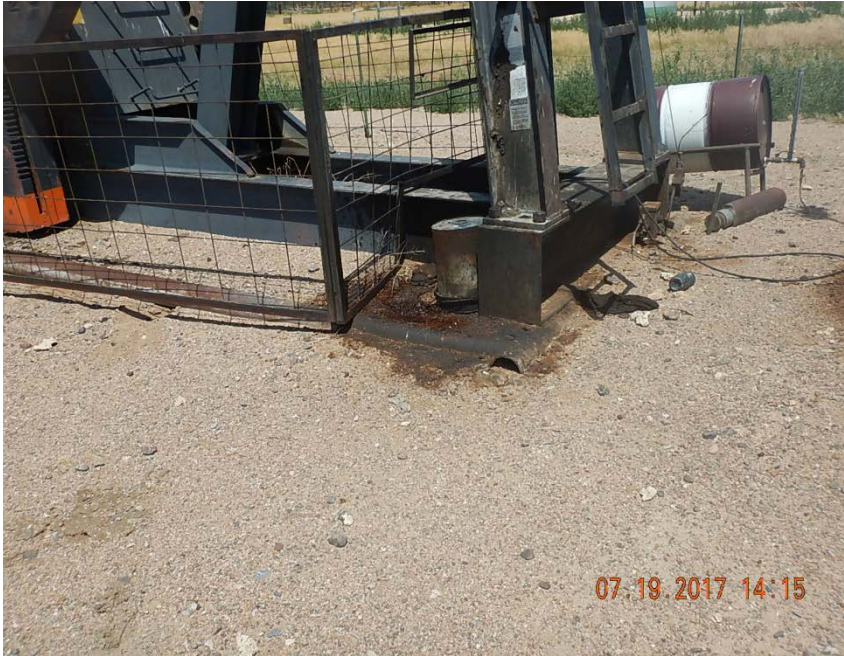
Photo 14: Stained soil at pump jack

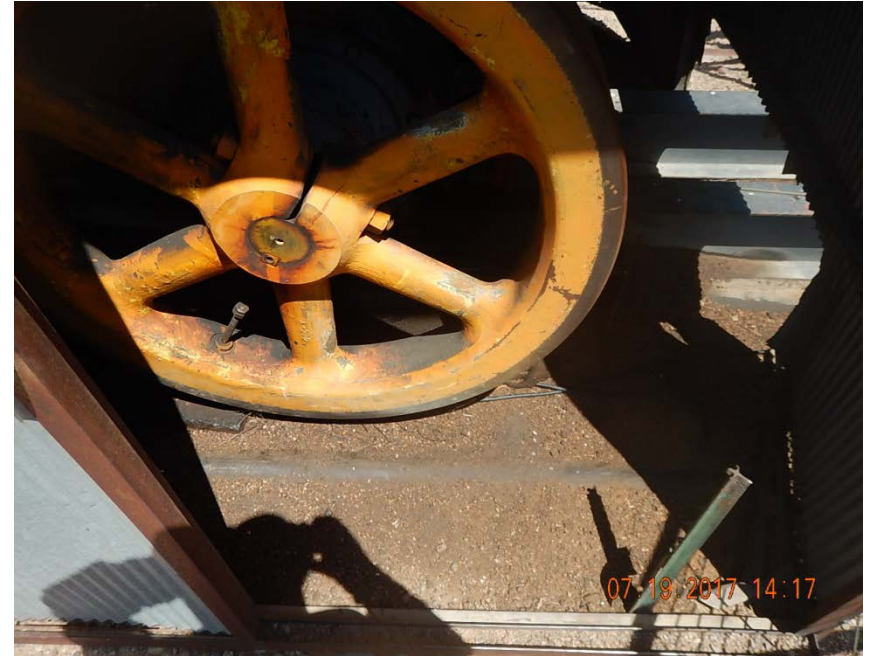
Photo 15: Stained soil around engine in engine house

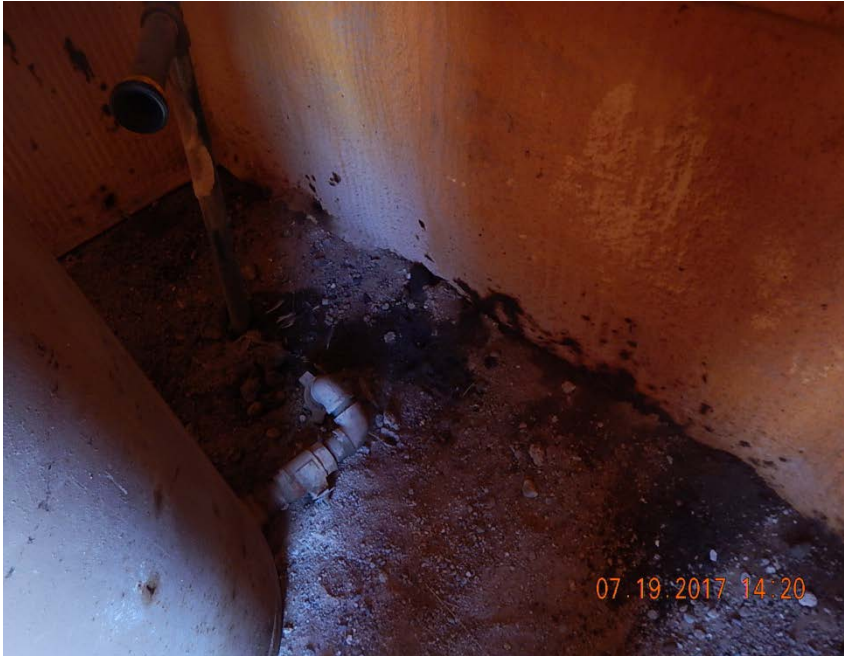
Photo 16: Stained soil by vertical separator

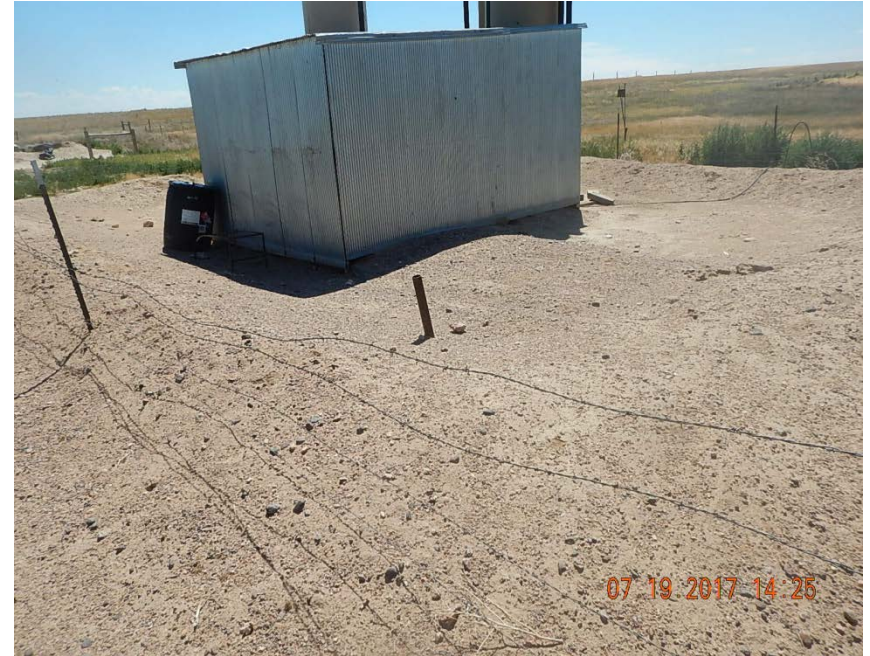
Photo 17: Riser near separator shack
