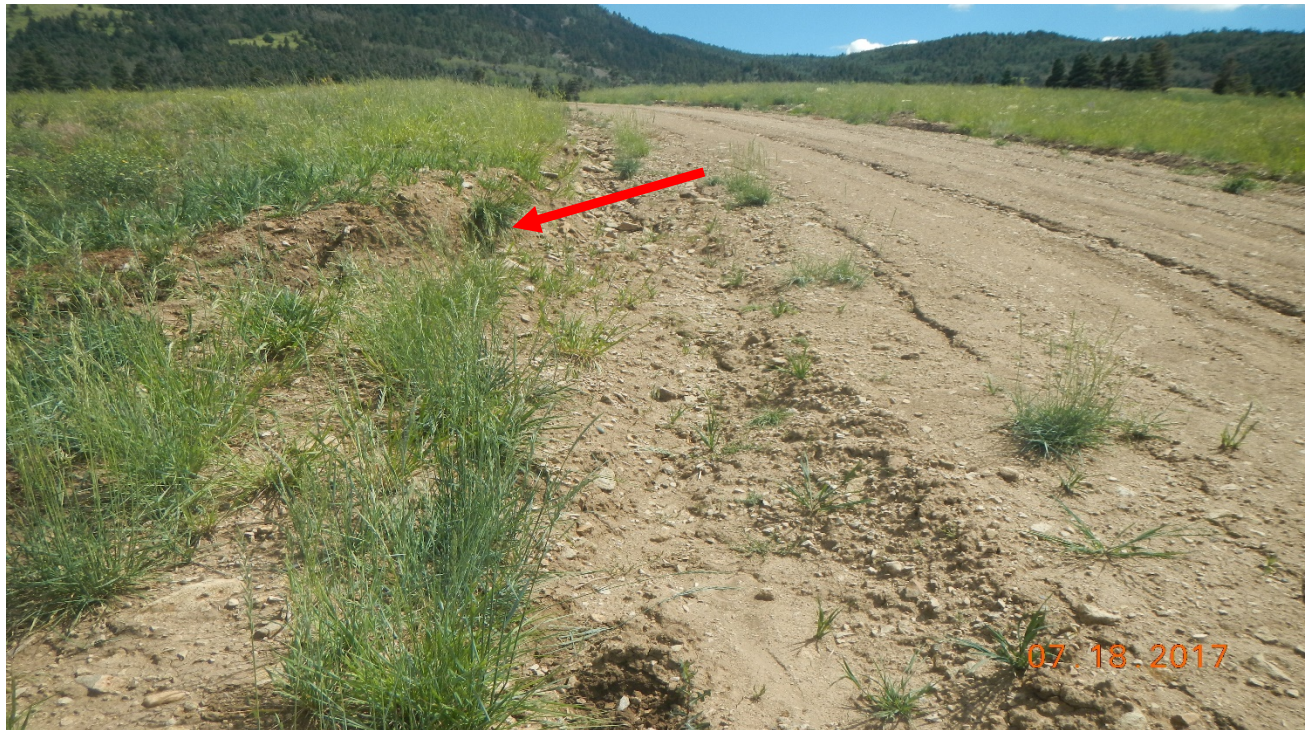
photo 1: Facing south along the access road toward the location. Stormwater is not adequately directed toward the sediment trap shown in photo below.

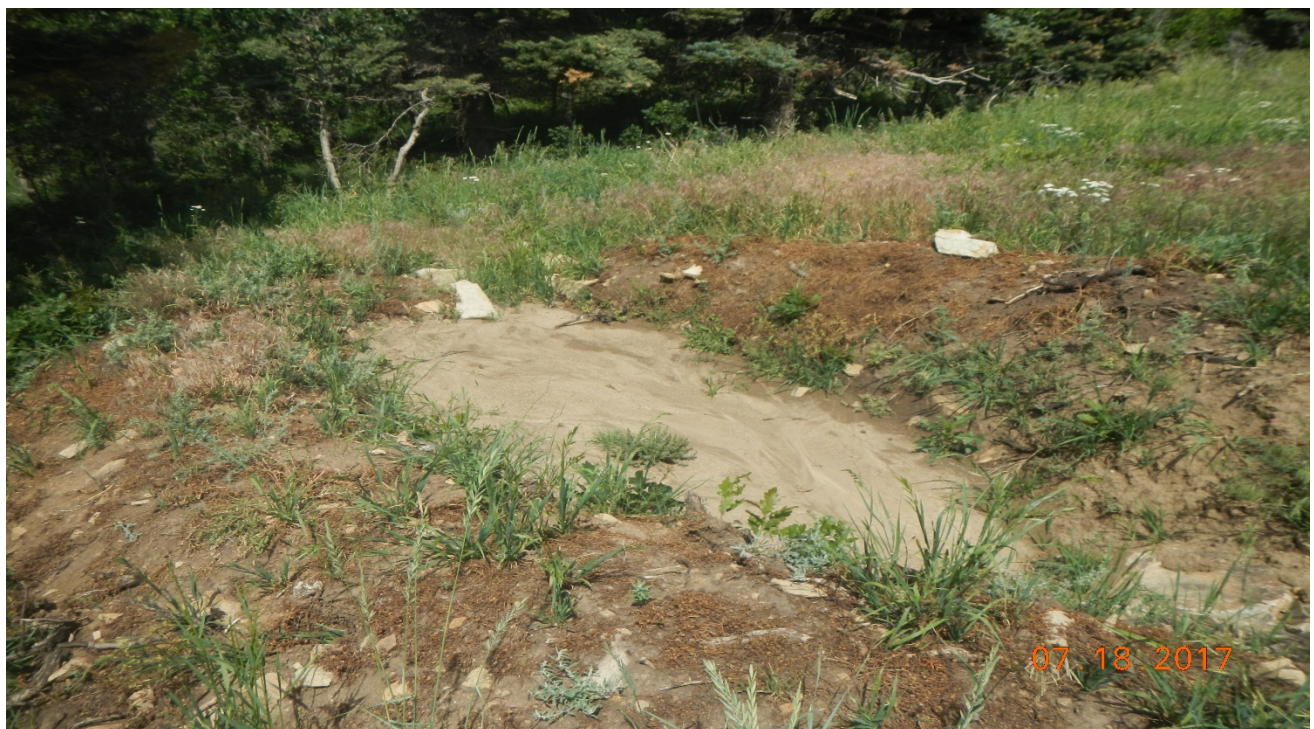
photo 2: The sediment trap has filled in with sediment and needs to be maintained.

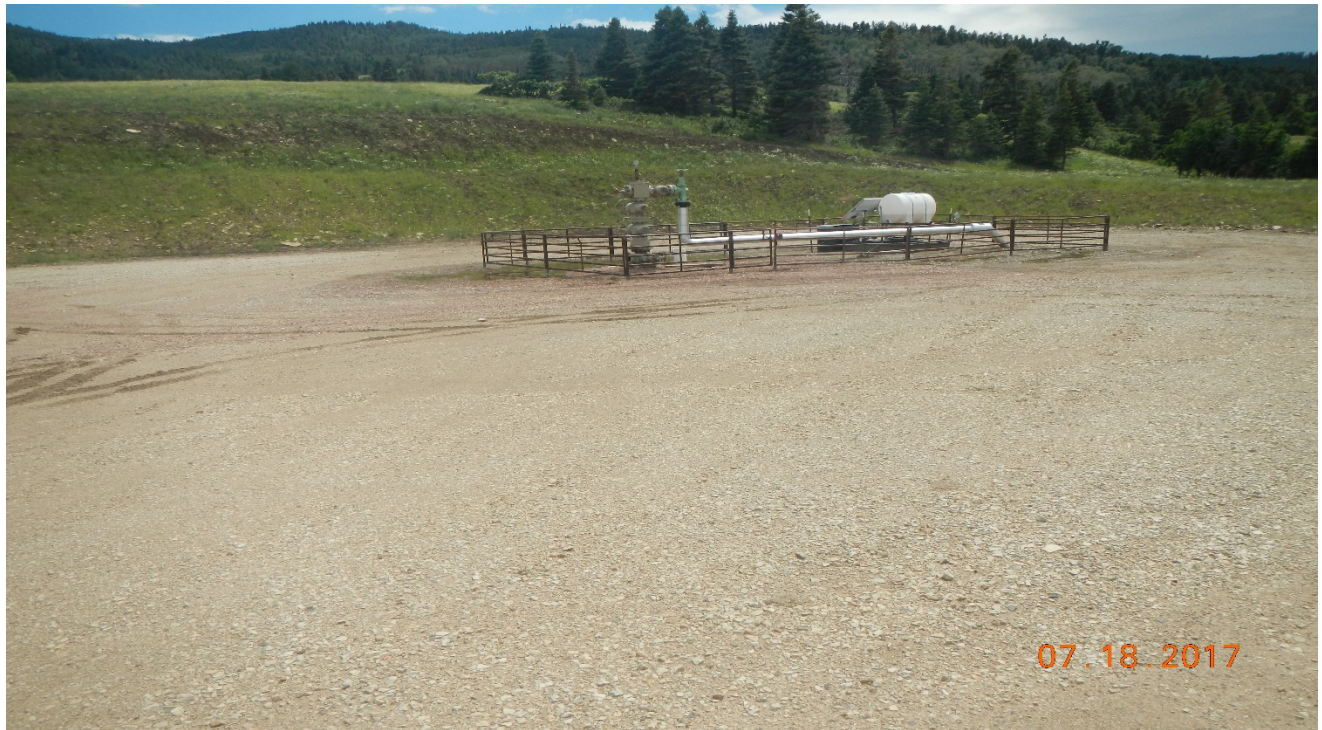
photo 3: Facing southwest toward the location.

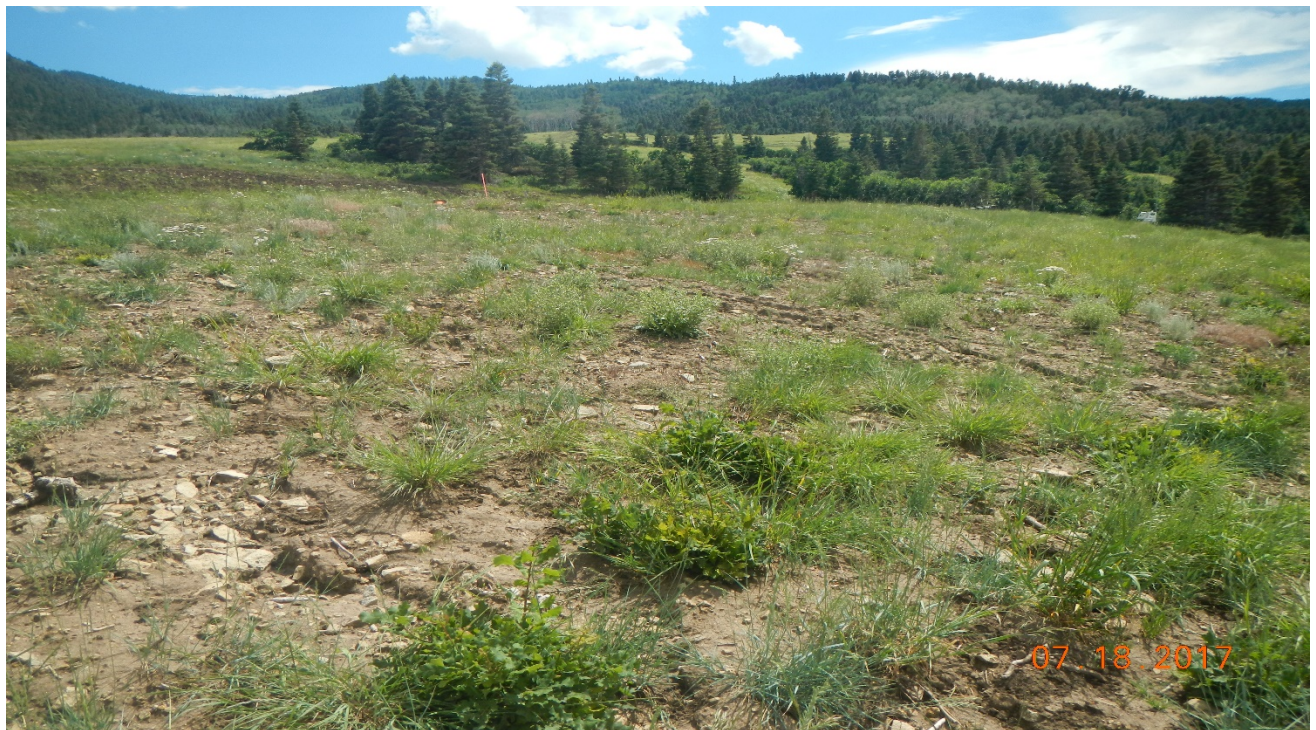
photo 4: Facing southwest along the fill slope of the location.

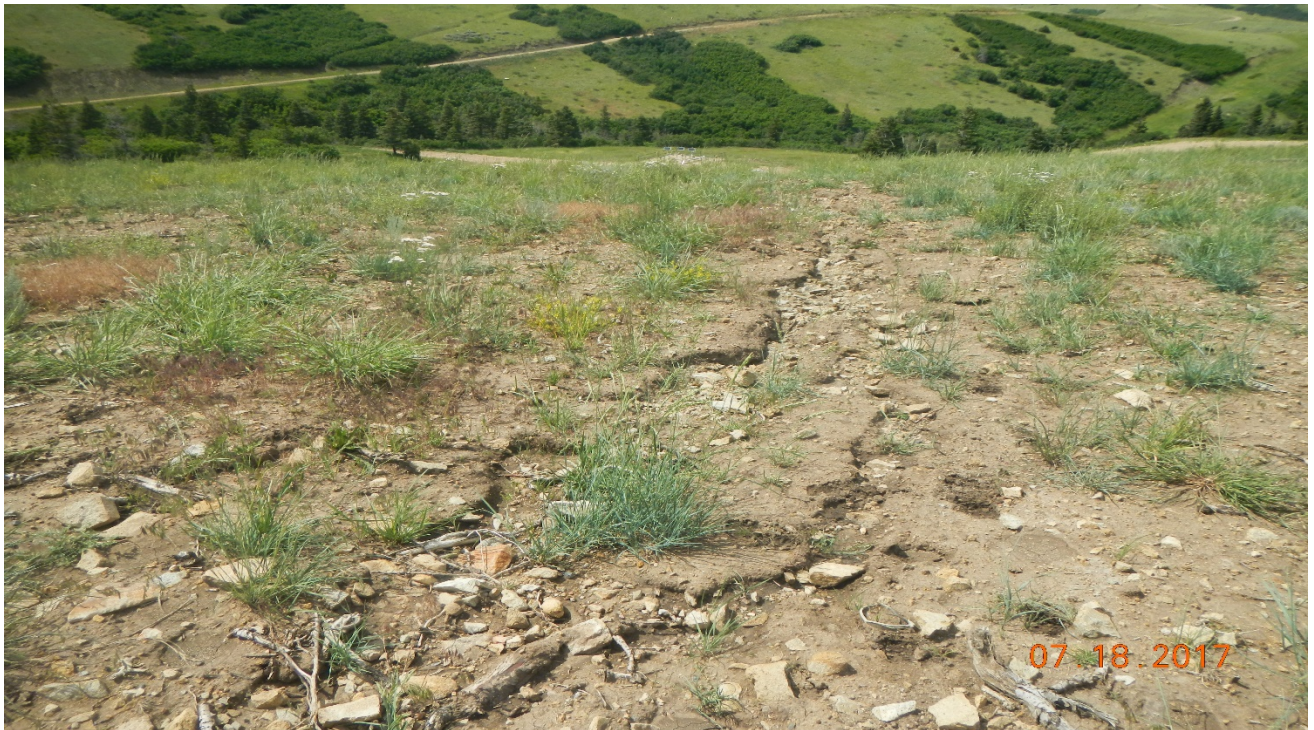
photo 5: There are areas along the northeast side where erosion is occurring.

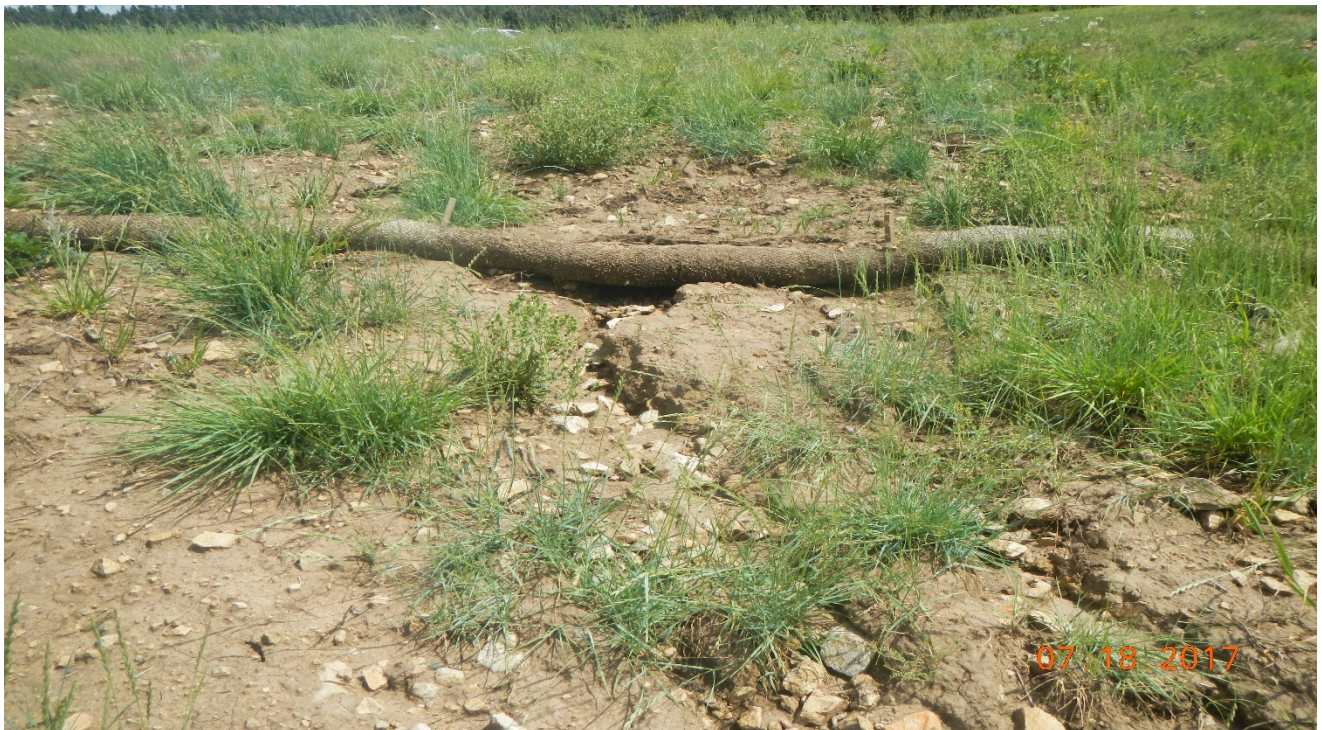
photo 6: Stormwater is flowing underneath the wattle causing erosion.

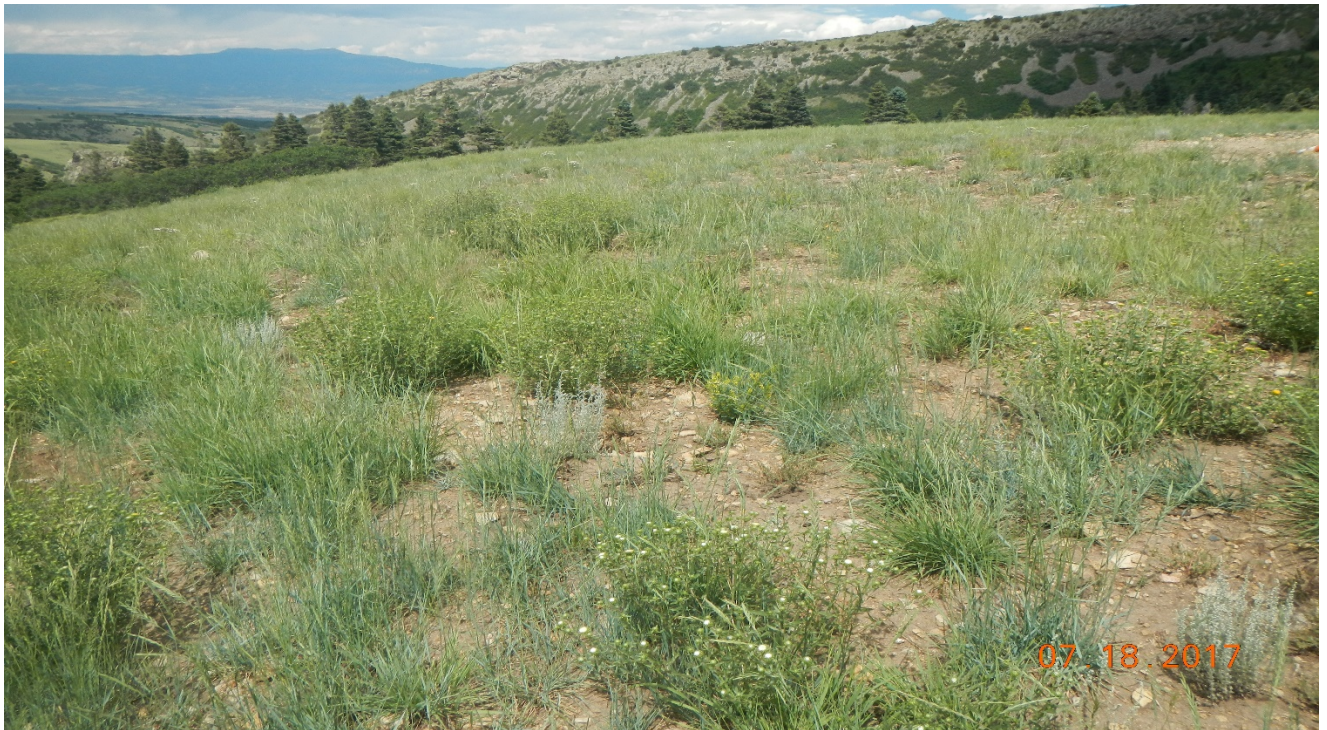
photo 7: Facing northeast along the fill slope. The vegetation has established well in this area.

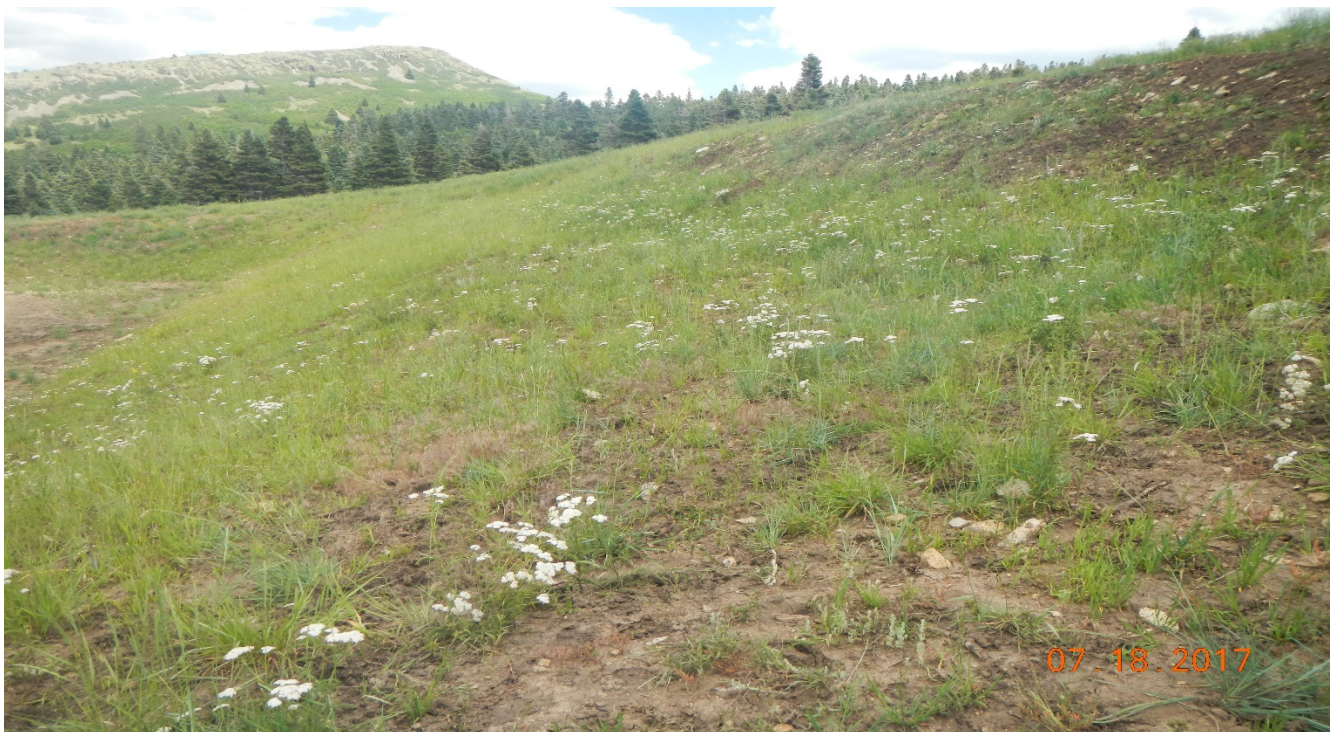
photo 8: Facing southwest toward the cut slope. The vegetation has established well in this area
