Inspection Photos
Location Name: Federal Goshawk 28-13
API: 05-123-22634

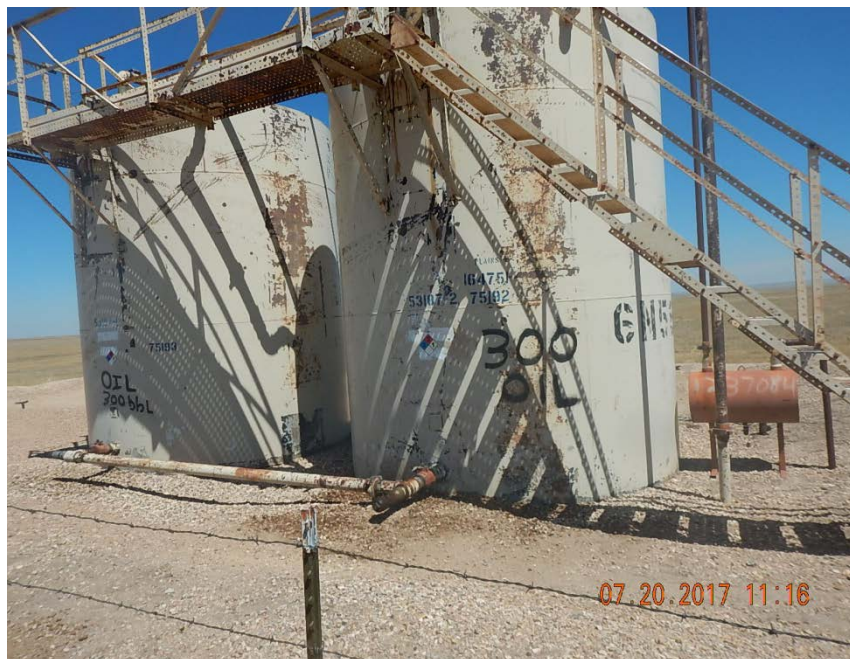
Photo 1: Tanks are rusted

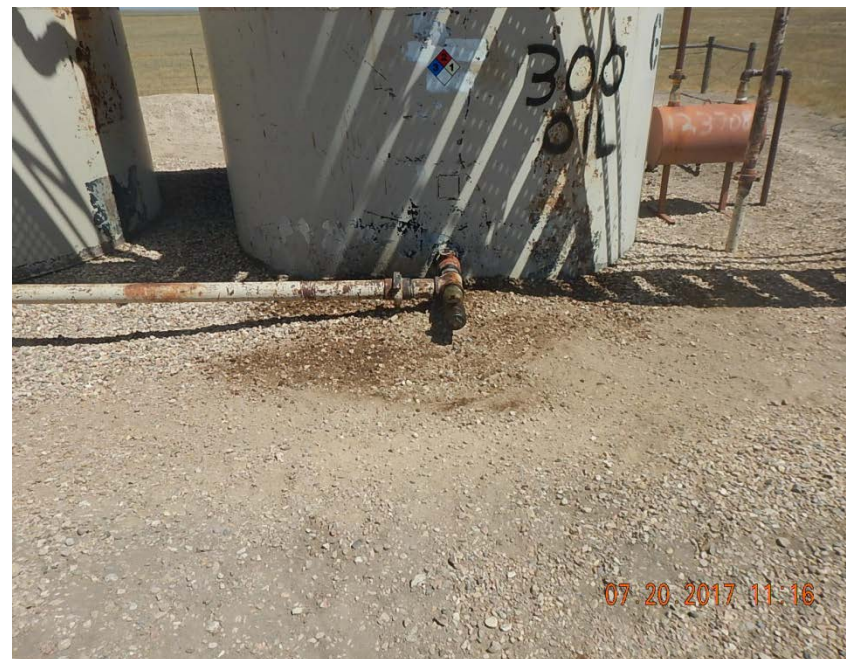
Photo 2: Stained soil at loadout

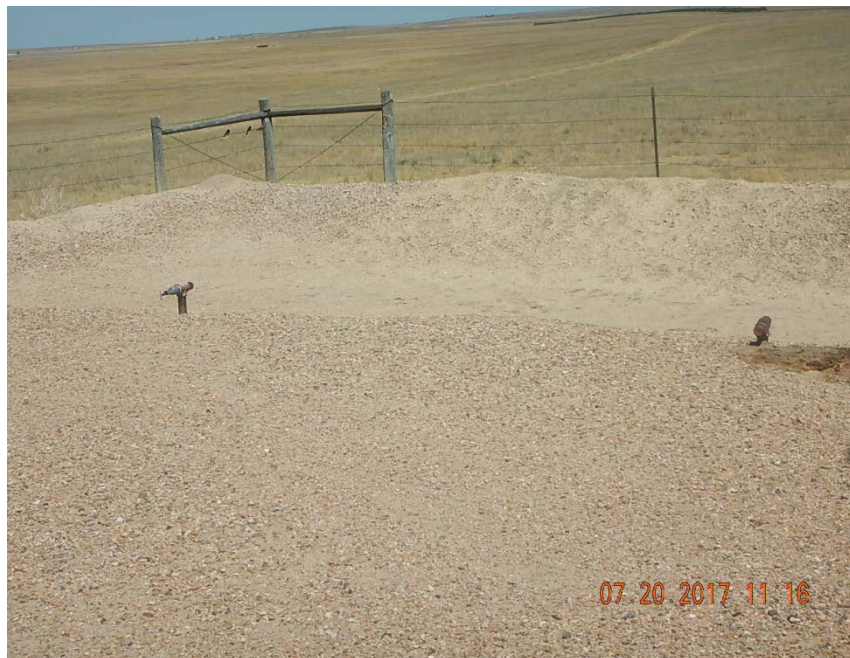
Photo 3: Stained soil at riser. Two risers on W side of tank battery.

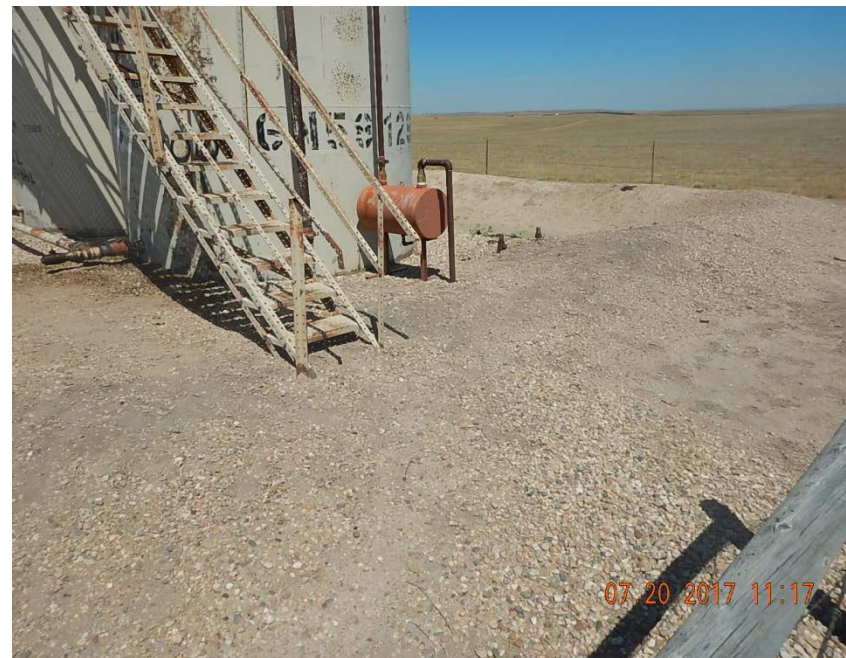
Photo 4: Two risers on E side of tank battery

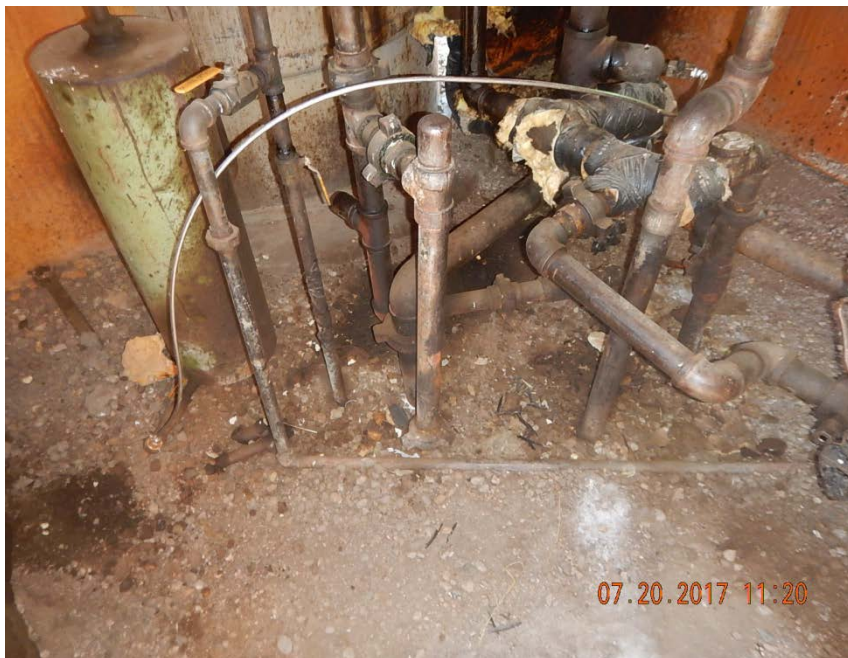
Photo 5: Stained soil in treater house

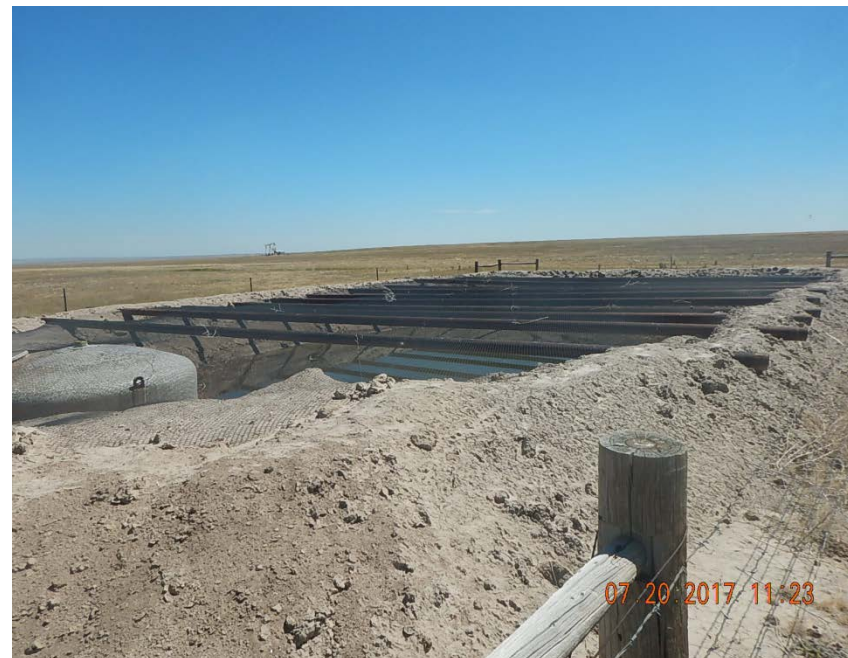
Photo 6: Unpermitted pit

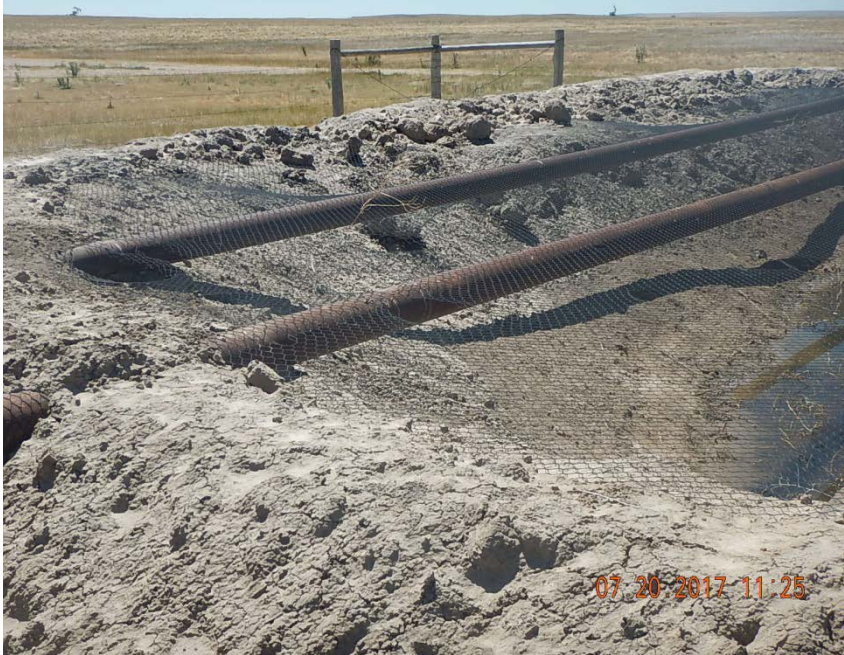
Photo 7: Holes in netting

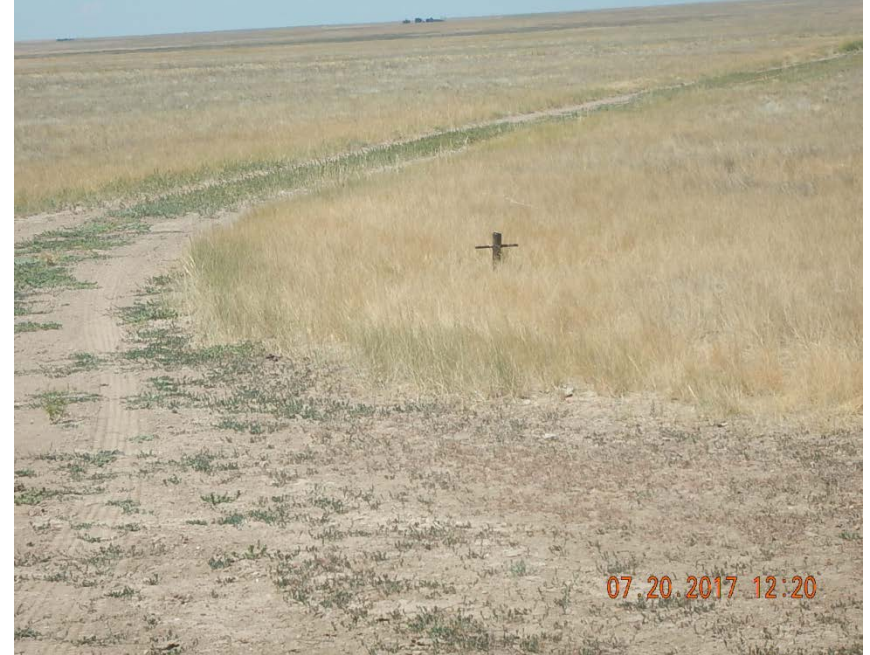
Photo 8: Unmarked deadman

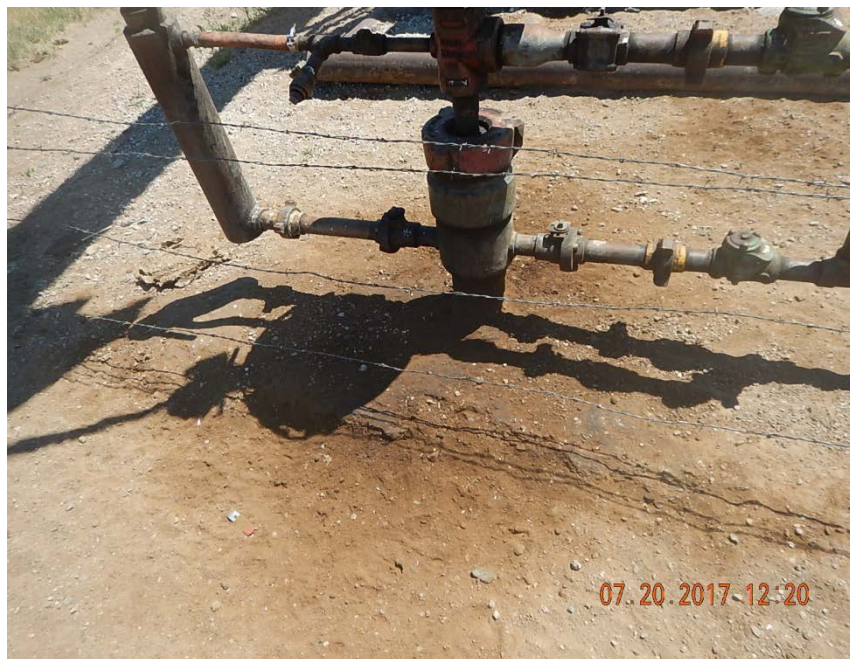
Photo 9: Stained soil at wellhead. No bradenhead at surface.

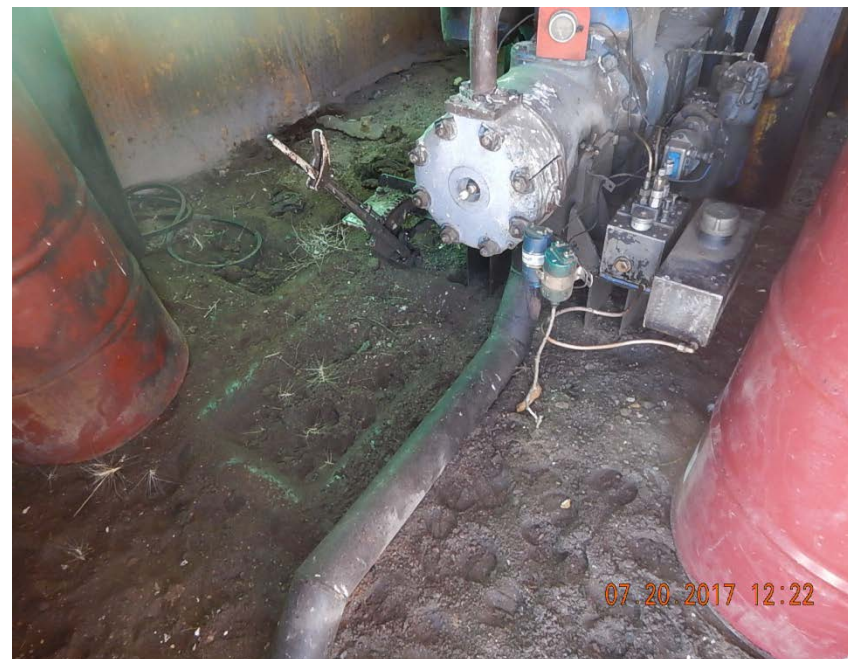
Photo 10: Stained soil in engine house.
