Inspection Photos

7/20/2017

Operator: PDC ENERGY INC - 69175

Location ID: 323128

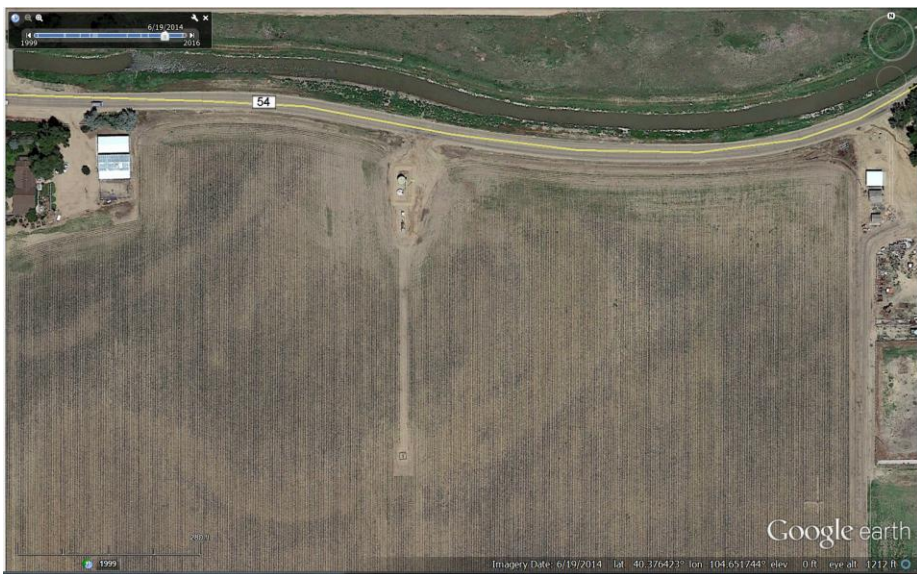
Photo 1: 2014 aerial imagery. Photo shows well and tank battery prior to plugging and abandonment.

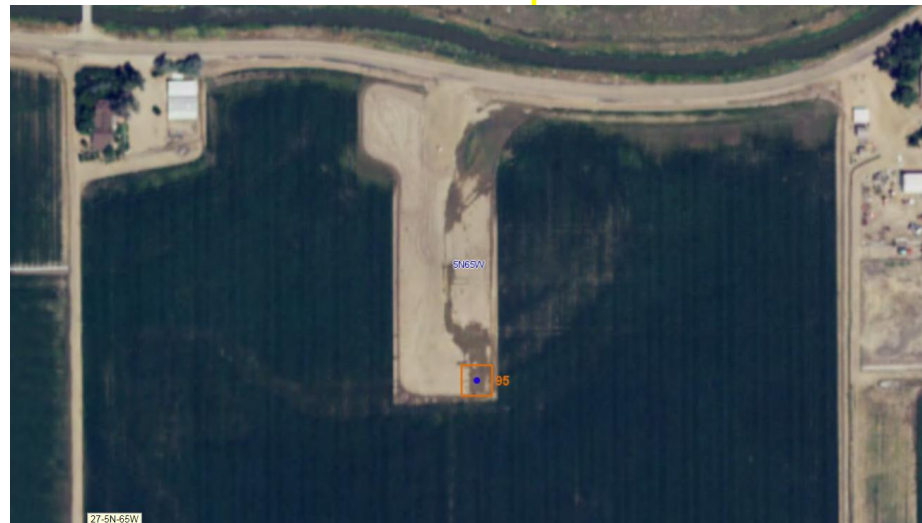
Photo 2: 2015 aerial imagery. Photo shows equipment has been removed and the extent of the disturbance due to plugging and abandonment.

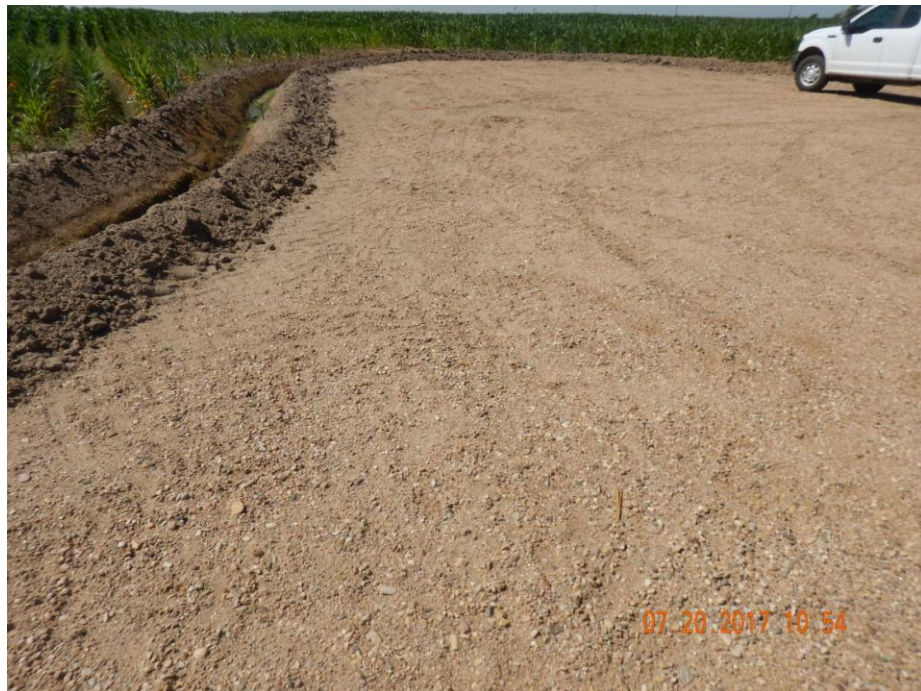
Photo 3: Photo taken from the northeast corner of the tank battery location, facing south. Photo shows tank battery location has not been reclaimed.

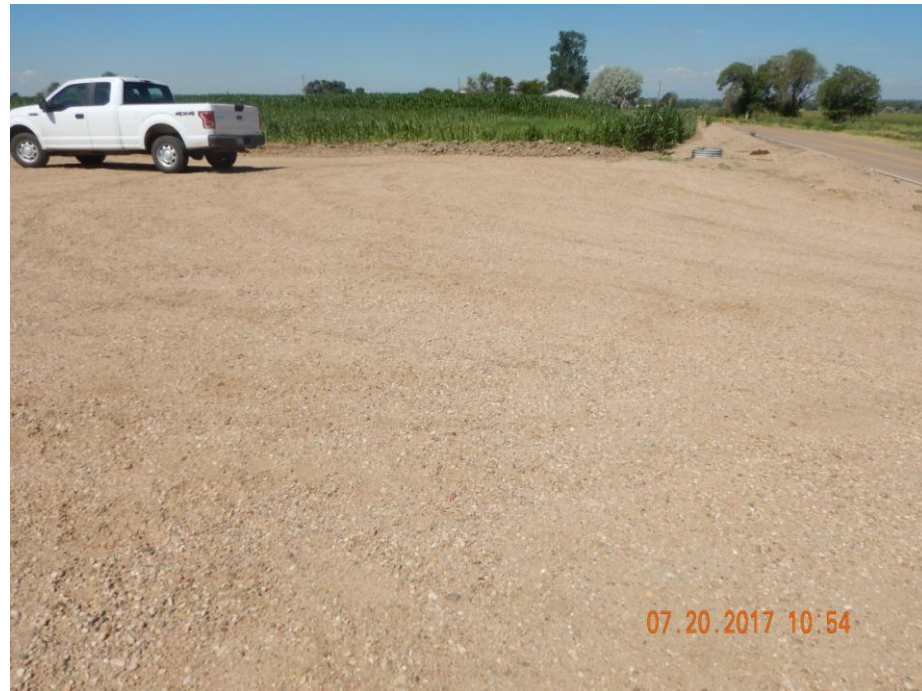
Photo 4: Photo taken from the northeast corner of the tank battery location, facing west. Photo shows tank battery location has not been reclaimed.

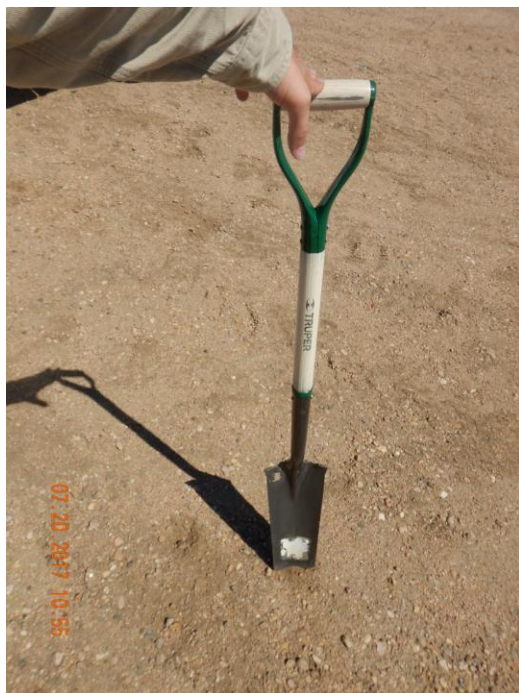
Photo 5: Photo taken from the tank battery location. Inspector made attempts to conduct a soil pit to test for compaction concerns. Inspector was unable to dig more than a couple inches. Location has not had compaction alleviation.

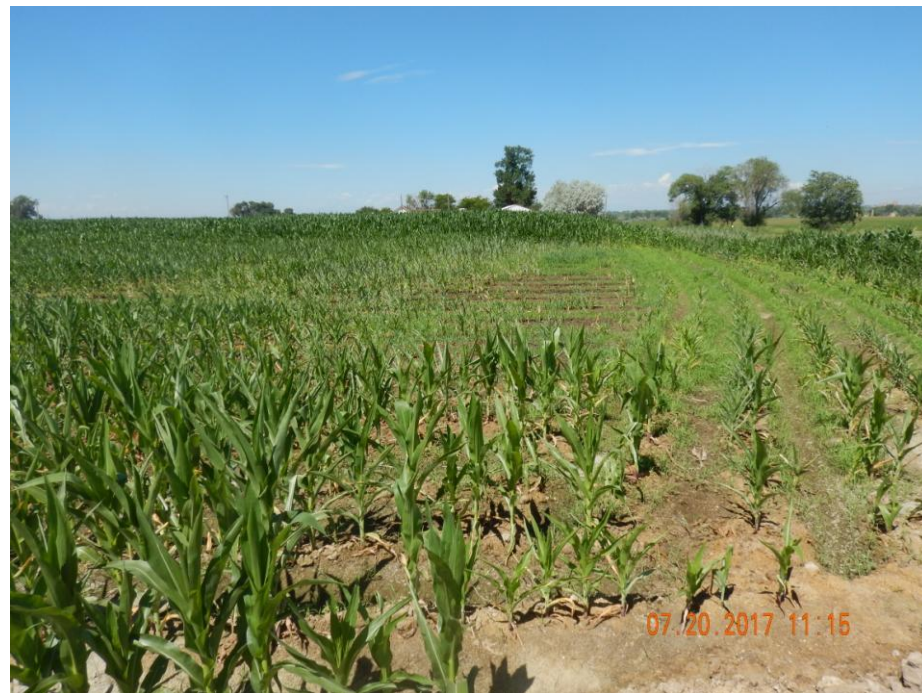
Photo 6: Photo taken from the west end of the battery location, facing east. Photo shows crop over the disturbance area is significantly stunted when compared to the reference (photo 14). Disturbed areas will require additional reclamation work conducted.

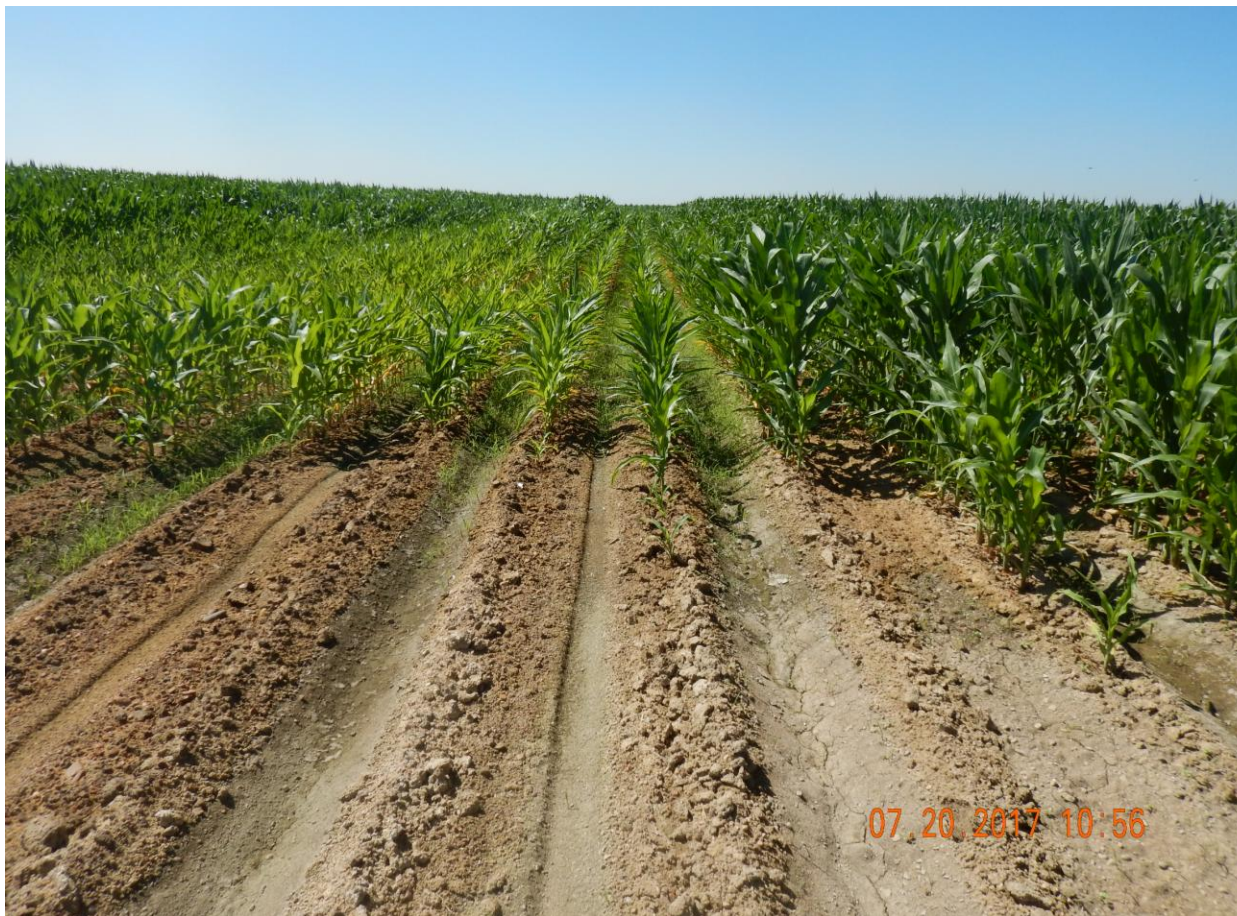
Photo 7: Photo taken from the well location. Photo shows crop at well appears uniform. 6 foot measuring stick for reference.

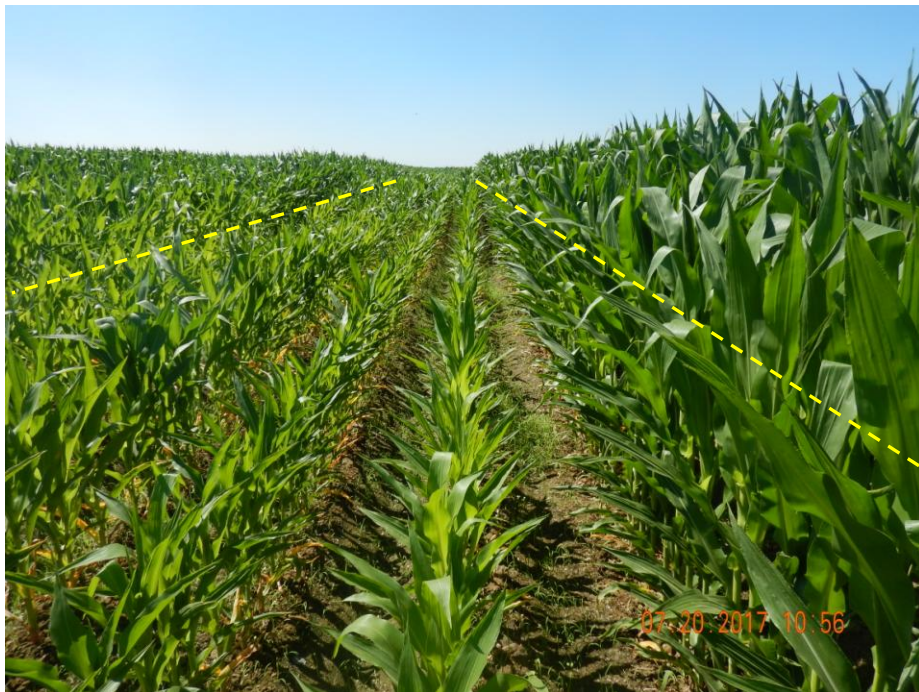
Photo 8: Photo taken from the access road, facing south. Photo shows vegetation along access road (yellow line) is stunted when compared to that or the reference area.

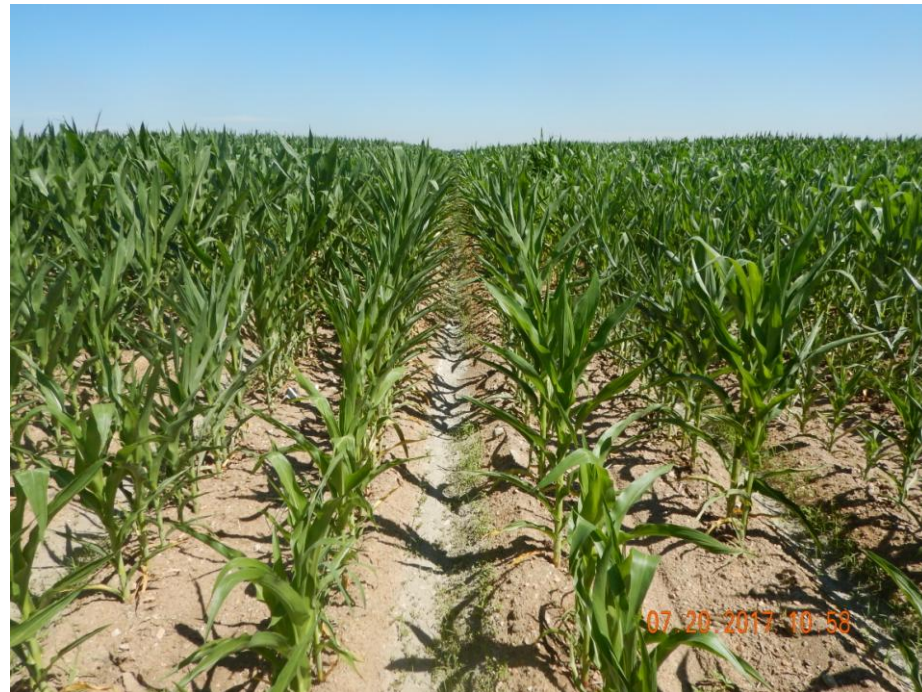
Photo 9: Photo taken from the well location, facing north. Photo shows crop vegetation over the well location is stunted when compared to the reference area.

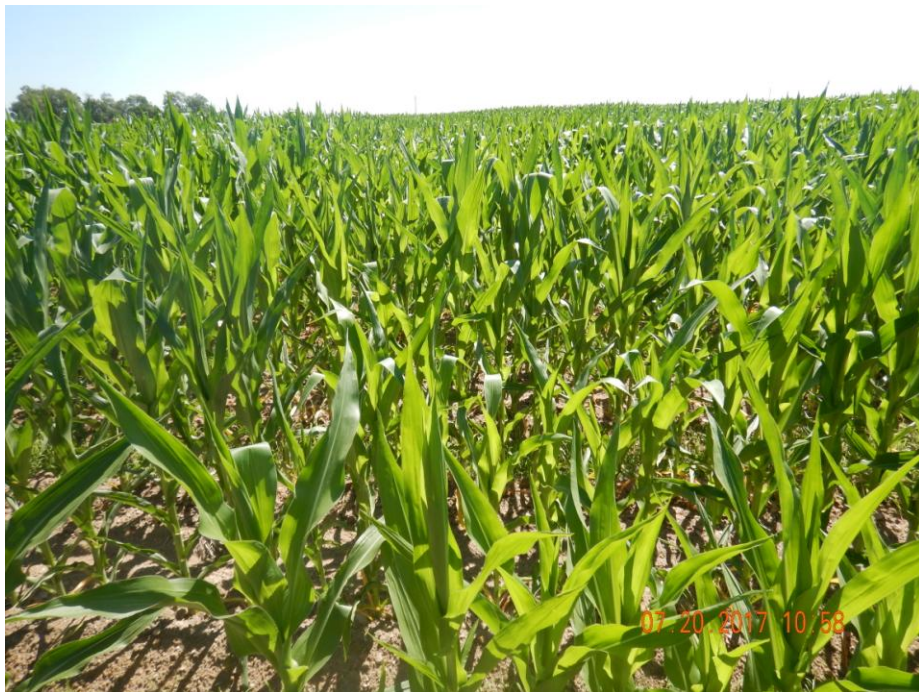
Photo 10: Photo taken from the well location, facing east. Photo shows crop vegetation over the well location is stunted when compared to the reference area.

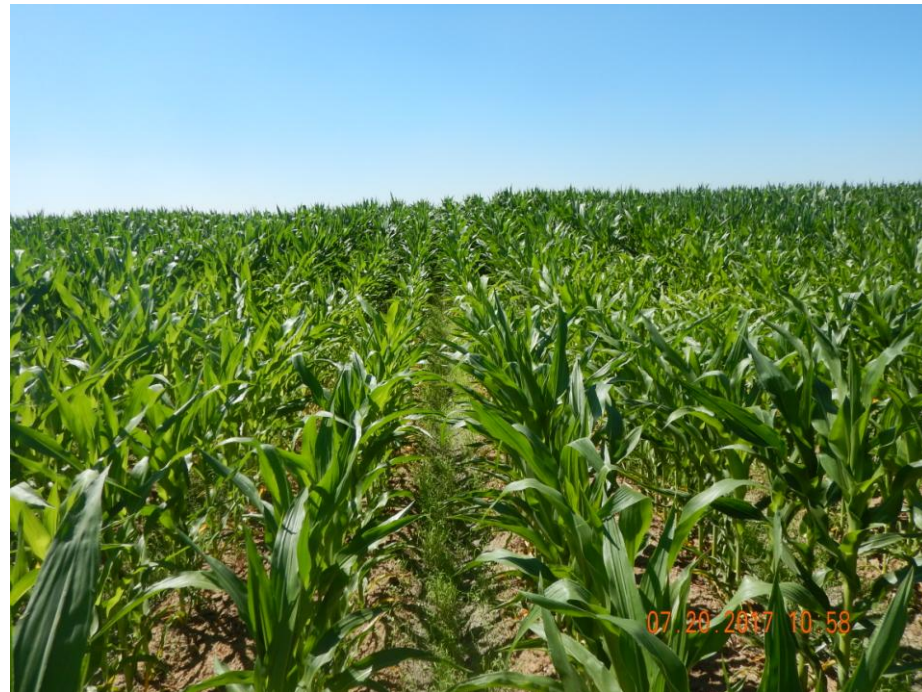
Photo 11: Photo taken from the well location, facing south. Photo shows crop vegetation over the well location is stunted when compared to the reference area.

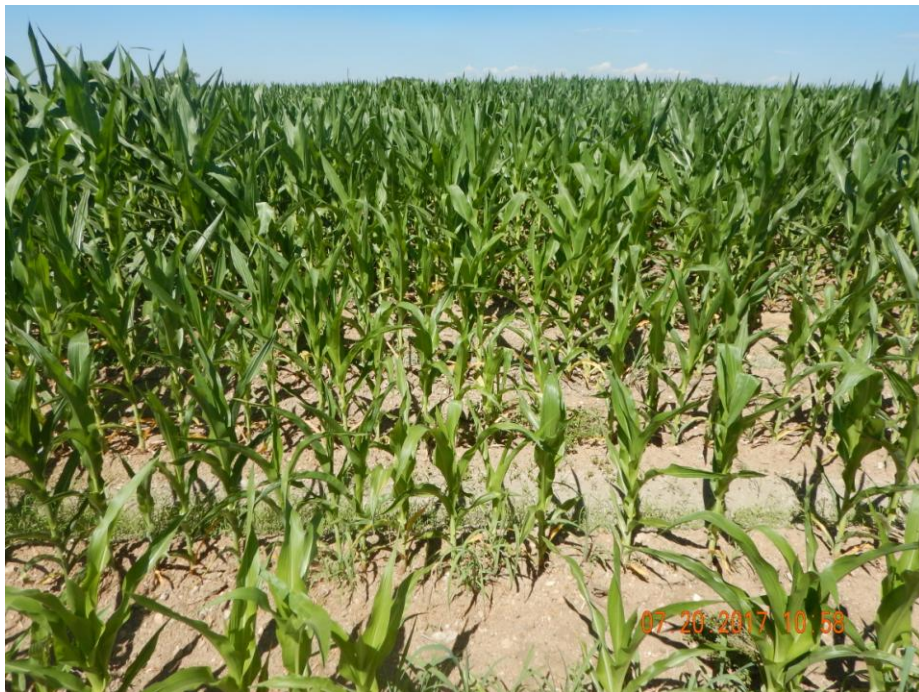
Photo 12: Photo taken from the well location, facing west. Photo shows crop vegetation over the well location is stunted when compared to the reference area.

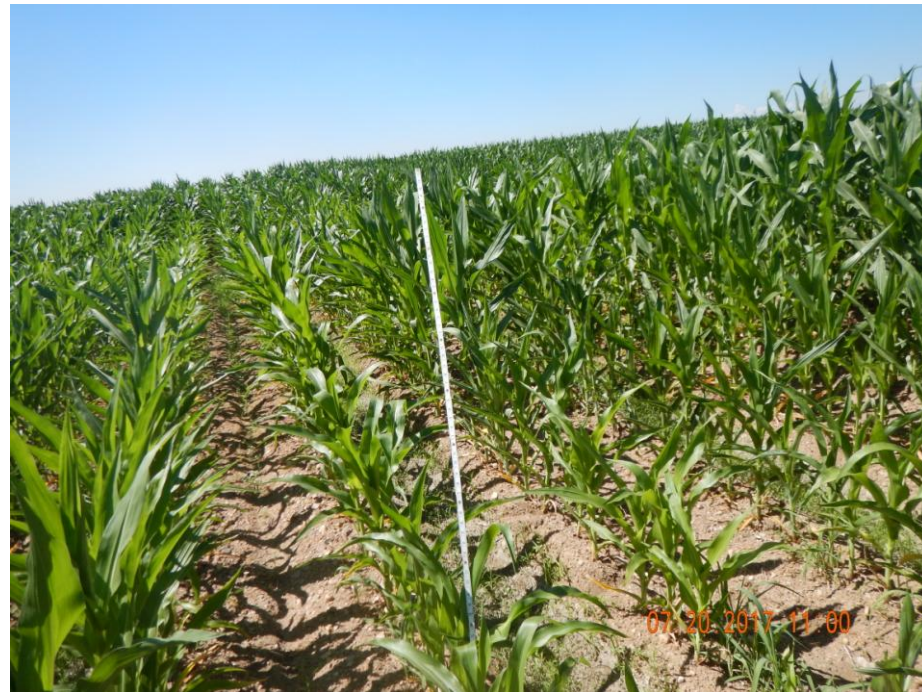
Photo 13: Photo shows of crop vegetation over the well location compared to a 6 foot measuring stick. Vegetation over the well location was ~2 feet in height.

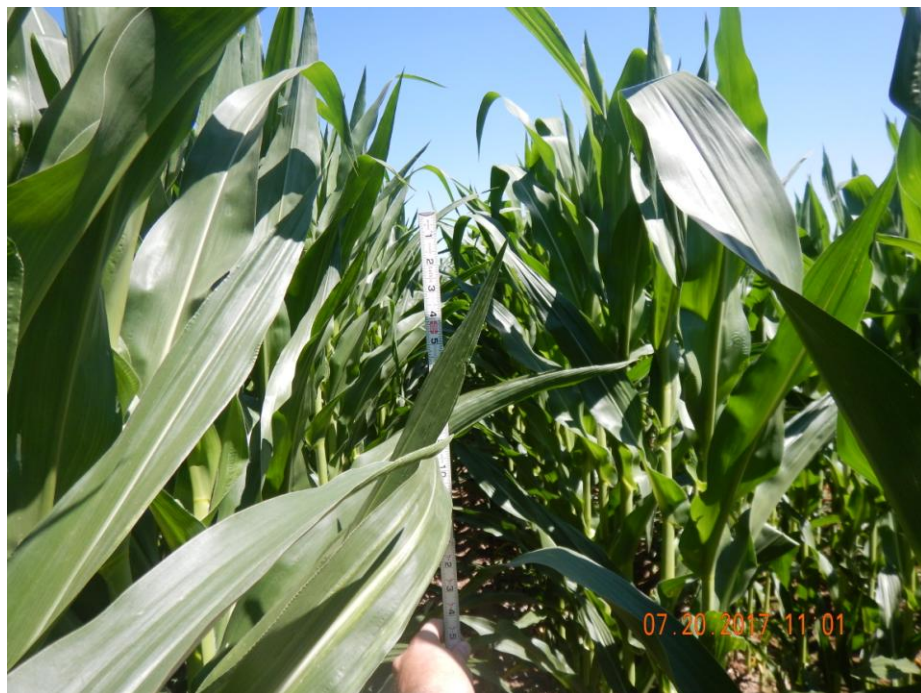
Photo 14: Photo taken from the reference area. 6 foot measuring stick for reference. Crop over the reference area >6 feet in height

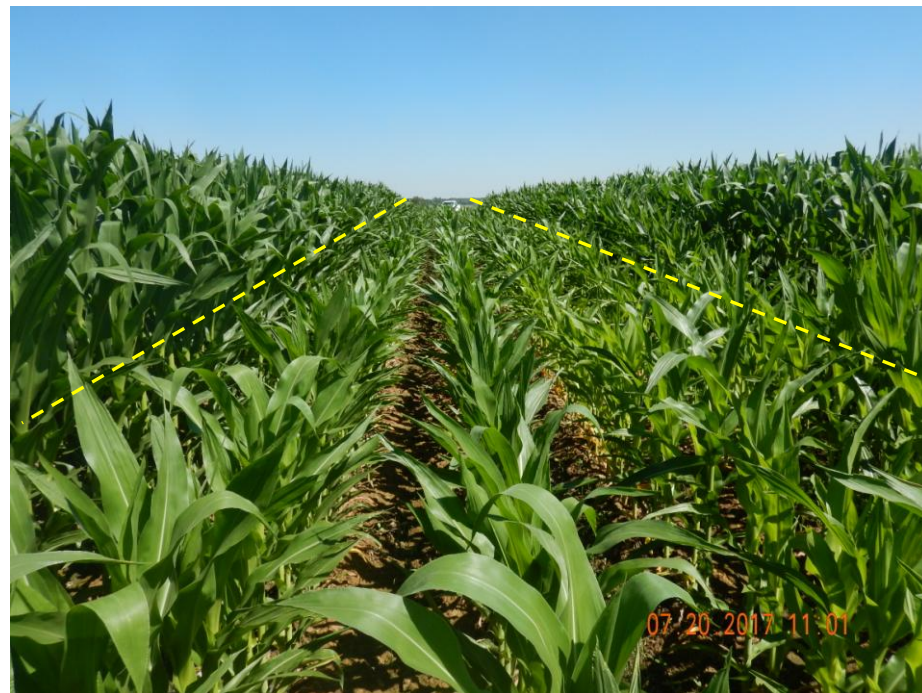
Photo 15: Photo taken from the well location, facing north. Photo shows crop vegetation over the access road is stunted when compared to that of the reference area.
