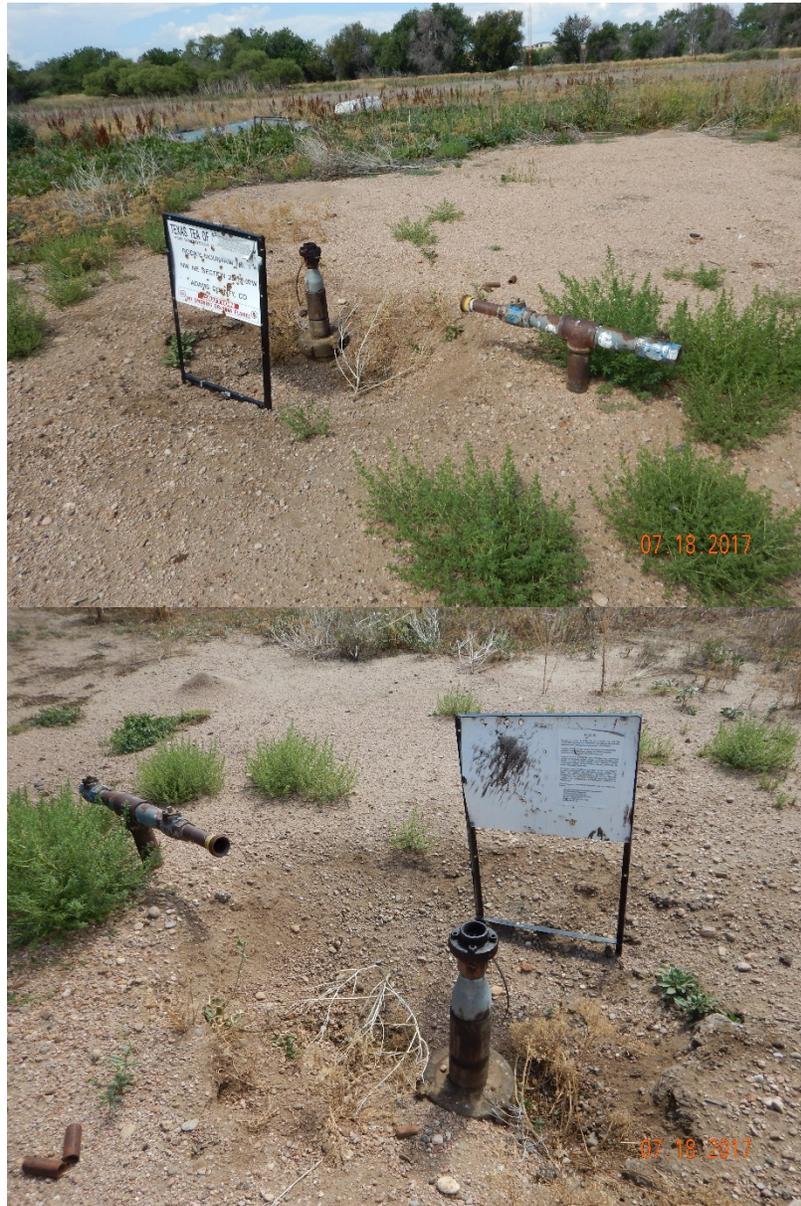
*Figure 1 - Rocky Mountain II 1 wellhead sign, wellhead, and flowline riser. Note: flowline riser is neither capped, painted, nor tagged (as required by 2017 Flowline NTO). Both wellhead and flowline are open to atmosphere and wellhead is sitting in a depression.*

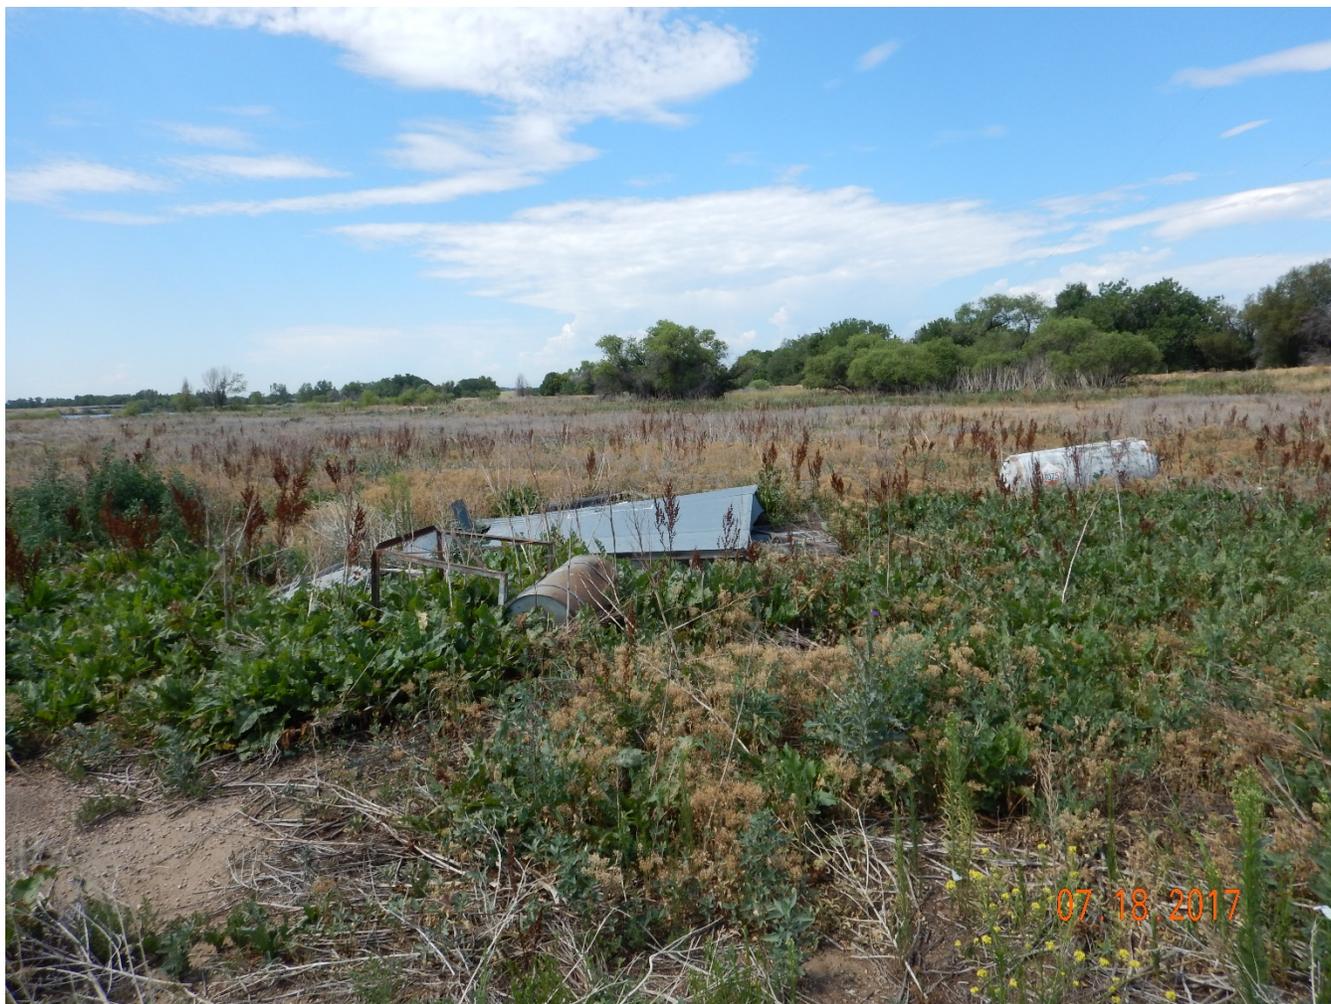
*Figure 2 - Junk and debris located SW of wellhead (abandoned prime mover shed, day tank, propane tank, pipe, assorted junk).*

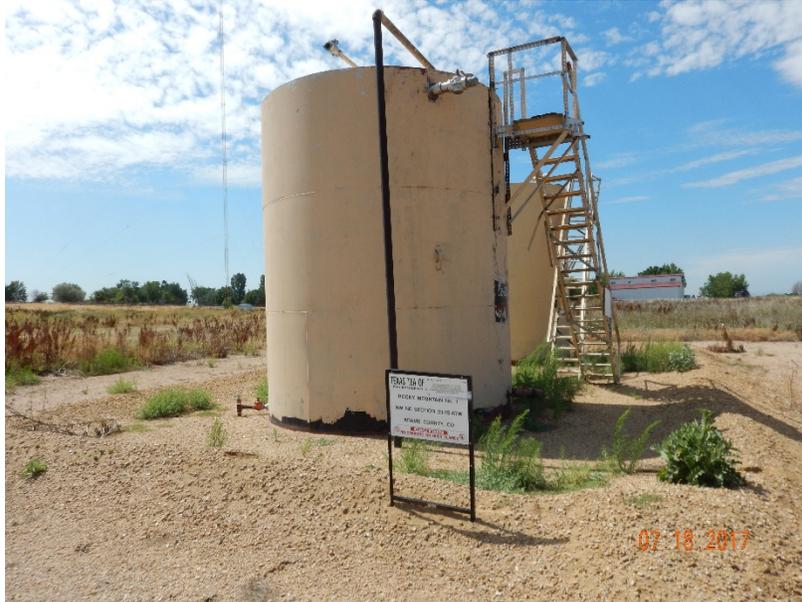
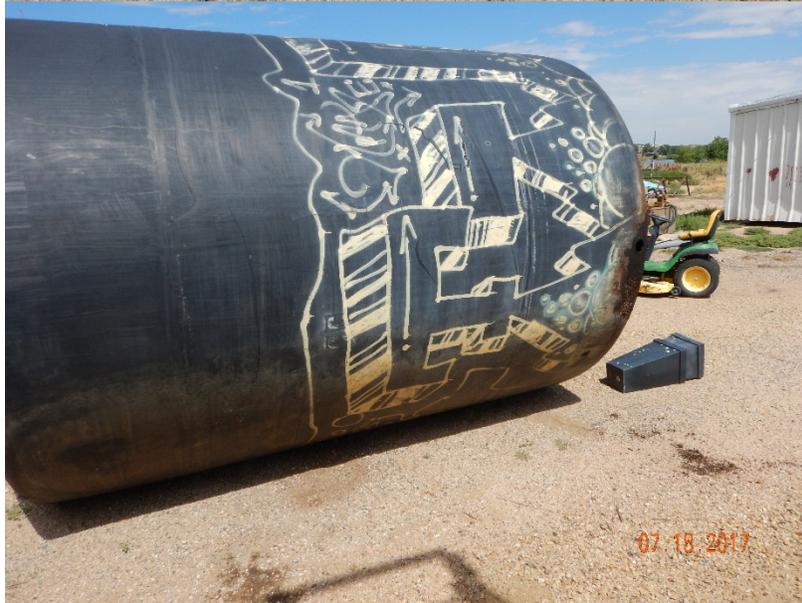
Figure 3 - Tank battery (top) with unused, overturned tank outside of berm (bottom).

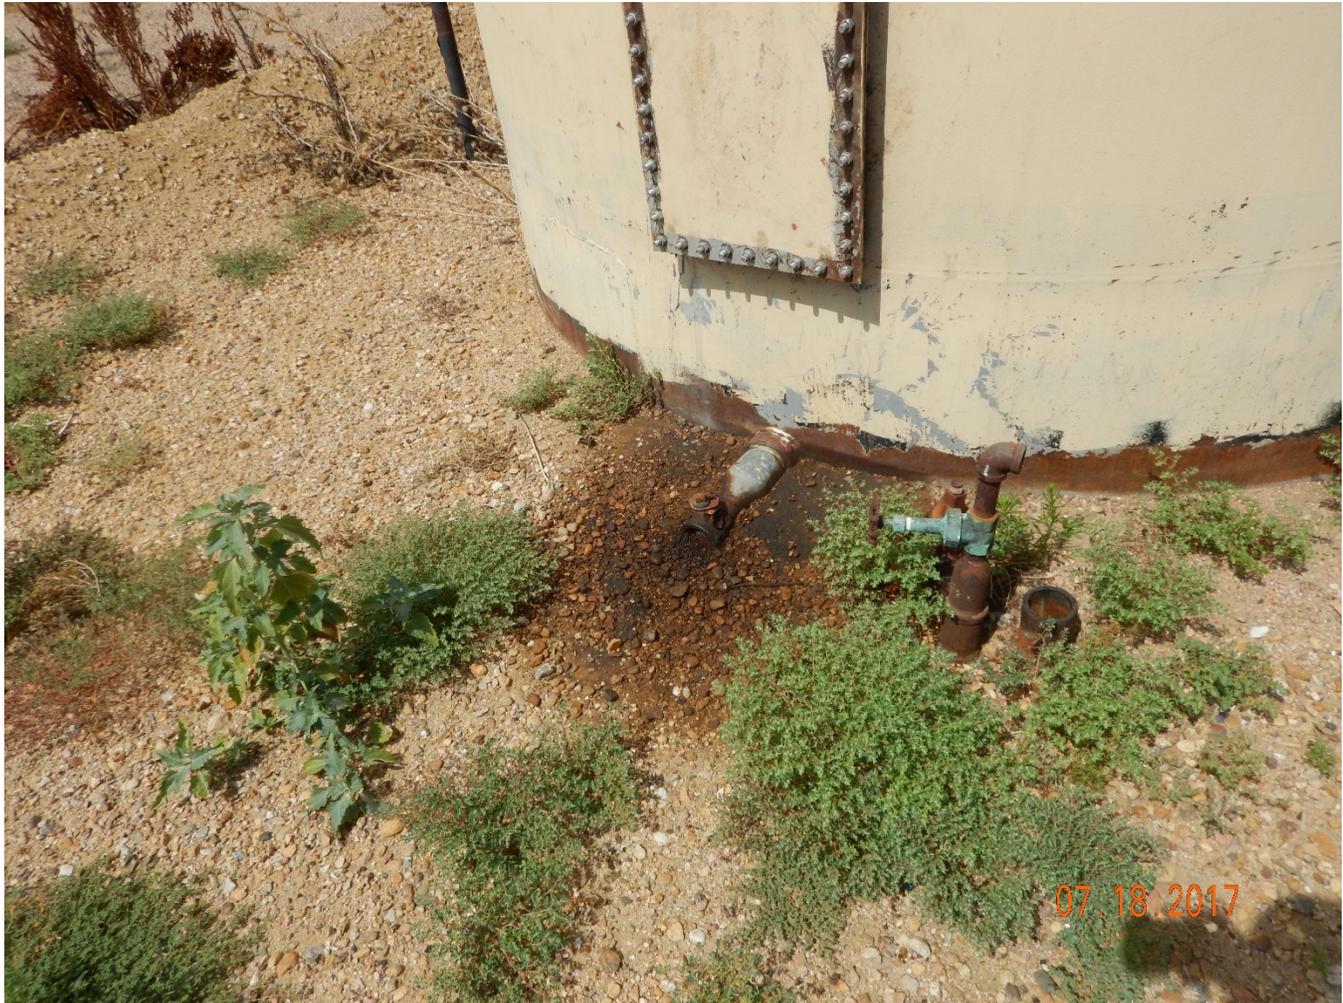
*Figure 4 - Localized, oil-stained soil at south tank.*

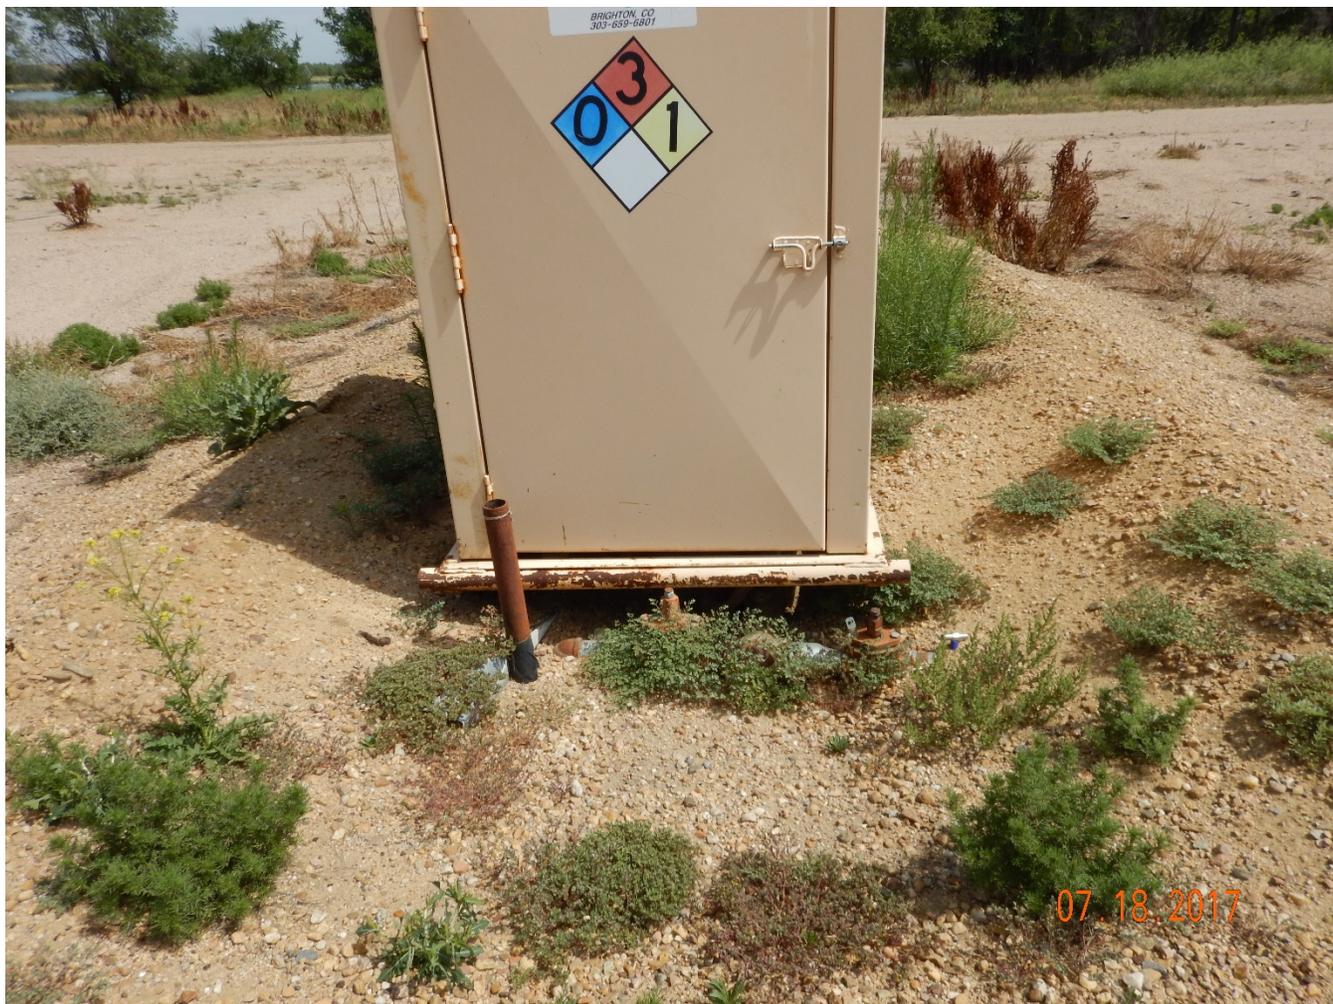
*Figure 5 - Uncapped, unmarked flowline riser at SW corner of separator.*

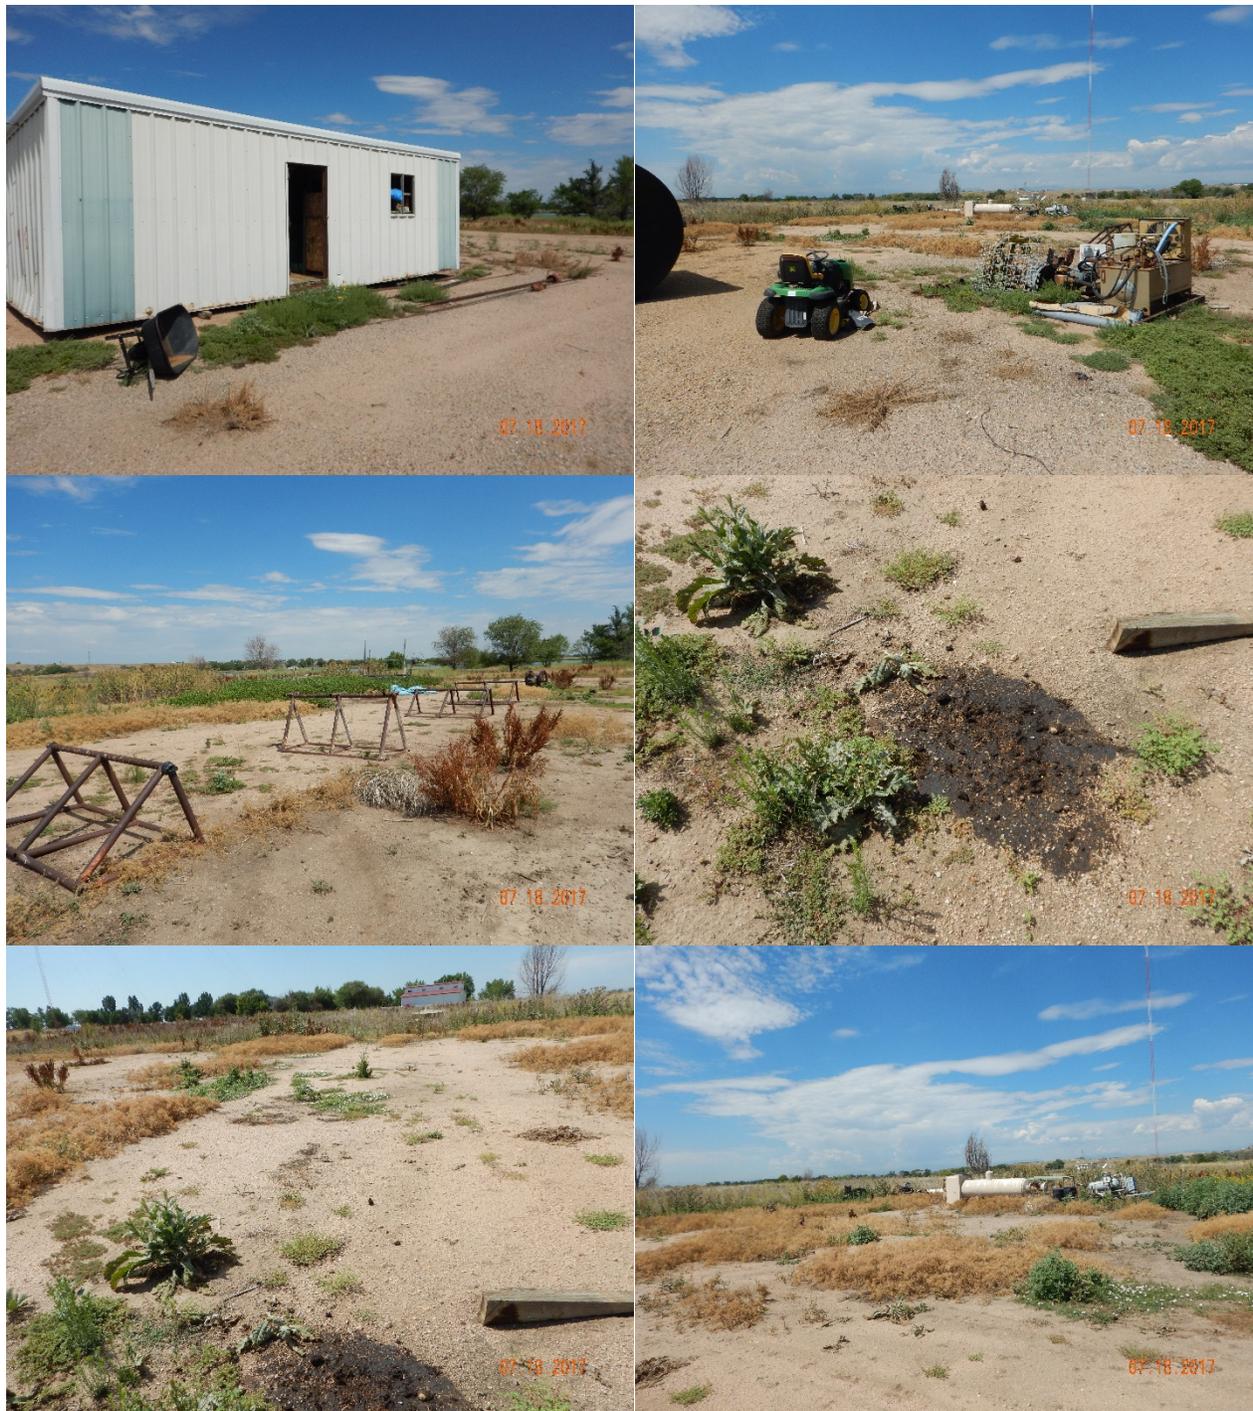
*Figure 6 - Assorted photos of unused equipment, junk, debris, stained soil, and weeds west of tank battery and separator.*
