Inspection Photos
Location Name: Kinder Morgan CX-2
API: 05-083-06720
Inspection Number: 685200360

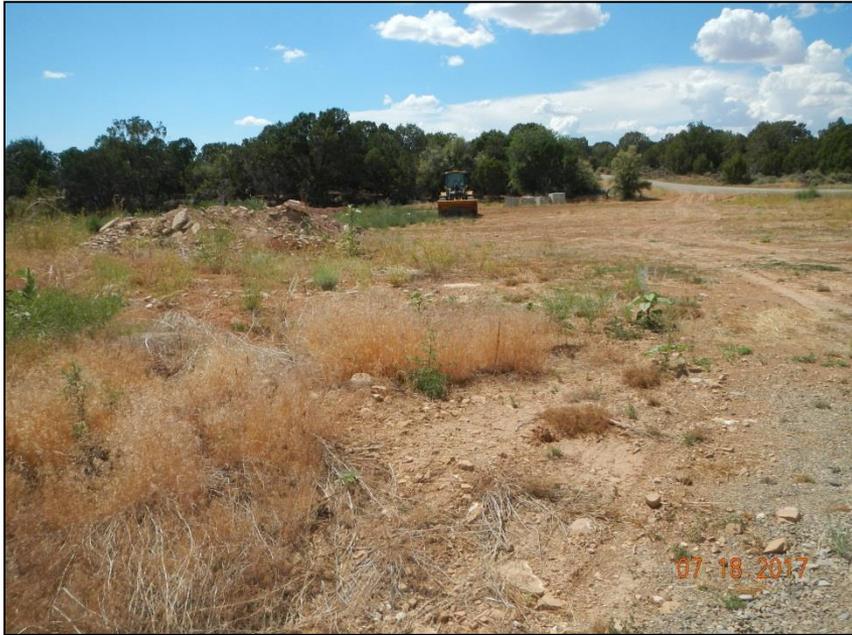
Photo 1. Widened area/filled in drainage/spoil dump along access road

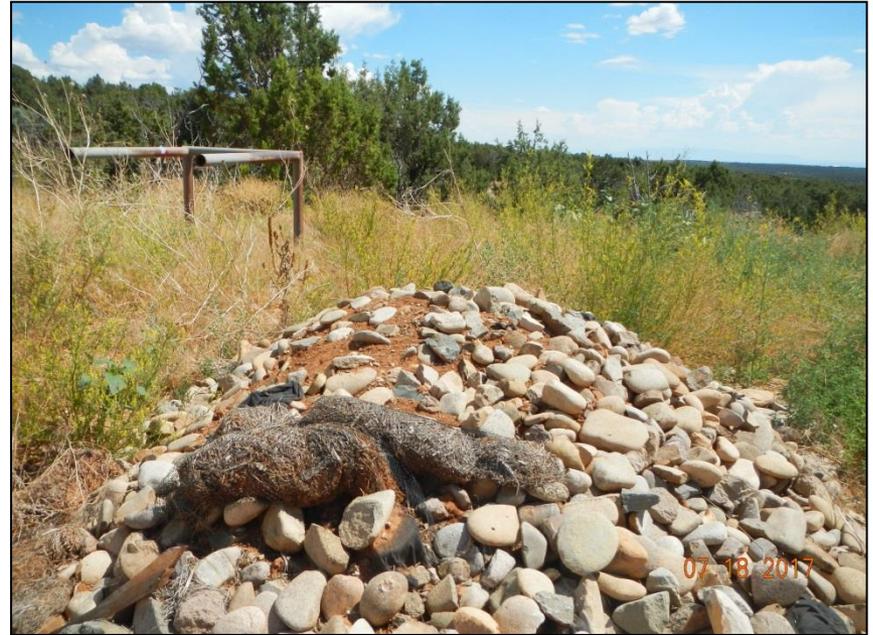
Photo 2. Industrial materials mixed in with spoil piles

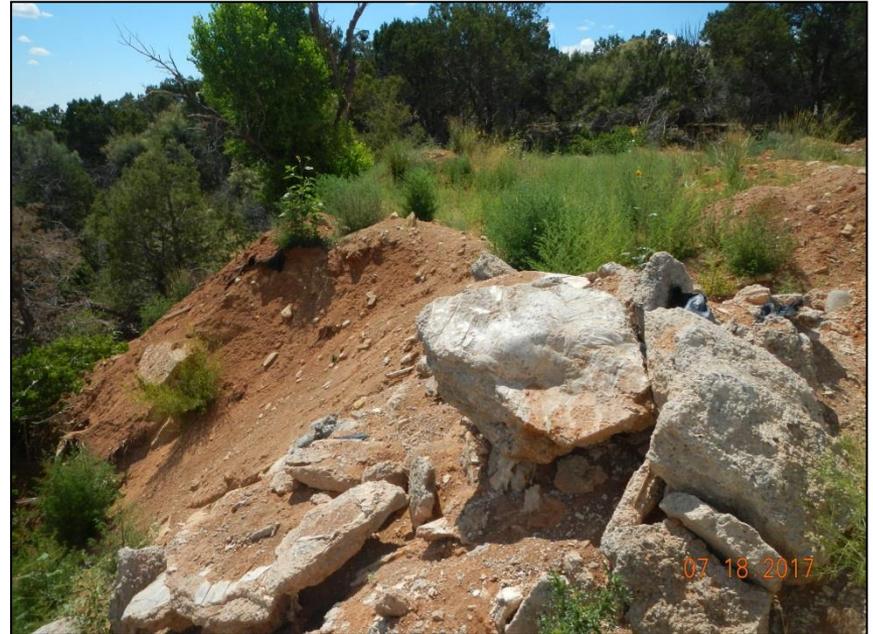
Photo 4. Spoil piles eroding into drainage, no stormwater/sediment controls

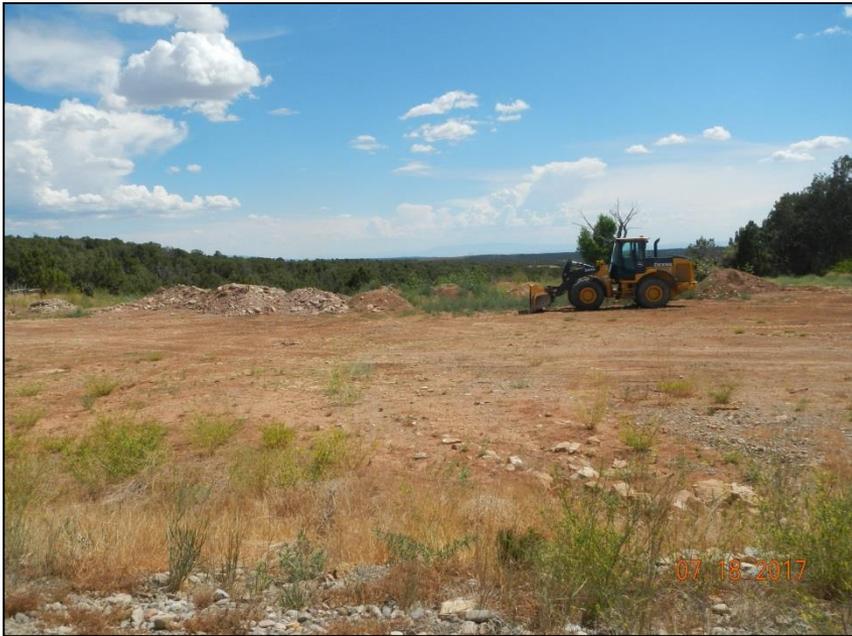
Photo 5. Widened area where drainage has been filled in by dumping spoil and waste materials from unknown origin

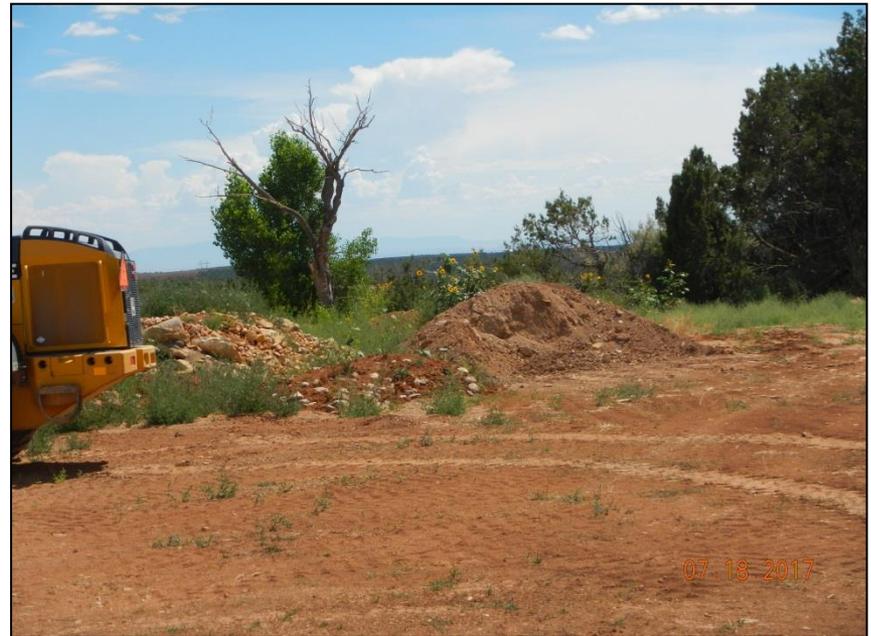
Photo 6. Heavy equipment staged by spoil piles, note recent tire tracks

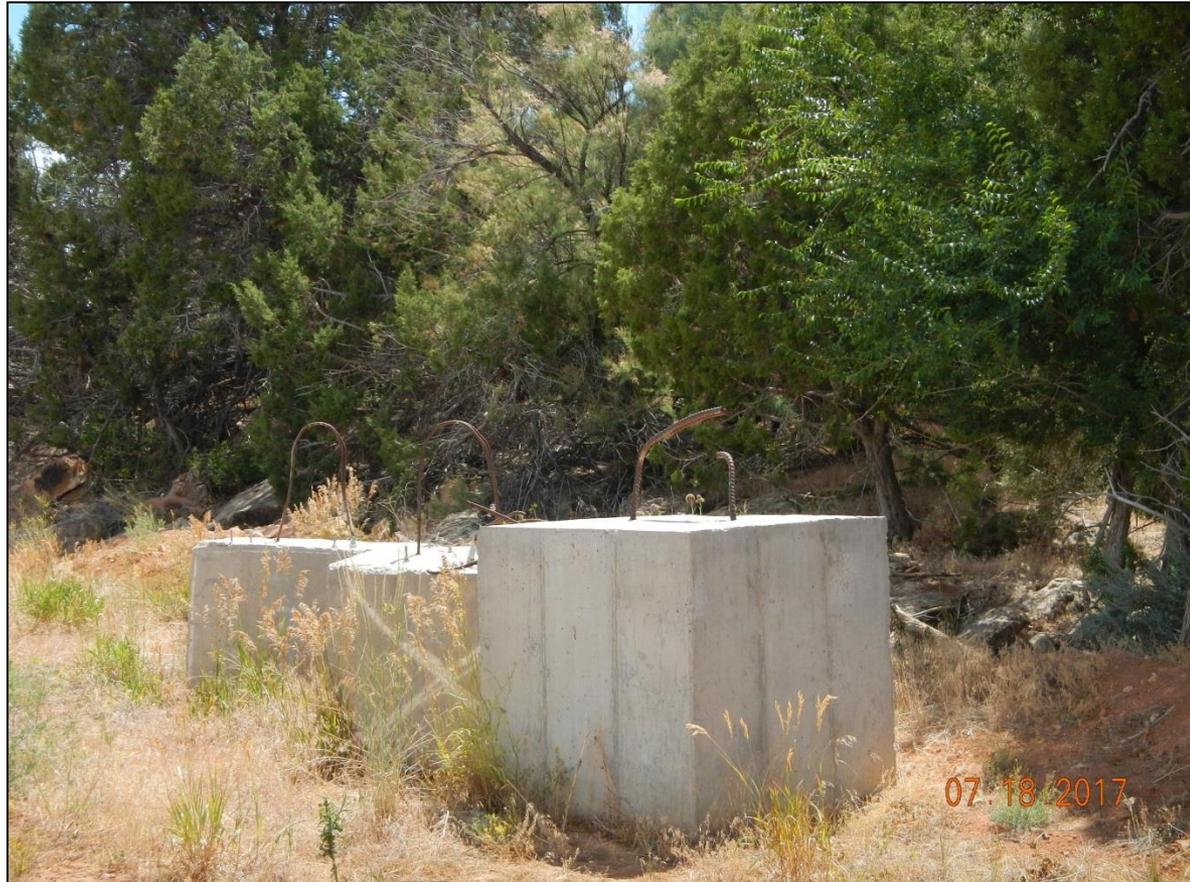
Photo 7. Pored concrete and rebar blocks on edge of staging area

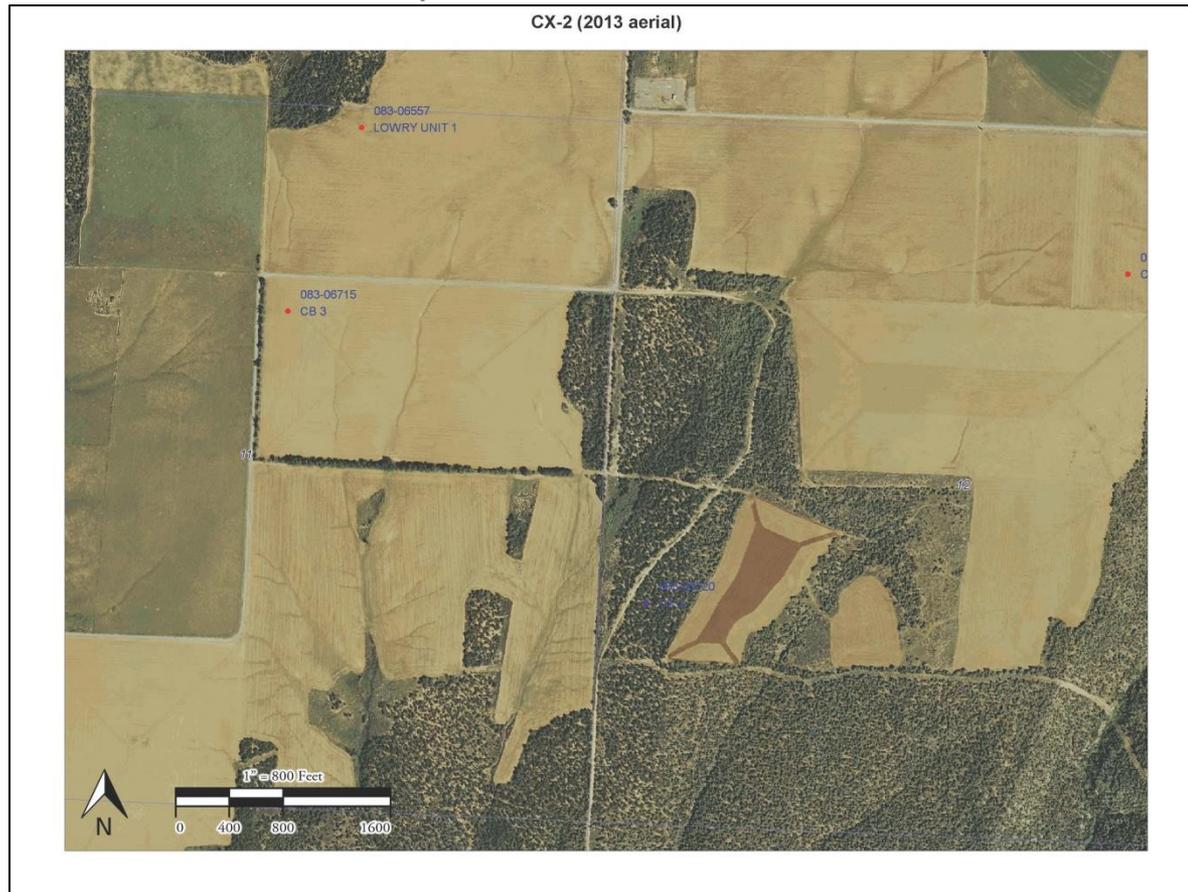
Photo 7. 2013 aerial of project area and existing road prior to CX-2 construction

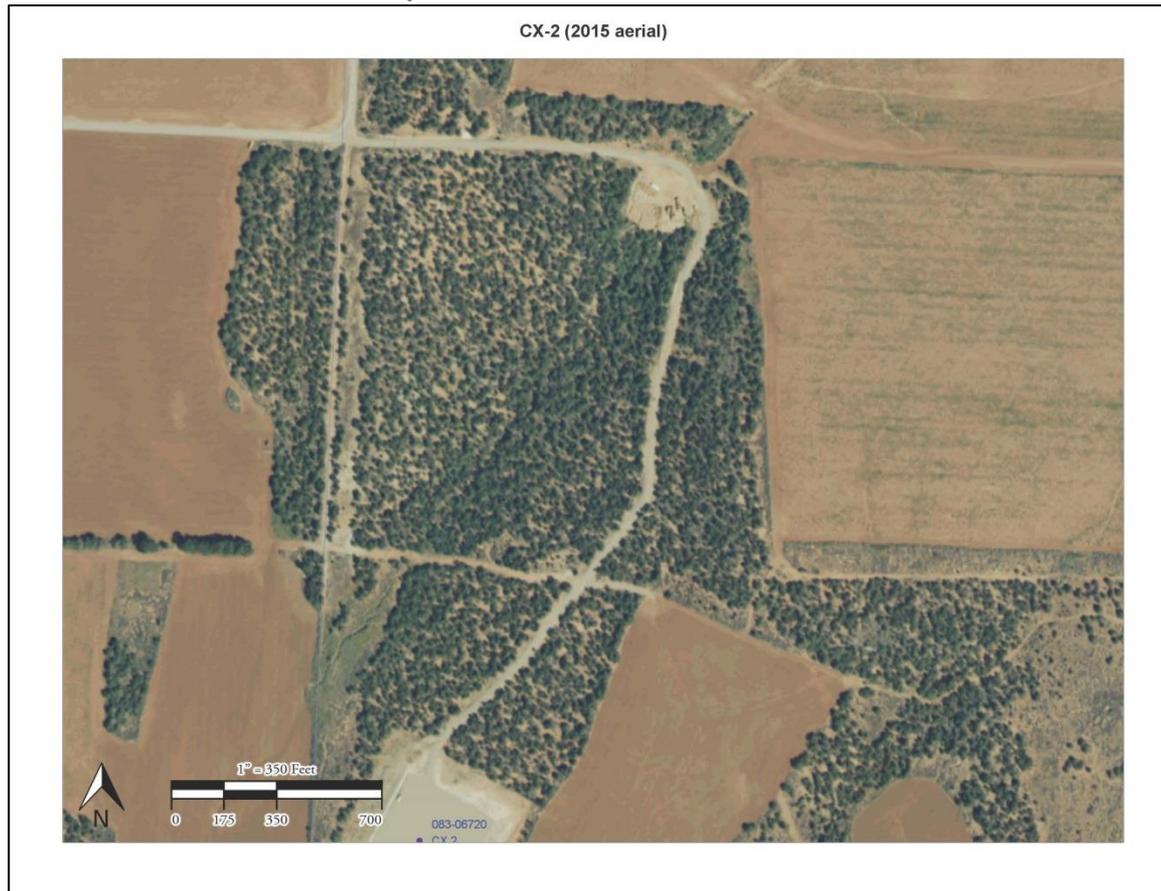
Photo 8. 2015 aerial after construction, note built out spoil dump in drainage at prominent bend in access road

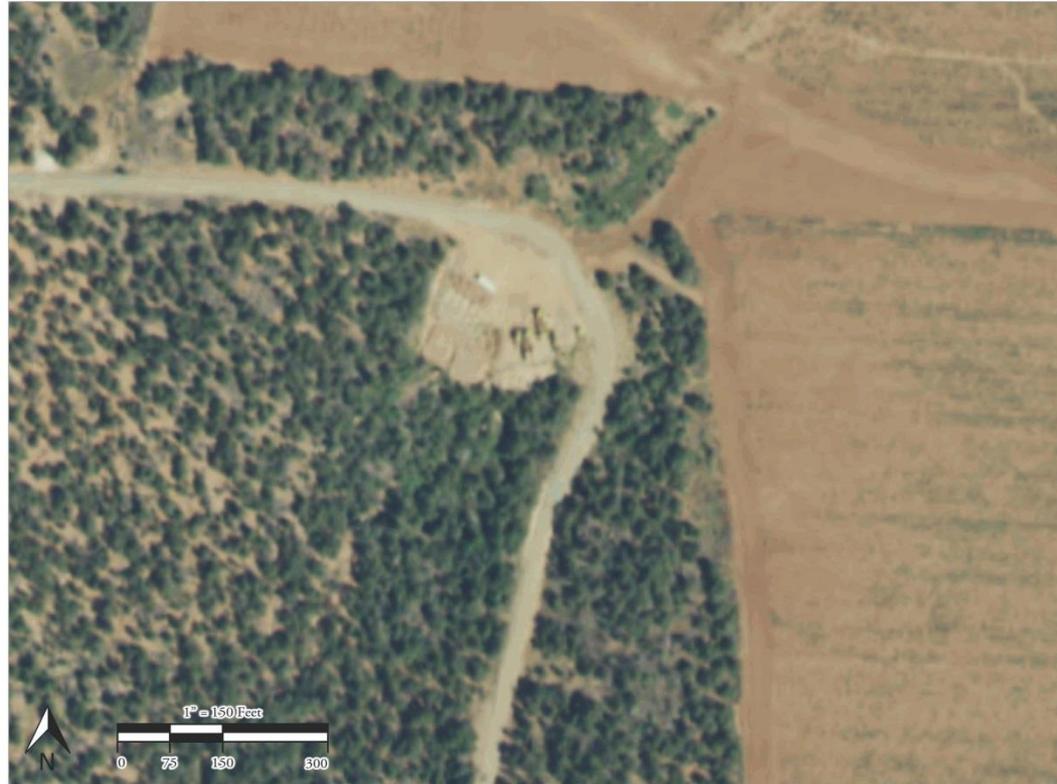
CX-2 (2015 aerial) access close-up

Photo 9. close-up of spoil dump in drainage, note heavy equipment staged at time of photo

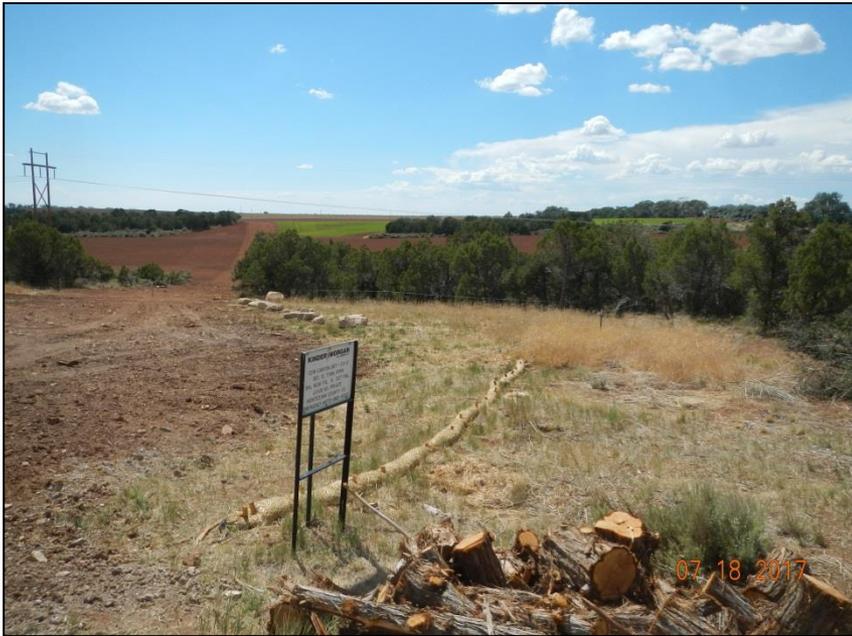
Photo 10. Newly disturbed area NW corner of location, well sign, slash pile. Note perimeter wattles have not been re-installed

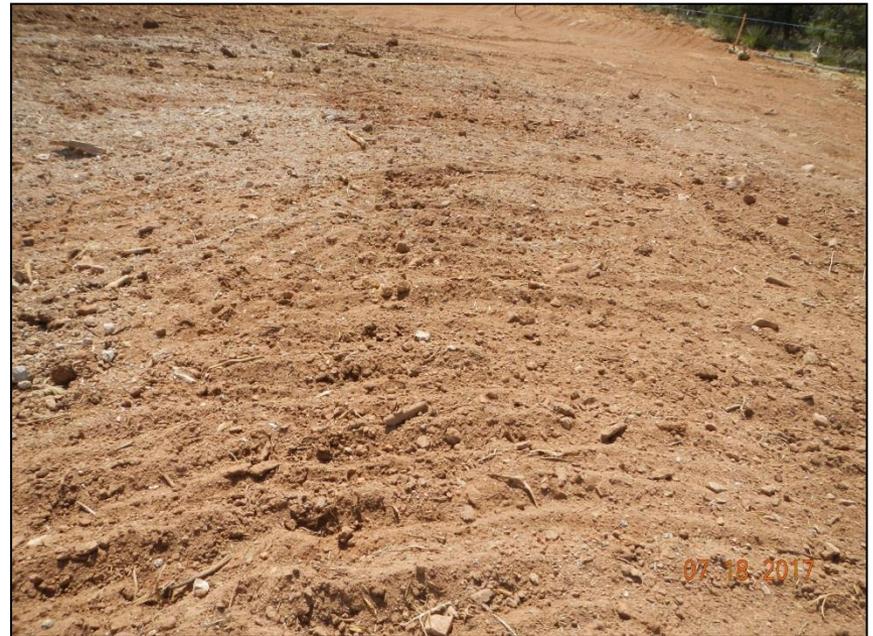
Photo 11. Newly disturbed area, seeding/stabilization not yet performed

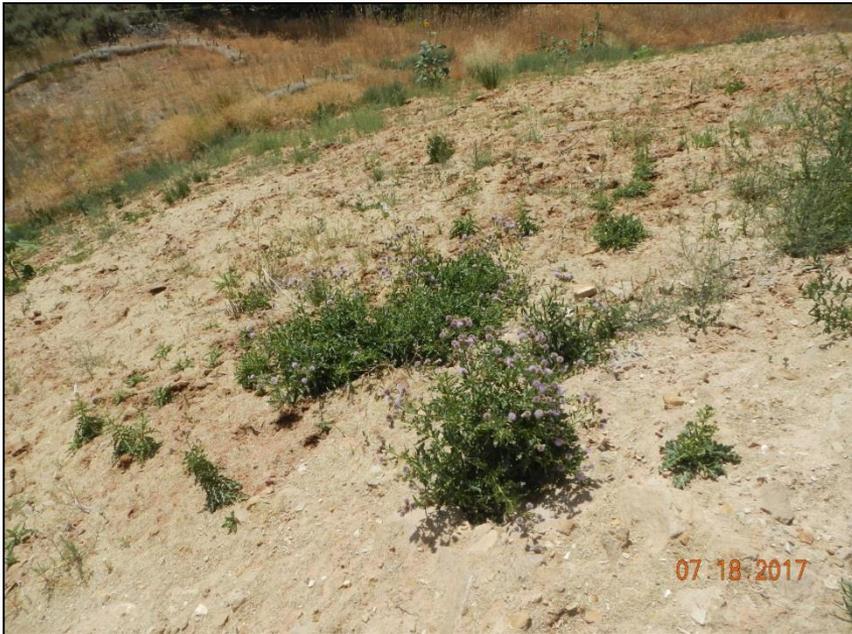
Photo 12 Flowering weed on SW corner of fill slope

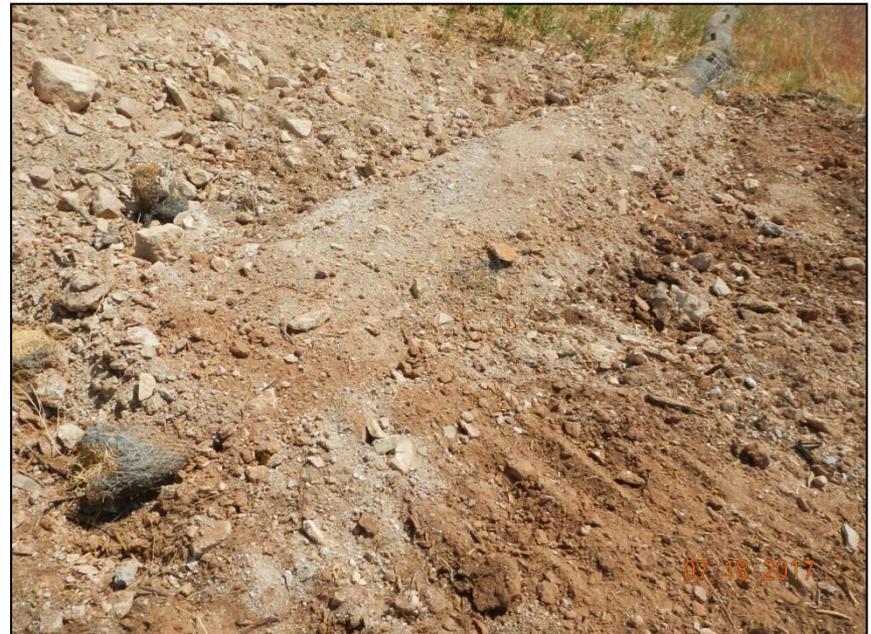
Photo 13. Straw wattle covered in material and in disrepair NW corner

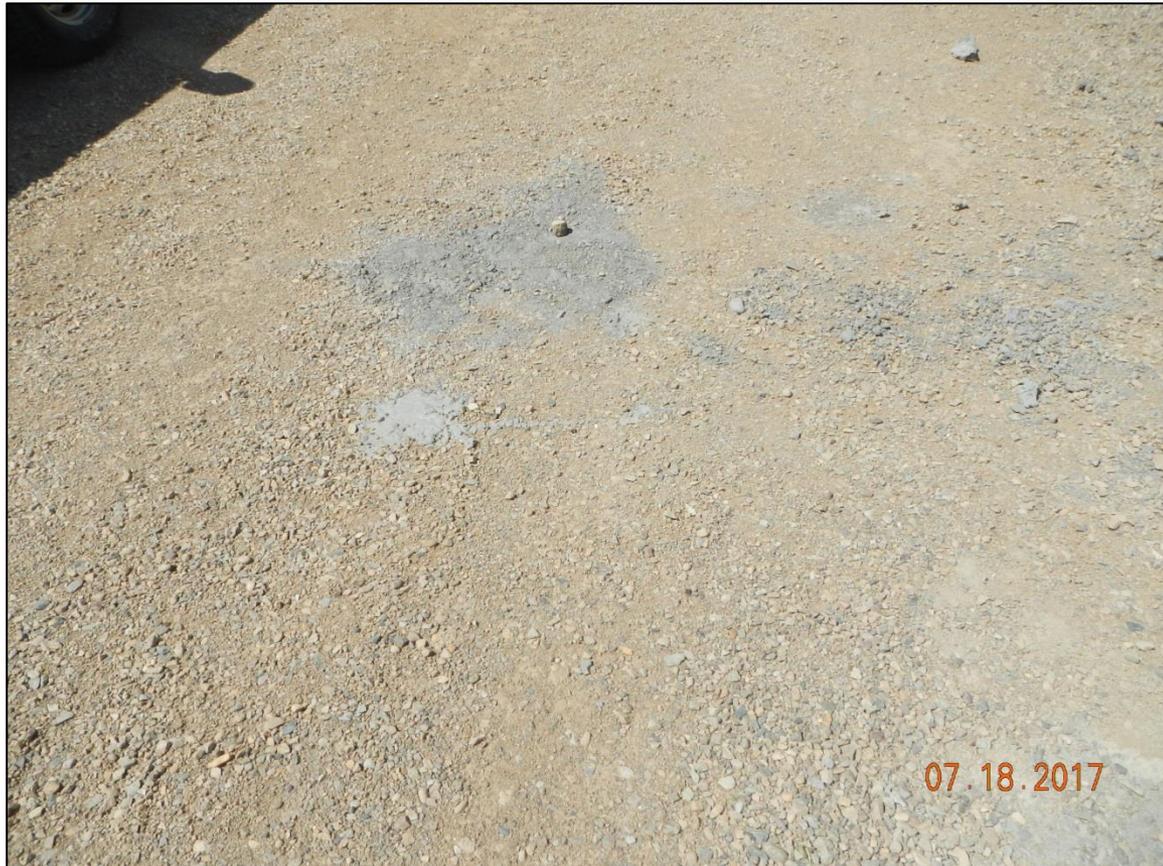
Photo 9. De minimis cement on east side of graveled pad
