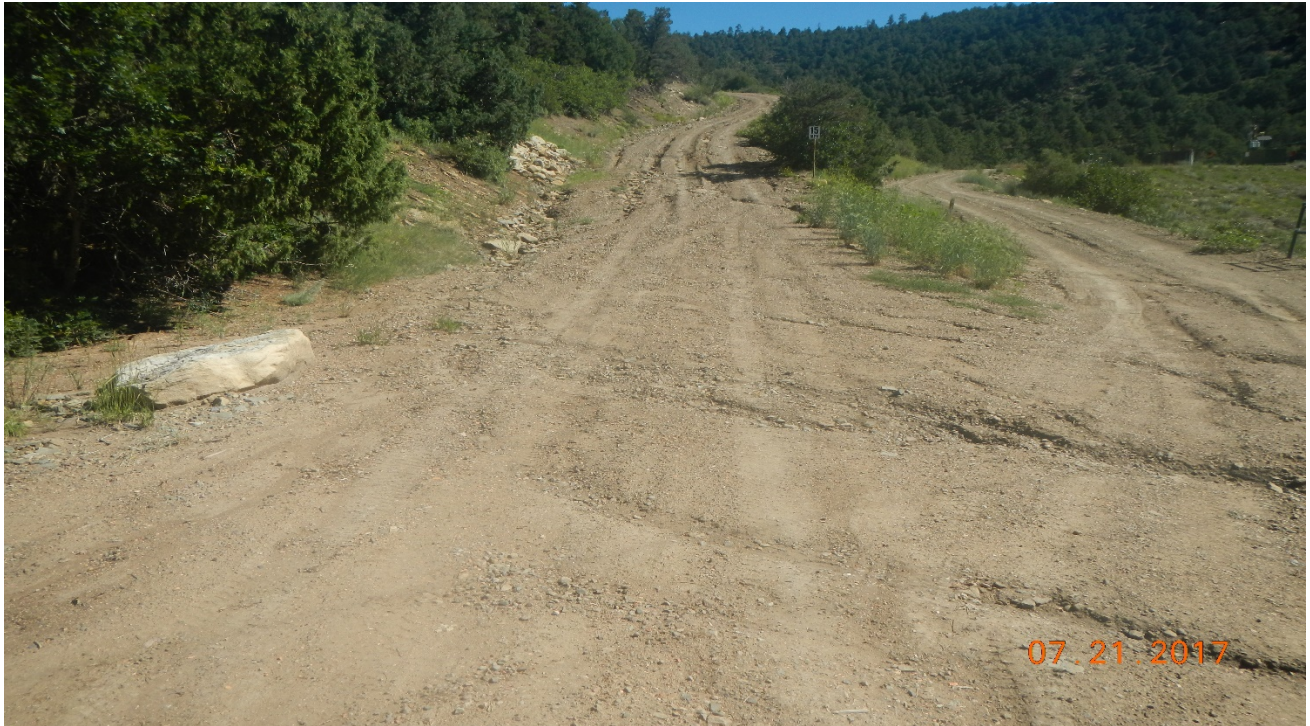
**photo 1:** Facing northeast along the main access road. Lat/Long:37.091603,-104.942226

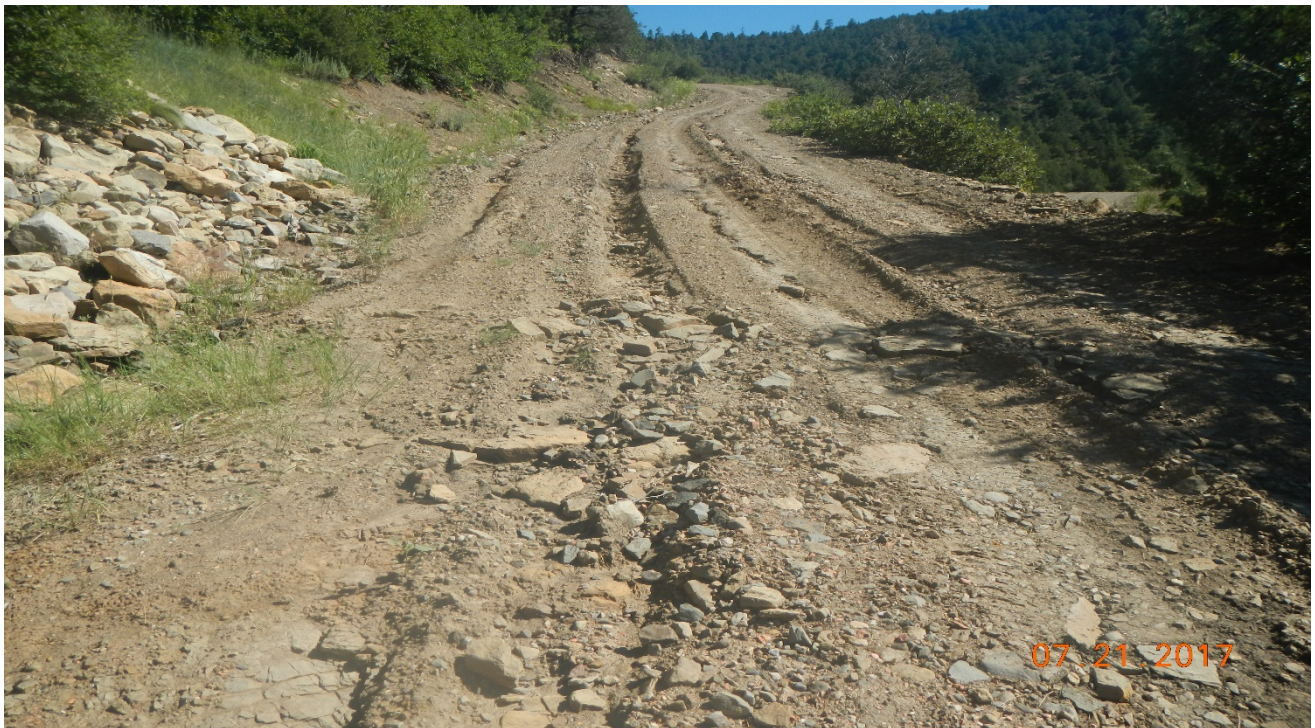
**photo 2:** Facing northeast along the main access road. Stormwater is not being properly diverted which is causing erosion along the road.

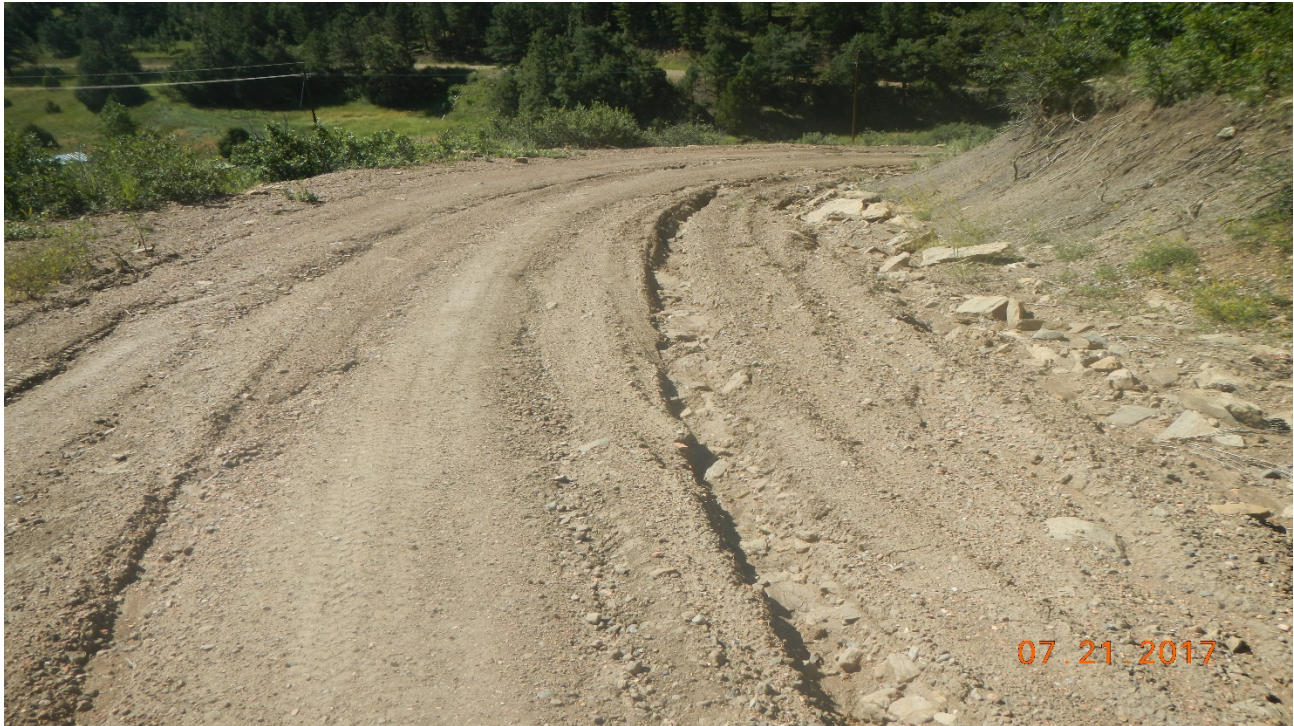
**photo 3:** Facing back along the main road. The ditches along the side of the road have filled in with sediment and stormwater is not properly diverted to the culverts.

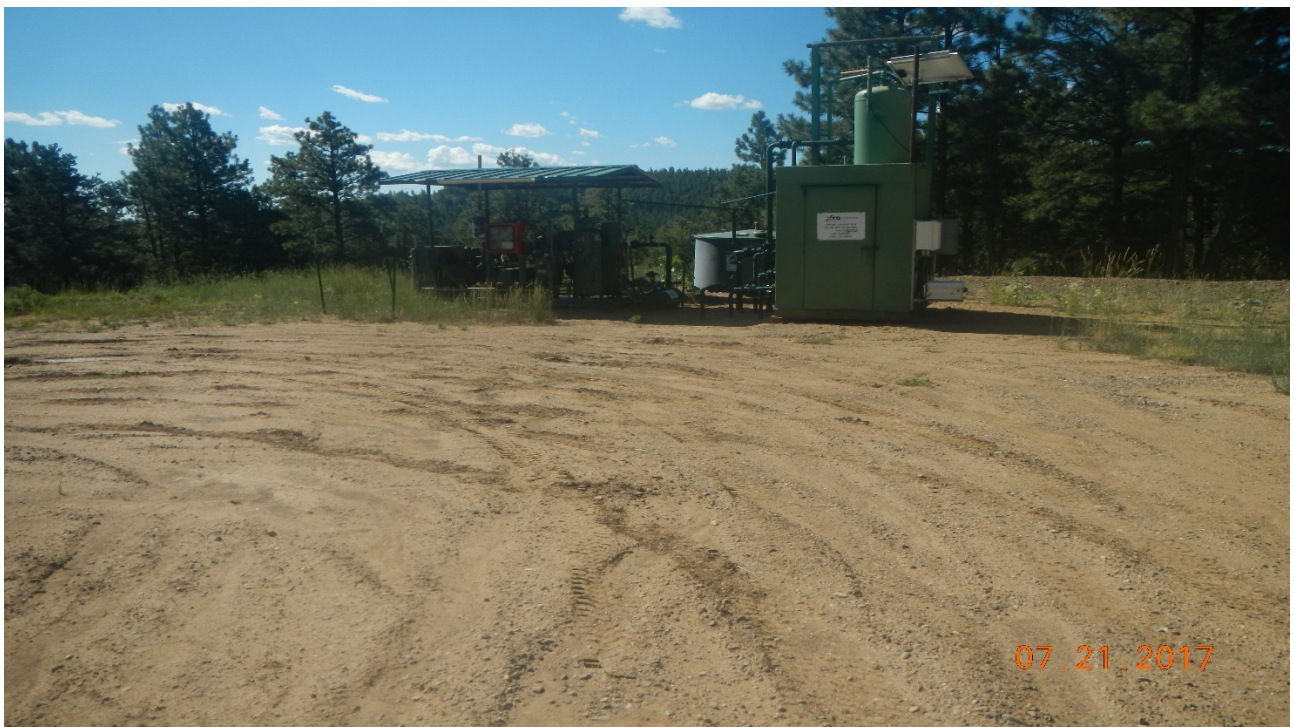
**photo 4:** Facing south at the location.

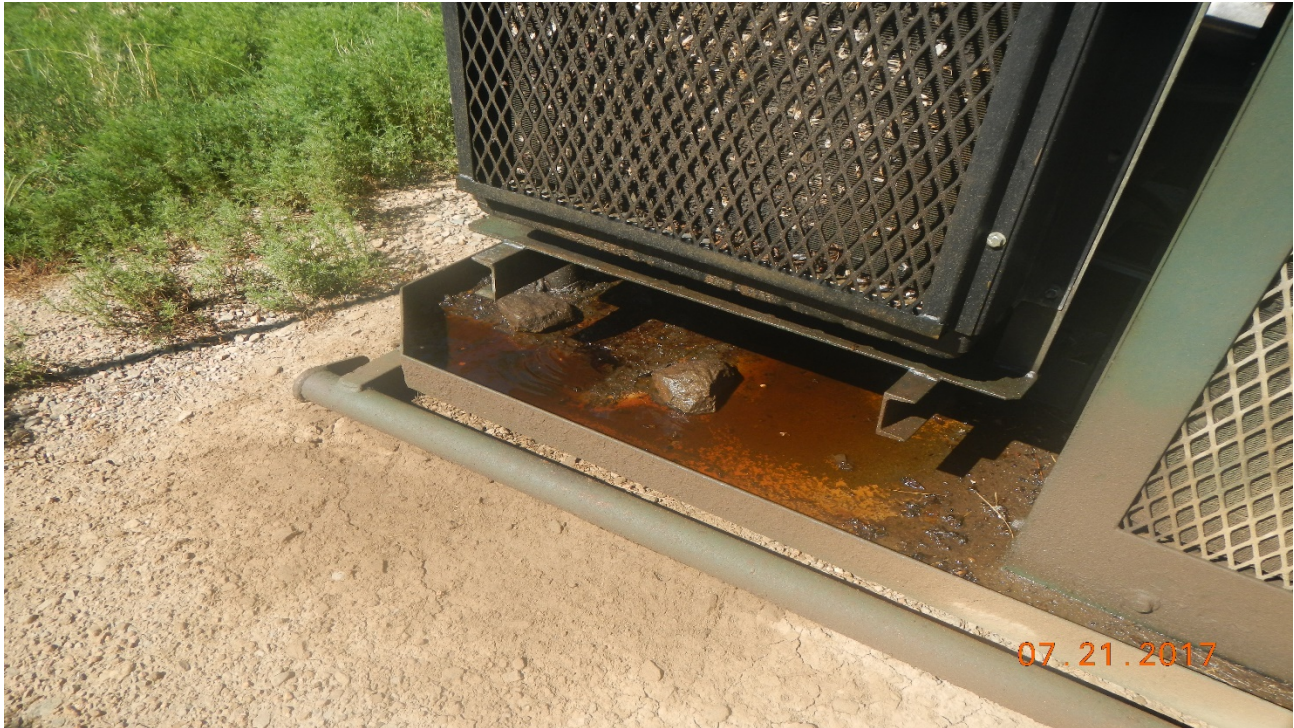
**photo 5:** There is oil on the engine skid.

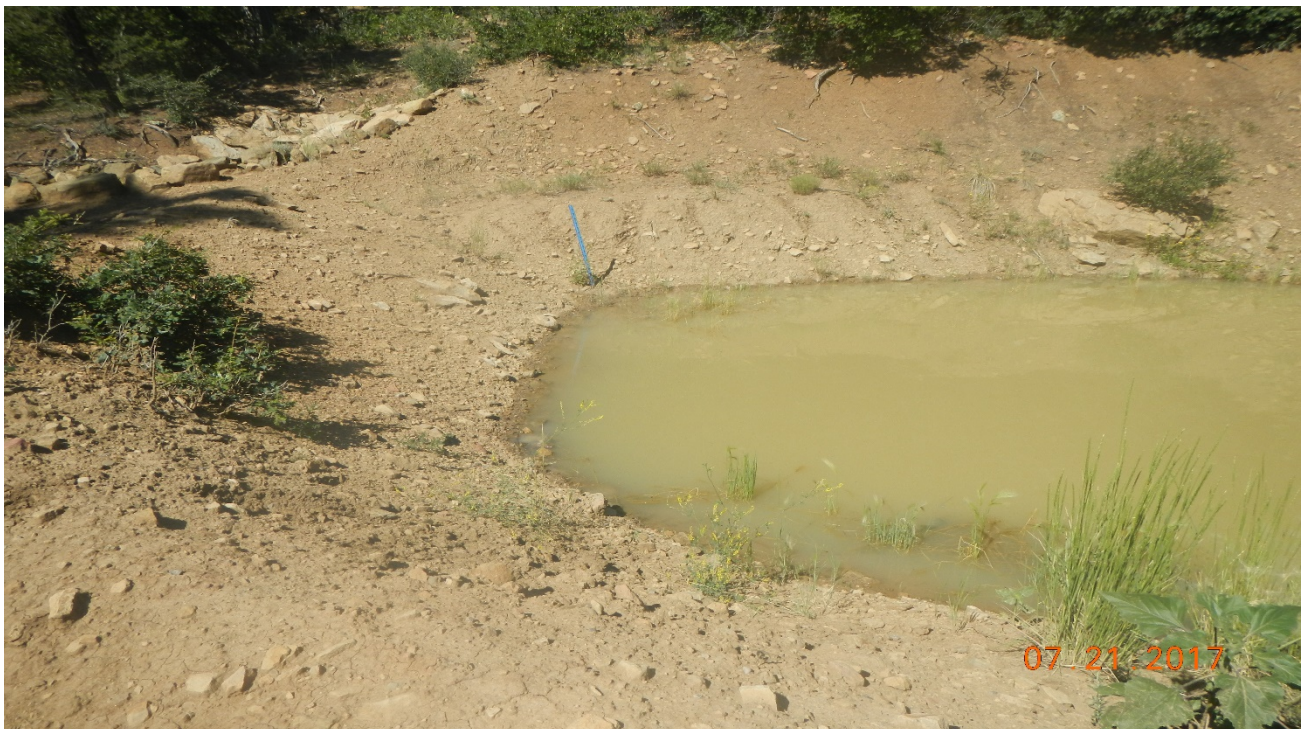
**photo 6:** There is 2 ft freeboard in the pit as shown by the marker.
