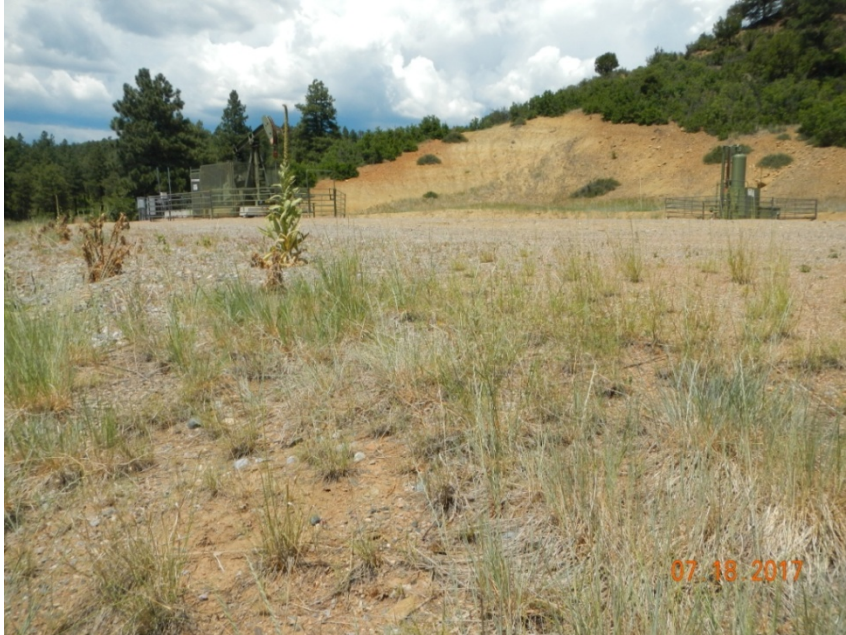
**Photo 1: View of the project area from the southwestern corner facing center.**

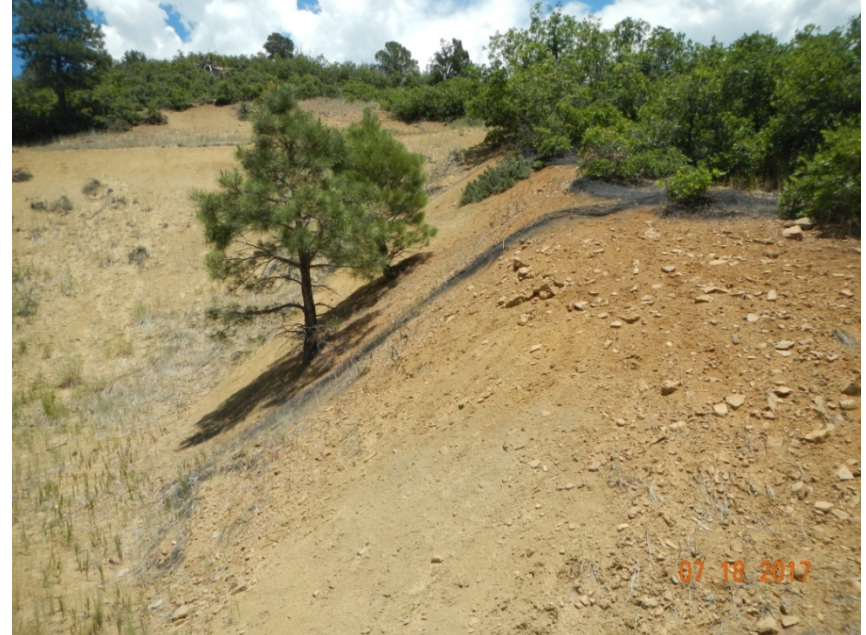
**Photo 2: View of the southern portion of the project area from the southwestern corner facing eastward. Black netting debris needs to be properly installed or removed.**

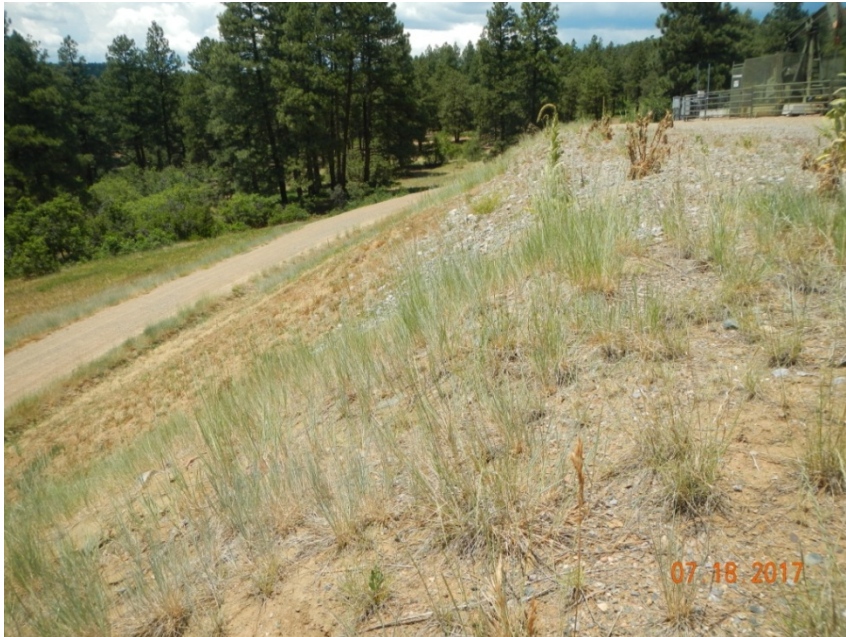
**Photo 3: View of the western portion of the project area from the southwestern corner facing northward. Revegetation is progressing, largely with grasses such as western wheatgrass (*Pascopyrum smithii*) and smooth brome (*Bromus inermis*).**

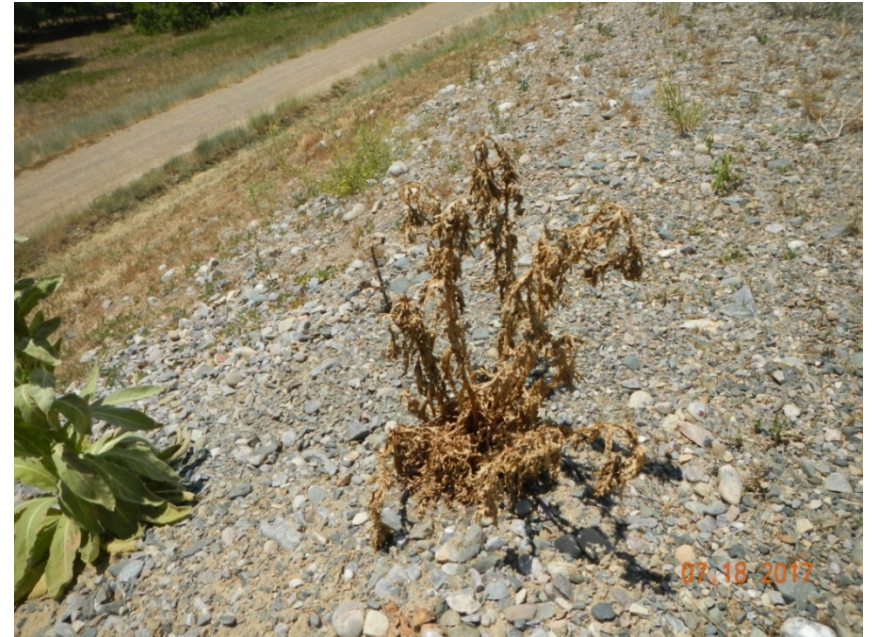
**Photo 4: View of musk thistle that was recently treated.**

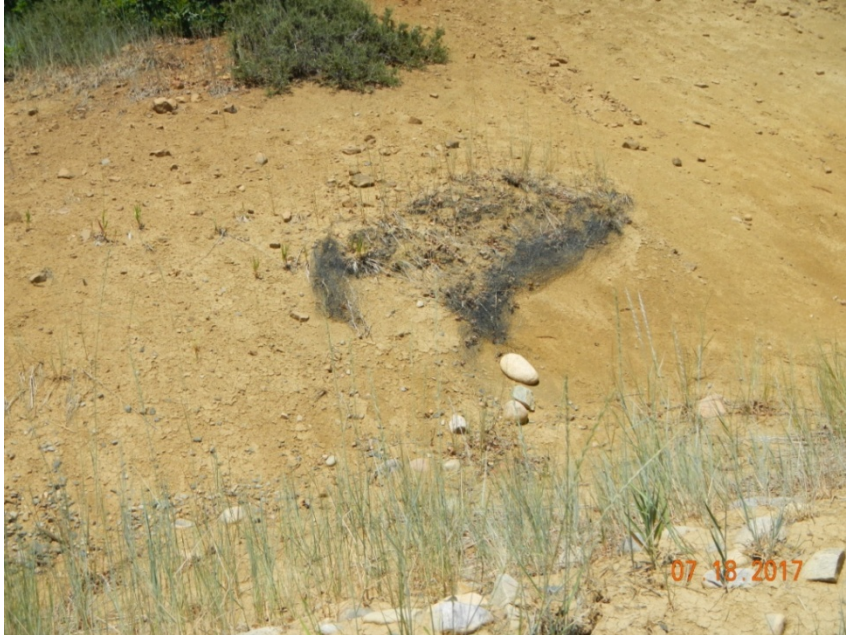
**Photo 5: View of black netting in the northern portion of the project area. This needs to be removed.**
