- Access road condition survey for the Sanchez 4 05-067-05321 and Sanchez 2 05-067-05345.

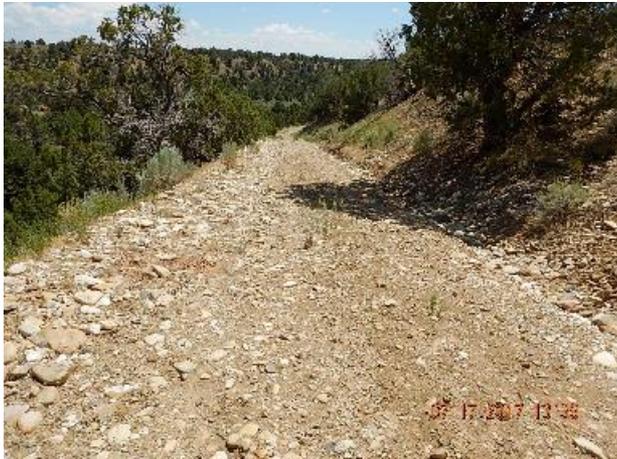
Photo 1: Access road dropping into canyon. Rock, gravel, and dirt with drainage ditch between base of hill and road.

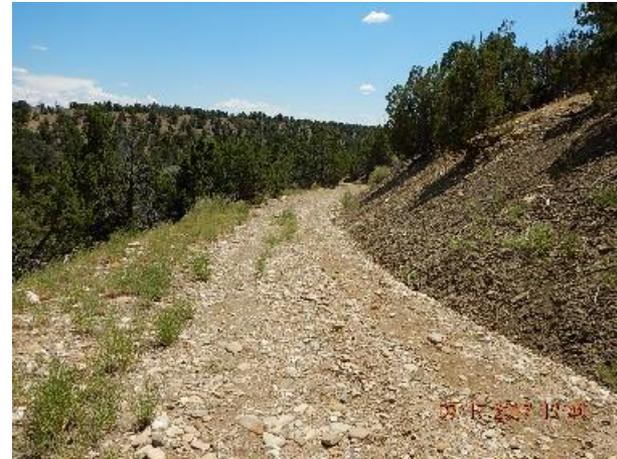
Photo 2: Access road is 12' – 13' wide from ditch edge to the vegetation along outside edge of road.

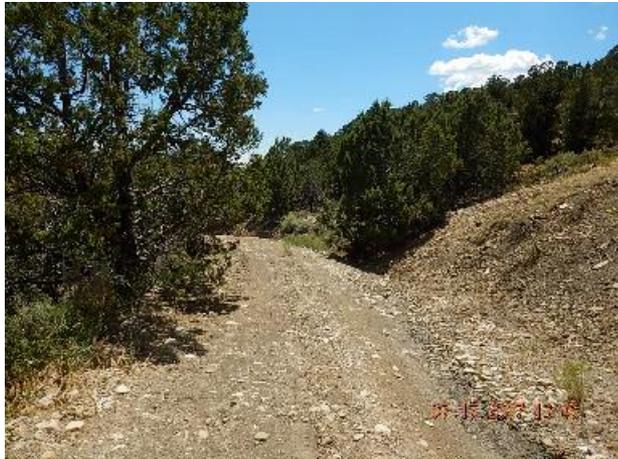
Photo 3: Tight spot on access road. Not as steep of grade but still driving towards bottom of slope. This section of road narrows to 9' – 10' from ditch edge to tree limbs growing over road.

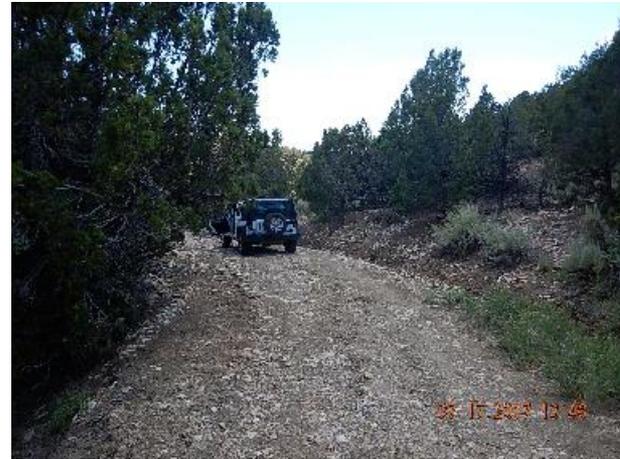
Photo 4: Tight spot as road bends to the slightly to the left close to the bottom. Road is 11' – 12' wide from ditch edge to tree limbs growing over road.

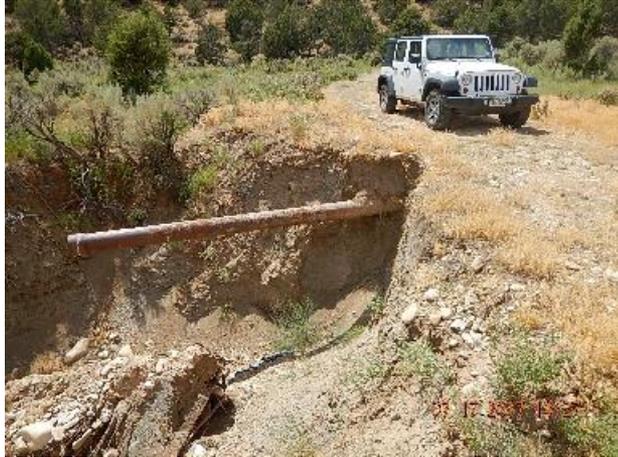
Photo 5: Access road drainage crossing. The sidewall has collapsed at culvert on down slope side of the road.

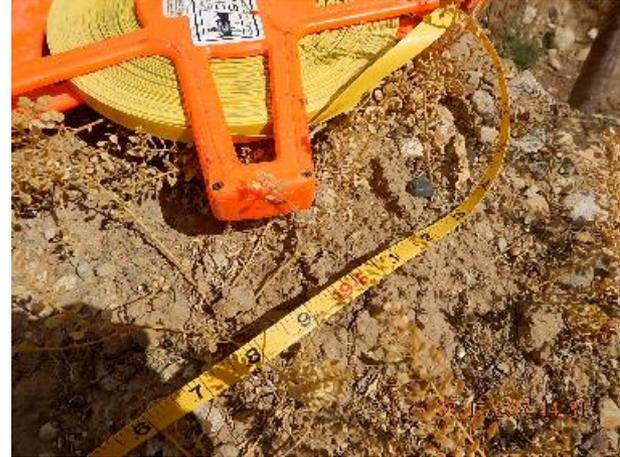
Photo 6: Access road is 19' wide from edge to edge across top of culvert.

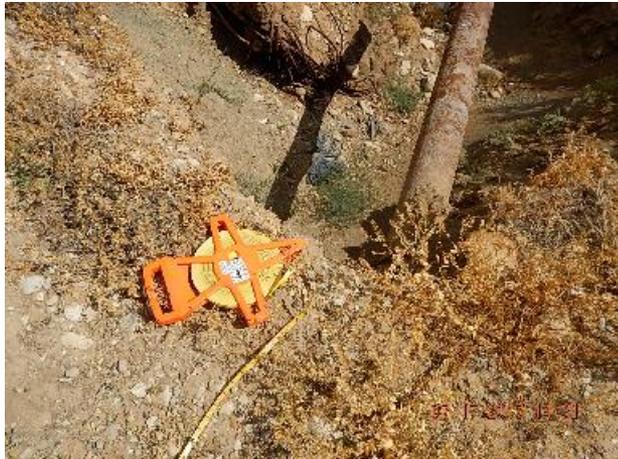
Photo 7: View looking down into drainage on the down slope side of road.

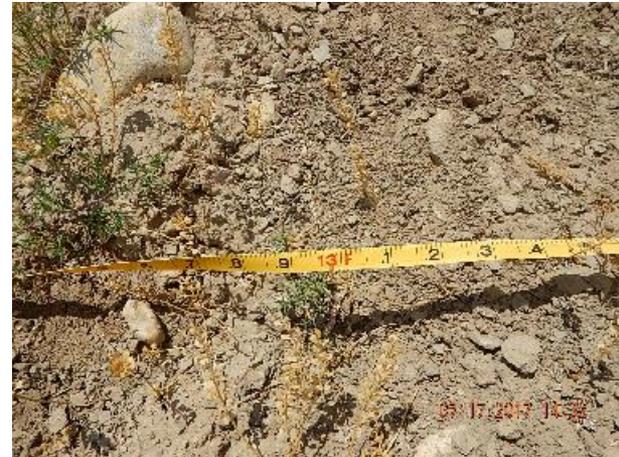
Photo 8: Just past the culvert on the drainage crossing the road narrows to 13' between edge of drainage to above ground steel flow line. This would be an area of concern as evidenced by possible weakened walls of drainage.

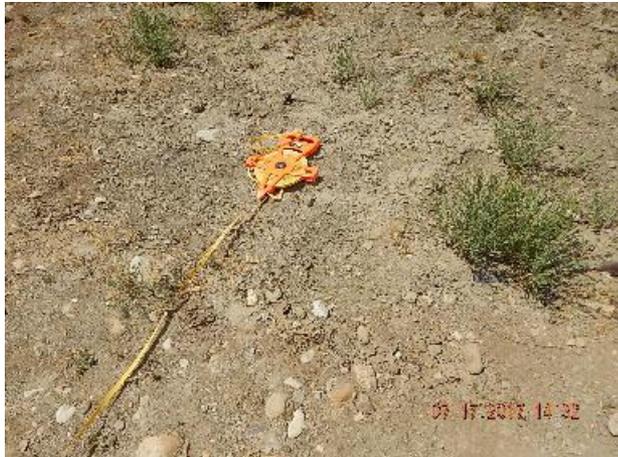
Photo 9: View of flowline at right edge of photo where to road narrows to 13'.

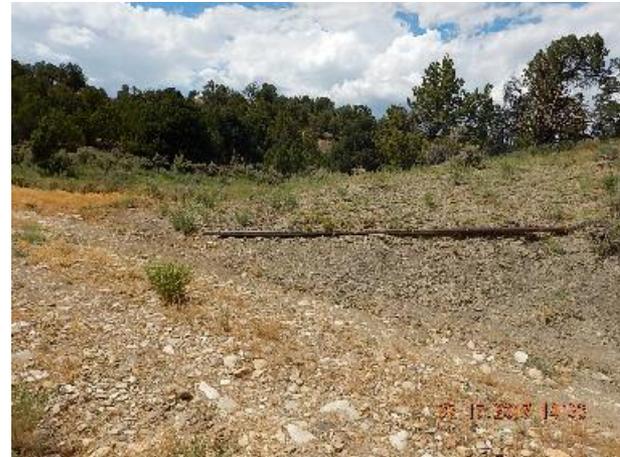
Photo 10: Wider view of above ground flowline along access road that creates tight spot where flowline crosses drainage.

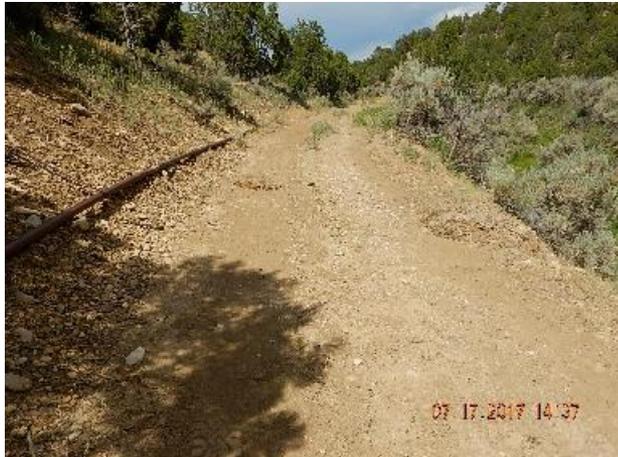
Photo 11: Access road tight spot where erosion has washed channel out on drainage edge of road. Road is 11' from above ground flowline to edge of erosion.

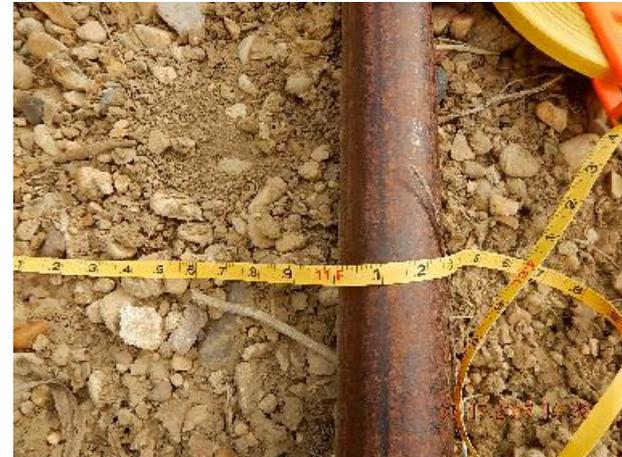
Photo 12: Measured from edge of erosion to steel flowline.
