**Inspection Photos**  
**Location Name: Legget 1-5H**  
**API: 05-123-35277**

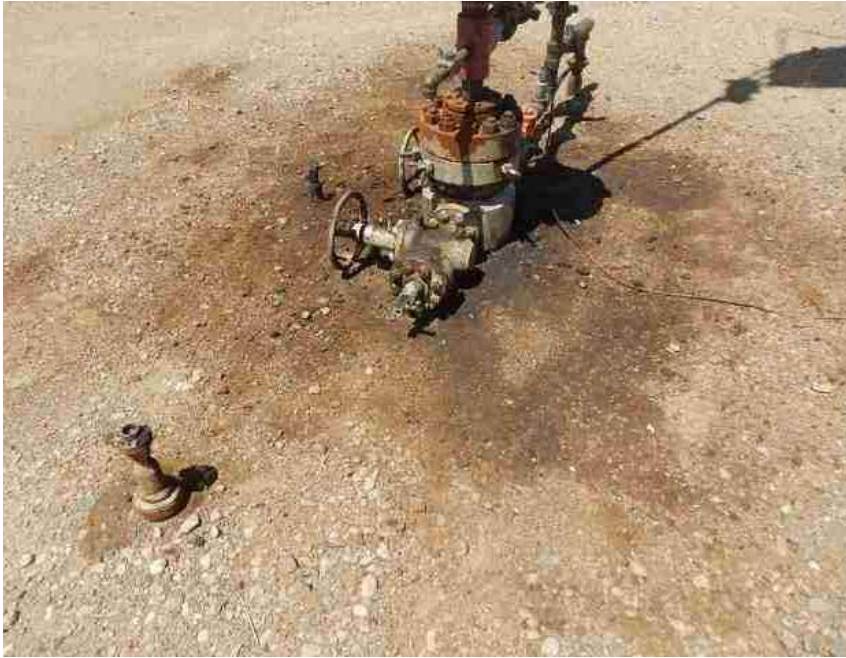
**Photo 1: Stained soil at wellhead**

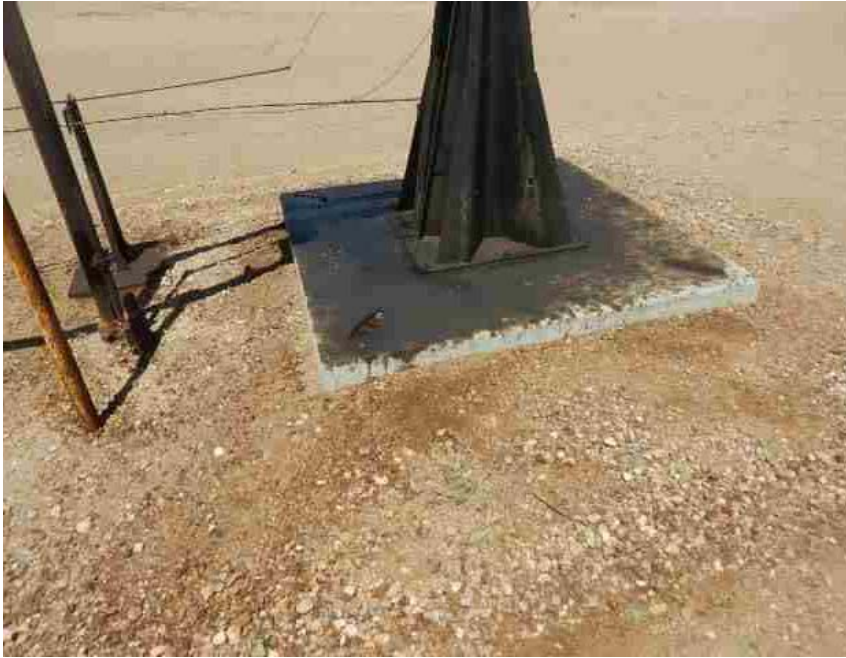
**Photo 2: Staining at flare**

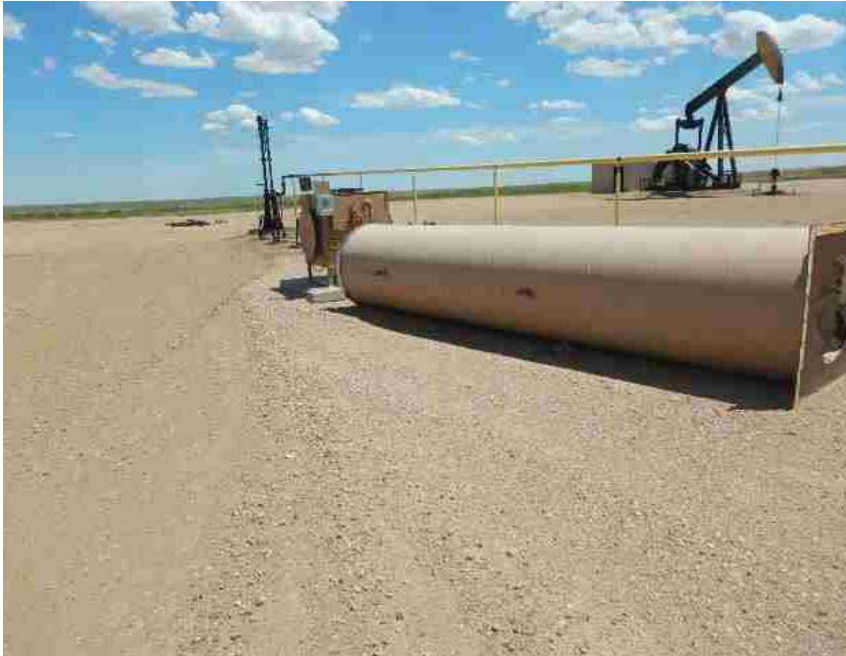
**Photo 3: Weeds at tank battery, unused ECD. Flare.**

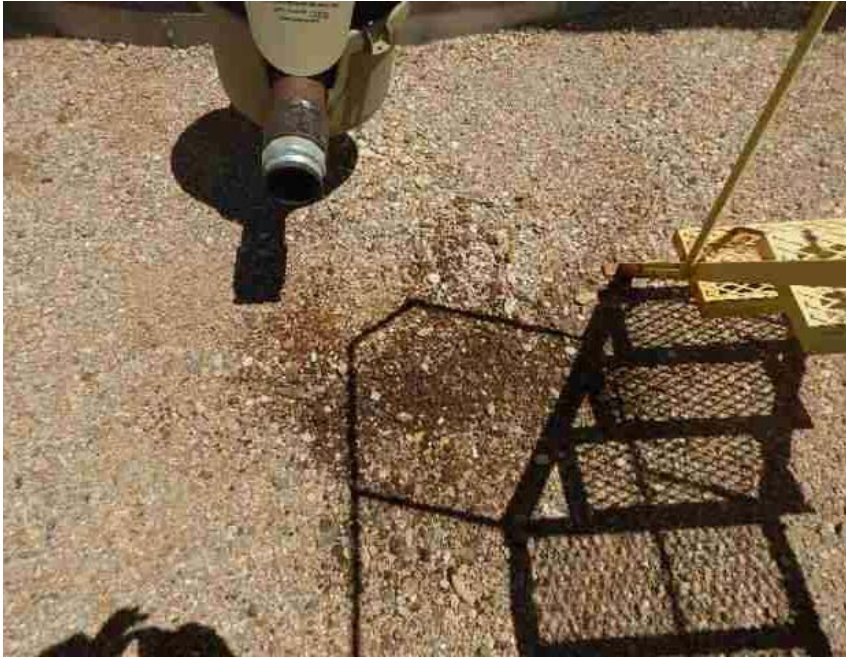
**Photo 4: Stained soil at loadout**

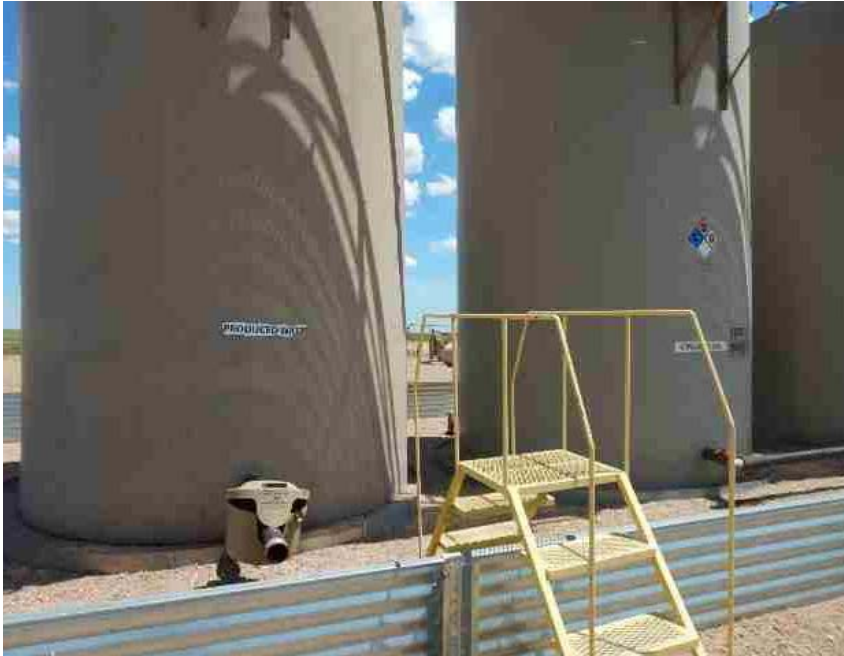
**Photo 5: No capacities on production tanks. No safety placarding on produced water tank.**

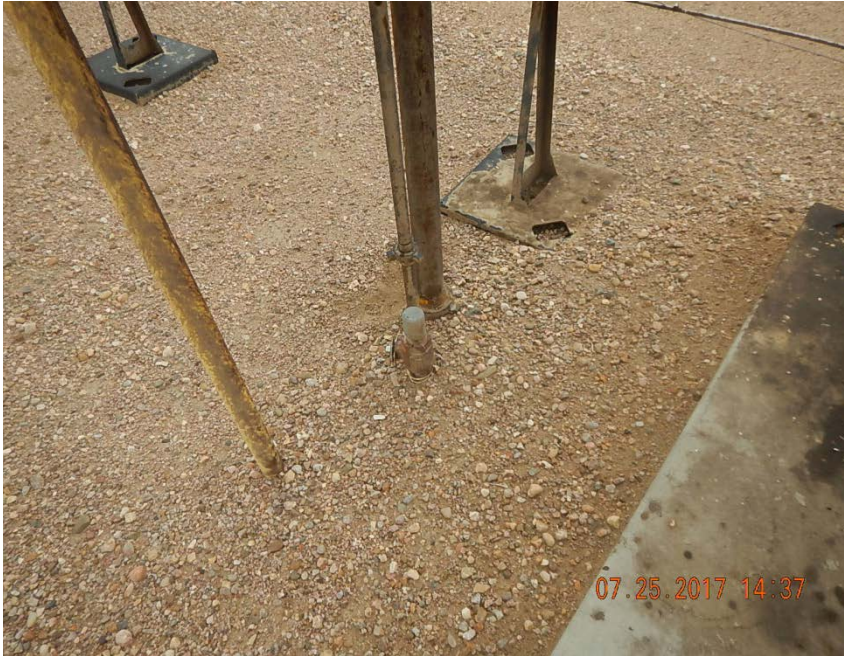
**Photo 6: Unused riser at flare.**

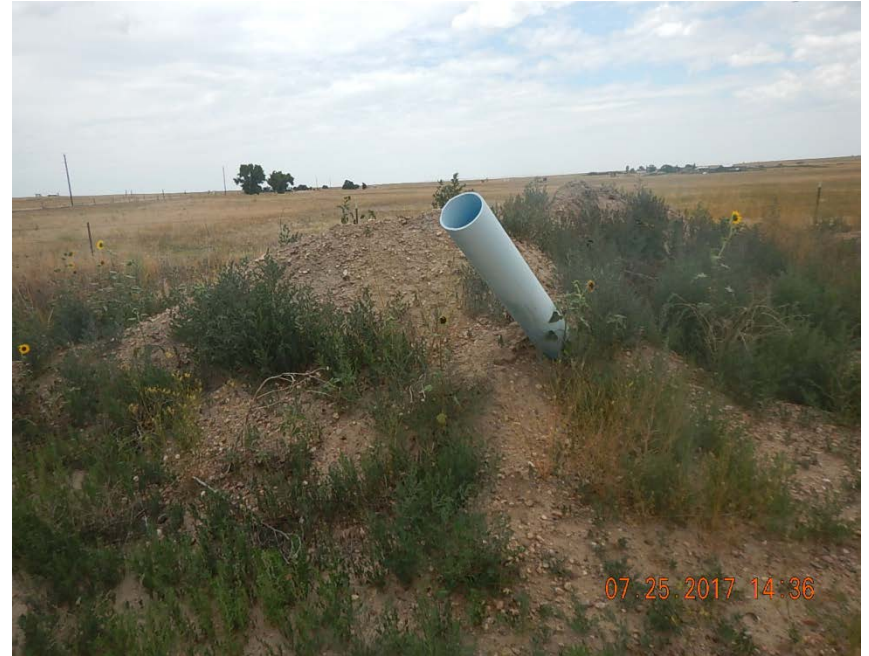
**Photo 7: Debris at E side of facility.**

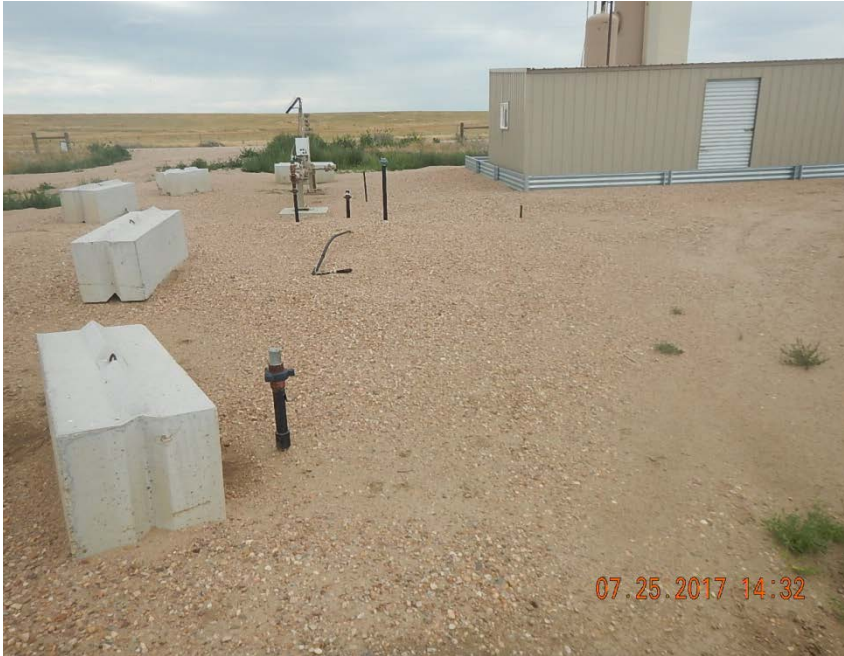
**Photo 8: Unused risers at separator**

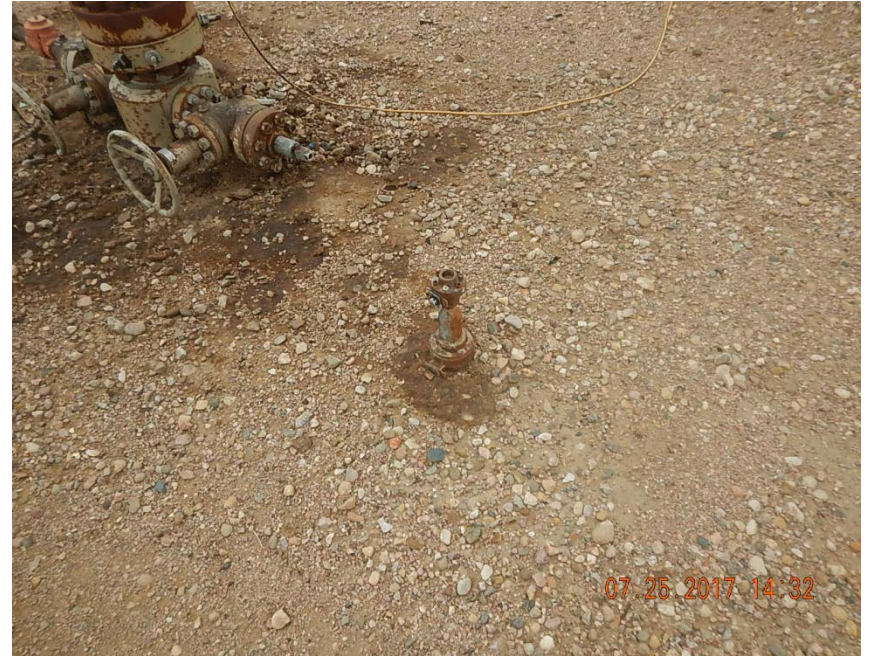
**Photo 9: Unused riser at wellhead**

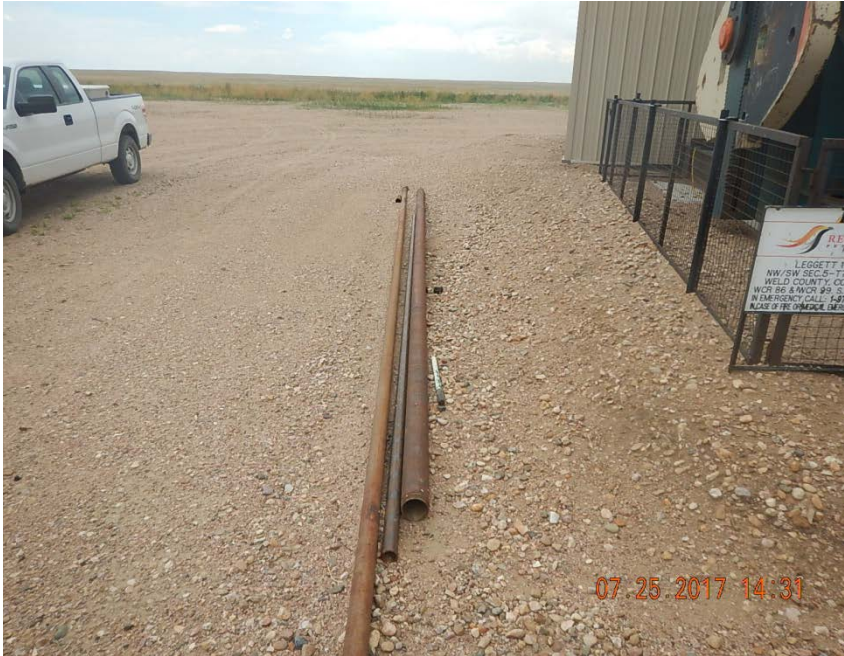
**Photo 10: Unused equipment at pump jack**

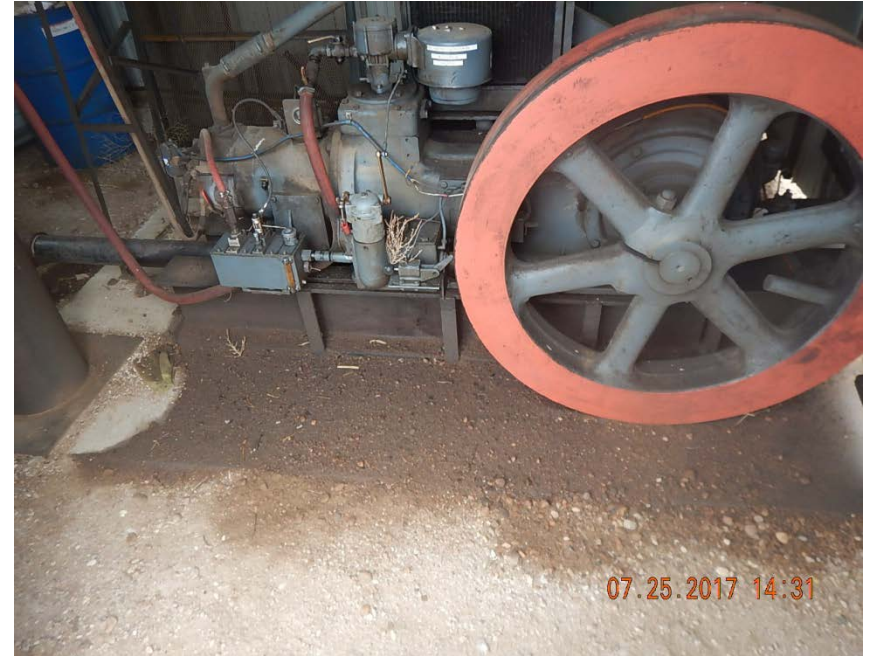
**Photo 11: Stained soil at engine**
