Inspection Photos  
Location Name: Reinholt 12-6  
API: 05-001-08163

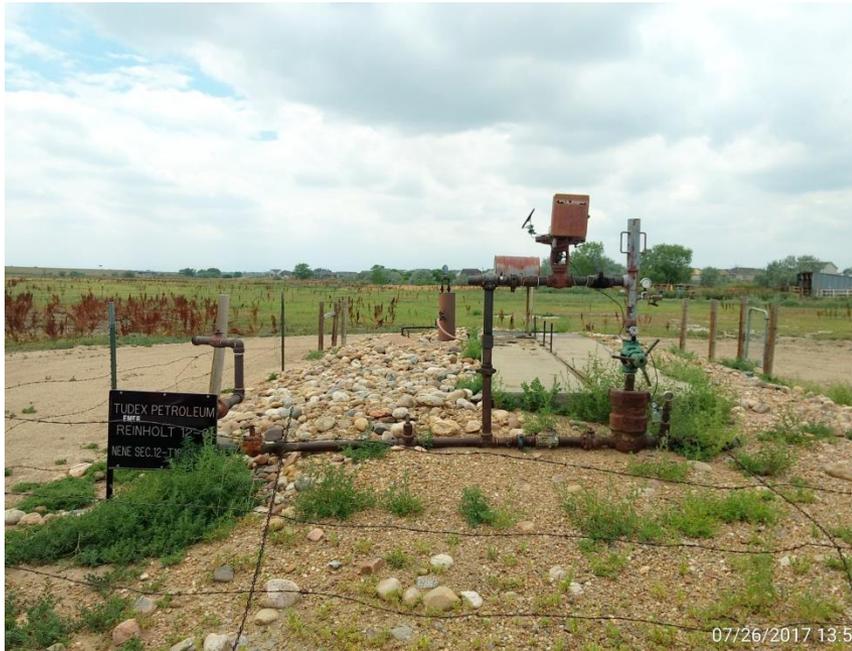
**Wellhead** Corrective action: Emergency Contact Info

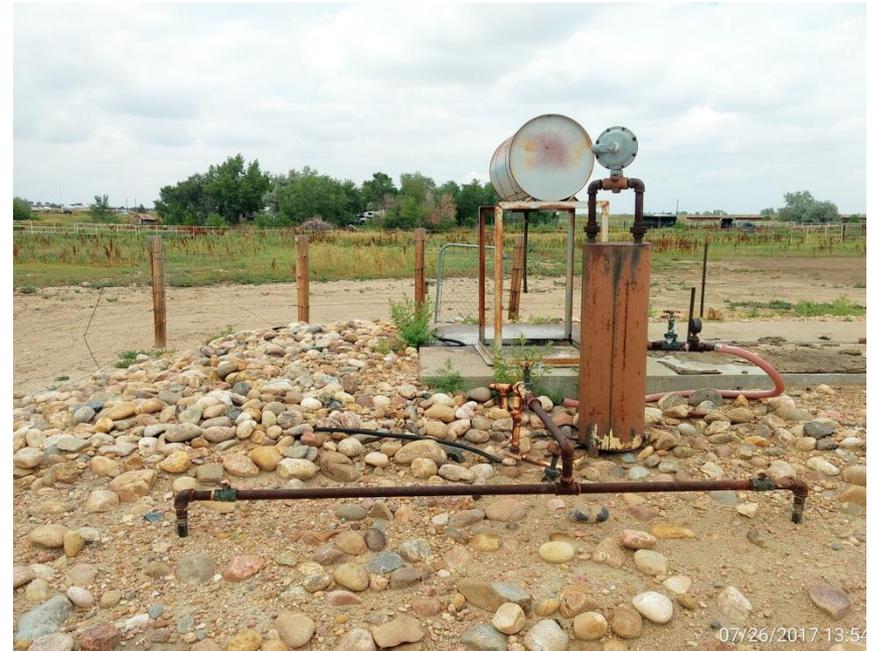
**Supply scrubber, note: unidentified 1" poly riser**  
**39.983924, -104.947282**

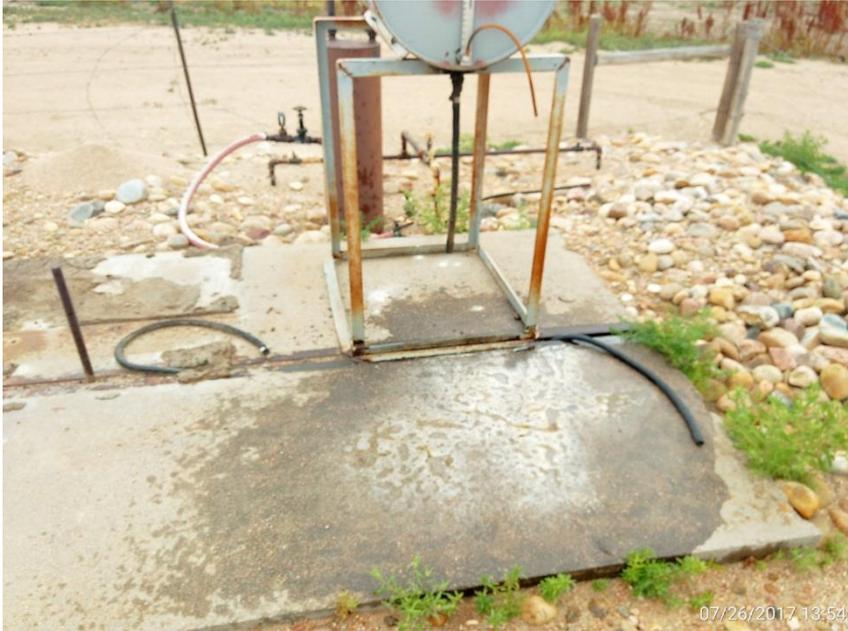
**Long run oil drum Note: fluid spilled on concrete pumping unit base.**

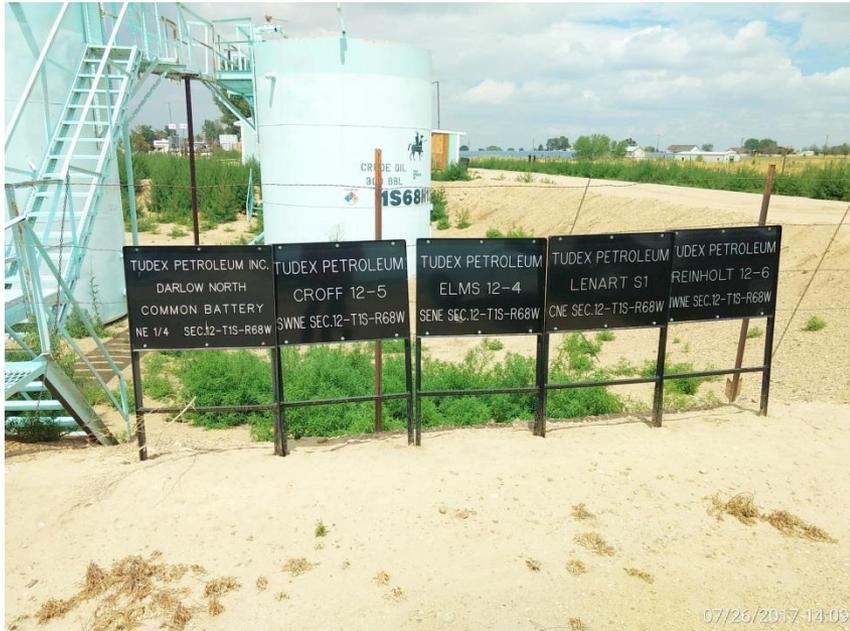
**Battery Signage** Corrective action: Emergency contact info missing

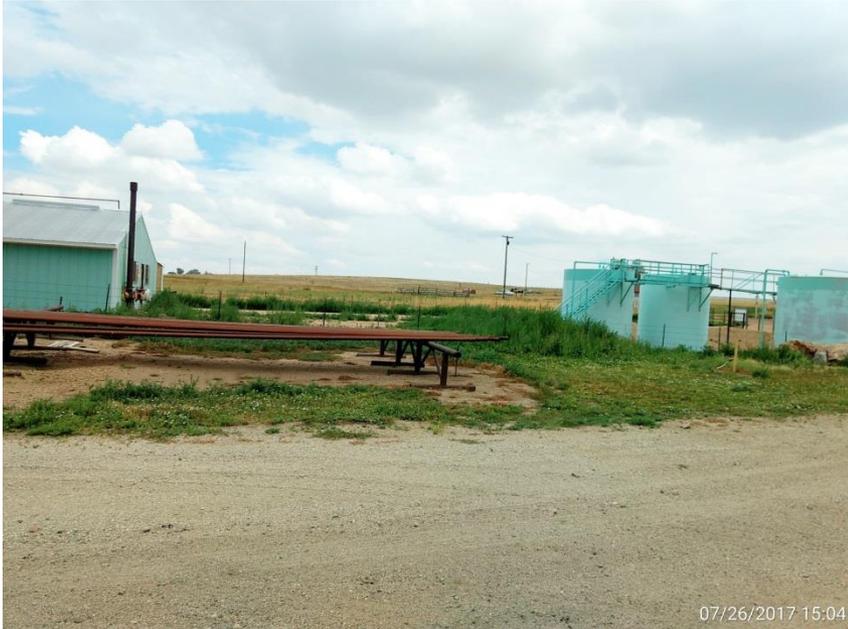
Location view **Corrective action: Weeds, storage of unused equipment (tubing)**

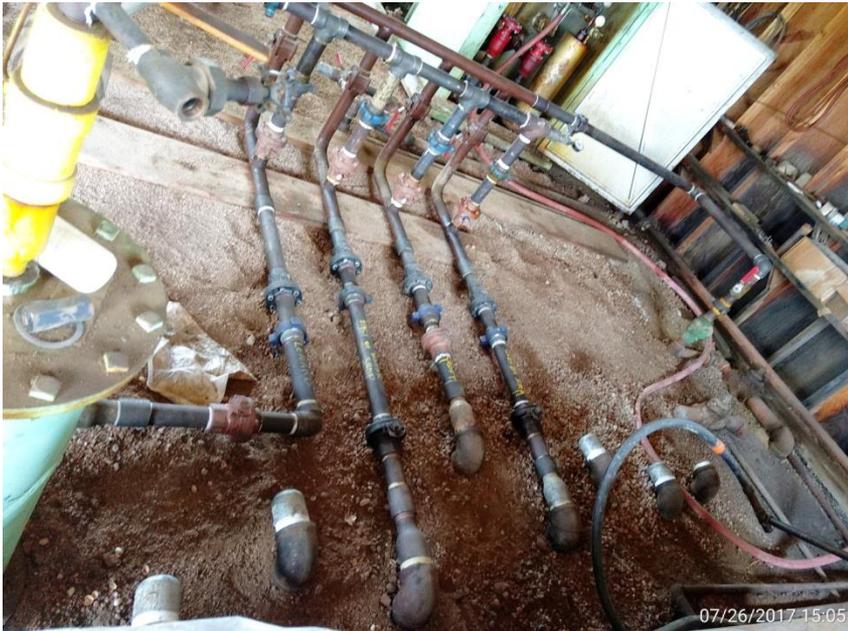
Inside separator housing **Note: unidentified risers (5)**  
**39.979830, -104.944194**

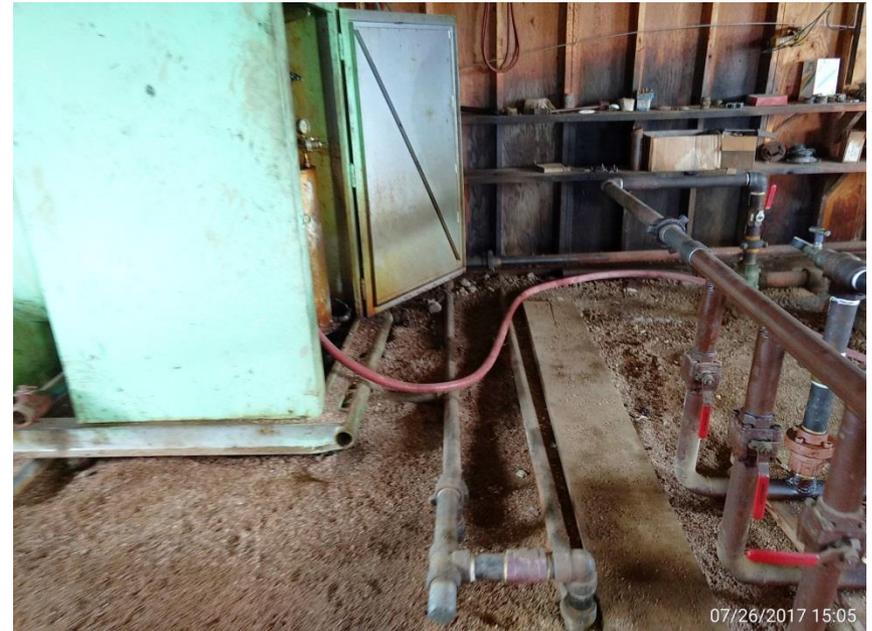
Inside separator housing **Corrective action: Storage of equipment**

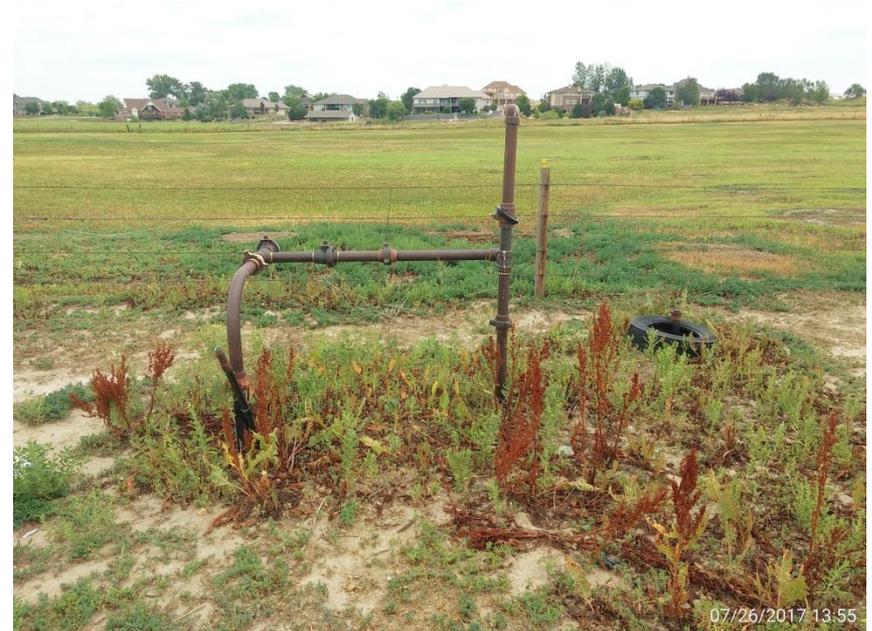
**Unidentified risers both 2" steel, and 1" poly.**  
**39.983979, -104.946858**

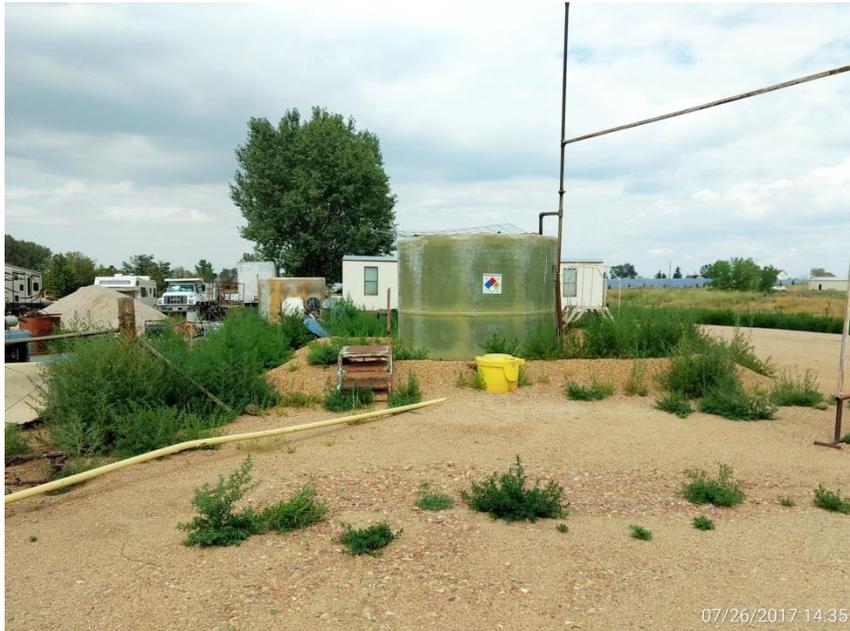
**Water tank** Corrective action: Weeds, and berm maintenance.

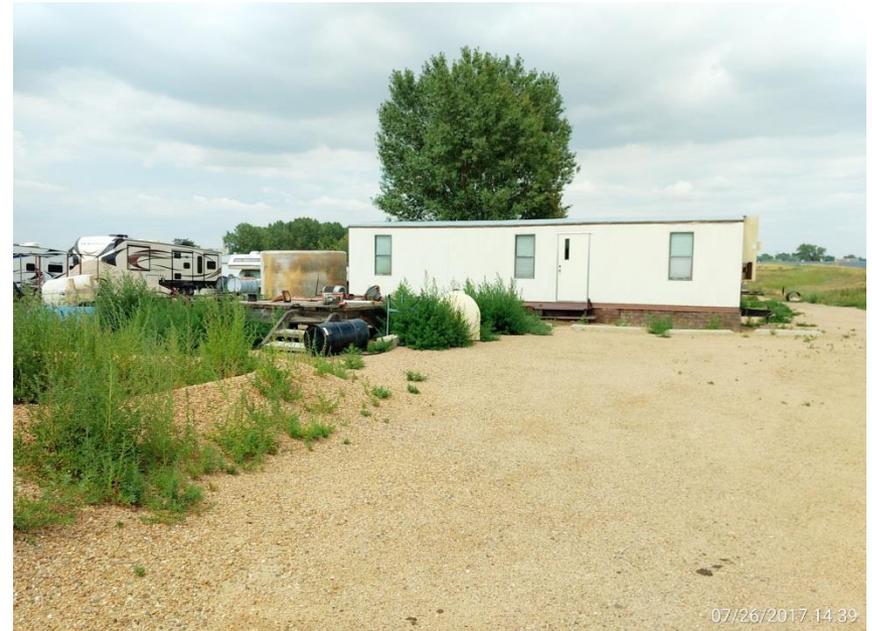
**Location** Corrective actions: storage of unused equipment ( Fiberglass tank) trash, weeds.
