**Inspection Photos**  
**Location Name: Marie Gerhardt B 5**  
**API: 05-123-08916**

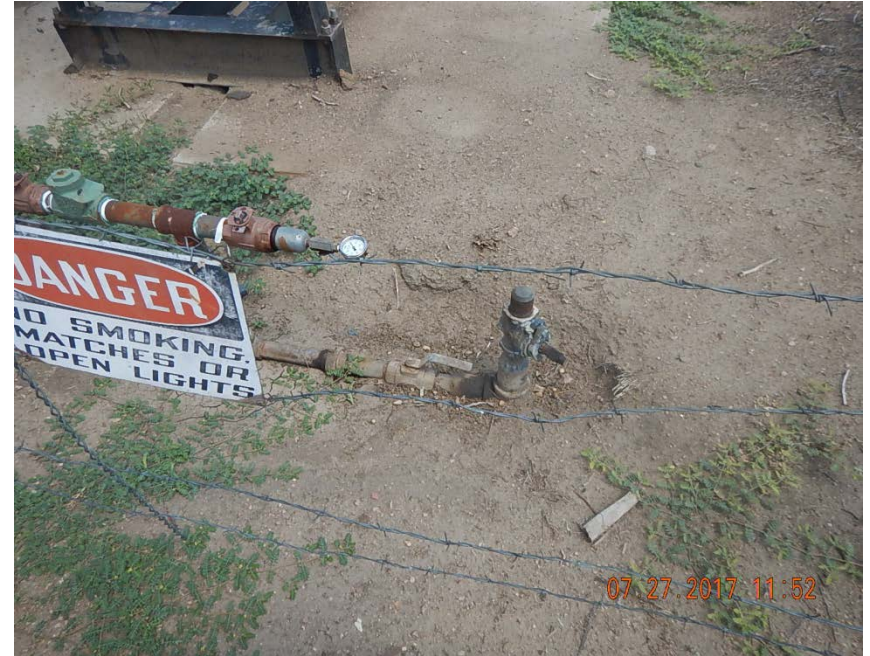
**Photo 1: Stained soil removed**

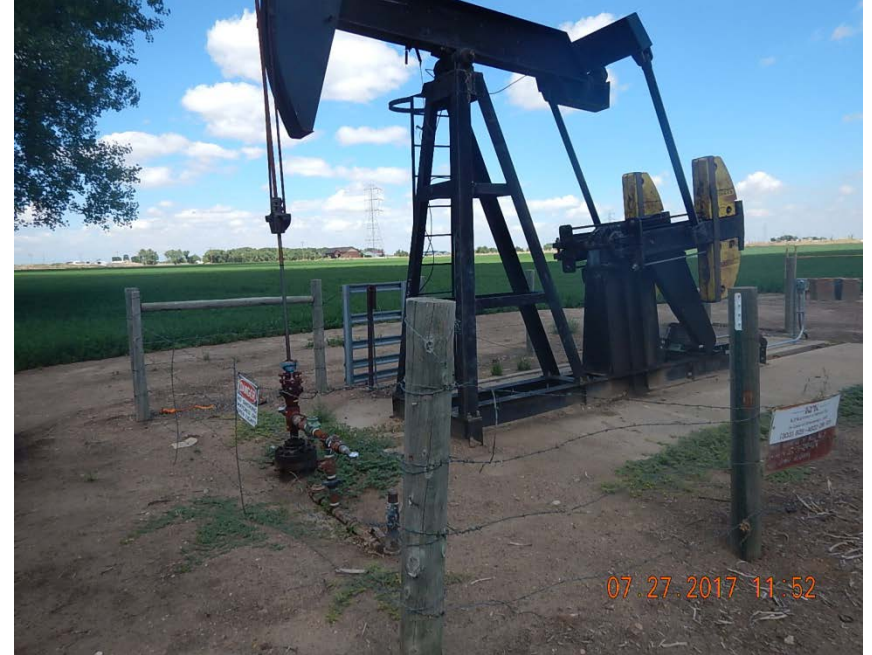
**Photo 2: Pump jack in use**

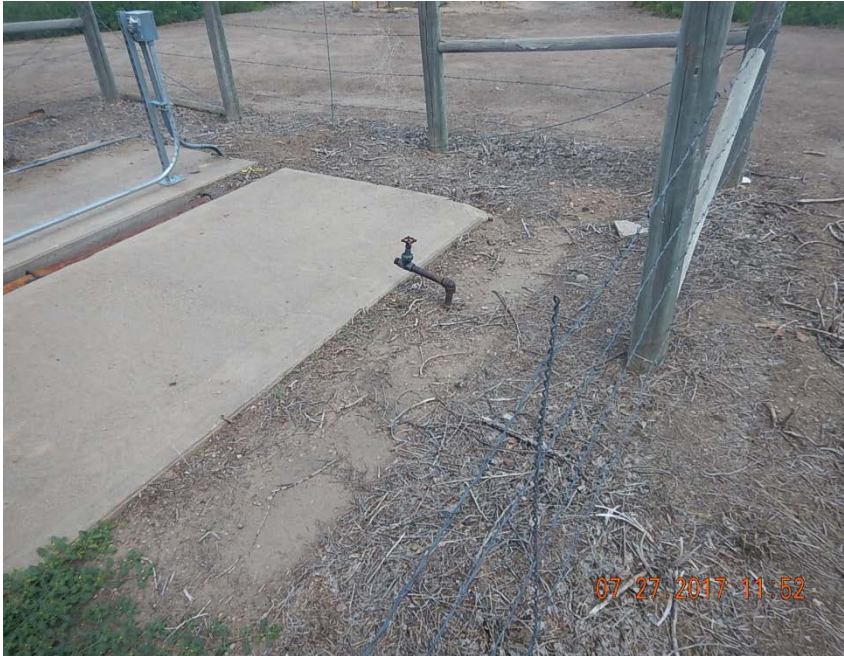
**Inactive riser at NE corner of pump jack**
