Inspection Photos

7/28/2017

Operator: OILFIELD SALVAGE & SERVICE CO - 65550

Location ID: 311709

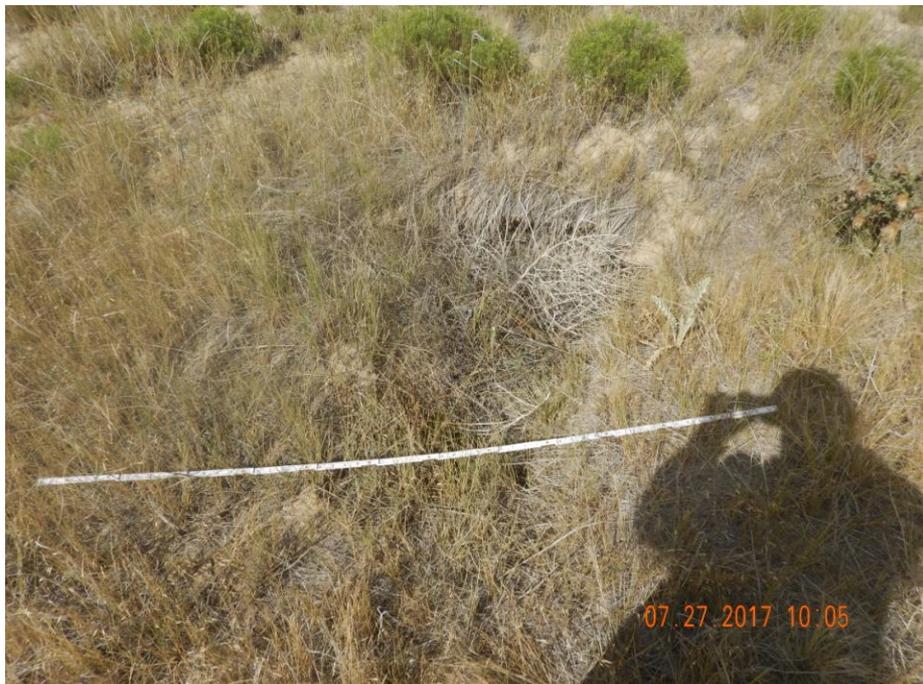
Photo 1: Photo taken from the location. Photo shows large hole on the location. Previous corrective actions required operator to repair hole. No work appears to have been conducted. 6 foot measuring stick for reference.

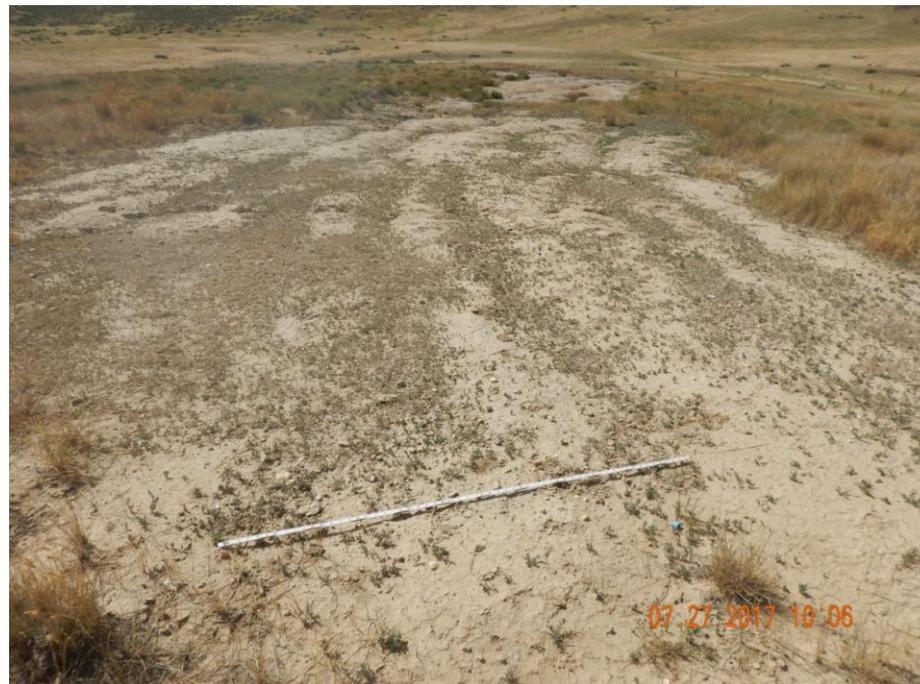
Photo 2: Photo taken from the south end of the location, facing south. Photo shows large un-vegetated area experiencing erosion. Photo shows stormwater and sediment control BMPs have not been installed per CAs from inspection doc. # 682501478 and doc # 682501125. Areas have continued to degrade due to erosion. 6 foot measuring stick for reference.

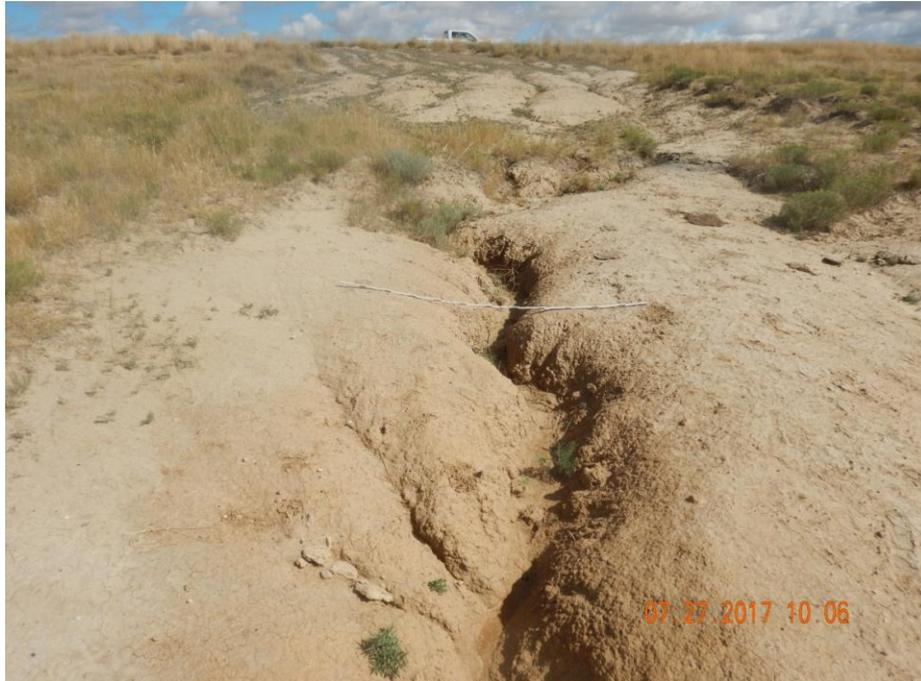
Photo 3: Photo taken from the south end of the un-vegetated area, facing north. Photo shows large un-vegetated area experiencing erosion. Photo shows stormwater and sediment control BMPs have not been installed per CAs from inspection doc. # 682501478 and doc # 682501125. Areas have continued to degrade due to erosion. 6 foot measuring stick for reference.

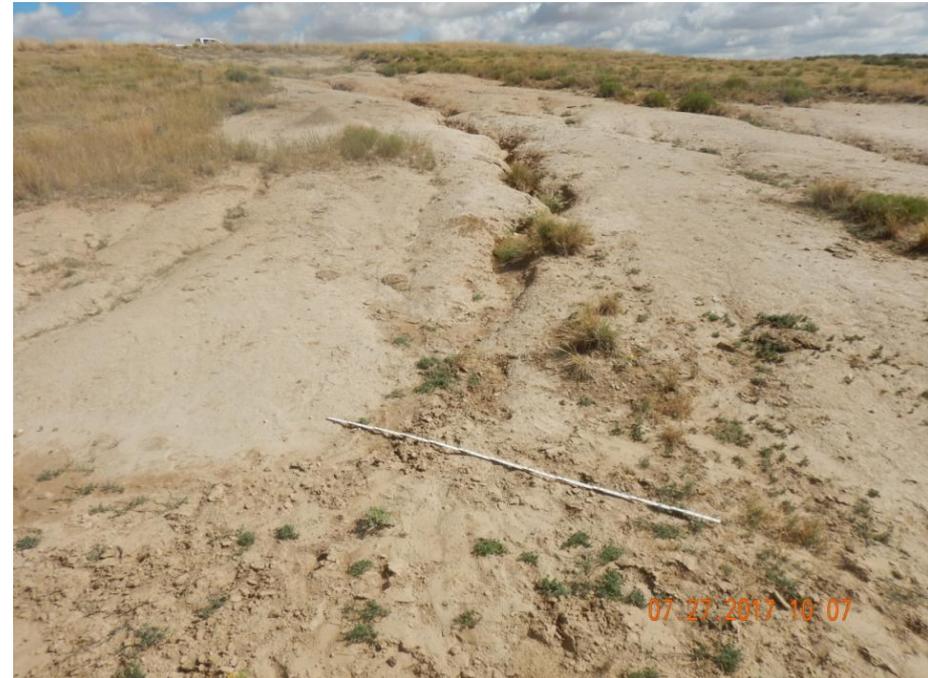
Photo 4: Photo taken from the southwest end of the un-vegetated area, facing north. Photo shows large un-vegetated area experiencing erosion. Photo shows stormwater and sediment control BMPs have not been installed per CAs from inspection doc. # 682501478 and doc # 682501125. Areas have continued to degrade due to erosion. 6 foot measuring stick for reference.

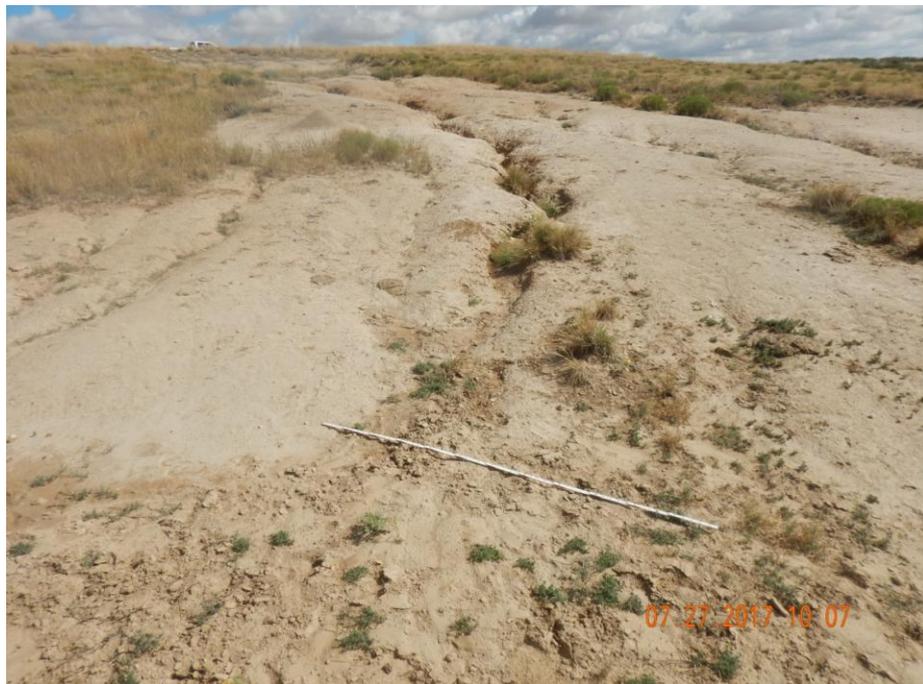
Photo 5: Photo taken from the southwest end of the unvegetated area, facing north. Photo shows large un-vegetated area experiencing erosion. Photo shows stormwater and sediment control BMPs have not been installed per CAs from inspection doc. # 682501478 and doc # 682501125. Areas have continued to degrade due to erosion. 6 foot measuring stick for reference.

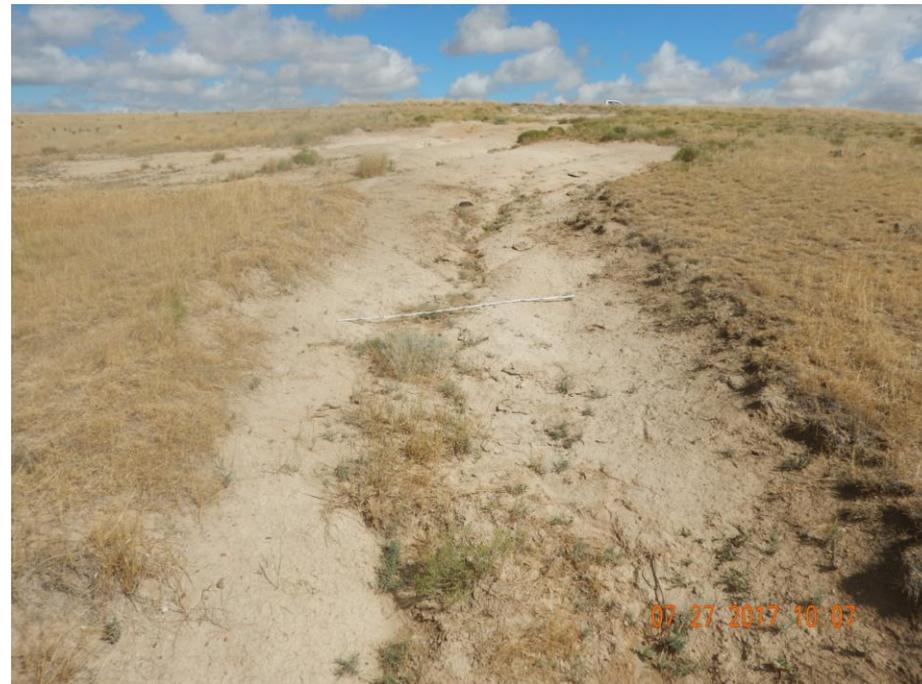
Photo 6: Photo taken from the southeast end of the unvegetated area, facing north. Photo shows large un-vegetated area experiencing erosion. Photo shows stormwater and sediment control BMPs have not been installed per CAs from inspection doc. # 682501478 and doc # 682501125. Areas have continued to degrade due to erosion. 6 foot measuring stick for reference.

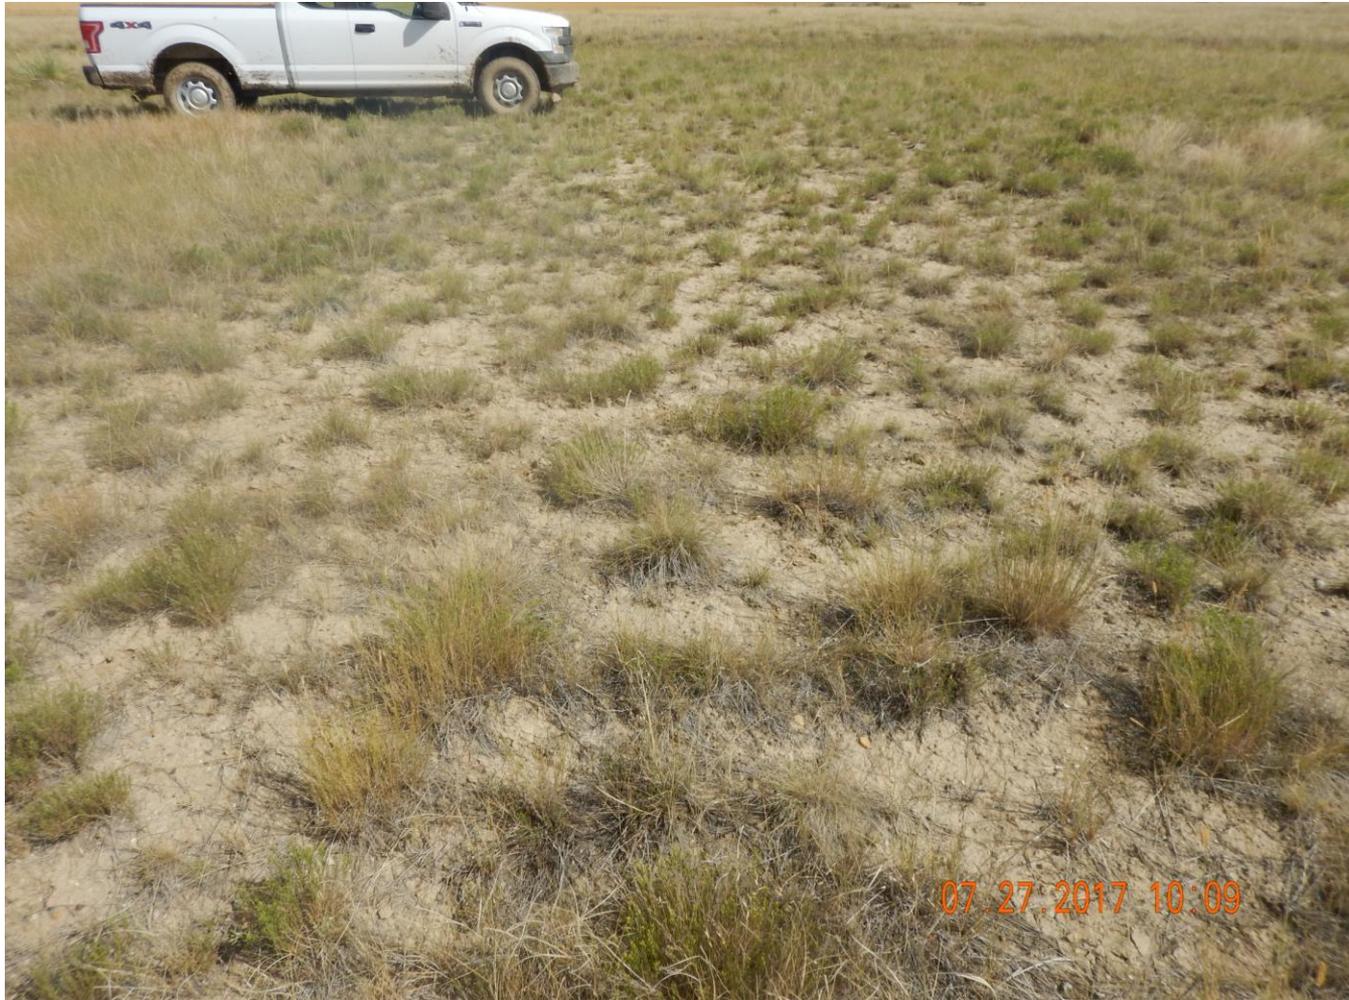
Photo 7: Photo taken from the well location. Photo shows vegetation has not achieved uniform desirable perennial vegetative cover to that of the reference. Photo also shows no additional reclamation activities have taken place per previous CAs
