Inspection Photos
Well API 123-14055

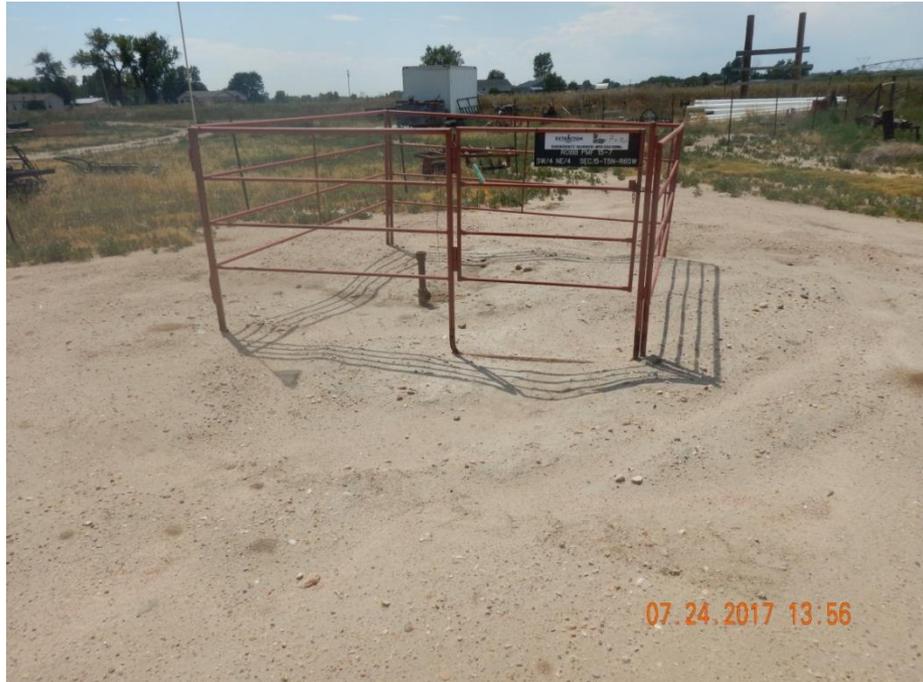
Photo 1: Photo taken from the Robb-PM #15-7 well location, facing west. Photo shows riser remaining at well location. Records indicate Bayswater as the last operator on record, however an extraction sticker has been placed on the sign.

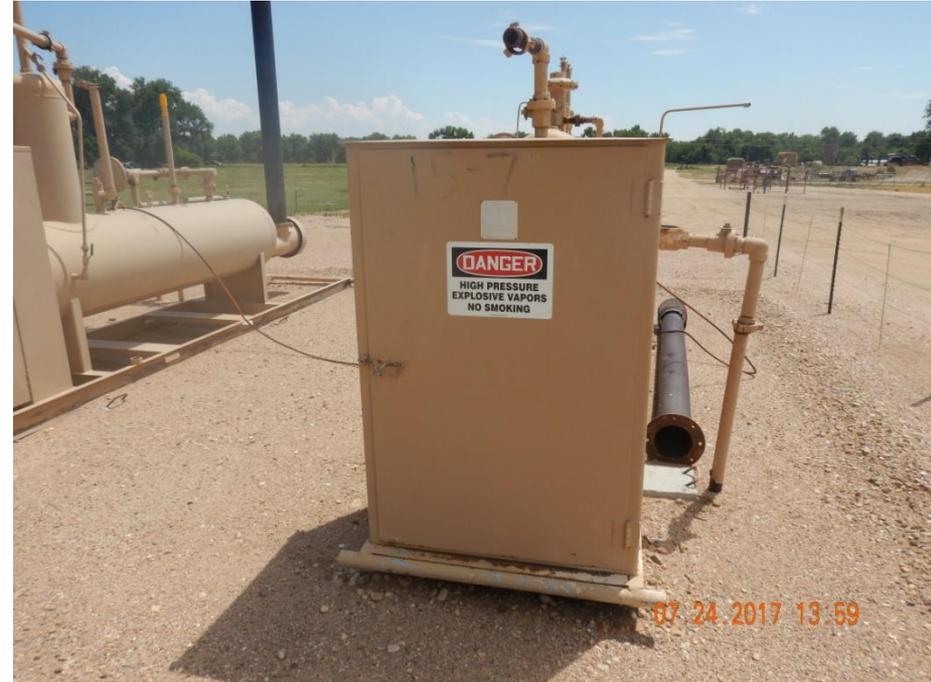
Photo 2: Photo taken from the Extraction battery location. Photo shows equipment associated with the Robb-PM F #15-7 appears to have been disconnected, but has not been removed per 1004.a.

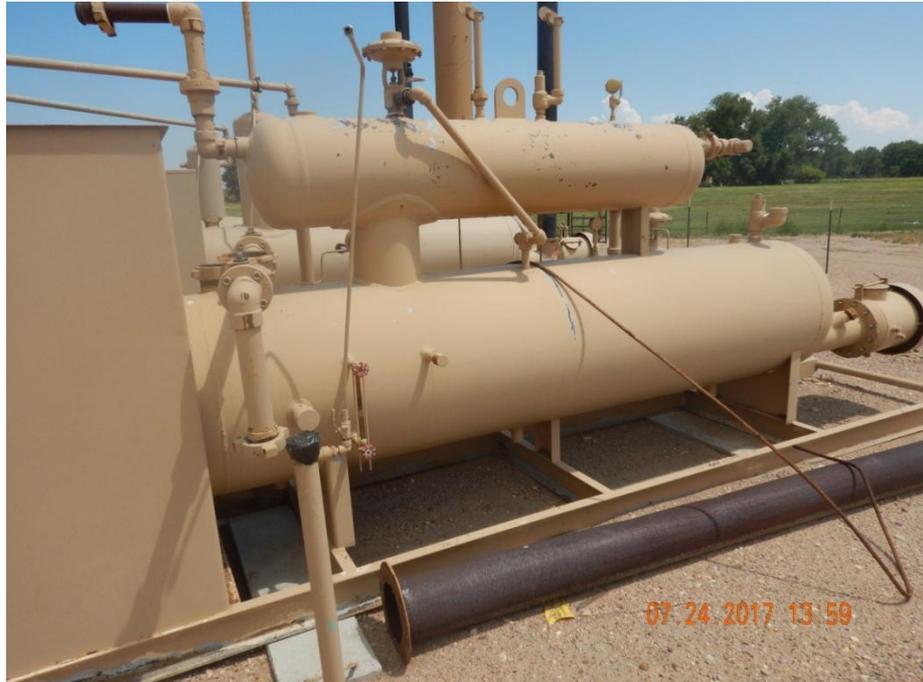
Photo 3: Photo taken from the Extraction battery location. Photo shows equipment associated with the Robb-PM F #15-7 appears to have been disconnected, but has not been removed per 1004.a.

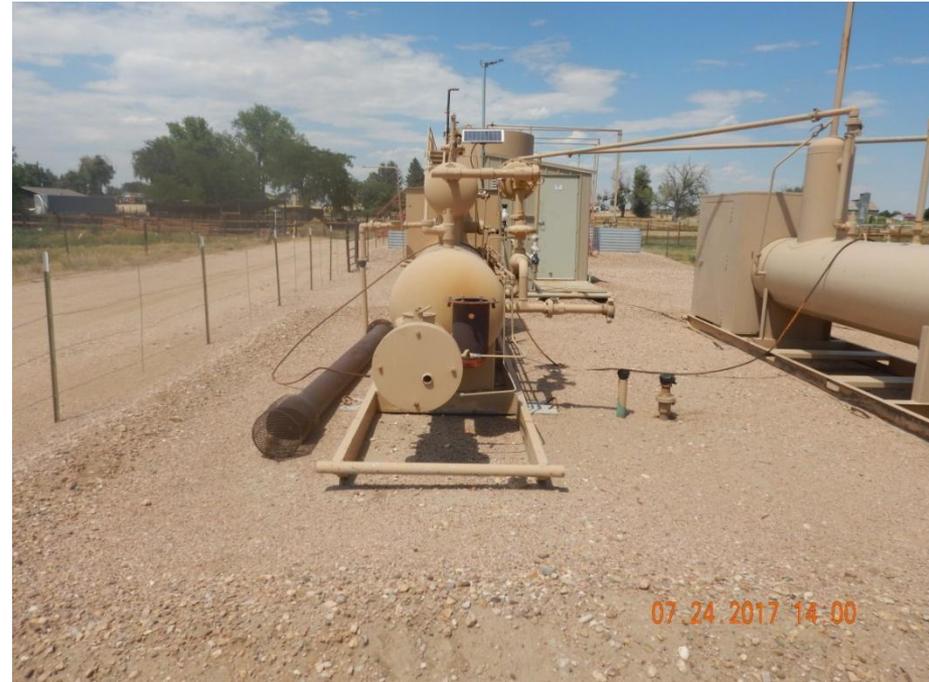
Photo 4: Photo taken from the Extraction battery location. Photo shows equipment associated with the Robb-PM F #15-7 appears to have been disconnected, but has not been removed per 1004.a. Photo also show risers that have not been marked or removed per phase I and II of the May 2, 2017 Flowline or Pipeline NTO, and per rule 1004.a.
