Inspection Photos
Location Name: Sidney Strear 1
API: 05-123-07883

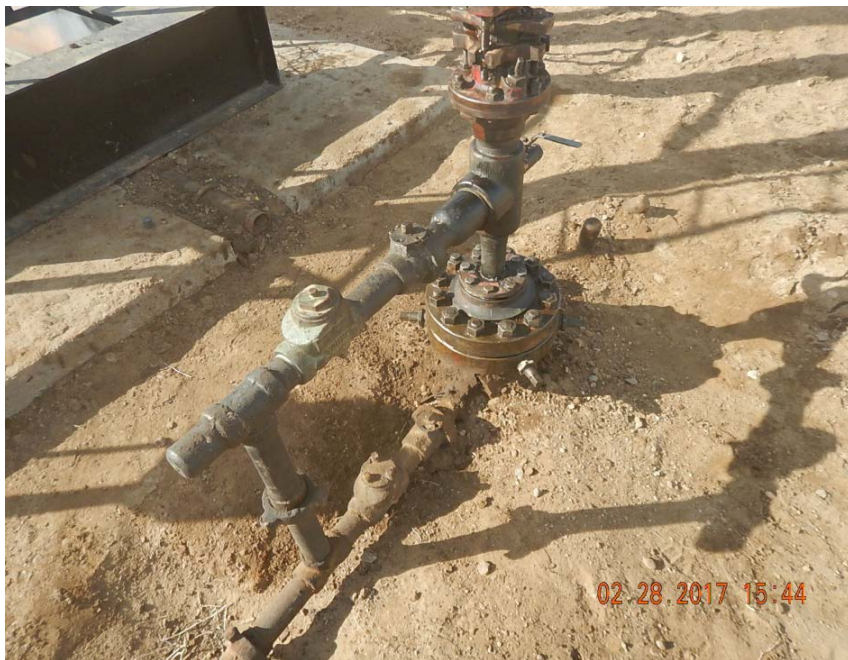
Photo from prior inspection for comparison

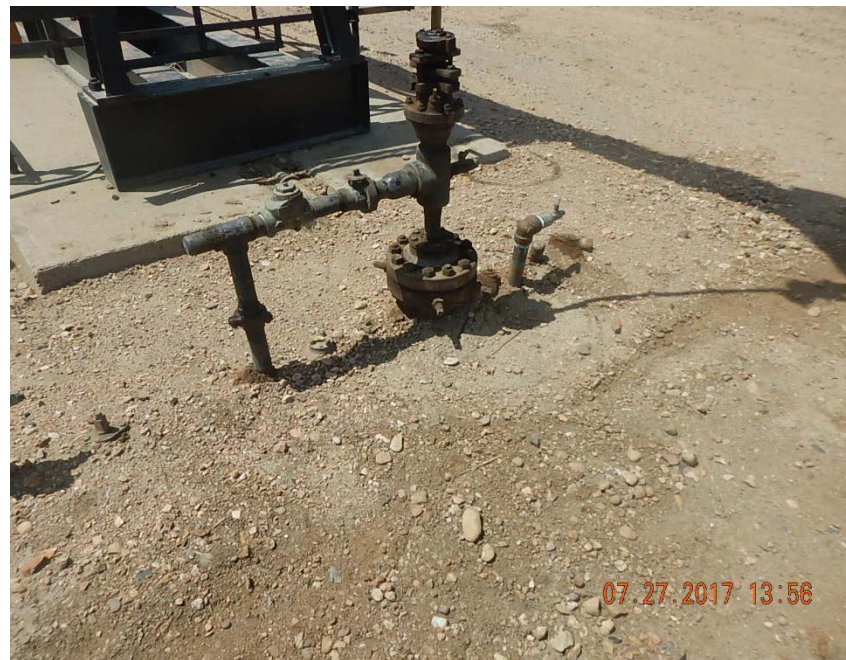
Photo 1: Stained soil at wellhead

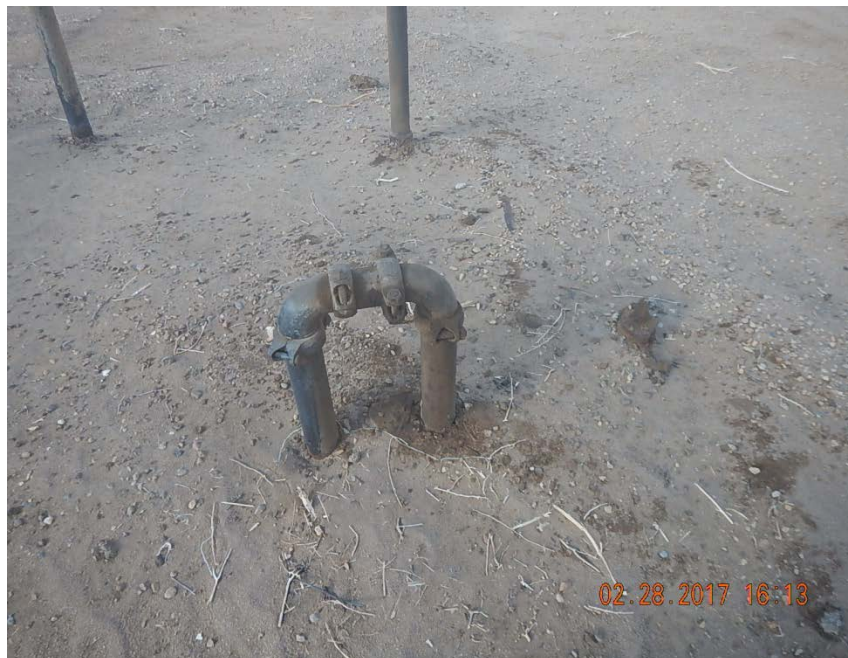
Photo from prior inspection for comparison

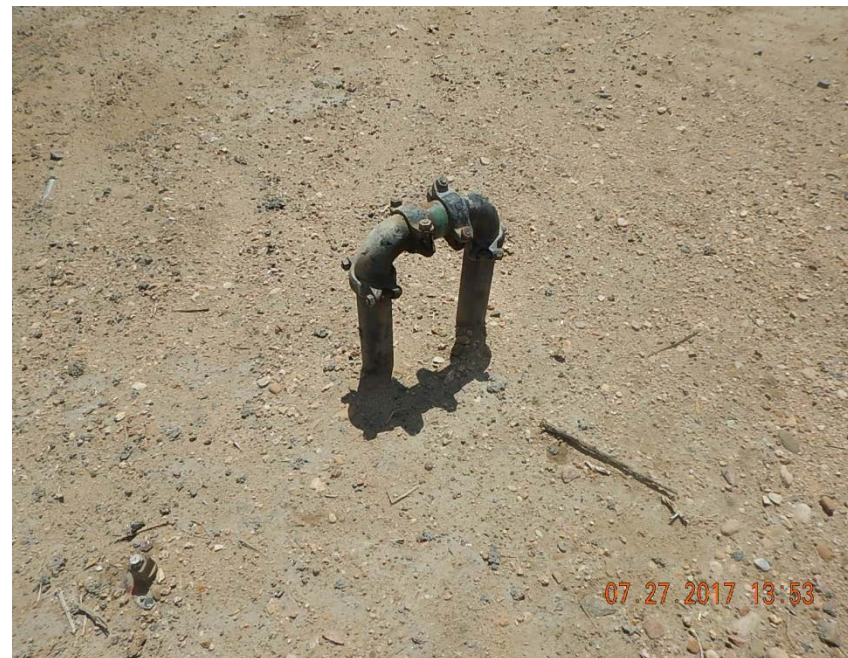
Photo 2: Stained soil at riser removed.

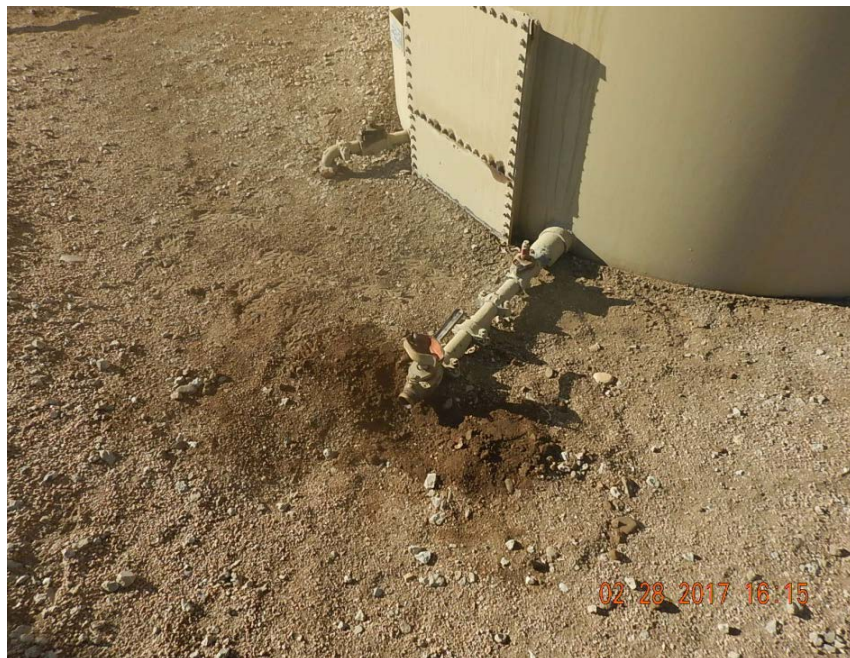
Photo from prior inspection for comparison

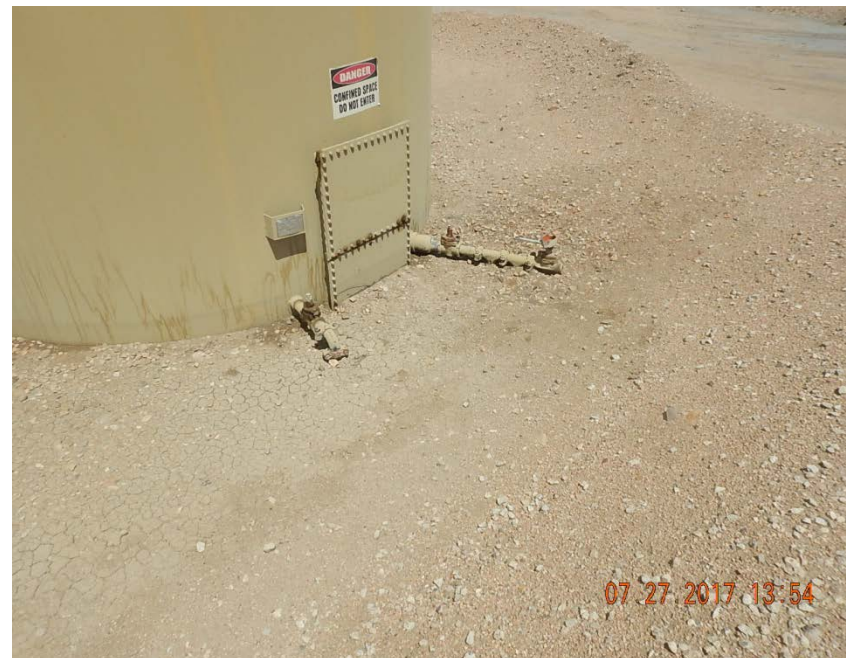
Photo 3: Stained soil removed

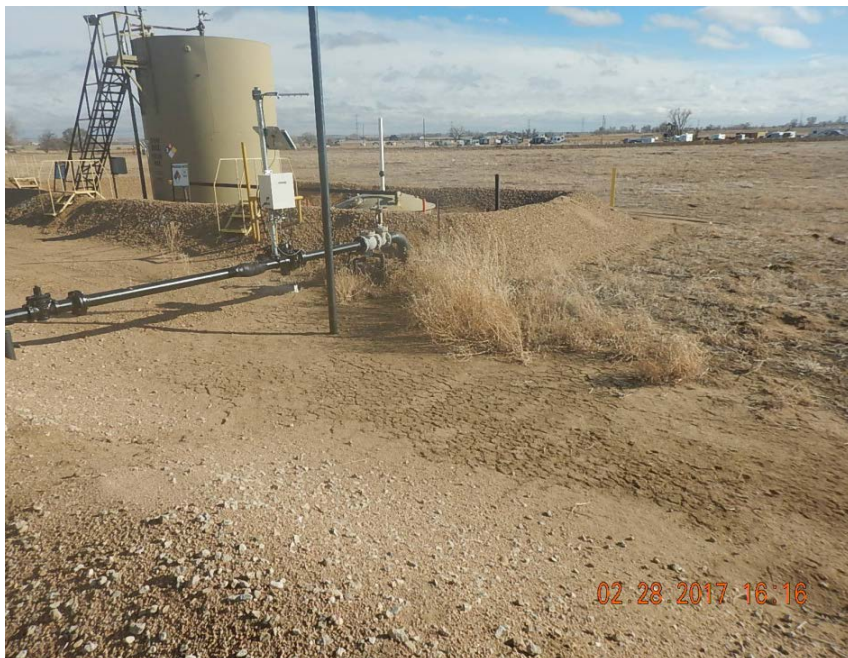
Photo from prior inspection for comparison

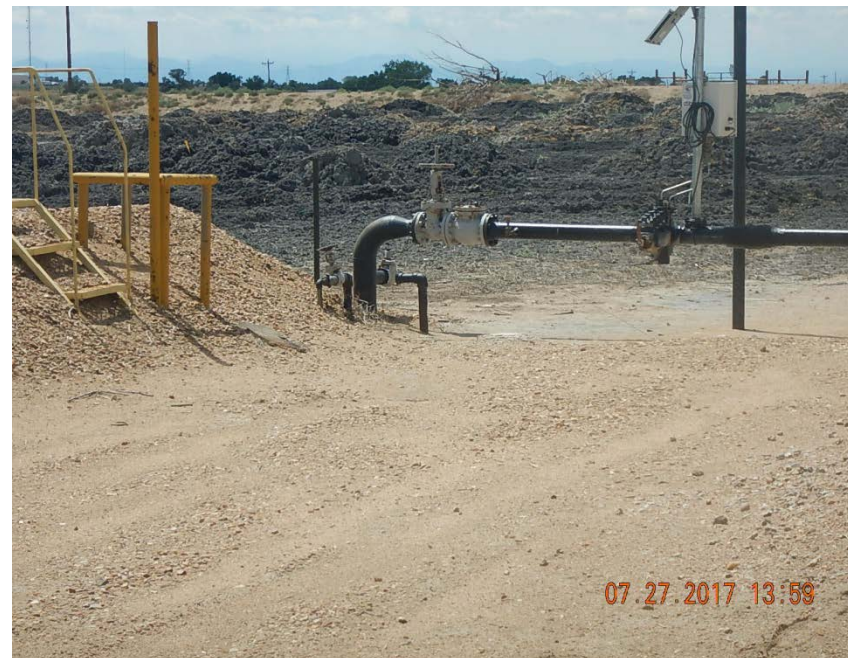
Photo 4: Weeds controlled

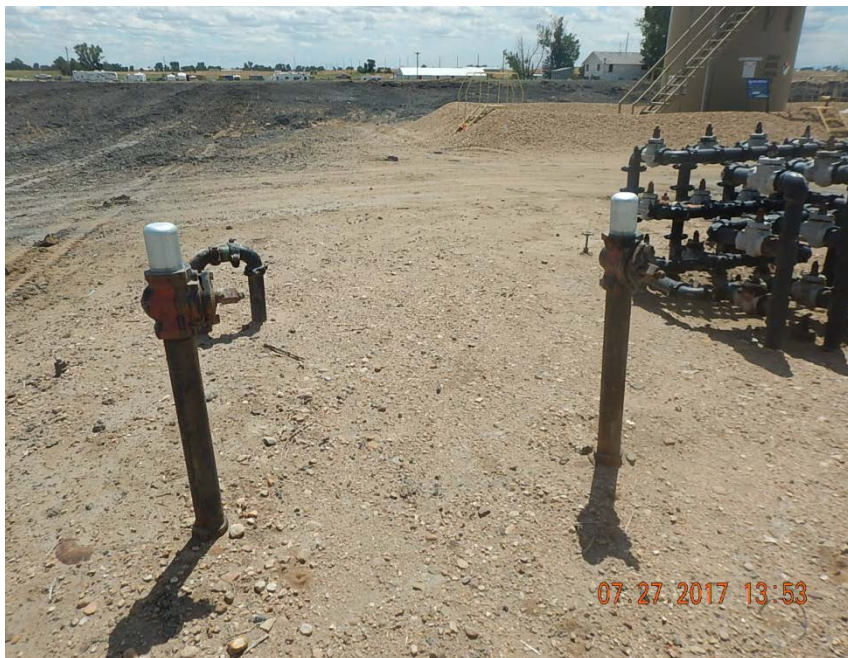
Photo 5: Risers at manifold

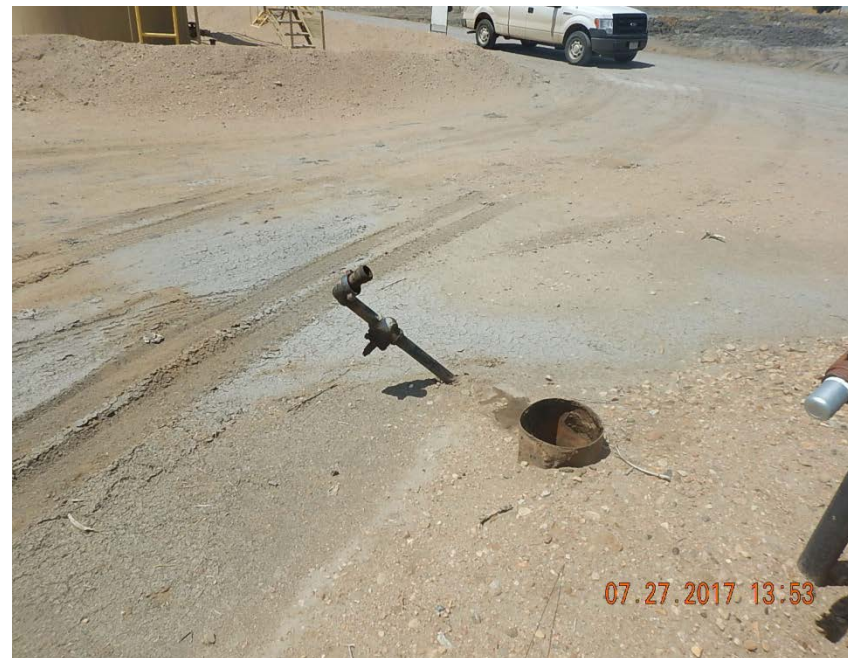
Photo 6: Riser, debris at manifold.
