Inspection Photos
Location Name: Lilli Unit #16-6
API: 05-123-13691

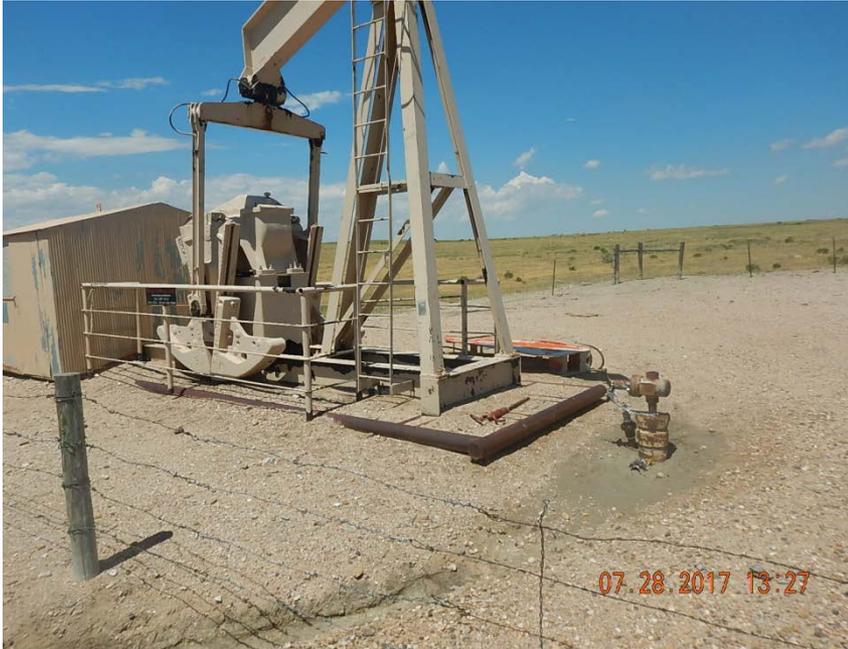
Photo 1: Wellhead, looking NW

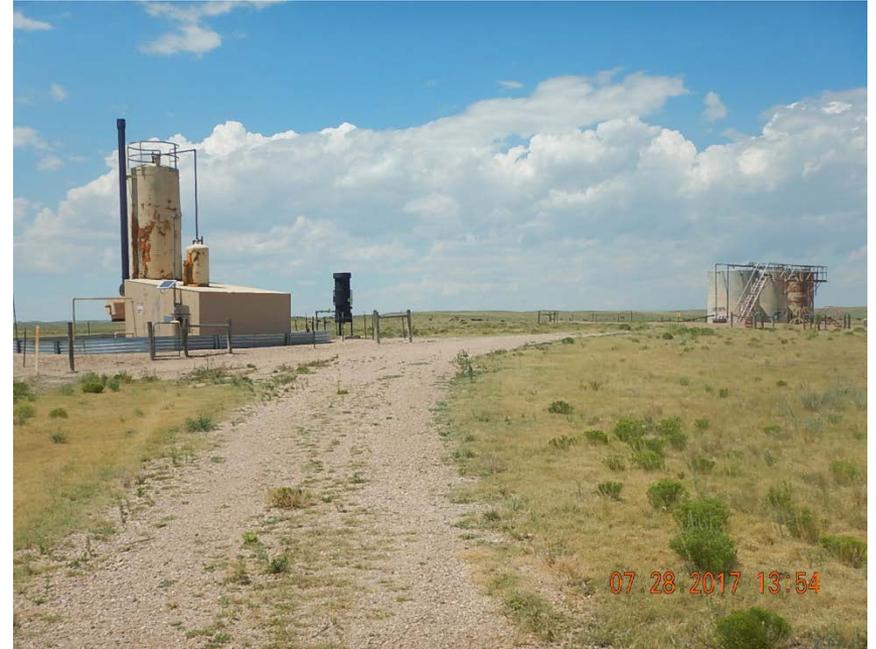
Photo 2: Location, looking NW

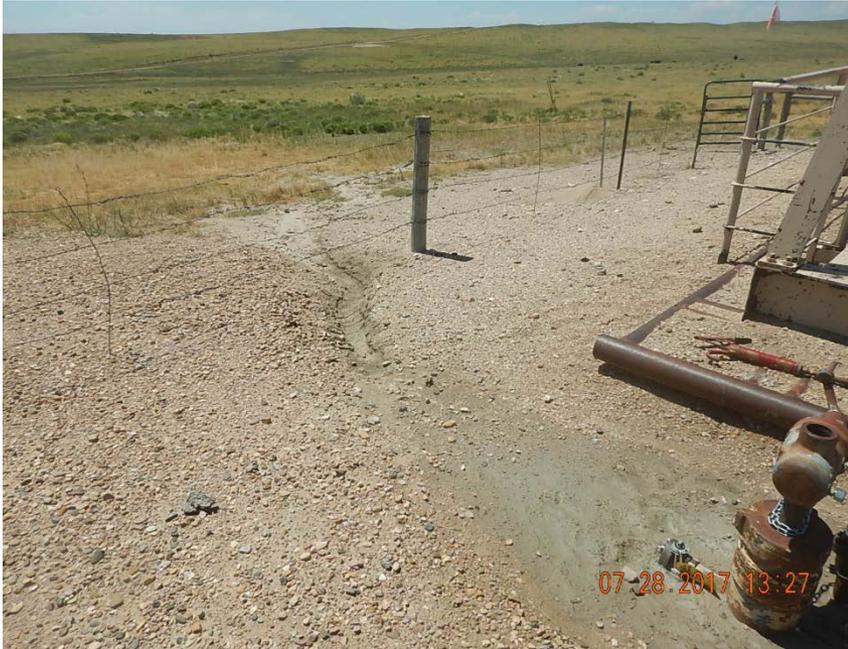
Photo 3: Stormwater erosion south off of wellhead
