COGCC conducted a follow-up inspection of the LC 15-01 location (Location ID 445191) on July 11, 2017 (Document 682402392). During that inspection, COGCC made the following observations:

Name: LC 15-01

Location ID: 445191

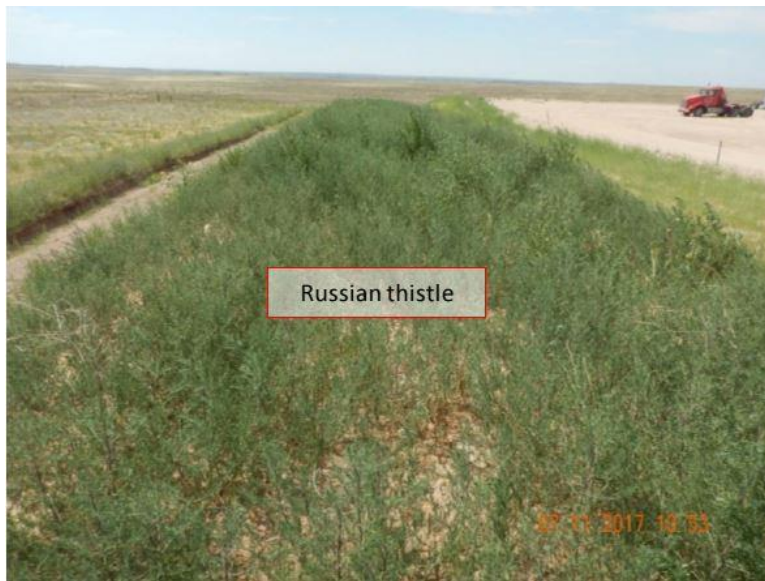
1. Weeds: Weedy, annual Russian thistle (*Salsola tragus*) and Kochia (*Kochia scoparia*) were observed throughout most disturbance areas, including topsoil stockpiles. Operator needs to control and manage both Russian thistle and Kochia using the best available practices, as this is weed waste and will spread onto adjacent lands. At maturity, Russian thistle often breaks off at the soil line and tumble long distances with the wind, widely dispersing seed for several kilometers (Stallings et al. 1995). Seed remains viable 2-3 years (Larimer County 5th Edition Weed Management Reference Guide).

Photo 1. Photo taken from the eastern pad on top of the topsoil stockpile, facing South. Topsoil stockpiles have predominately Russian thistle growth and Kochia growth which is not in compliance with Rule 1002.c. and Rule 1003. Hydromulch application was observed on the topsoil stockpile but is only a temporary BMP.

Photo NBL1. Weeds have been mowed where accessible, and weeds have been sprayed site-wide. Hydro-mulch will be applied once weeds die back.

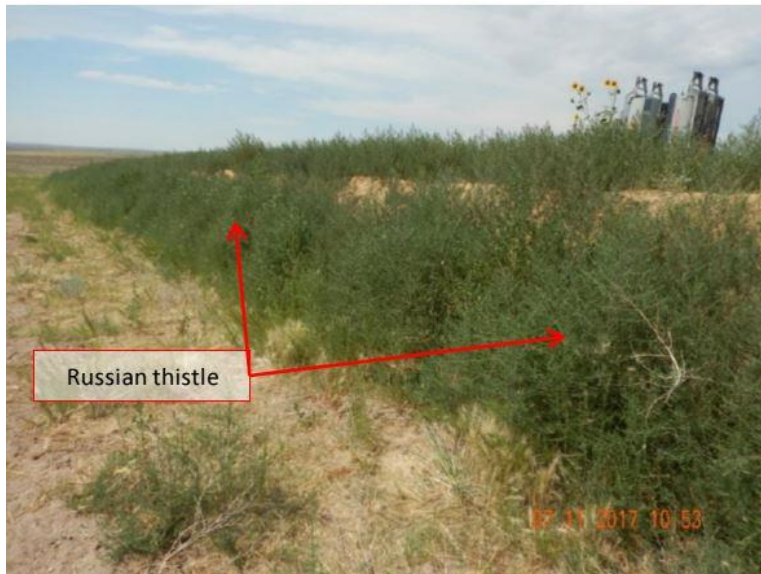
2. Protection of Soils: The topsoil stockpile has significant weed cover including Russian thistle and Kochia with no perennial vegetation that would compete with the weedy vegetation and generally work to decrease weed growth.

Photo 2. Photo taken from the eastern pad by the topsoil stockpile, facing South. Topsoil stockpiles were left with steep sides making it difficult to seed into for long-term stabilization and to prevent weed establishment.

Photo NBL2. Weeds have been mowed where accessible, and weeds have been sprayed site-wide. Once the weeds have died, slopes may be re-sloped and seeded or hydro-mulch may be reapplied for stabilization

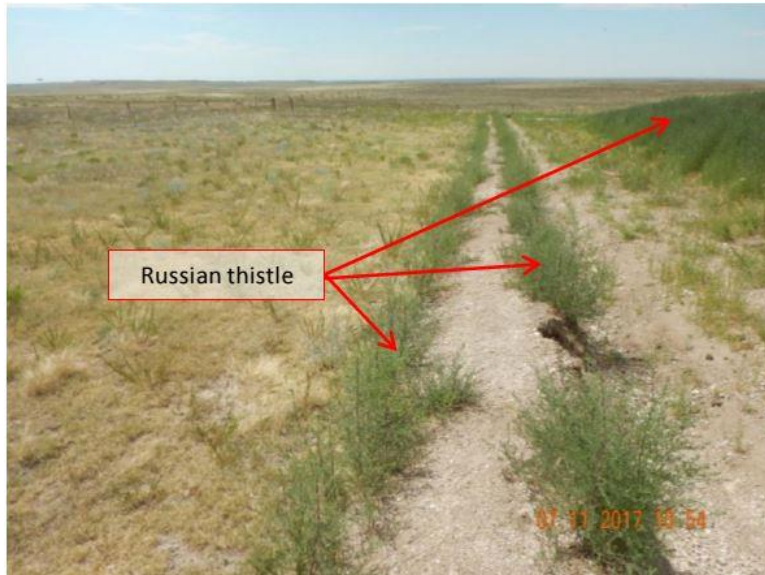
Photo 3. Photo taken from the eastern perimeter of the location facing South. Ditch and berm BMP installed along the entire perimeter of the location.

Photo NBL3. Weeds have been mowed where accessible, and weeds have been sprayed site-wide. Ditch was re-cut and cleaned out and perimeter ripping was reinstalled.

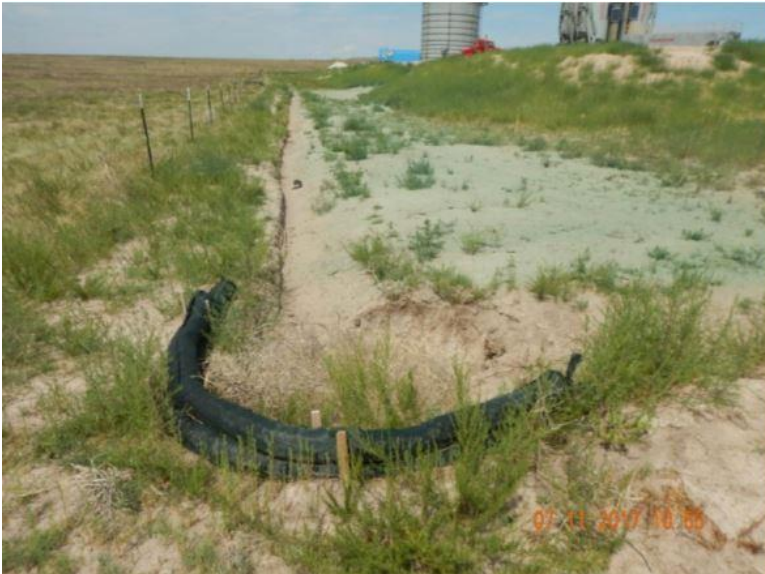
5. General: Per this inspection, stormwater controls were inadequate and the Operator has not installed sediment traps or other BMPs in accordance to their own BMP Manual. The Operator has failed to implement their suggested BMP specifications. For example, the two sediment traps installed for this location (totaling 6.4 acres of disturbance) have a sediment trap volume capacity for both dry and wet storage that equals approximately 144 ft³. Based off Noble's own BMP Manual, the required sediment trap volume for one acre is 3,600 ft³. Therefore, based off Nobles BMP Manual, the sediment trap volume for the entire location would require approximately 23,040 ft³ of sediment trap volume.

Photo 4. Photo taken from the southeast location, facing West. Sediment trap size was measured at ~6'x6'x2' (width x length x depth= 72ft³) with filtrex at the overflow point of the trap.

Photo NBL4. The sediment trap was enlarged and the ditches draining to this sediment trap were recut and cleaned out. Sediment traps are used in conjunction with other BMPs as needed to minimize the transportation of sediment in stormwater runoff

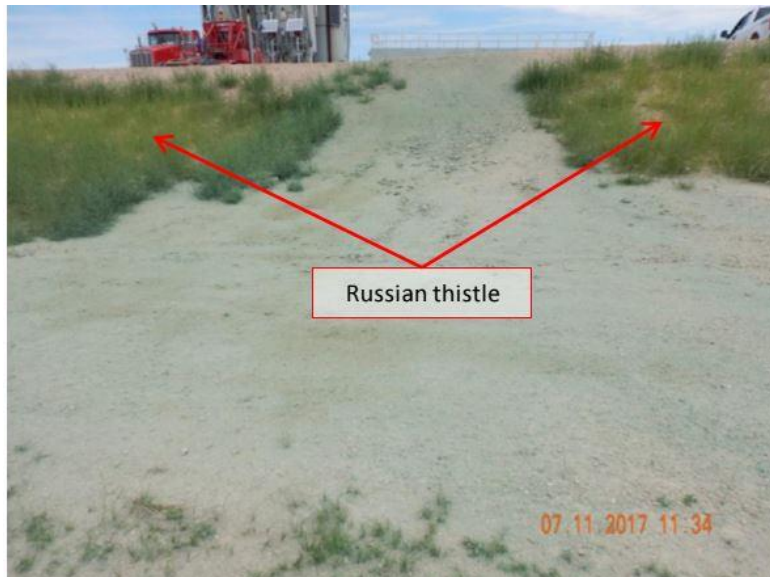
Photo 5. Photo taken from the southern perimeter of the location, facing North. Appears repairs have been conducted based off lack of vegetative growth, recent hydromulch application, and evidence of sediment discharge beyond the perimeter ditch and berm BMP.

Photo NBL5. Weeds site-wide have been sprayed, sediment from the discharge has been recovered, and berms at this location have been re-compacted. To avoid discharge from this point again an outlet was created on the top of the pad on the east side, with a trench and straw wattles placed approximately every 10-12' installed running south between the pad and topsoil pile connecting to perimeter ditches running into the sediment trap (see photo NBL11).

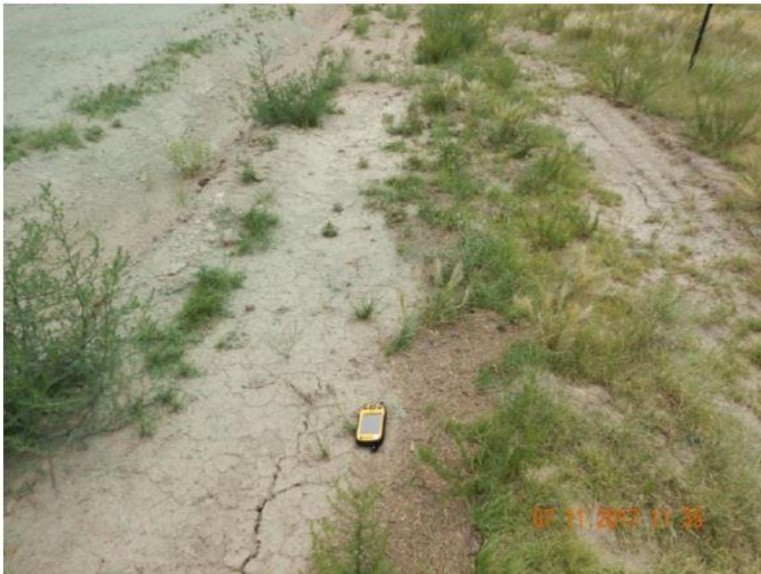
Photo 6. Photo taken from the previous photo location, facing East. Photo illustrates stormwater runoff appears to be washing sediment over the ditch and berm BMP off location. Refer to photo 7 for more detail.

Photo NBL6. Perimeter ditches have been re-cut and perimeter ripping was reinstalled (see photo NBL12). Sediment from this point was recovered.

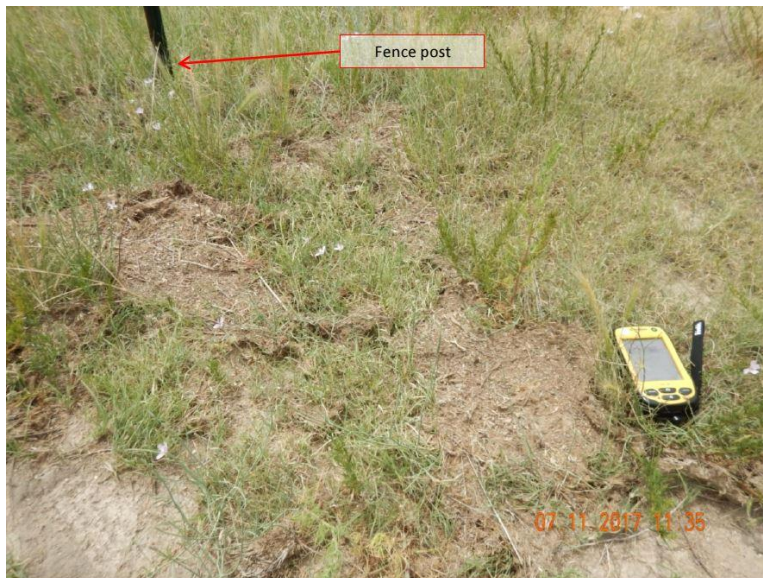
Photo 7. Close up photo taken from the southern perimeter of the location, illustrating stormwater runoff appears to be washing sediment over the ditch and berm BMP off location.

Photo NBL7. Sediment from this area has been recovered. Perimeter ditches and ripping were reinstalled to prevent future sediment loss (photo NBL13).

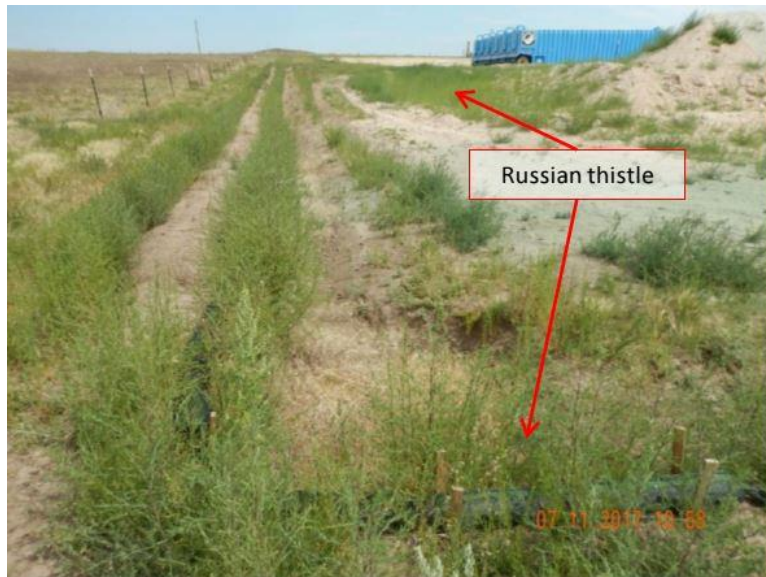
Photo 8. Photo taken from the southeast location, facing West. Sediment trap size was measured at ~6'x6'x2' (width x length x depth= 72ft³) with filtrex at the overflow point of the trap.

Photo NBL8. Weeds have been mowed and sprayed and the slope is still stabilized with hydro-mulch. A ditch to direct runoff to the perimeter ditches and ripping were installed. Sediment traps are used in conjunction with other BMPs as needed to minimize the transportation of sediment in stormwater runoff

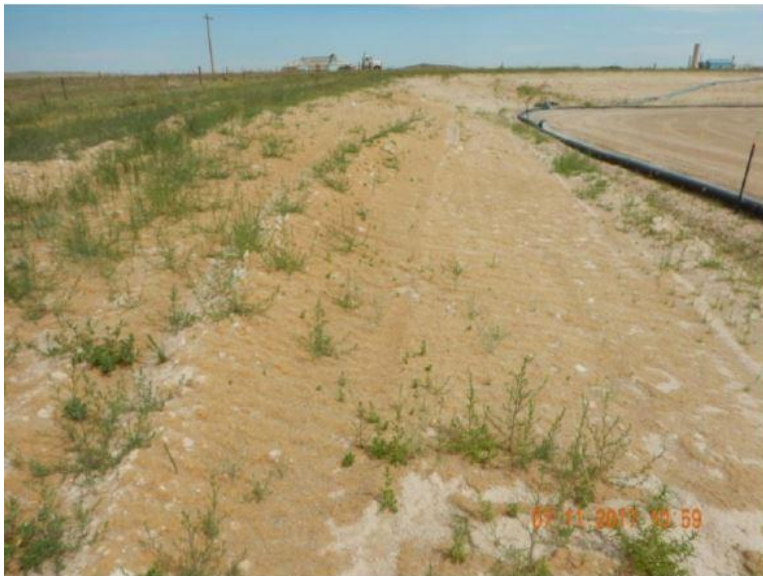
3. Noxious Weeds: Vegetation in portions of the interim reclamation area is predominantly undesirable weedy plant species, Russian thistle and Kochia, and is likely hindering the establishment of desirable vegetation. These areas will need to be reseeded to establish a uniform vegetation cover of at least eighty (80) percent of reference area levels.

Photo 9. Photo taken from the western perimeter of the location, facing North. Cut slope appears to be stabilized with hydromulch but is only a temporary BMP.

Photo NBL9. Weeds have been mowed and sprayed and the slope is stabilized with hydro-mulch. A ditch to direct runoff to the perimeter ditches and ripping were installed (photo NBL14).

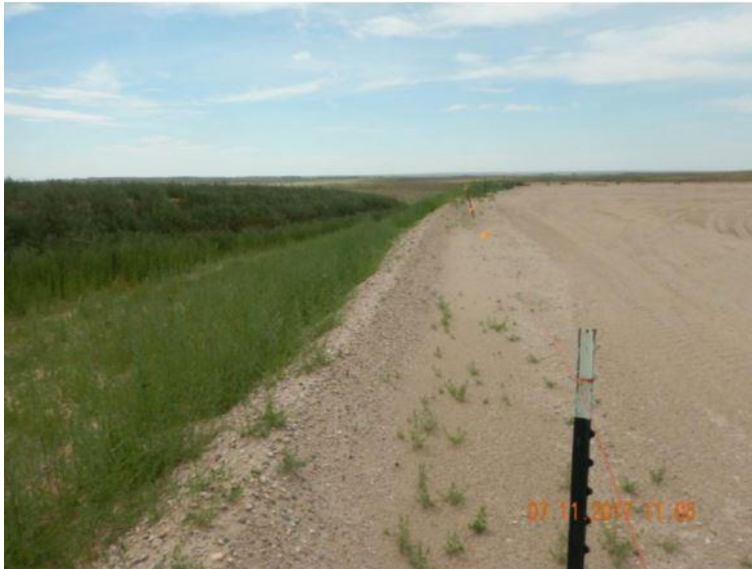
Photo 10. Photo taken from the eastern pad, facing South. A berm ~18" has been constructed along the west, east and south pad perimeter, but does not appear to be properly compacted.

Photo NBL10. All berms on pad have been repaired with fresh road base and recompact. The exit point for water created using a ditch to direct water to the perimeter ditches and sediment trap (photos NBL15, NBL16, NBL17)
