COGCC conducted an inspection of the LC11-13 location (Location ID 445209) on April 3, 2017 (Document 682401989). During that inspection, COGCC made the following observations:

Name: LC11-13

Location ID: 445209

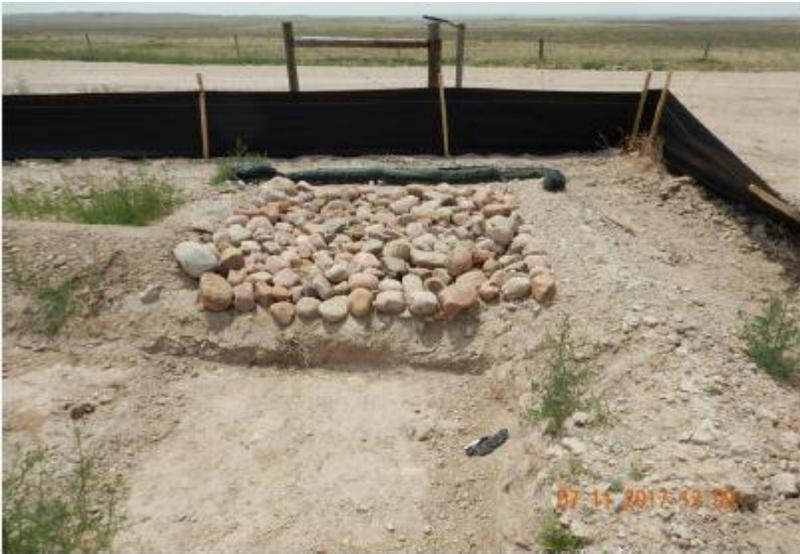
Photo 1 Photo taken from the southwest Holliday pad, facing South. Sediment trap size was measured at ~5’x4’x1.5’ (width x length x depth= 30ft³) with a stabilized outlet. Silt fence BMP has not been properly installed. Silt fence is only pinned down and not buried/back-filled/compacted. Also, silt fence stakes should be installed to the outside of the silt fence, not inside of the silt fence.

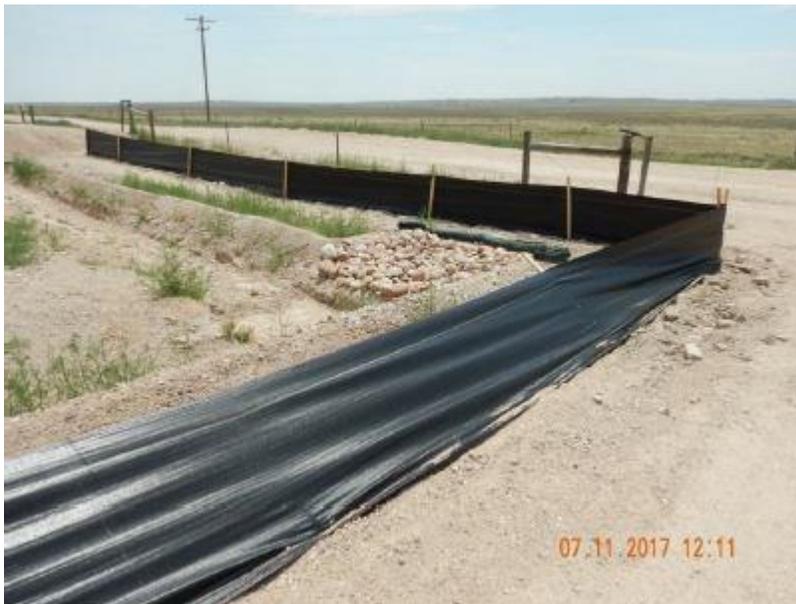
Photo 2. Photo taken from the southwest Holliday pad, facing Southeast. Silt fence BMP has not been properly installed. Silt fence is only pinned down and not buried/back-filled/compacted. Also, silt fence stakes should be installed to the outside of the silt fence, not inside of the silt fence

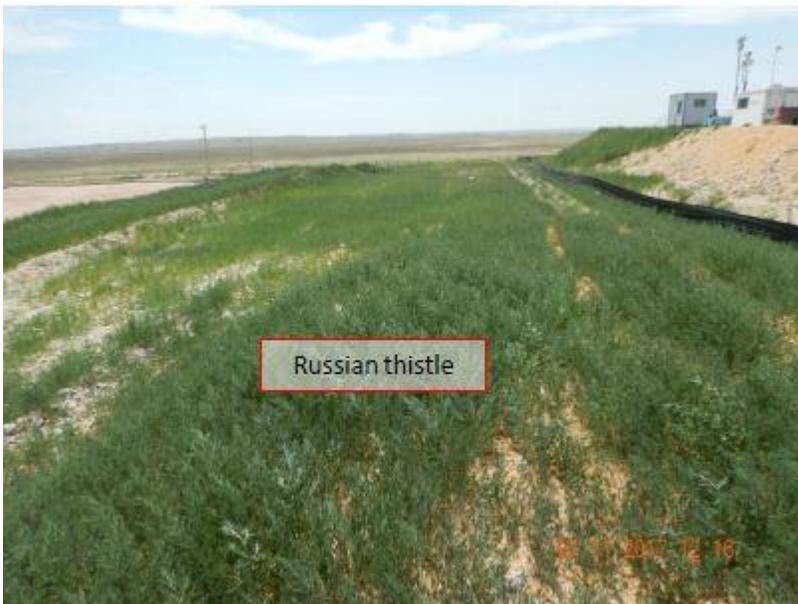
Photo 3. Photo taken between the Holliday pad and Tombstone pad on top of the topsoil stockpiles, facing South. Topsoil stockpile has predominately Russian thistle growth and Kochia growth which is not in compliance with Rule 1002.c. and Rule 1003. Hydromulch application was observed on the topsoil stockpile but is only a temporary BMP.

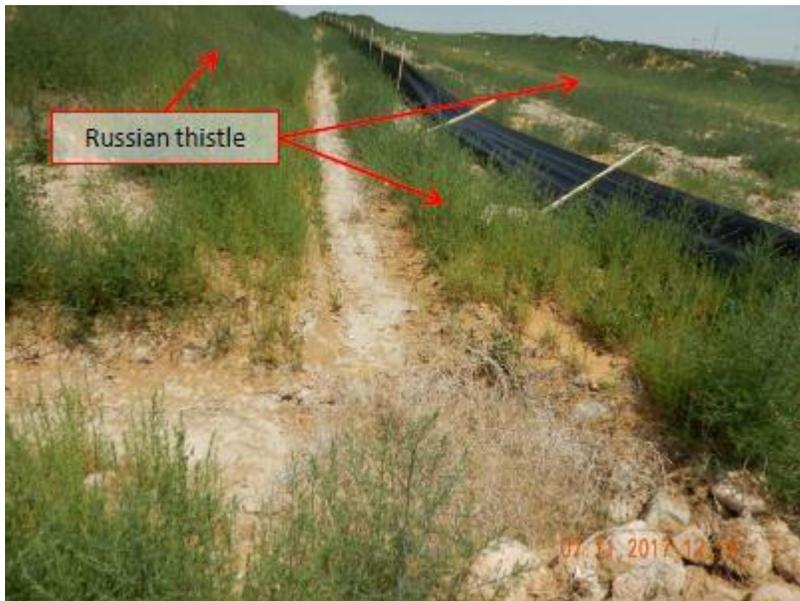
Photo 4. Photo taken from the southeast Holliday pad, facing North. Sediment trap size was measured at ~5'x4'x1.5' (width x length x depth= 30ft³) with a stabilized outlet.. Silt fence has not been properly installed. Silt fence is only pinned down and not buried/back-filled/compacted. Also, silt fence stakes should be installed to the outside of the silt fence, not inside of the silt fence. Russian thistle growth observed throughout most disturbance areas.

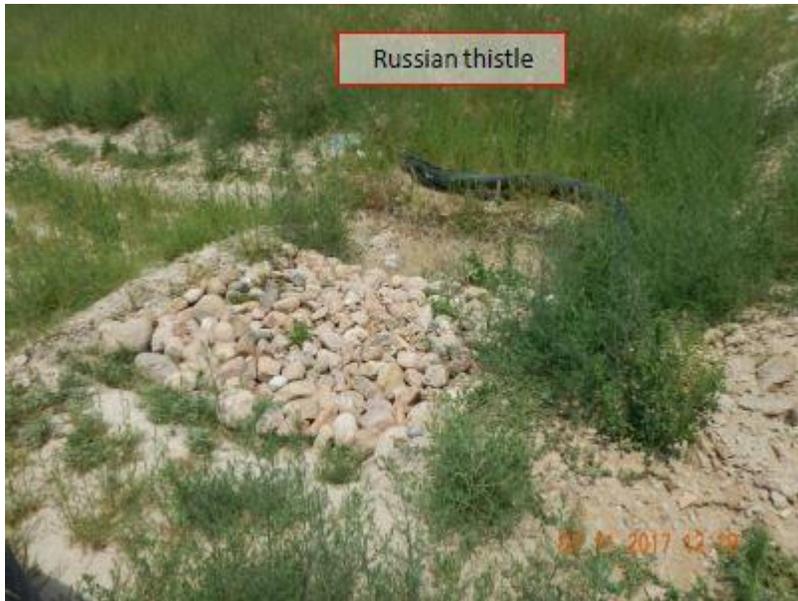
Photo 5. Photo taken from the southeastern Holliday pad, facing North. Sediment trap size was measured at ~5’x4’x1.5’ (width x length x depth= 30ft³) with a stabilized outlet.

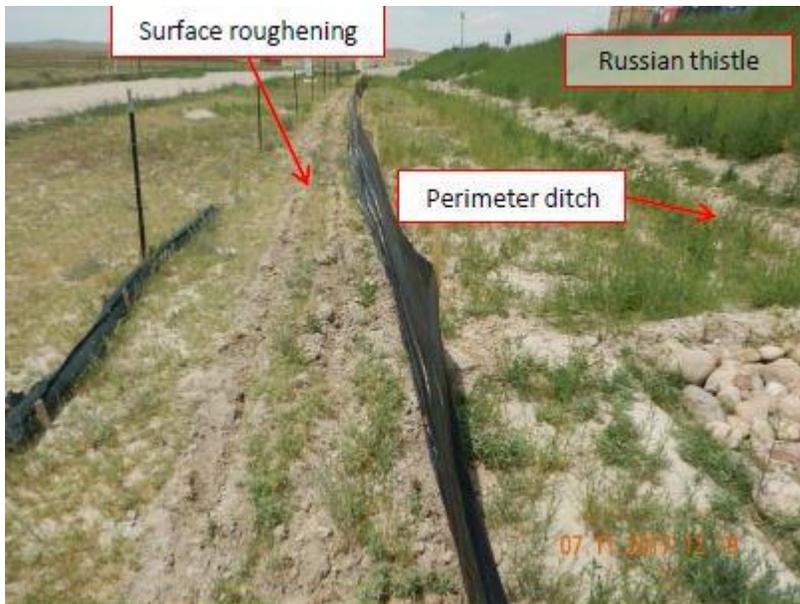
Photo 6. Photo taken from the southeastern Holliday pad, facing West. Silt fence improperly installed outside of the perimeter ditch, then surface roughening with filtrex BMP along a portion of the southeastern perimeter. Silt fence is only pinned down and not buried/back-filled/compacted. Also, silt fence stakes should be installed to the outside of the silt fence, not inside of the silt fence.

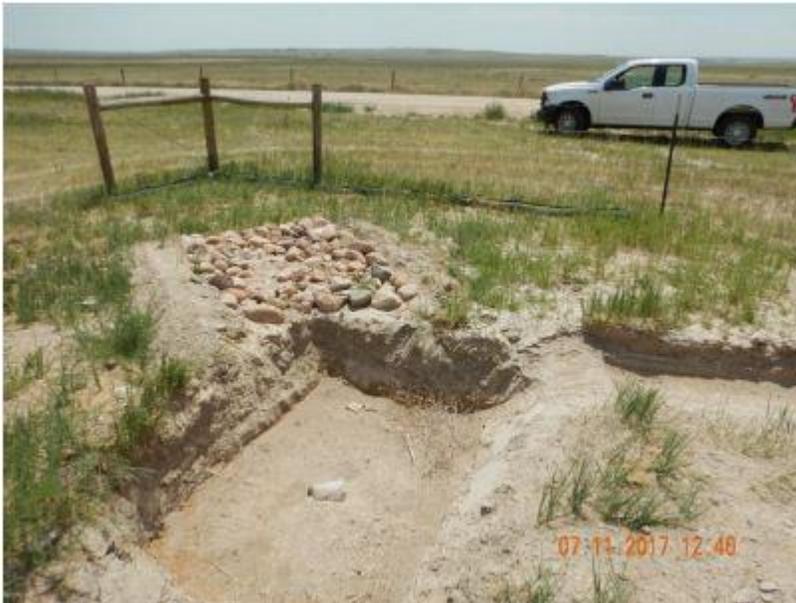
Photo 7. Photo taken from the southeast location of the Tombstone pad, facing South. Sediment trap size was measured at ~7'x4.5'x2' (width x length x depth= 63ft³) with a stabilized outlet. Sediment discharge was observed beyond the outlet area and beyond the filtrex BMP along the corner of the fence. Refer to photos 9 & 10..

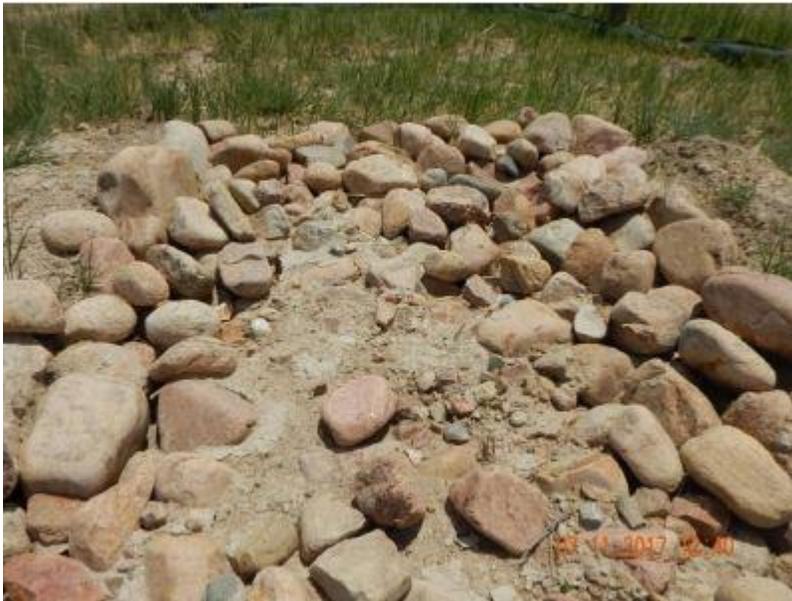
Photo 8. Close up photo taken from the outlet area of the sediment trap illustrating sediment build up which indicate the sediment trap is not built to a sufficient size.

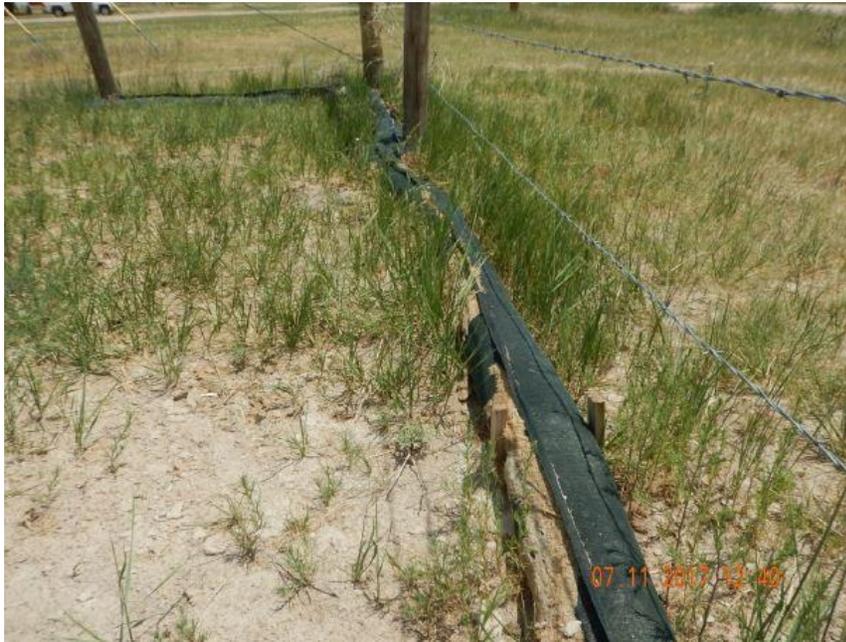
Photo 9. Close up photo taken just beyond the sediment trap at the corner of the fence, illustrating stormwater runoff appears to be washing hydromulch material and sediment off location over the filtrex BMP.

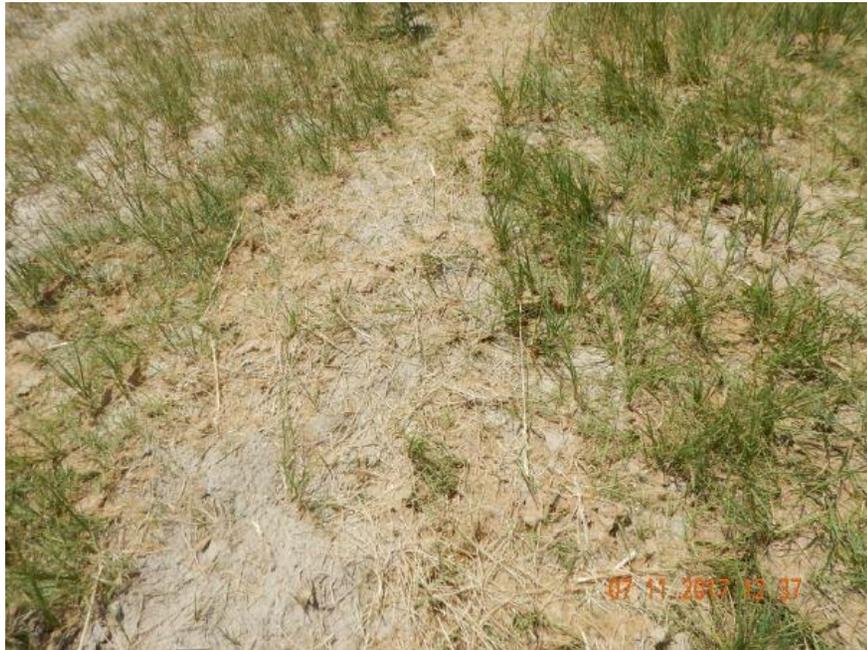
Photo 10. Close up photo taken just beyond the corner of the fence, illustrating stormwater runoff appears to be washing hydromulch material and sediment off location.

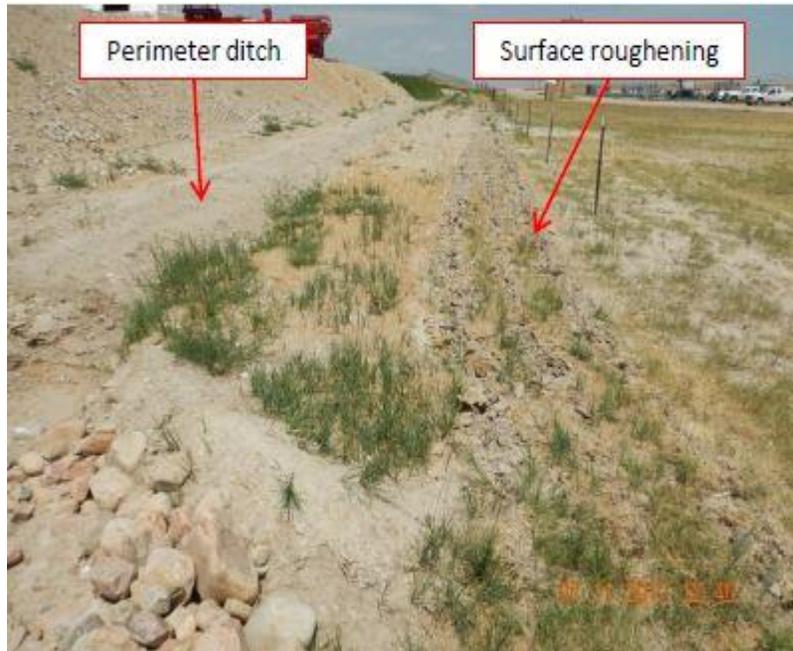
Photo 11. Photo taken from the southeast location of the Tombstone pad, facing North. Perimeter ditch with surface roughening BMP installed along the eastern perimeter. Portions of the fill slope may need additional stabilization as it appears hydromulch does not appear to be consistently observed throughout.

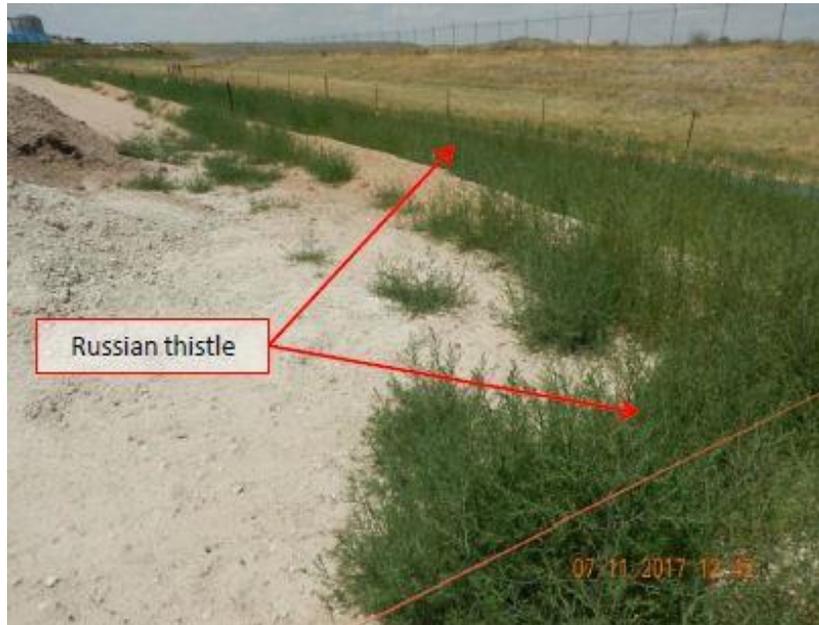
Photo 12. Photo taken from the northeast location of the Tombstone pad, facing Northwest. A berm ~18" has been constructed along the north, east and south pad perimeter, but does not appear to be properly compacted.

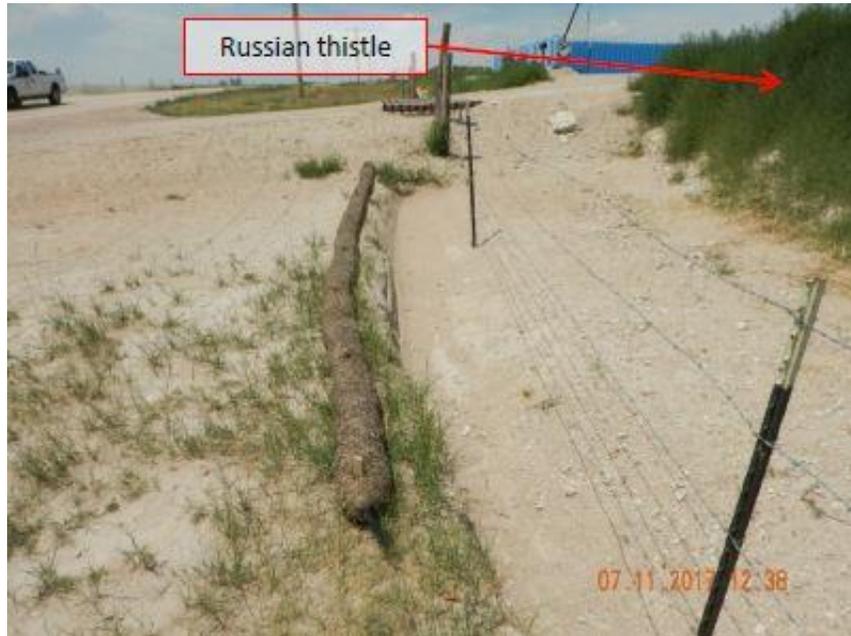
Photo 13. Photo taken from the entrance of the Tombstone pad, facing West. Straw wattle BMP does not appear to be properly installed and therefore not properly functioning.
