*Figure 1 – Crude oil tanks at LBDSU Battery, COGCC Facility ID #451504. Note crude oil stain at truck loadout.*

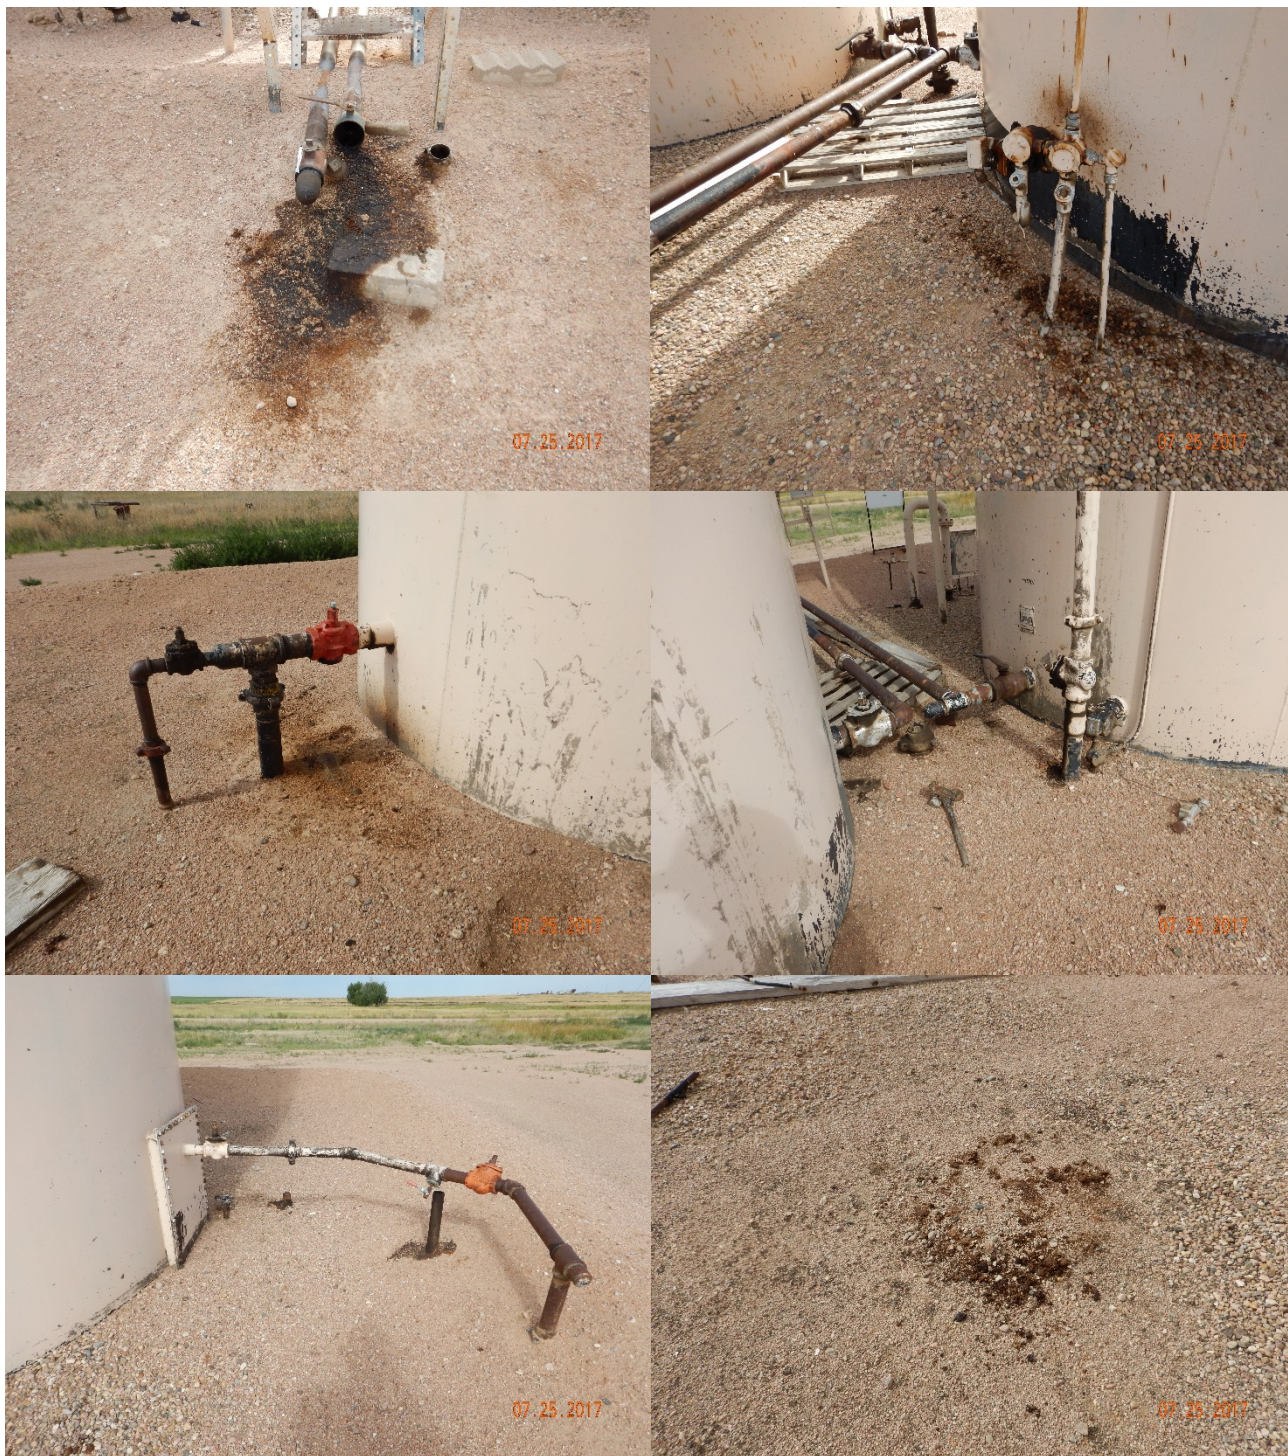
*Figure 2 - Localized, oil-stained soil at multiple locations associated with crude oil ASTs.*

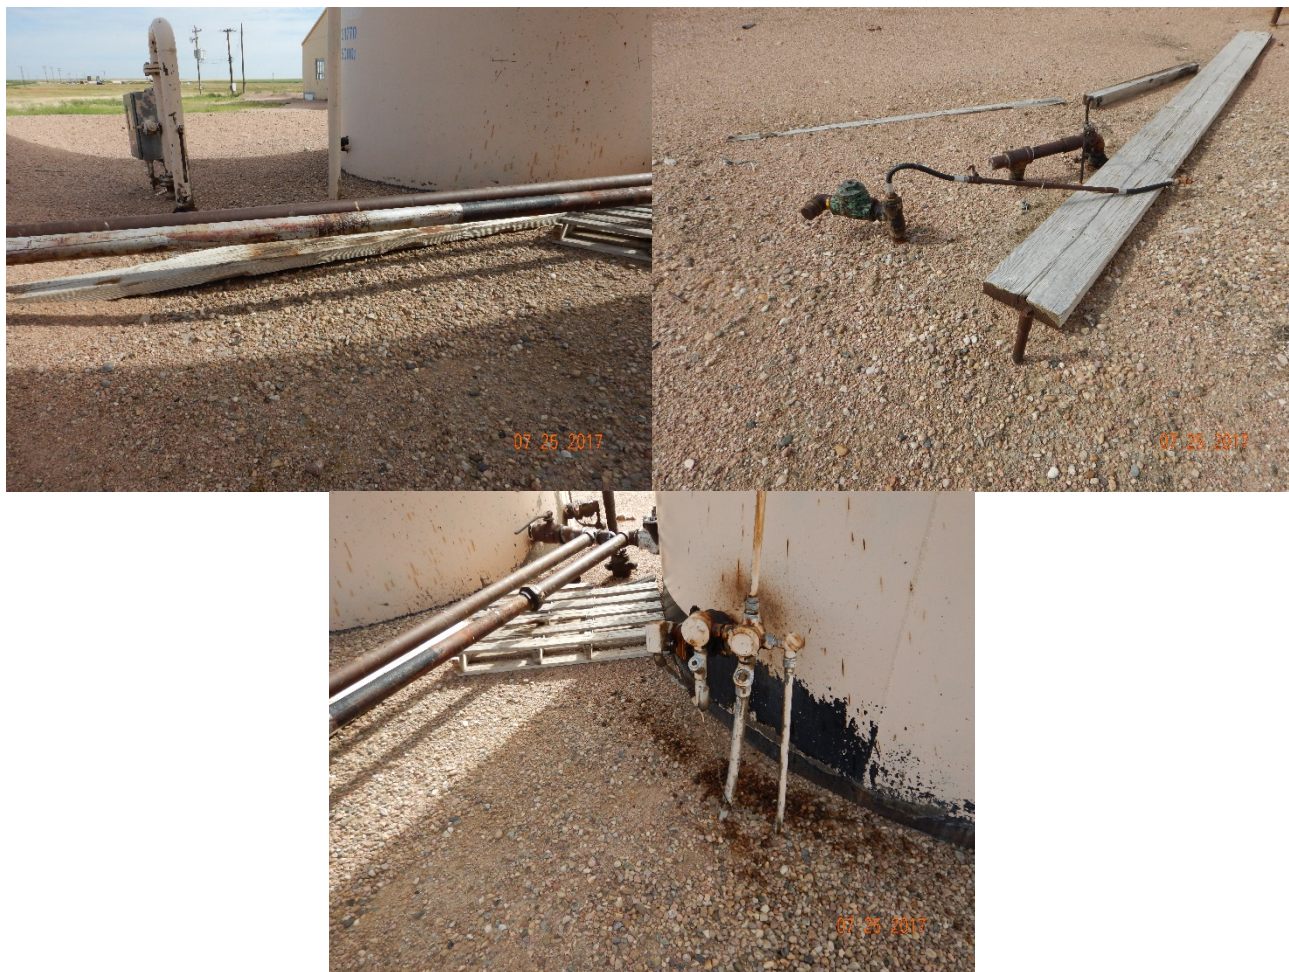
*Figure 3 - Wood debris at crude oil ASTs.*

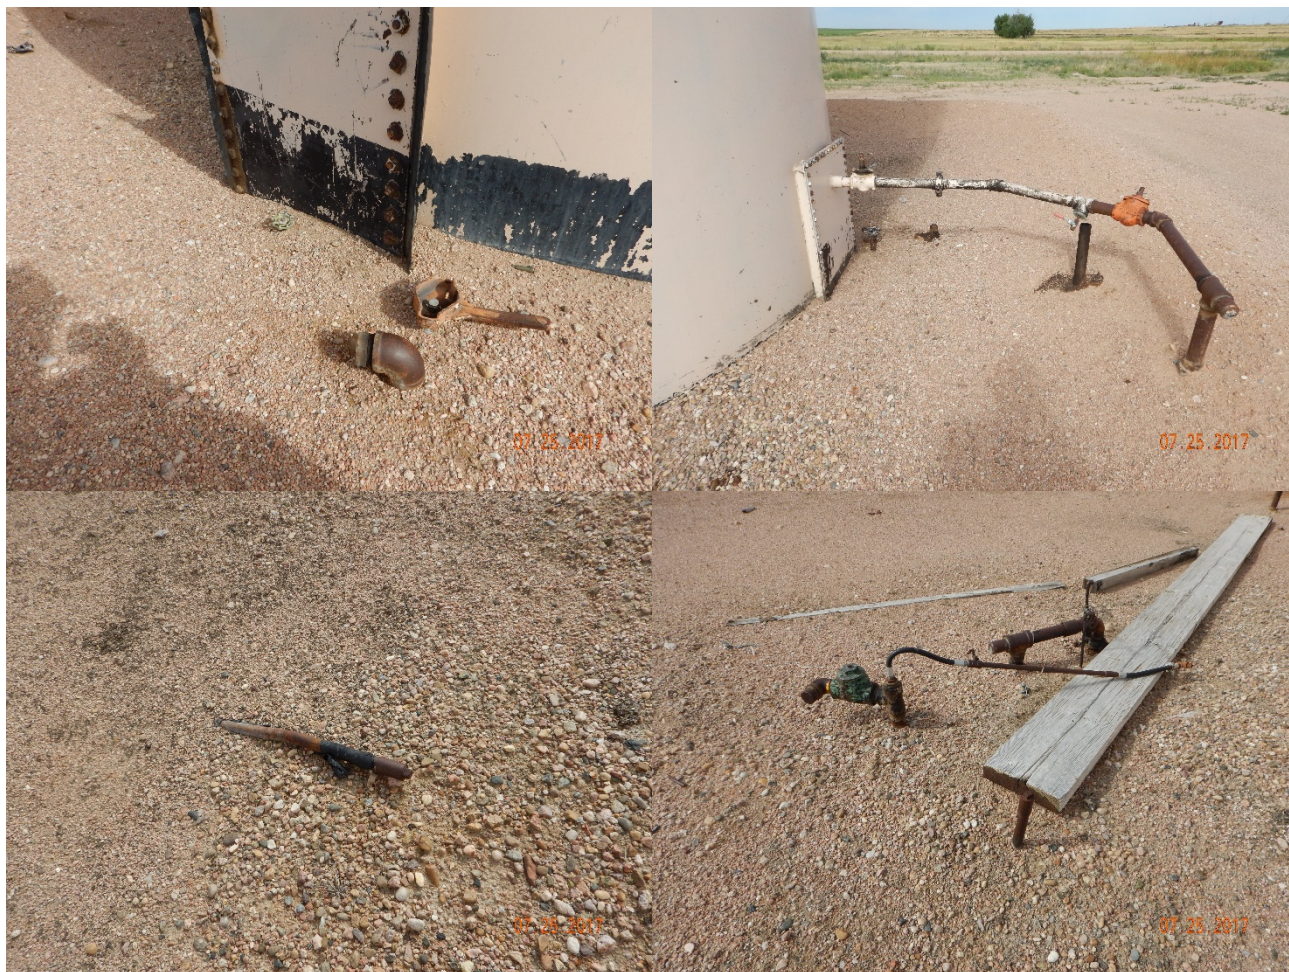
*Figure 4 - Assorted flowline risers associated with crude oil ASTs.*

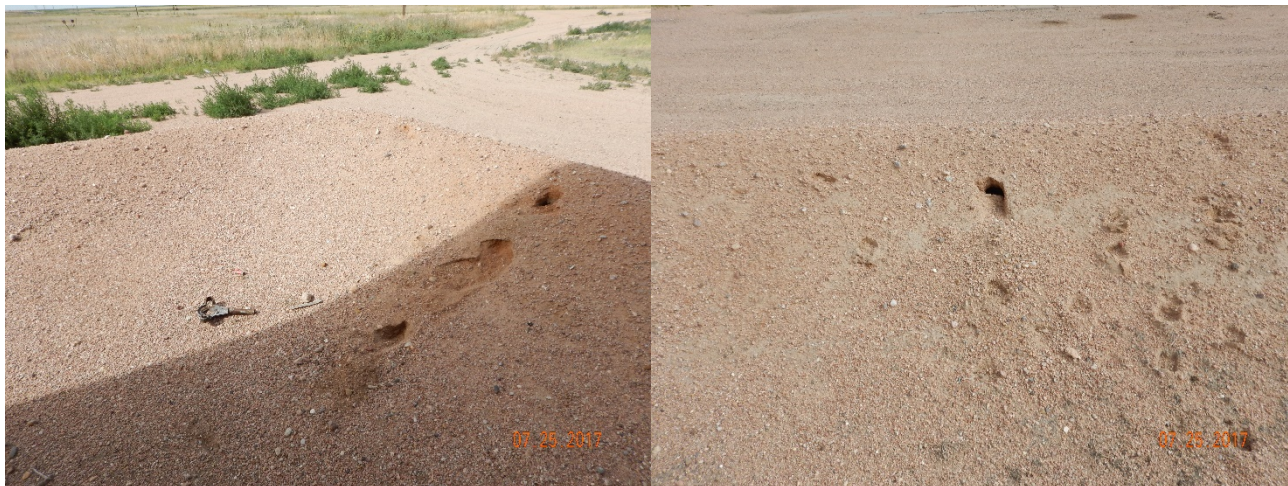
*Figure 5 - Damaged earthen berms at crude oil ASTs.*

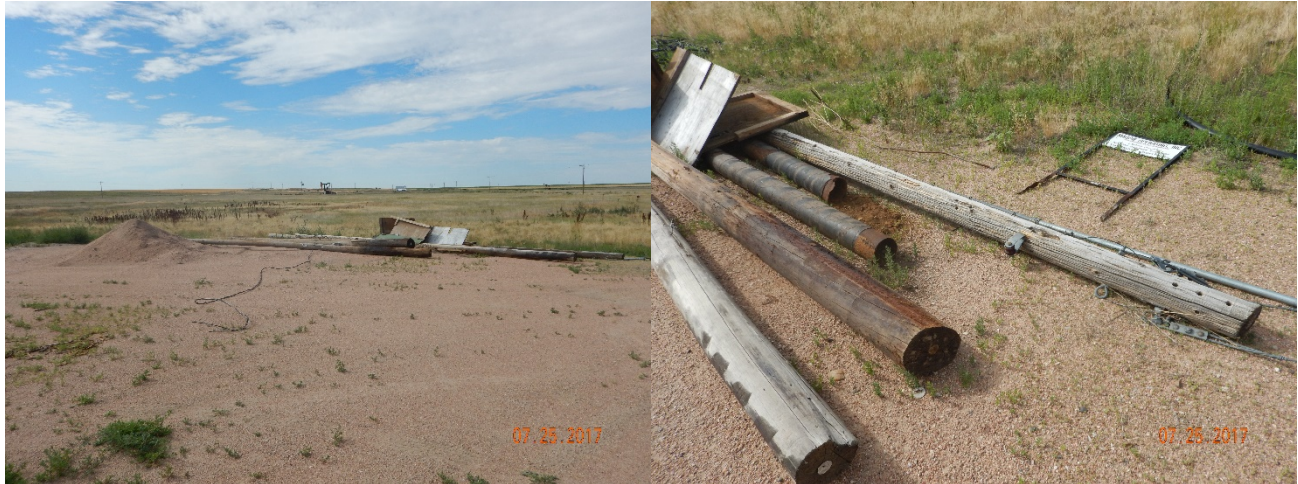
*Figure 6 - Junk and equipment stored on south side of facility.*

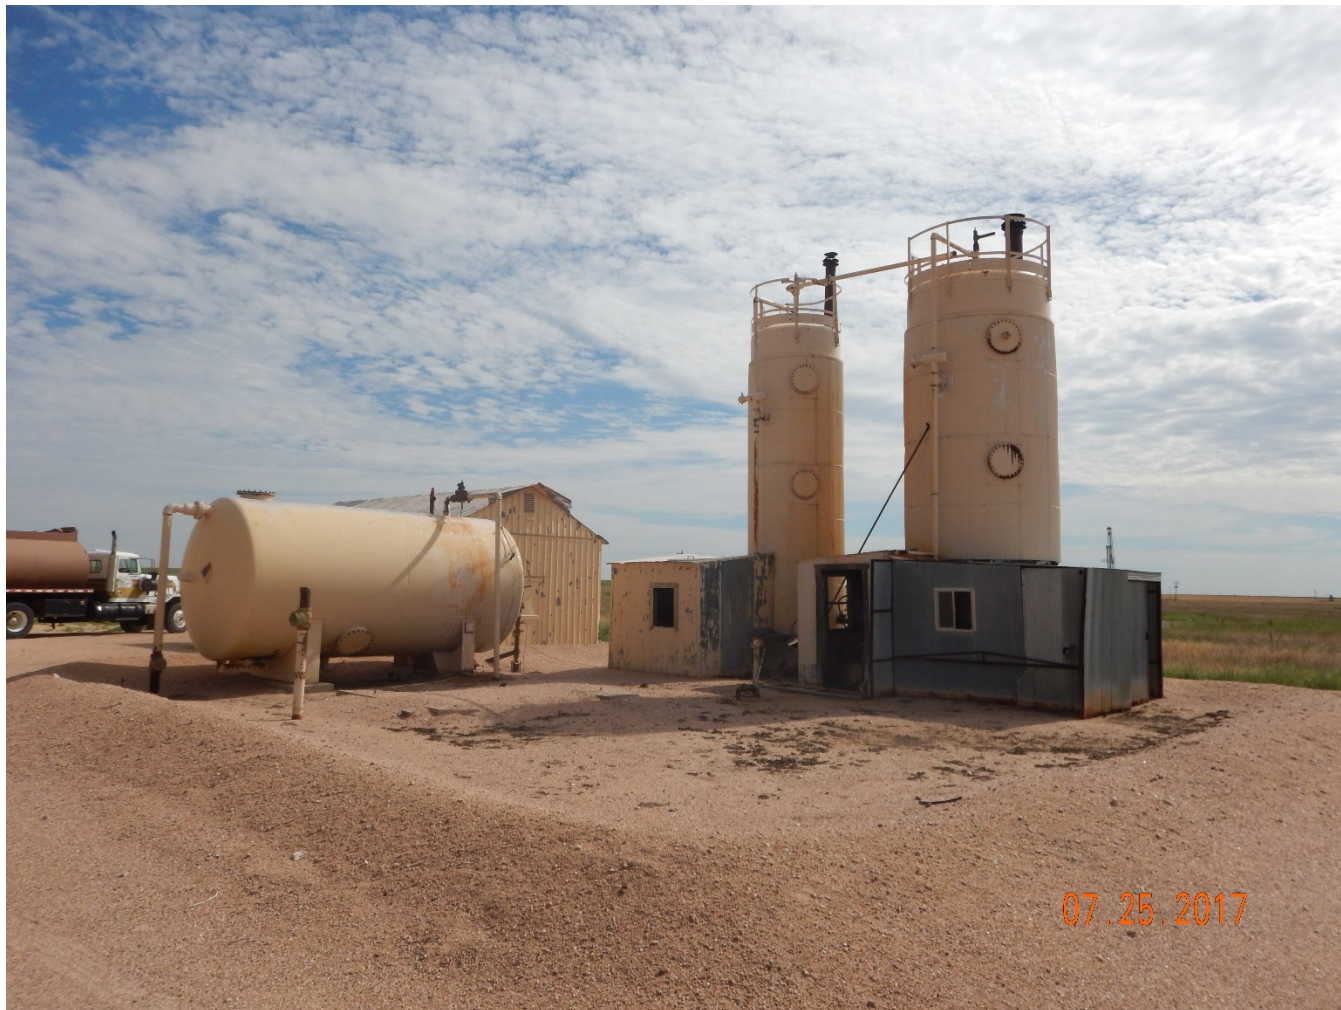
*Figure 7 - Unlabeled horizontal AST and VHT sheds at SE corner of facility.*

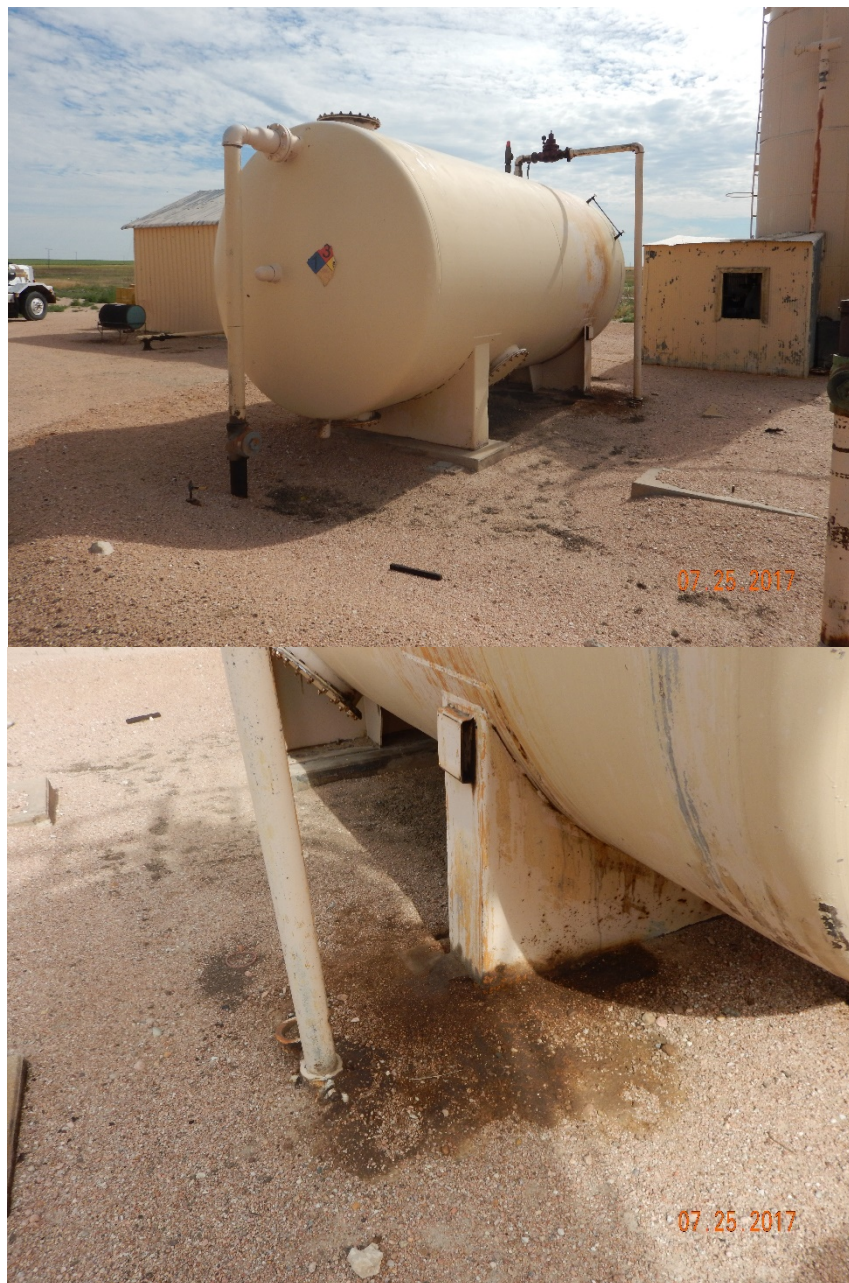
*Figure 8 - Horizontal AST lacks volume and contents labels, NFPA placard needs replacement. Bottom photo: localized, oil-stained soil at SE corner of tank.*

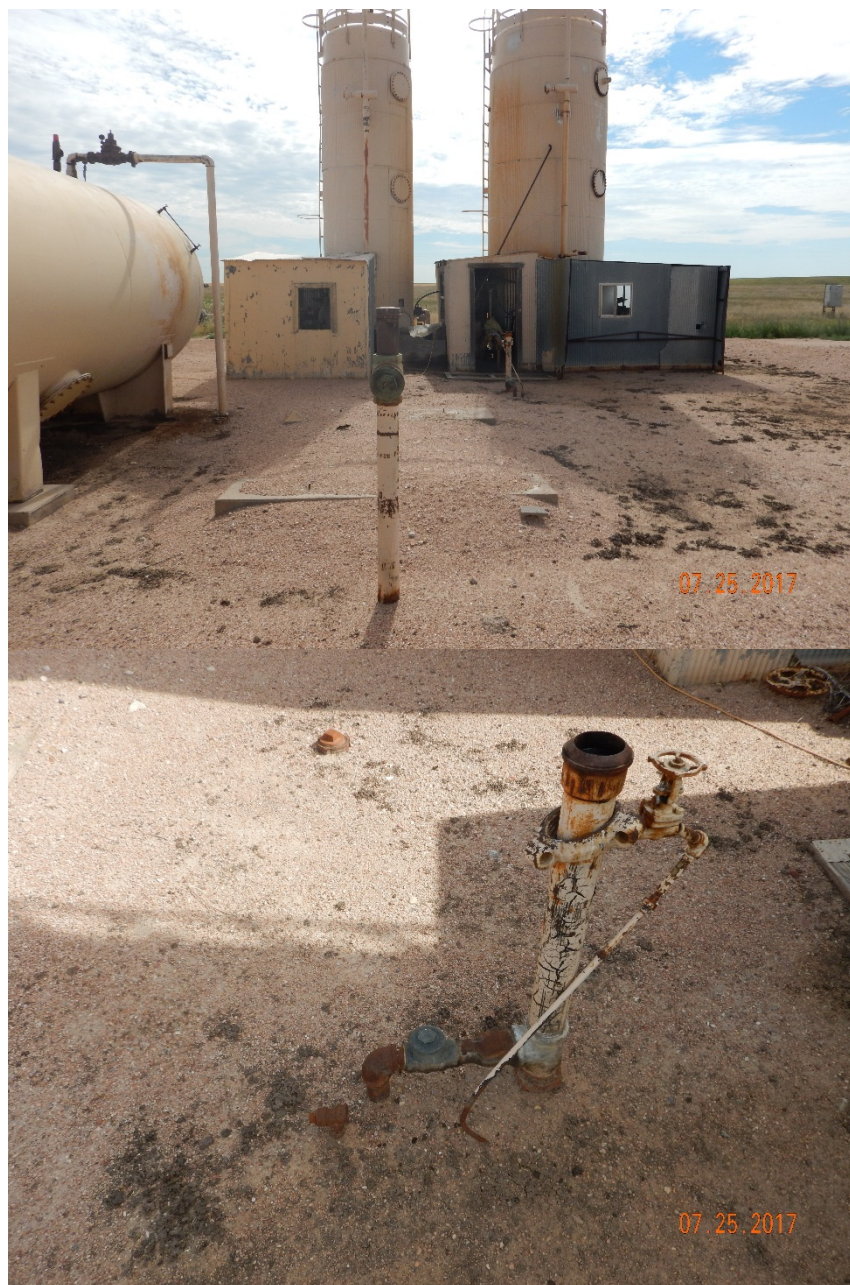
*Figure 9 - Unused 4" flowline risers (top photo, foreground and background) located south of horizontal crude oil AST. Bottom photo shows 4" uncapped flowline riser, 1" riser, and 0.5" steel line just west of VHT sheds.*

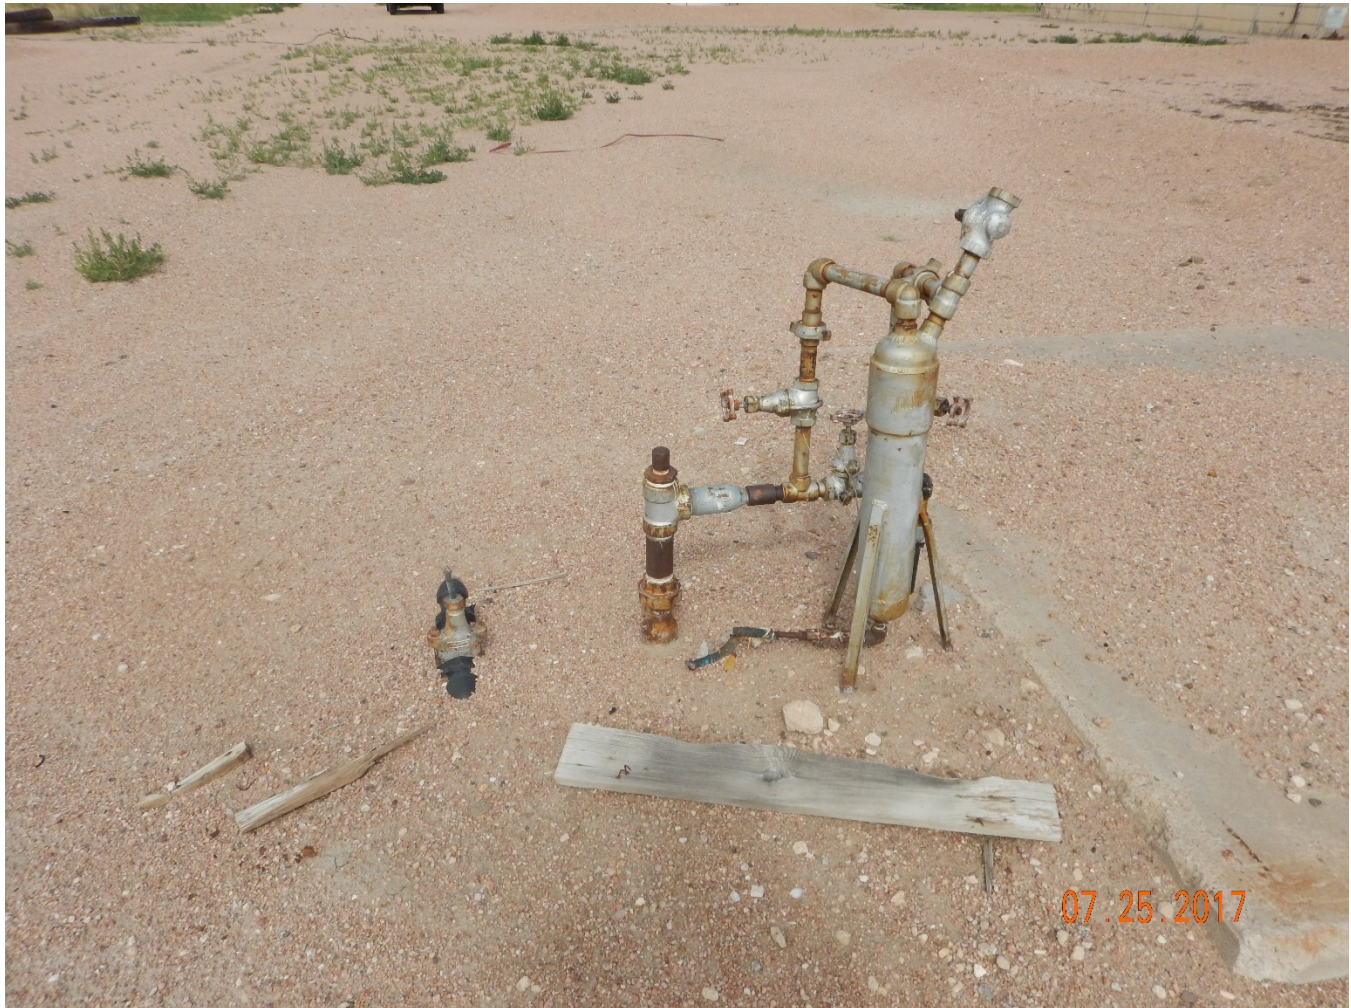
*Figure 10 - Flowline manifold, wood debris, and concrete pad south of VHT sheds (outside of berm).*

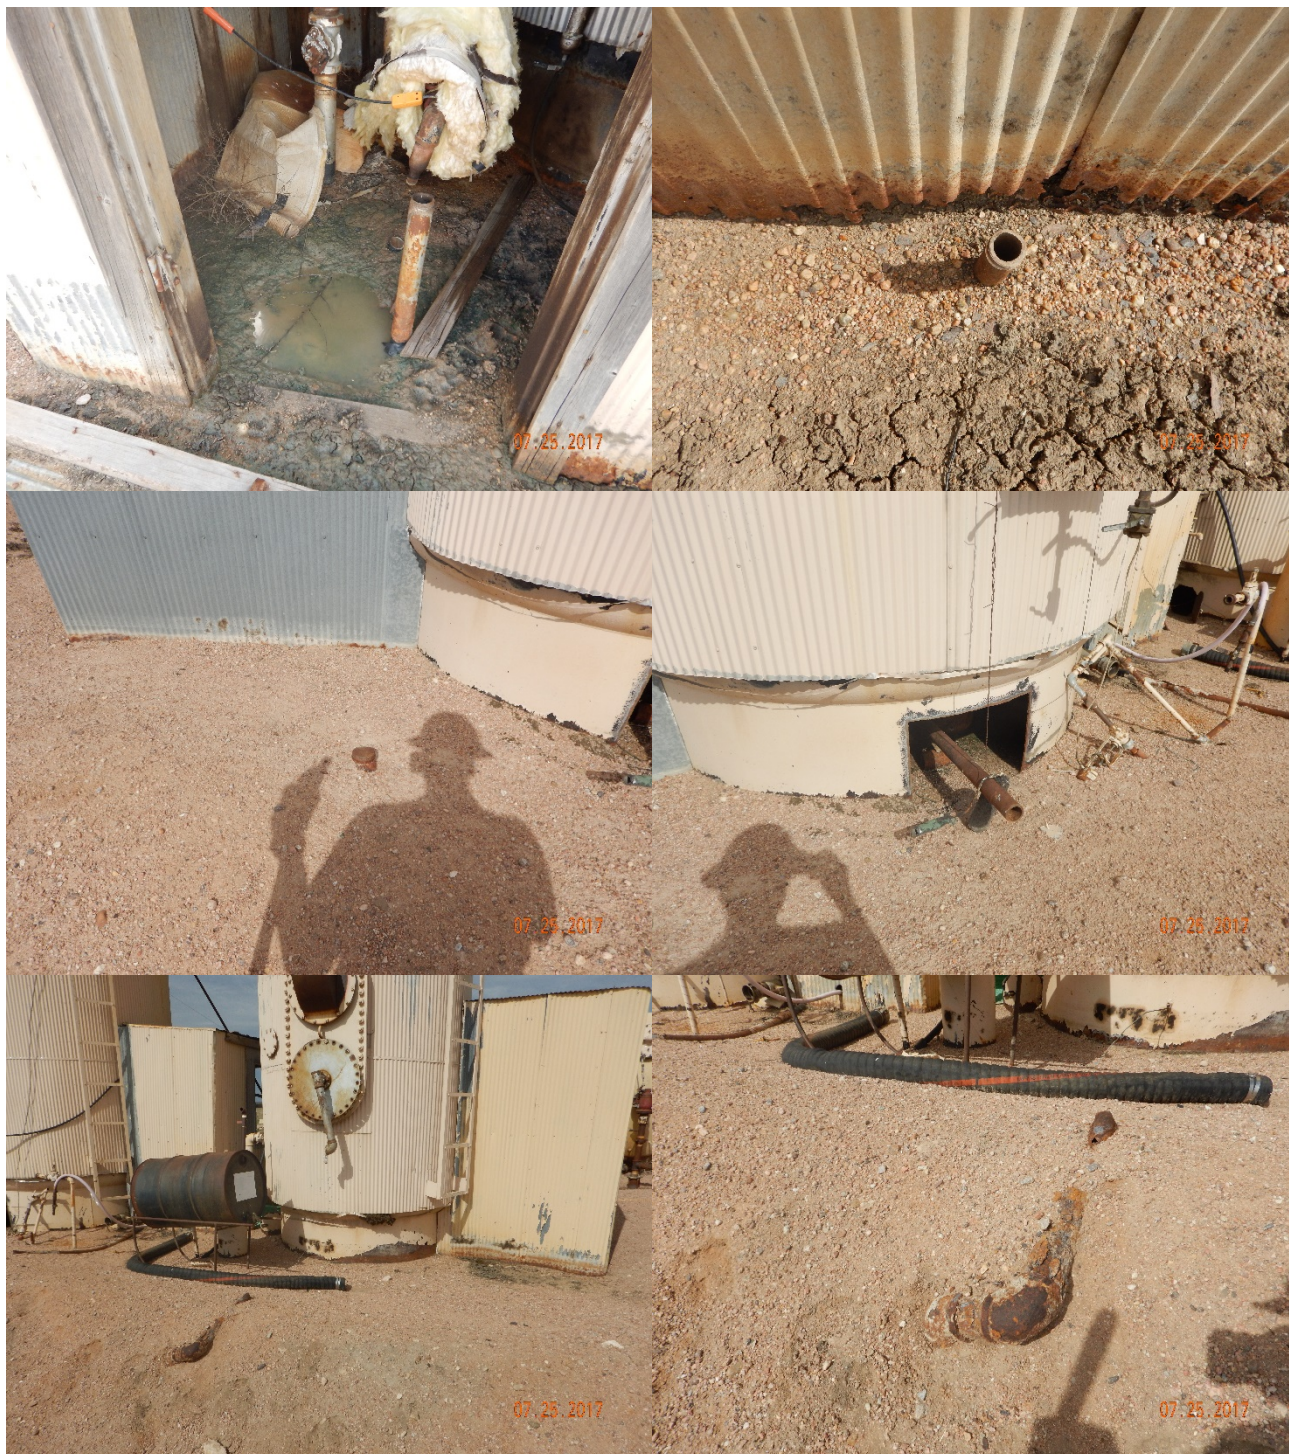
*Figure 11 - Assorted flowline risers, pipes, and hoses (capped and uncapped) associated with VHT sheds.*

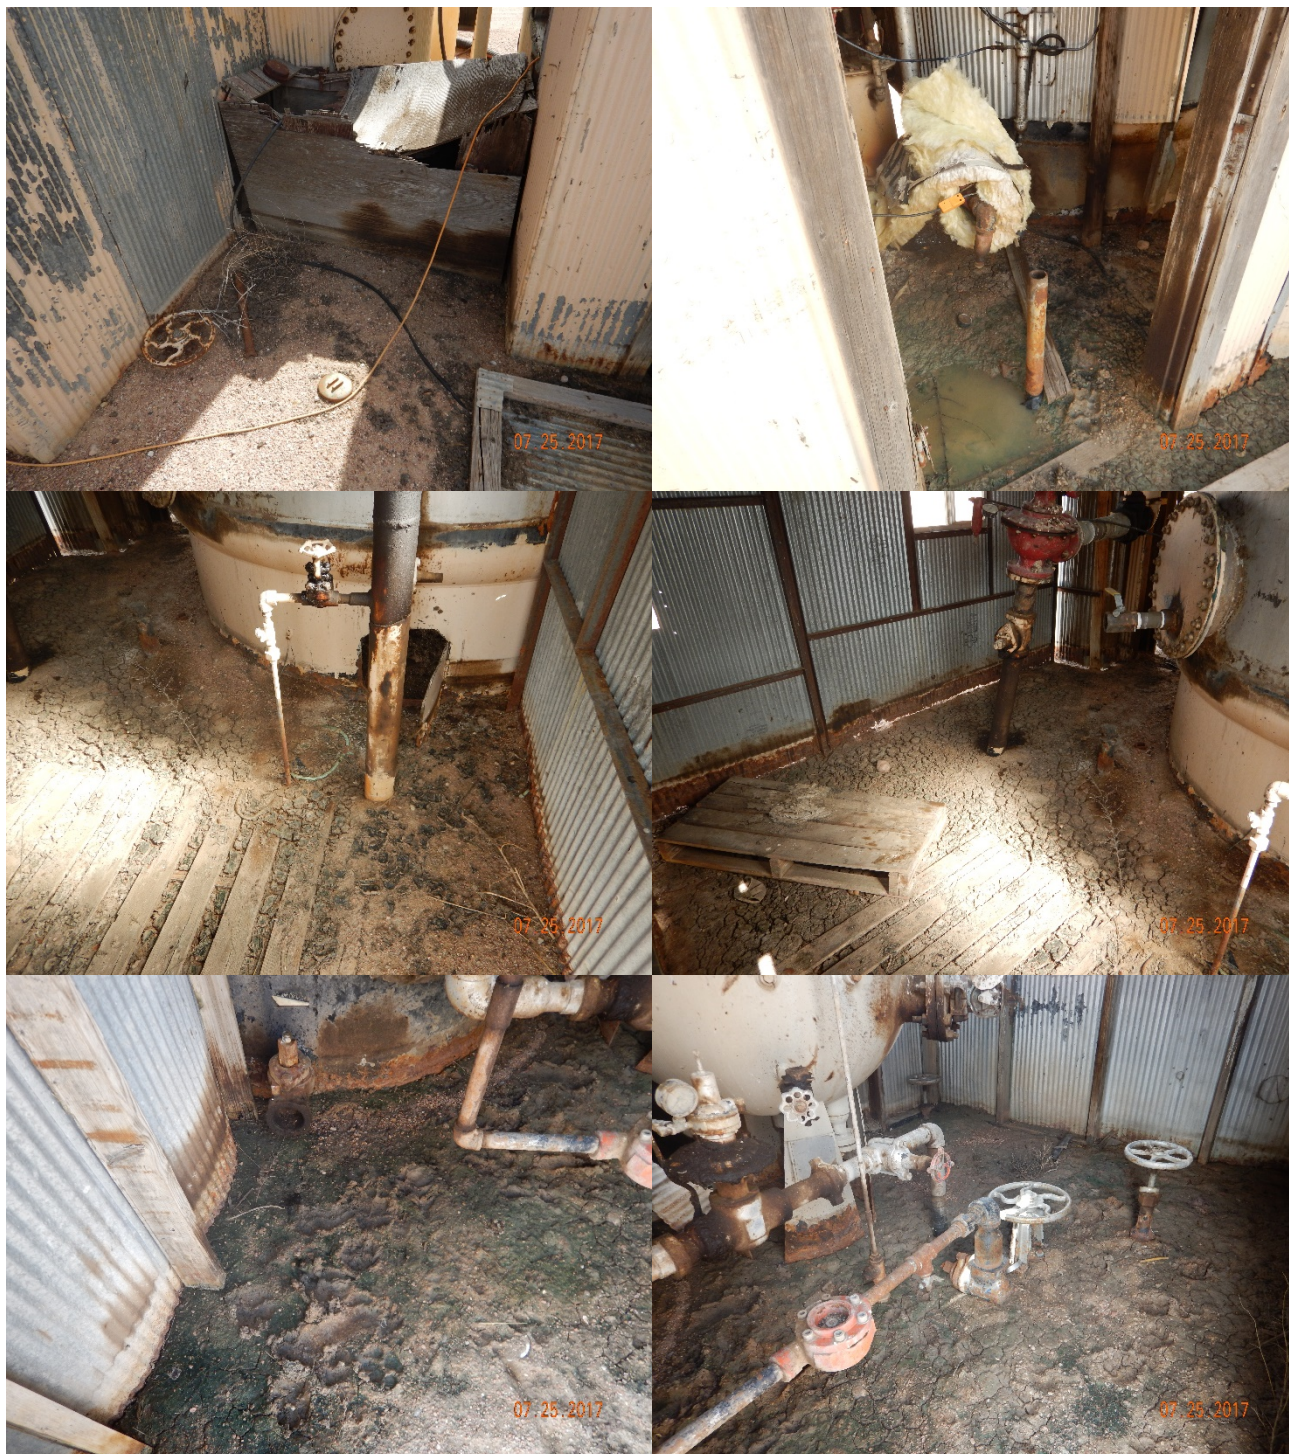
*Figure 12 - Historical accumulations of oily waste, junk, and debris inside of VHT sheds.*

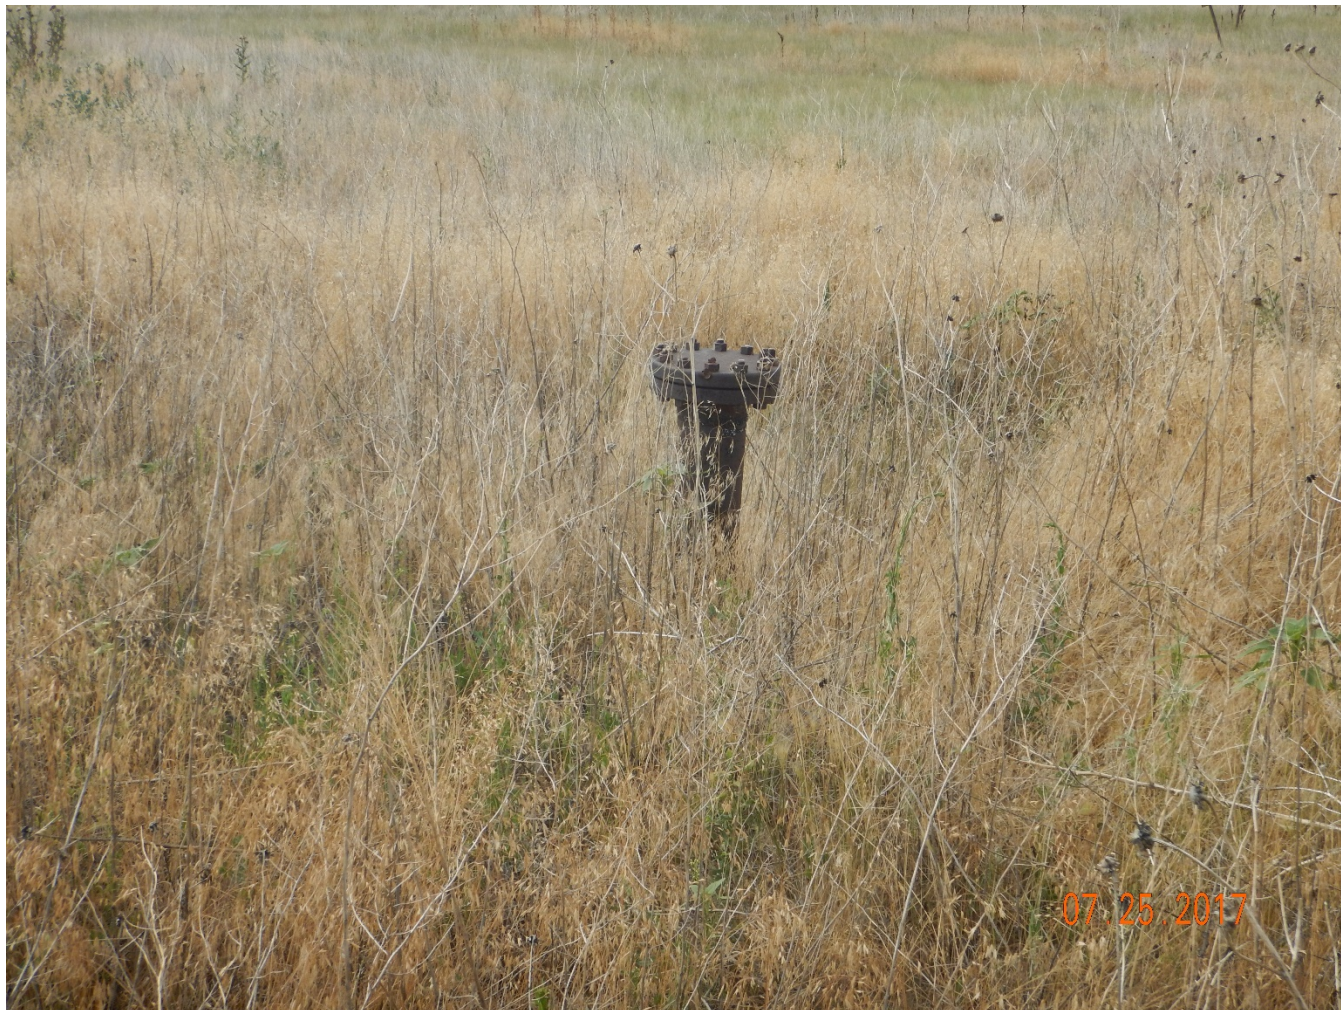
*Figure 13 - Capped 8-12" riser south of crude oil ASTs.*

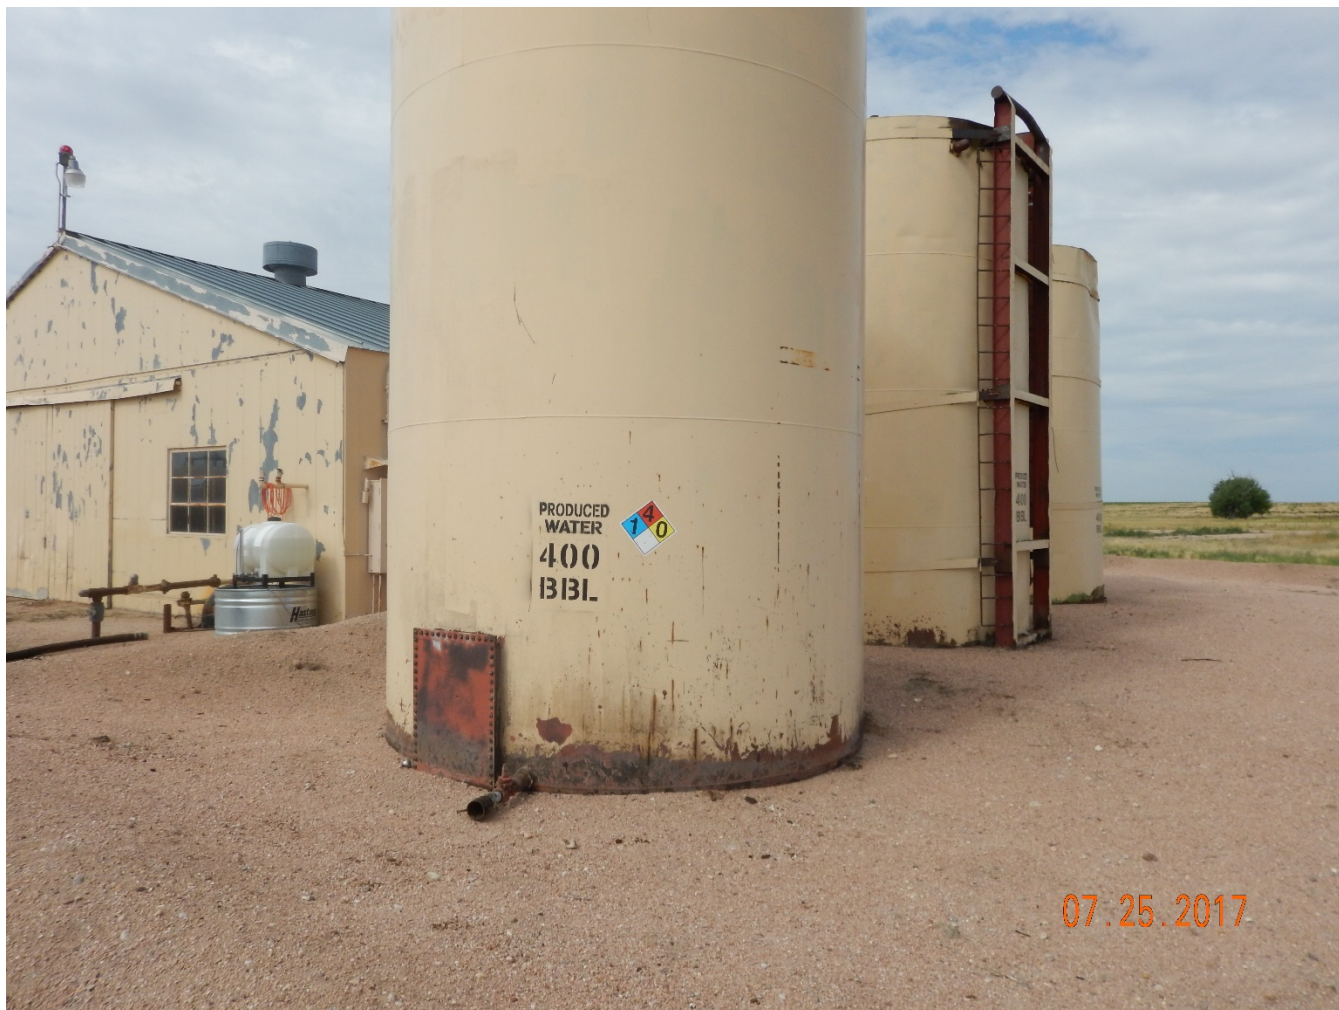
*Figure 14 - Produced water ASTs on north side of injection plant (background).*

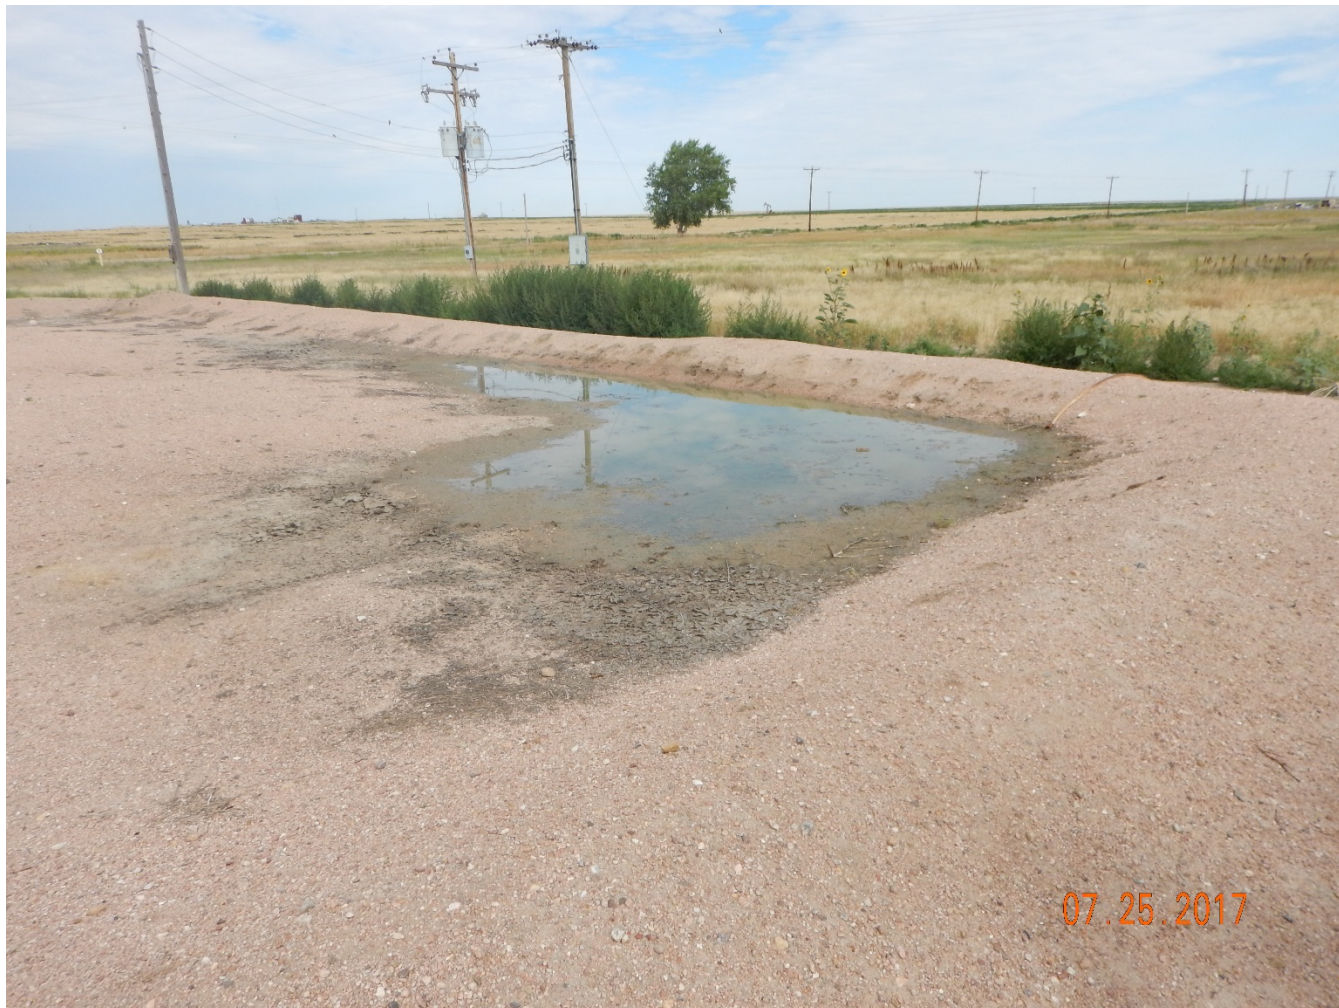
*Figure 15 - Pool of water at NE corner of earthen berm around produced water tanks. Fluid source unknown.*

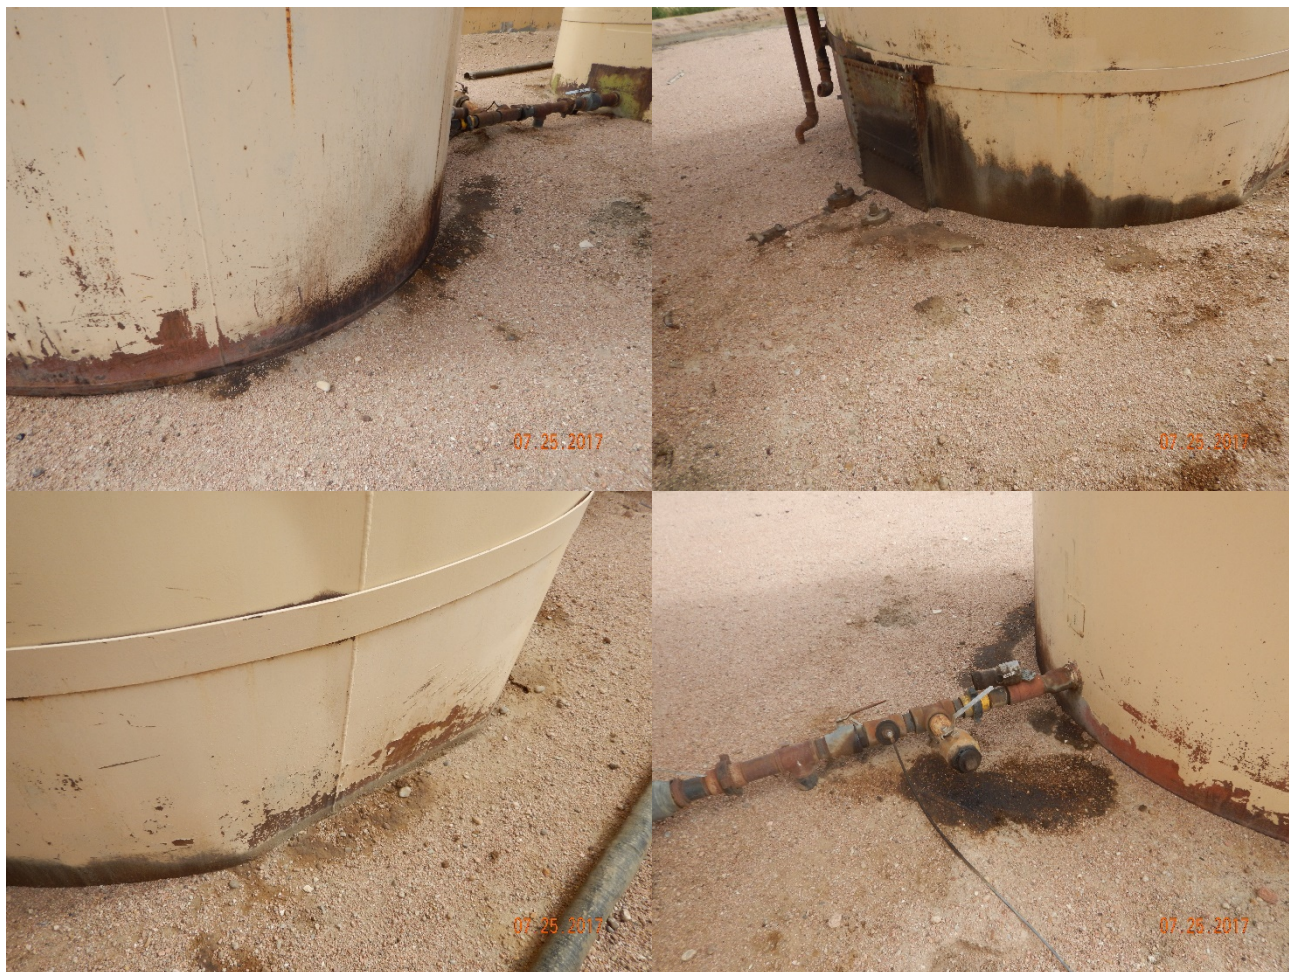
*Figure 16 - Localized, oil-stained soil associated with produced water ASTs.*

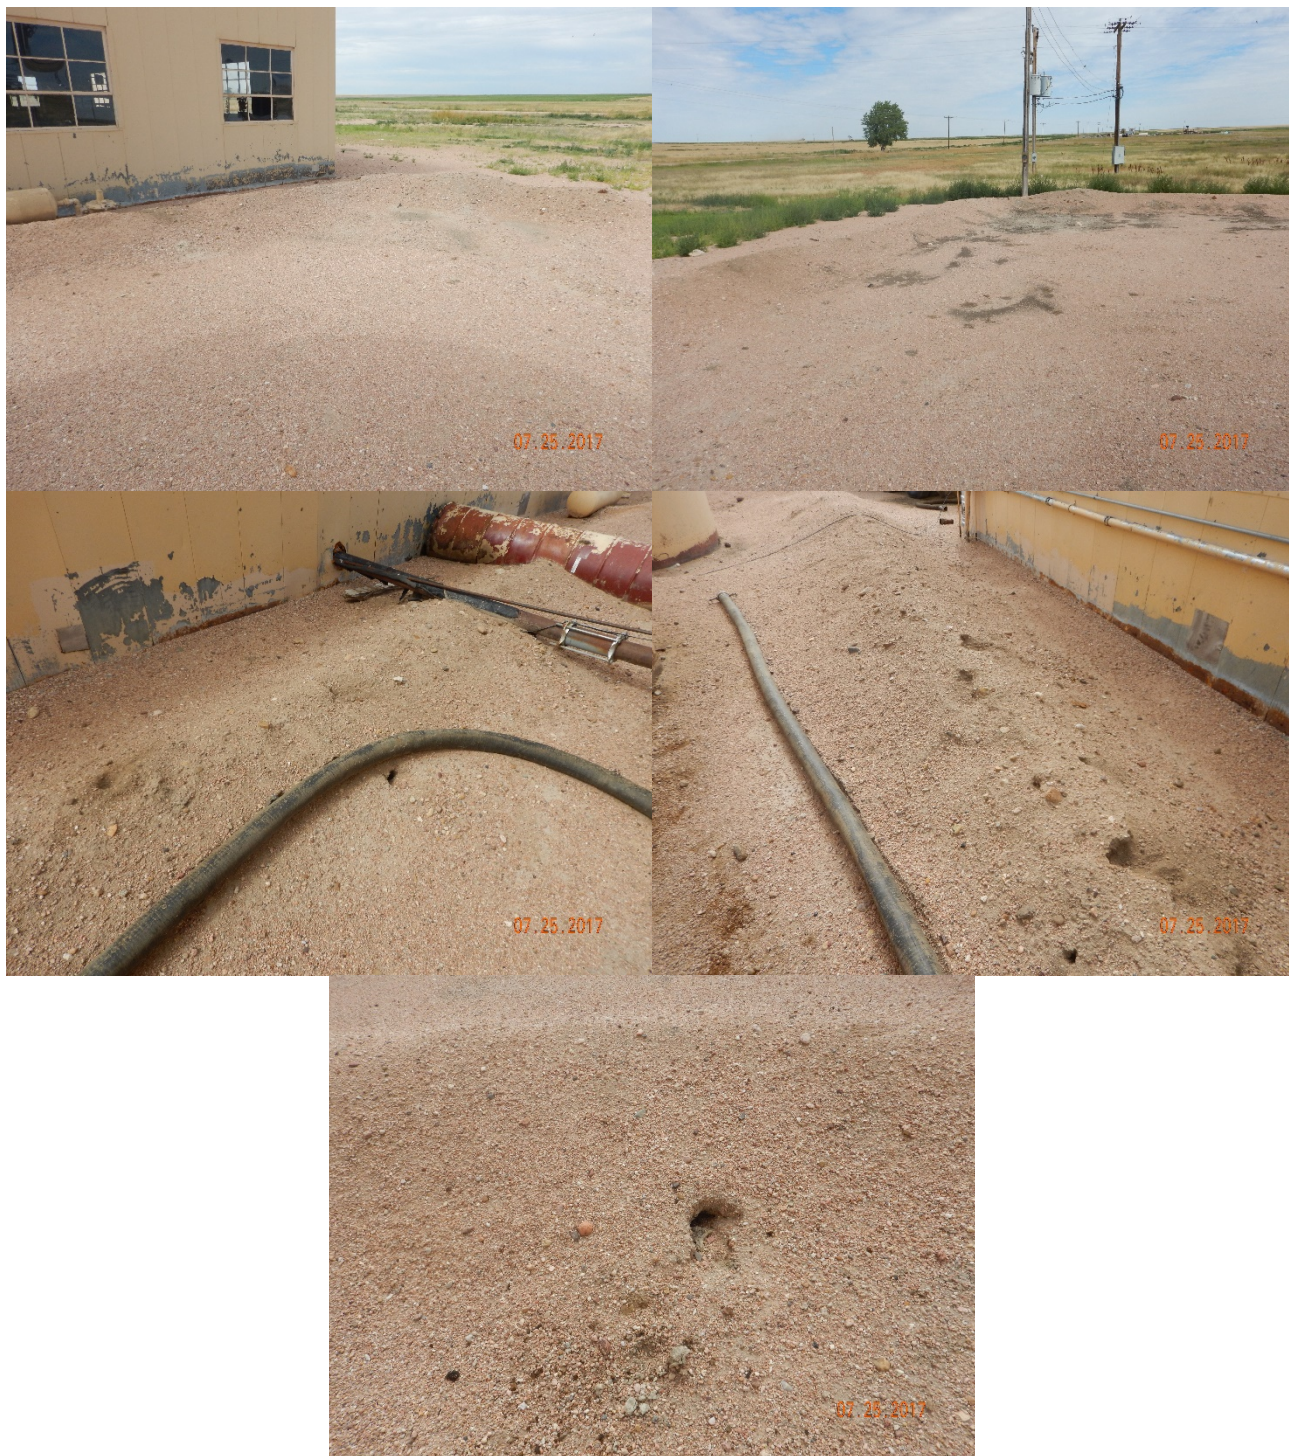
Figure 17 - Berm maintenance required for earthen berm around produced water ASTs.

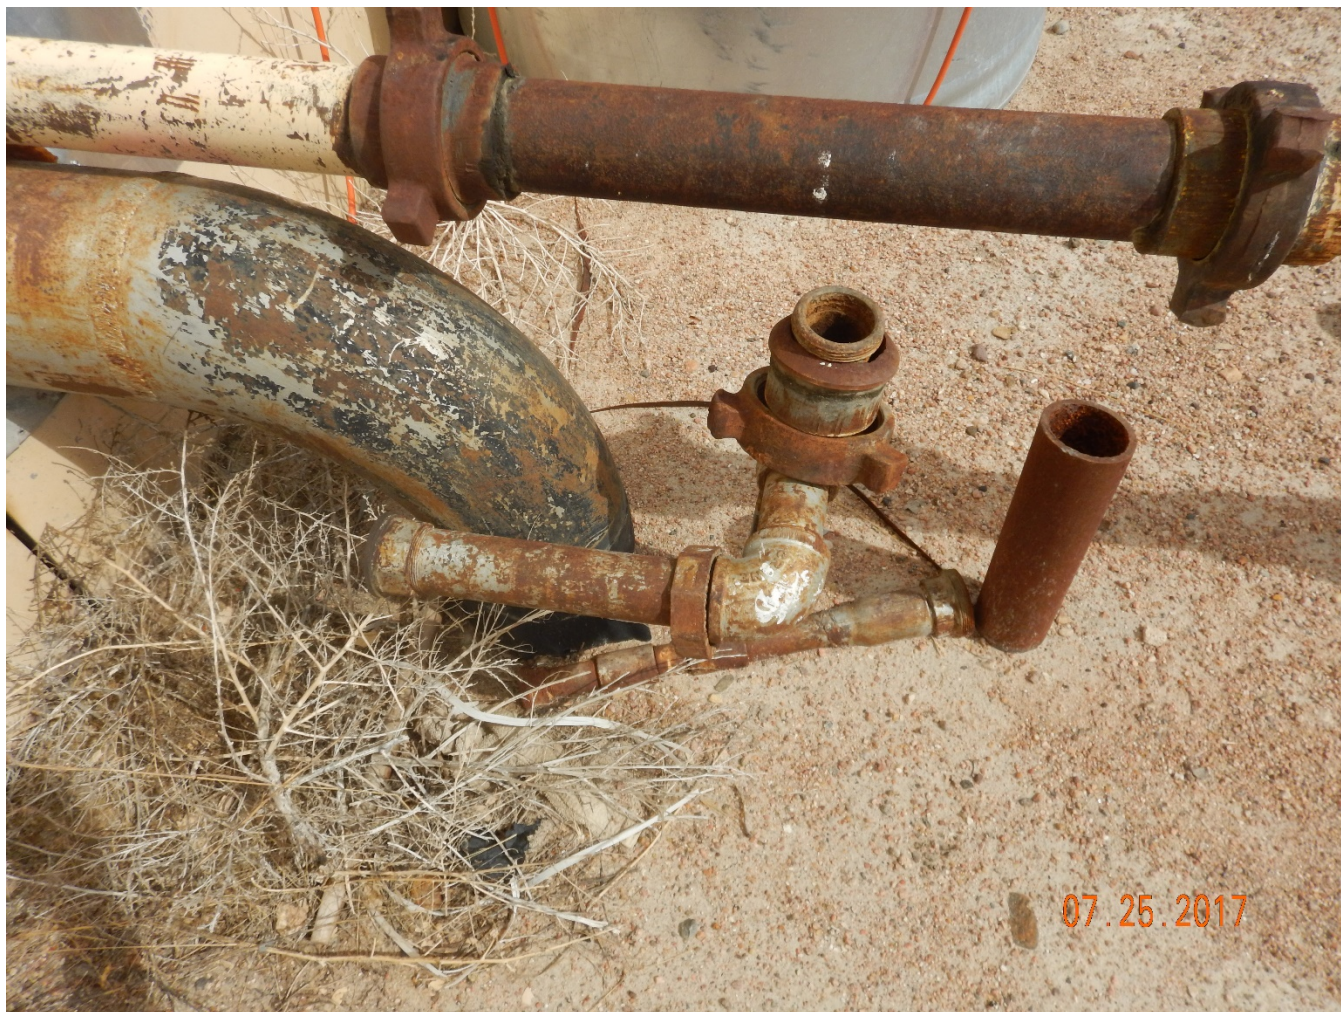
*Figure 18 - Uncapped flowline risers at NE corner of injection plant.*
