*Figure 1 – Crude oil tanks at LBDSU Battery, COGCC Facility ID #451504. Note crude oil stain at truck loadout.*

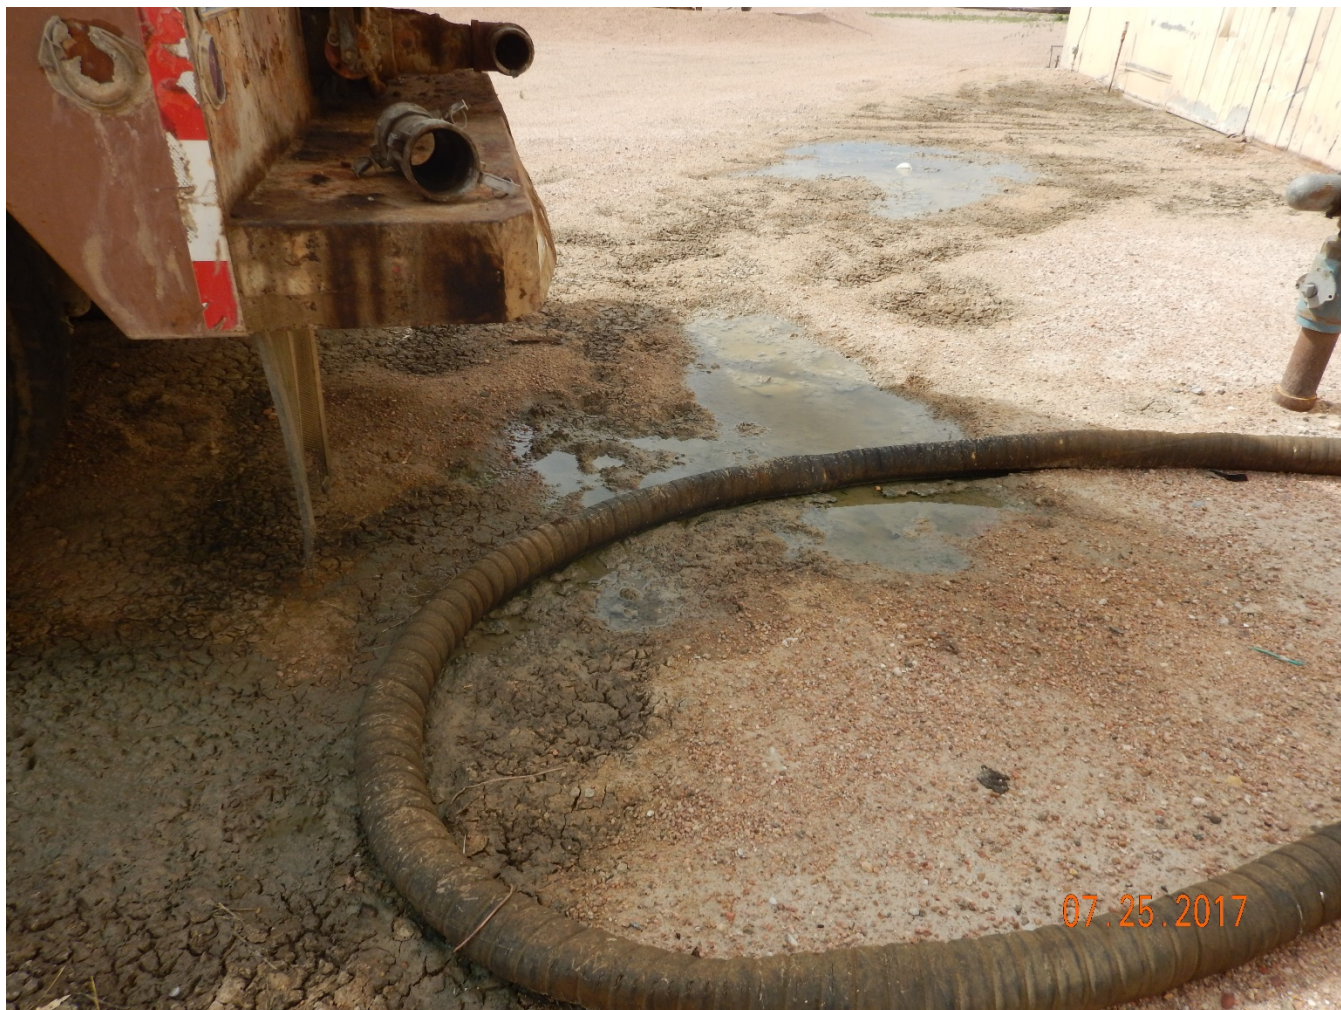
*Figure 19 - Impacted soil from historical releases of produced water stretching from double doors on east side of injection plant to vacuum truck ~30' NE. Vacuum truck was observed to be dripping on date of inspection.*

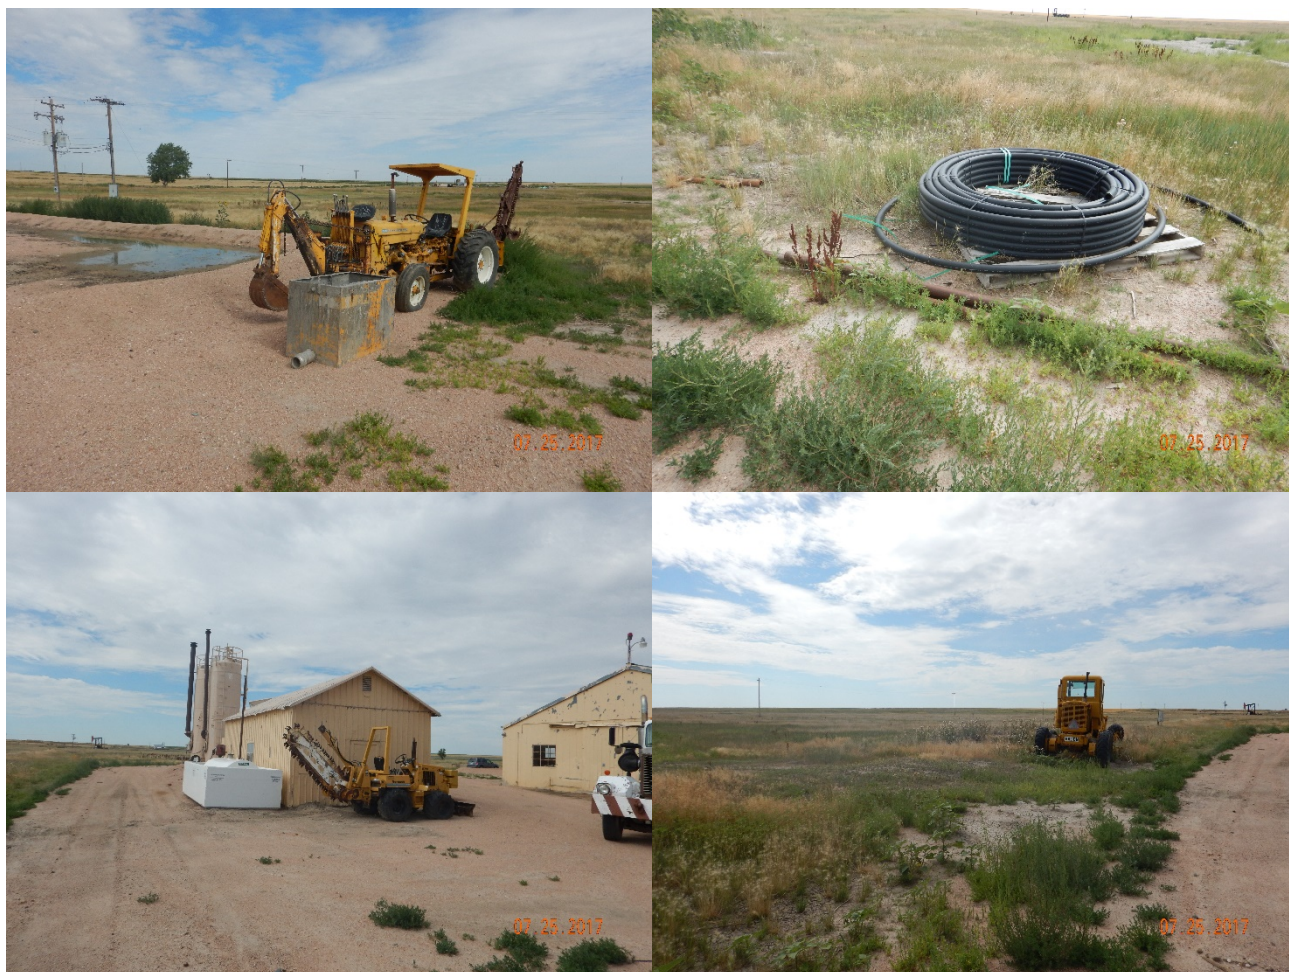
*Figure 20 - Heavy equipment storage around location.*

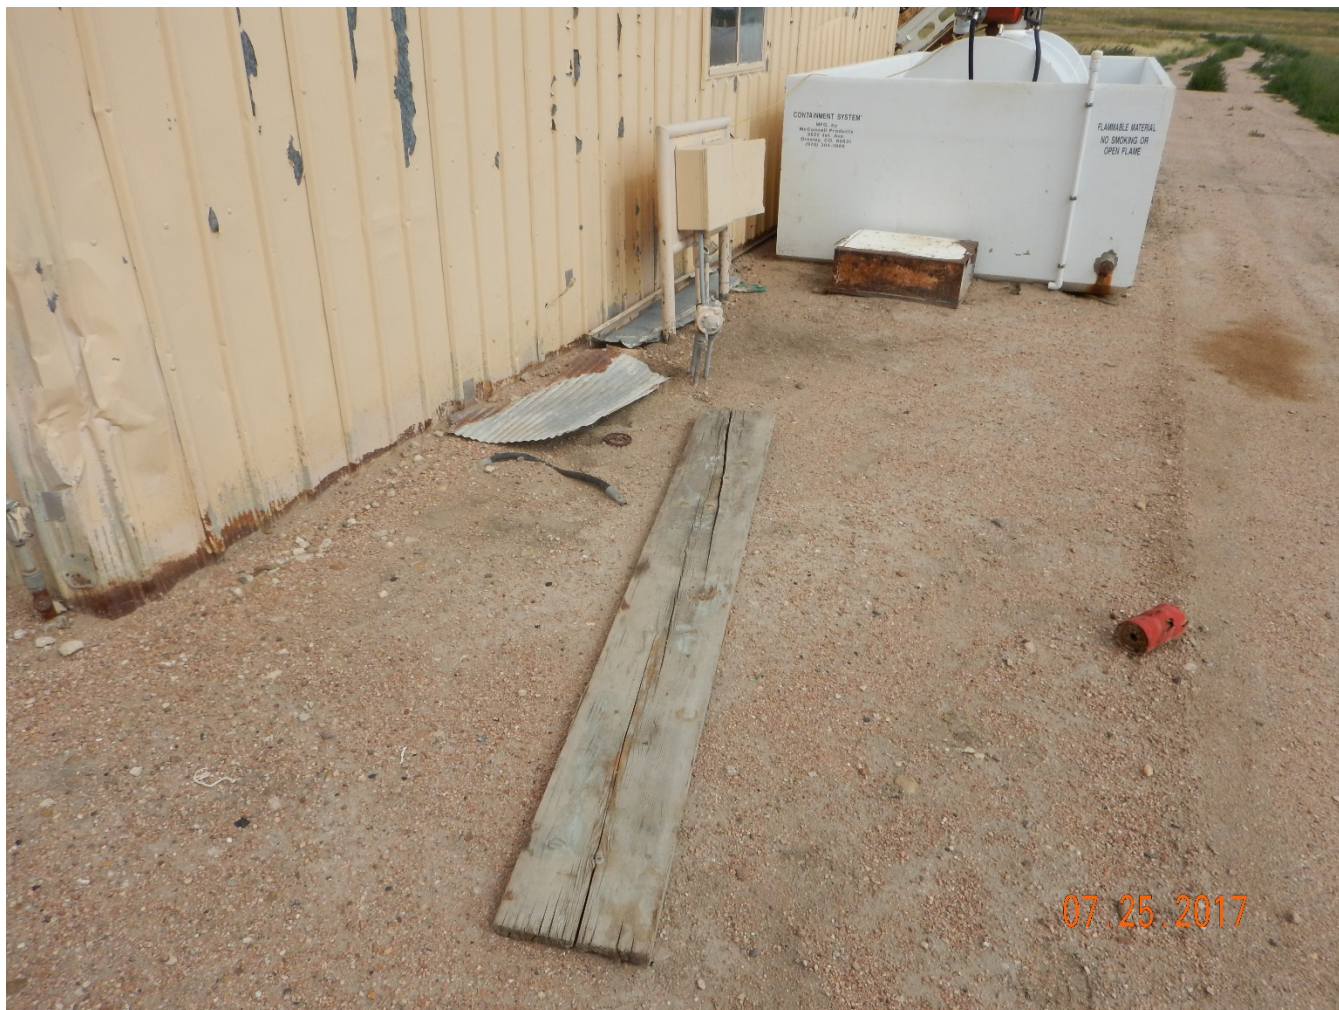
*Figure 21 - Debris south of contained diesel AST.*

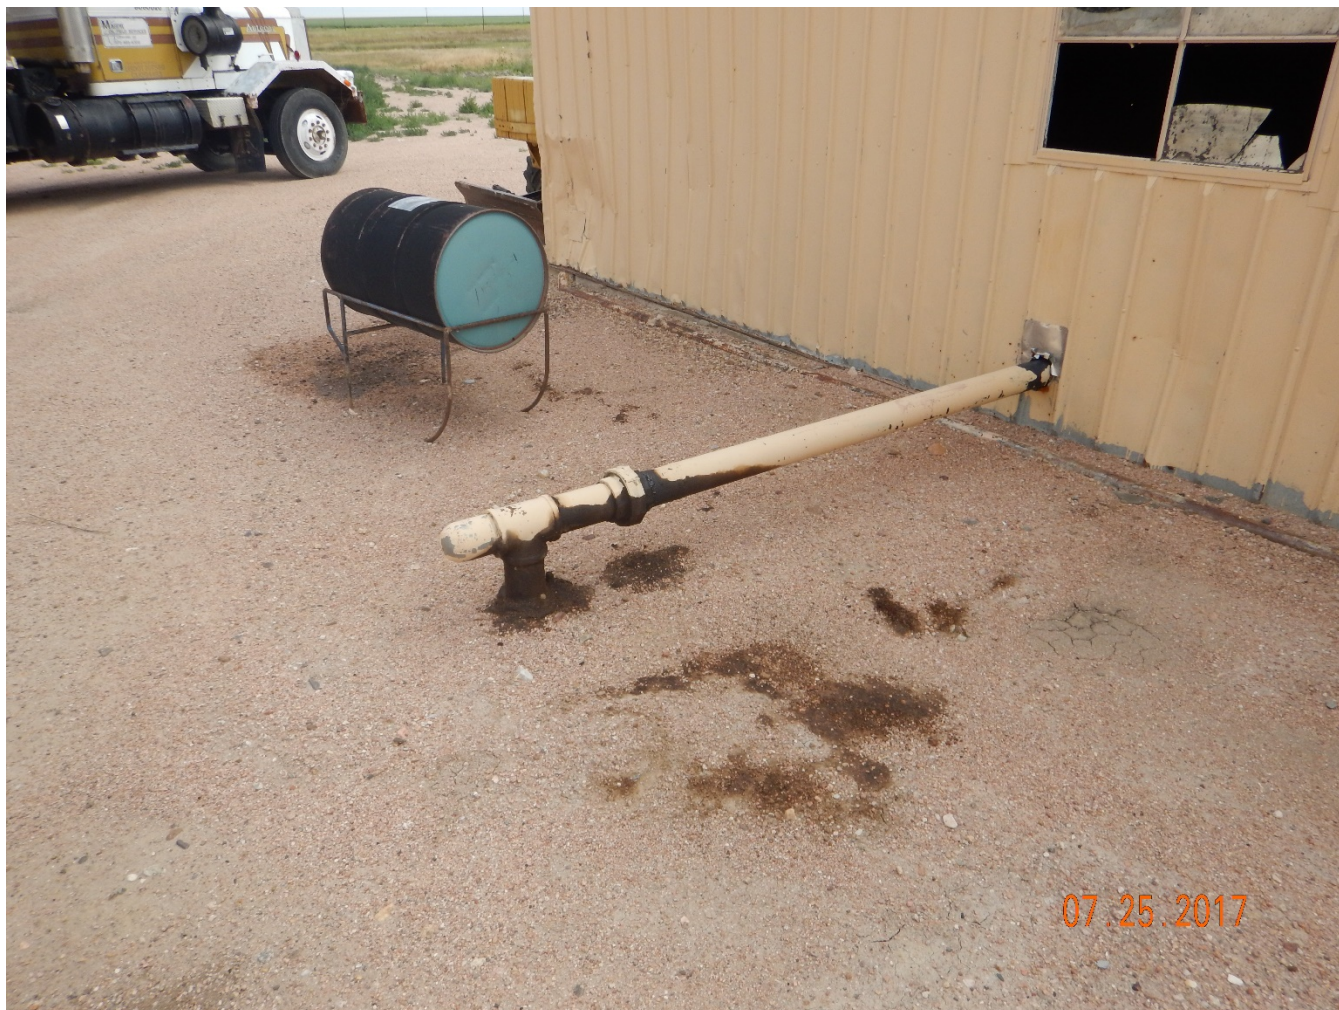
*Figure 22 - Oily waste underlying flowline and 55-gallon drum south of vacuum truck.*

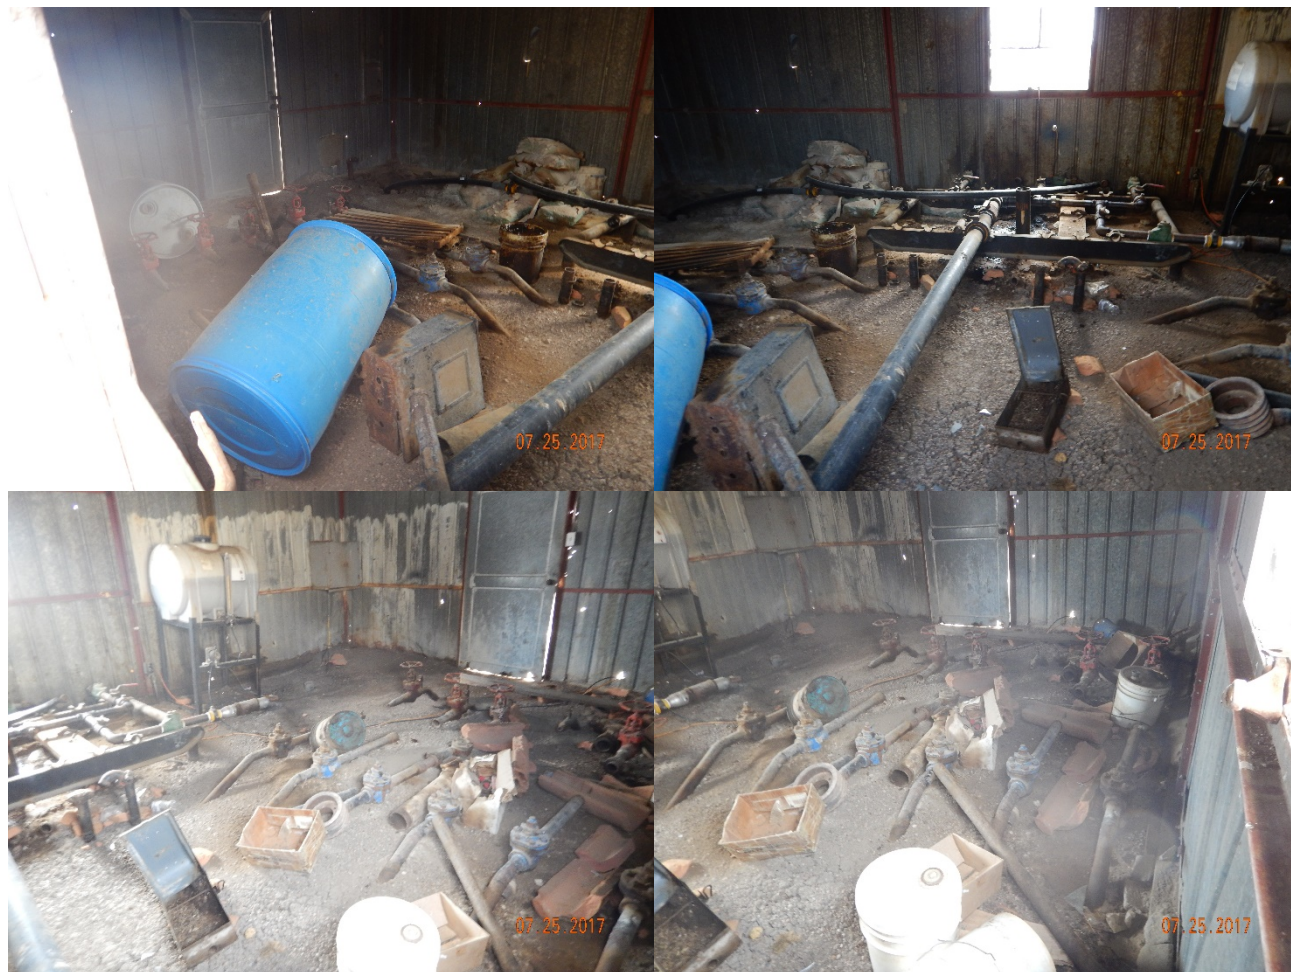
*Figure 23 - Historical accumulations of E&P waste, unused equipment, junk, trash, and flowlines inside of manifold building on east side of location.*

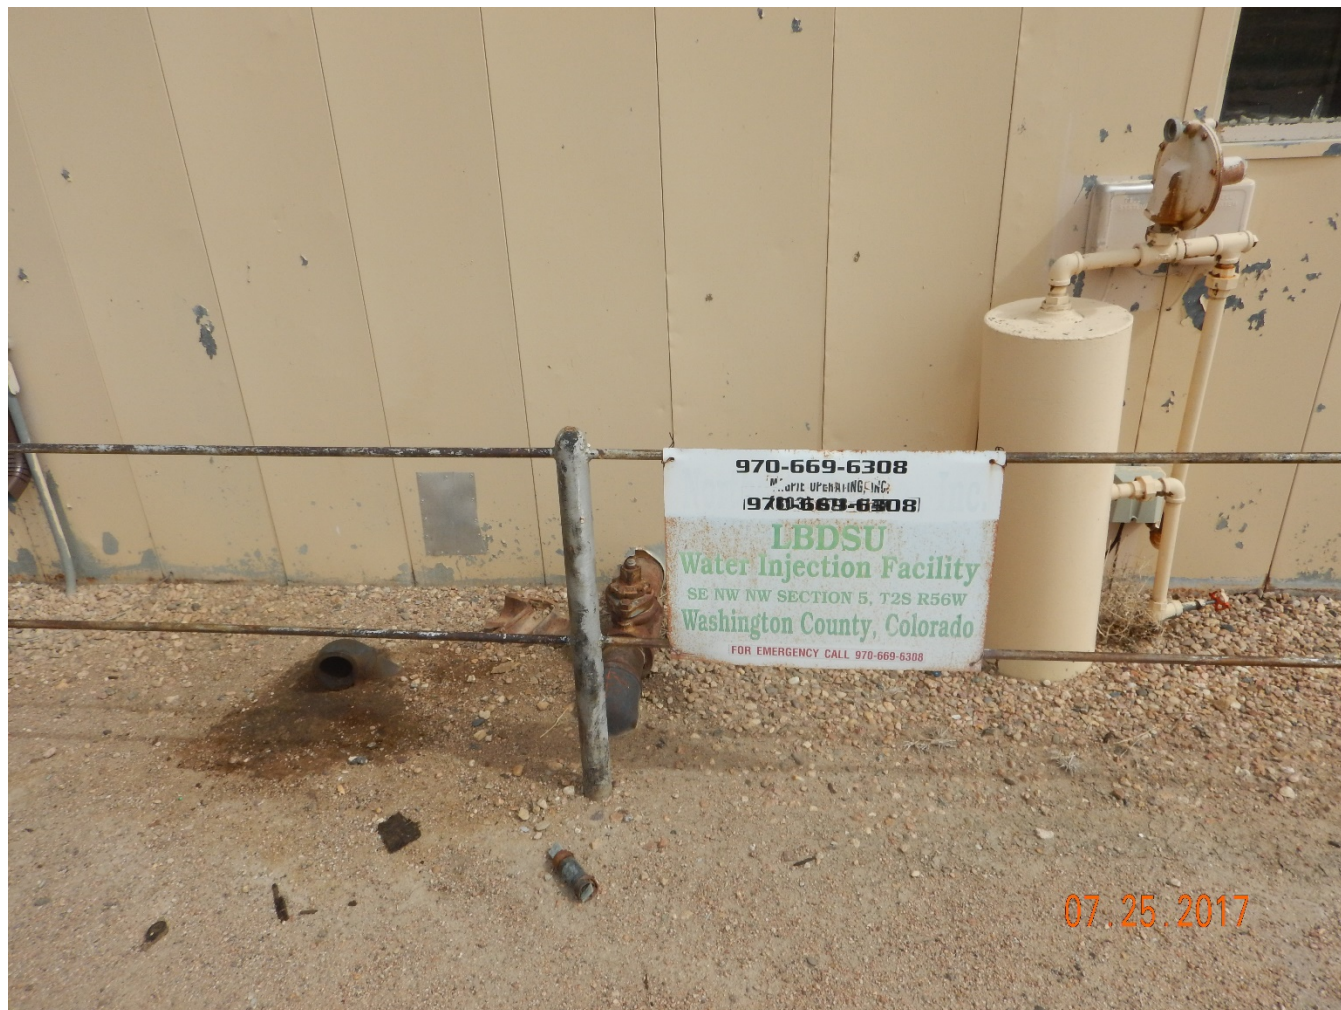
Figure 24 - Sign on south side of main injection plant, COGCC Facility ID #451505. Note; Localized, oil-stained soil at exposed pipes behind the sign.

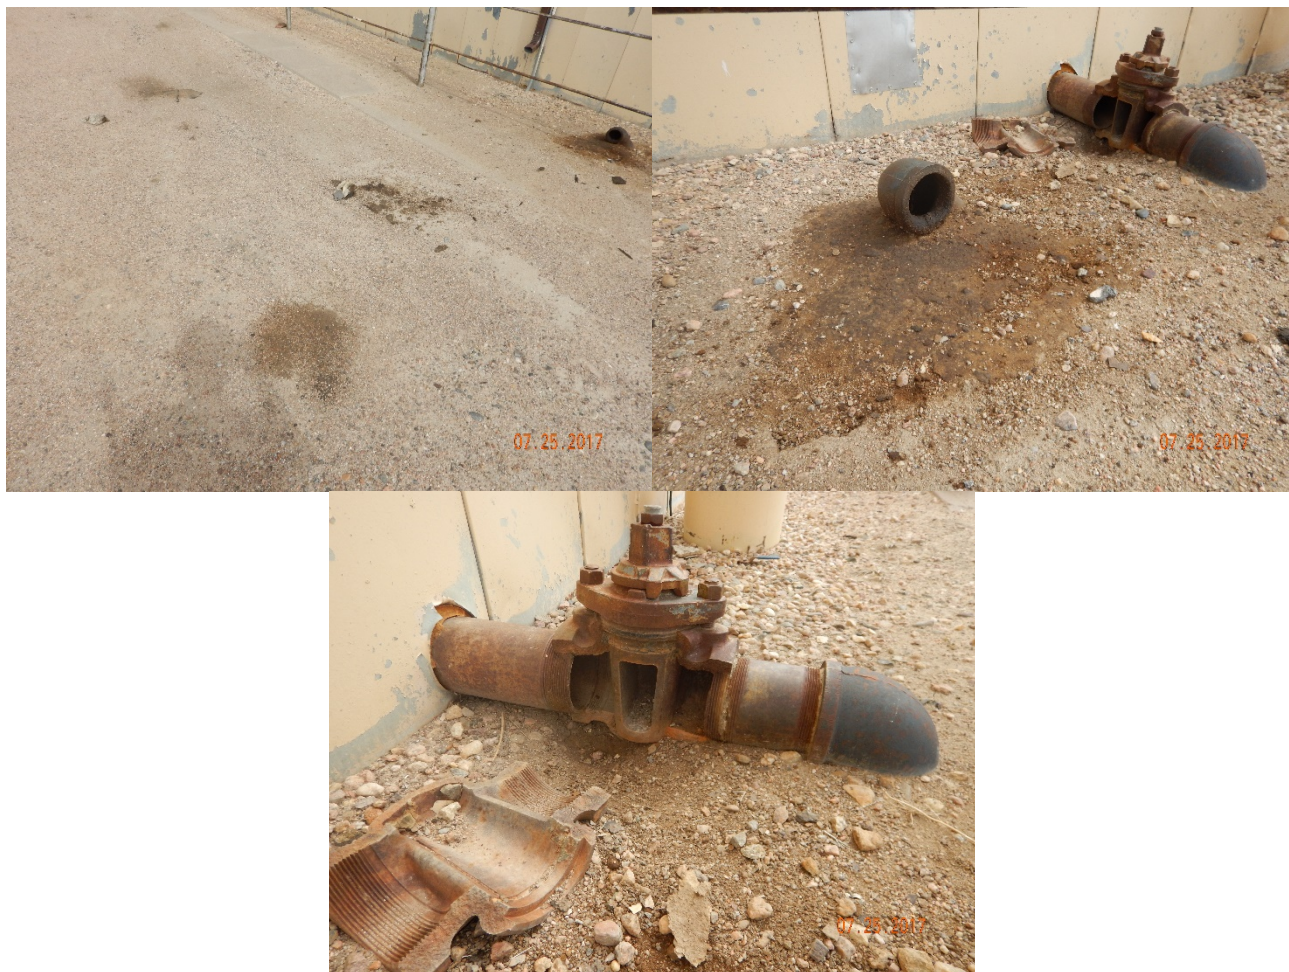
*Figure 25 - Oily waste and irreparable flowline valve south of main injection building.*

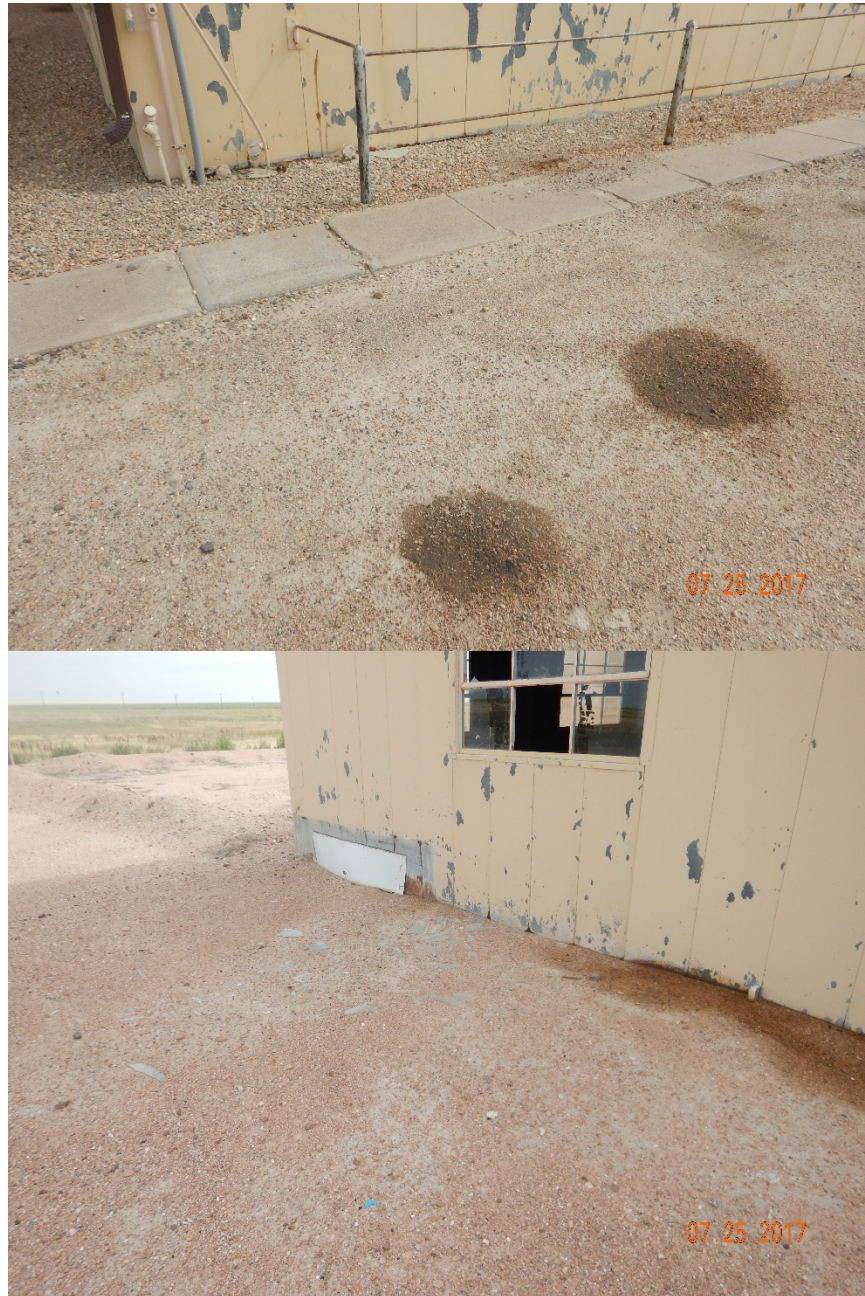
*Figure 26 - Localized oily waste impacts at SW corner of main building (top photo) and with broken glass along west side of building (bottom photo).*

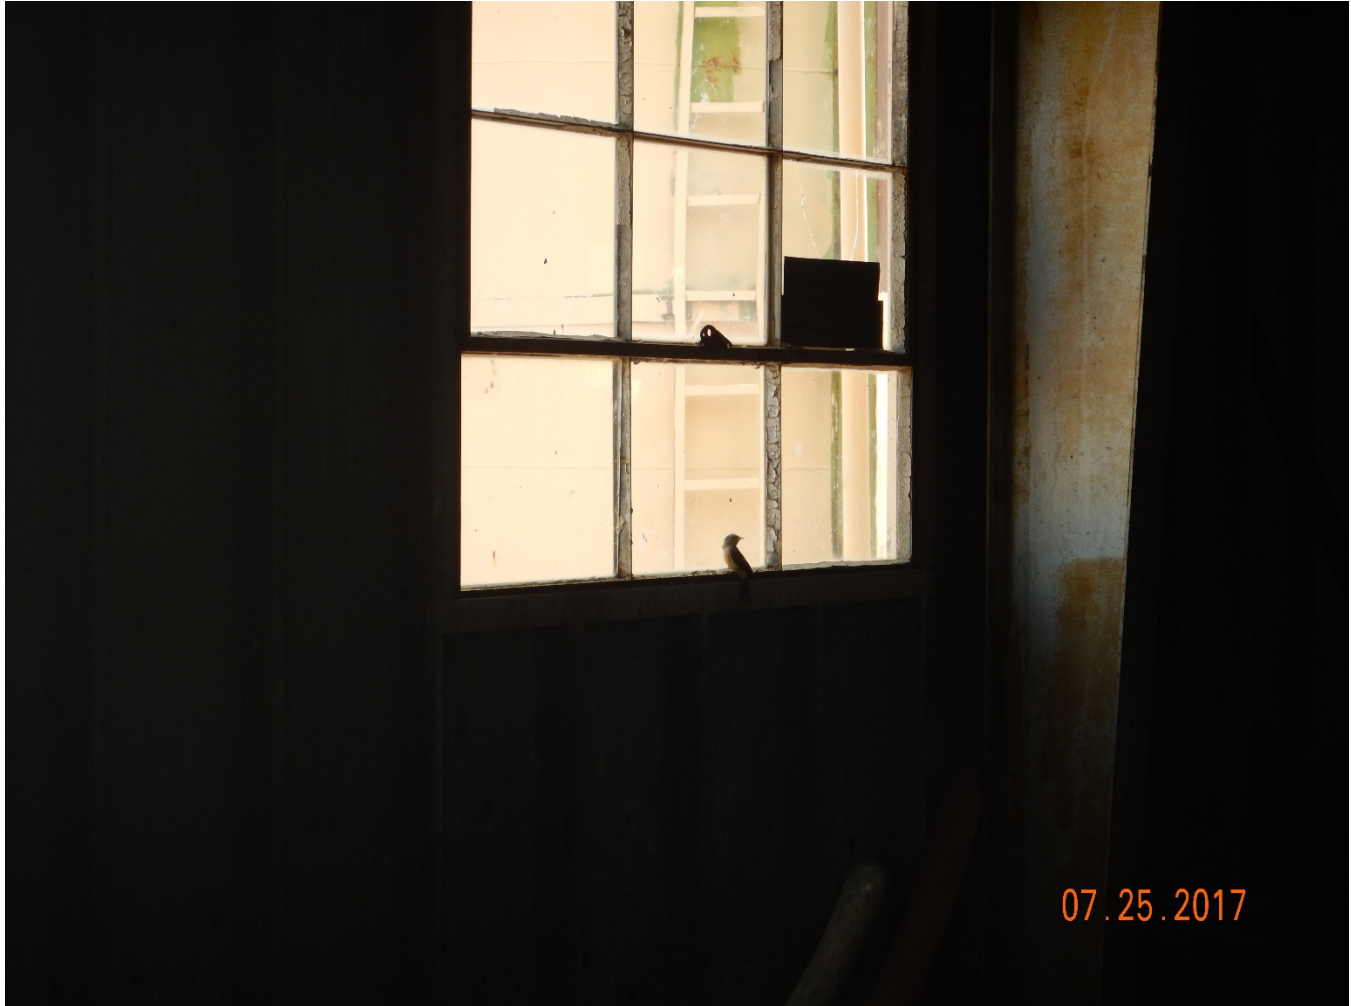
*Figure 27 - Wildlife access enabled by broken window on west side of main building.*

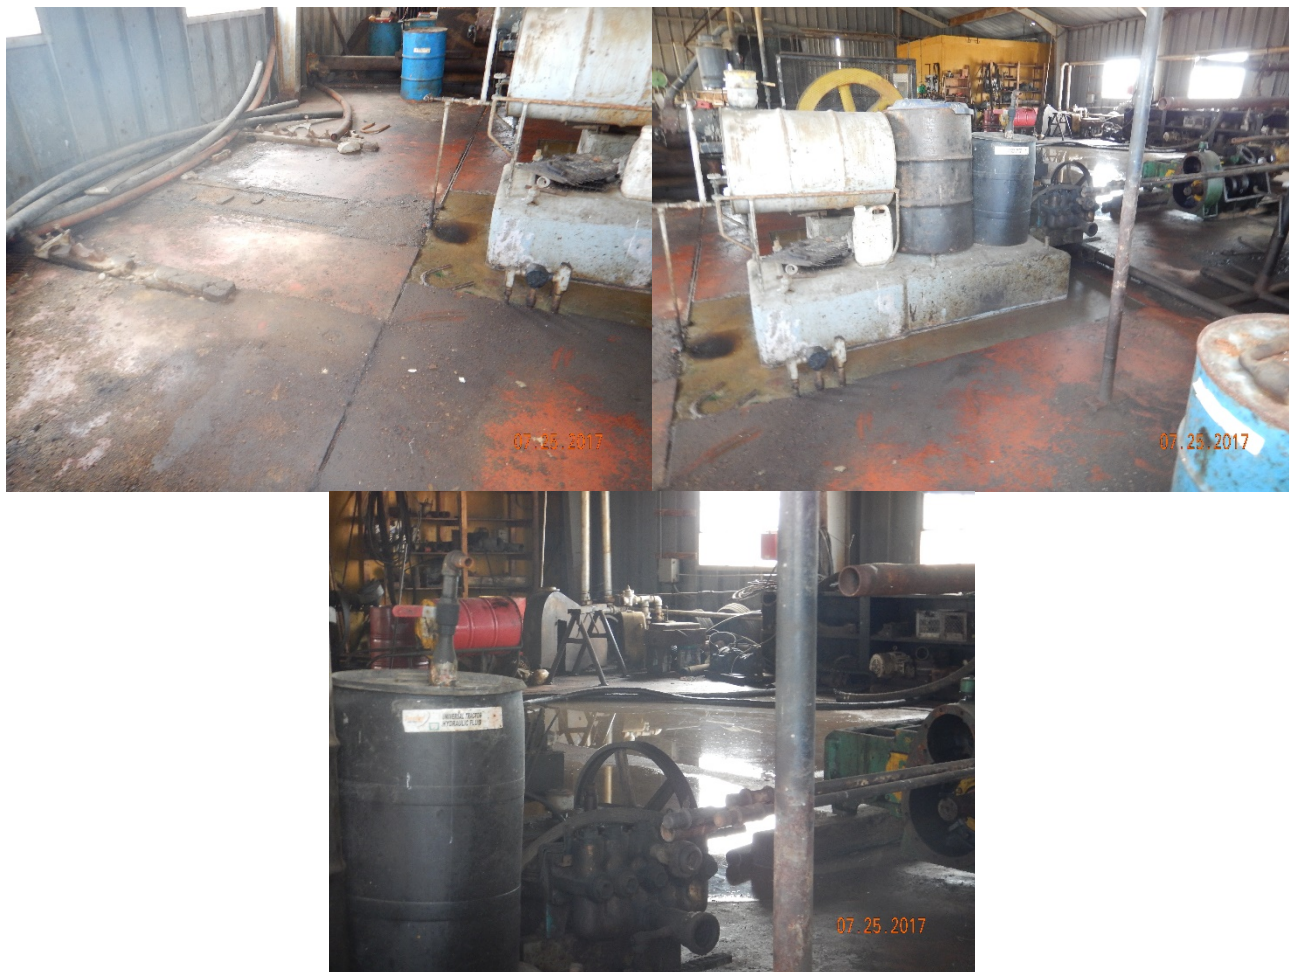
*Figure 28 - Localized staining and large puddle in center of main building likely caused by leaking equipment.*
