Inspection Photos

Operator: WHITING OIL & GAS CORPORATION -
96155

Location ID: 442134

Inspection Doc. Number: 675103778
Weld County, CO

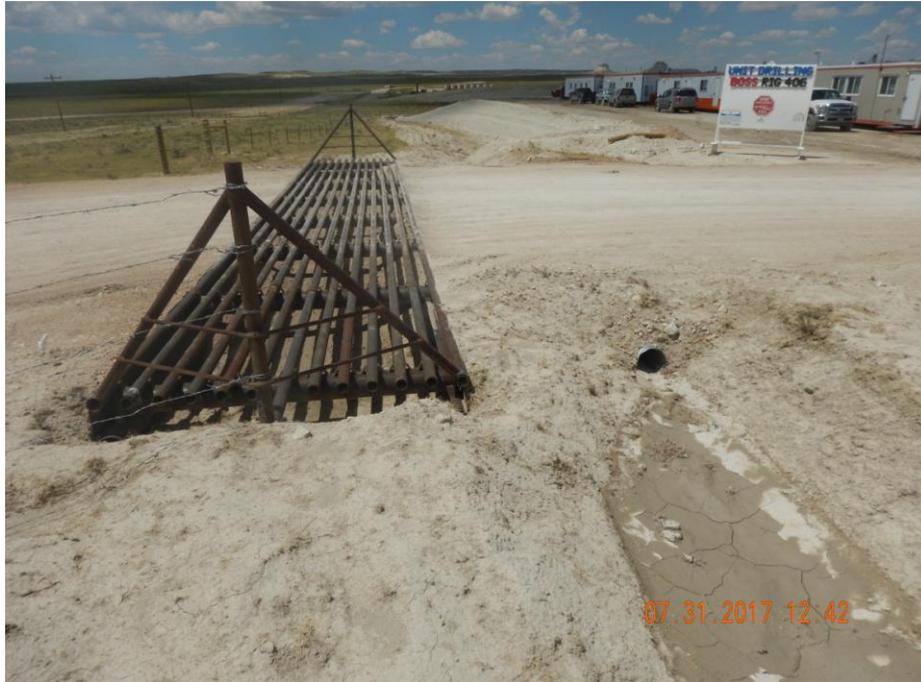
Photo 1: Photo taken from the south end of the location, facing west. Photo shows culvert and cattle guard.

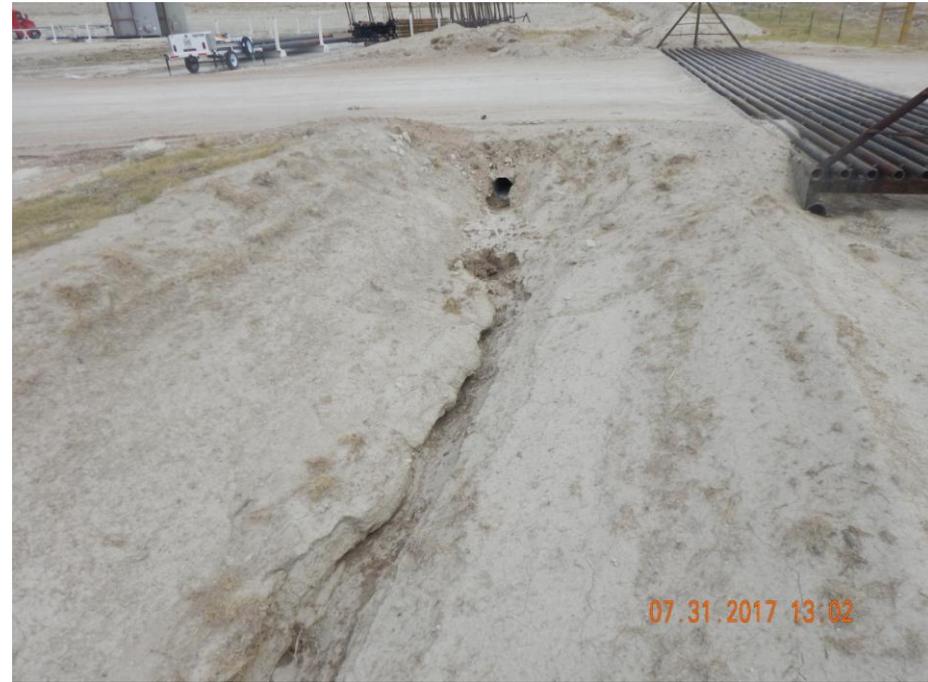
Photo 2: Photo taken from the south end of the location, facing east. Photo shows the west end of the culvert at the access road. Photo shows stormwater erosion has begun to incise the perimeter ditch at the culvert. Culvert does not appear to have sufficient outlet protection.

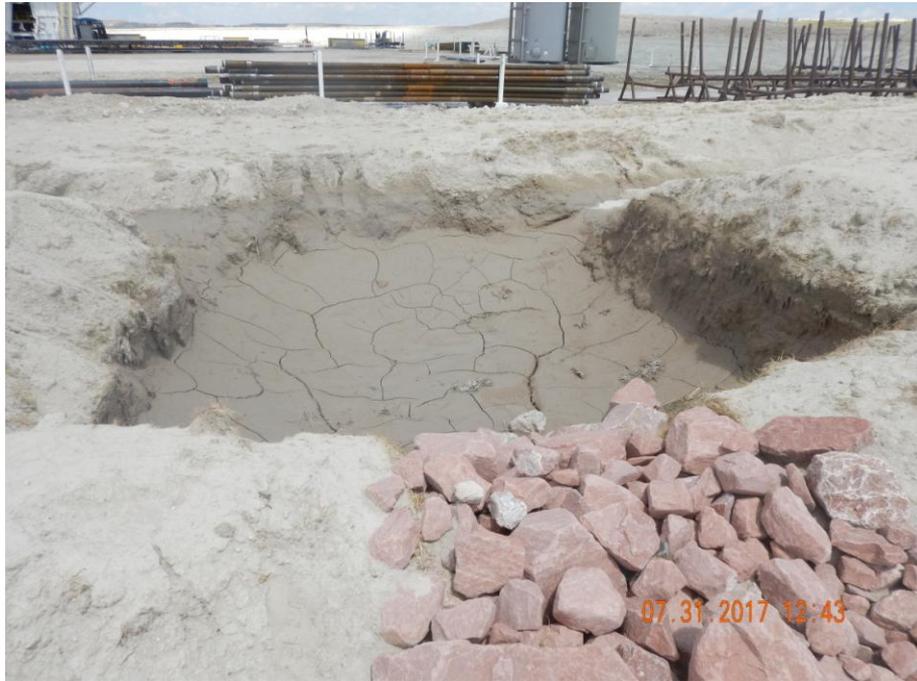
Photo 3: Photo taken from the south end of the location. Photo shows sediment trap. Trap appears to either have filled with sediment, or constructed with a shallow depth.

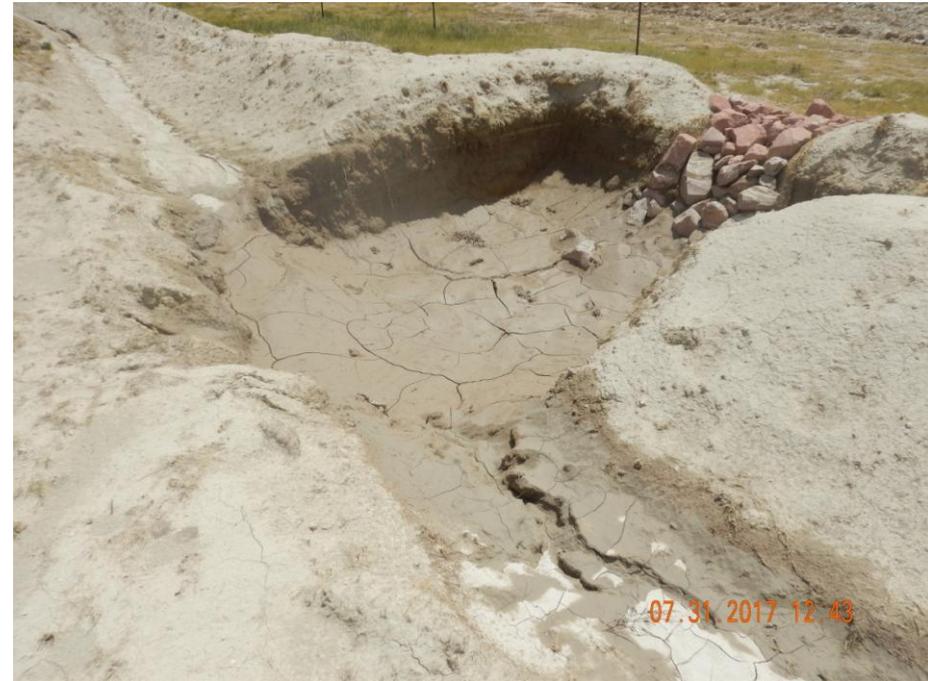
Photo 4: Photo taken from the south end of the location. Photo shows sediment trap. Photo shows stormwater erosion has begun to erode at the inlets of the trap. Sediment does not appear to have sufficient inlet protection.

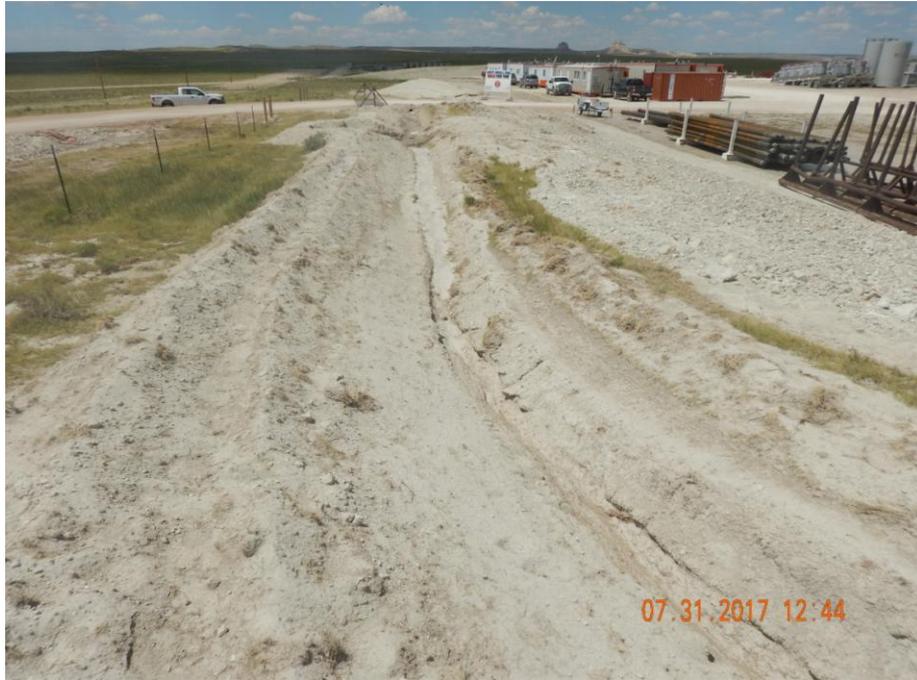
Photo 5: Photo taken from the southeast end of the location, facing west. Photo shows stormwater control ditch along perimeter of the location. Photo also shows stormwater erosion has begun to incise the perimeter ditch. Advise incorporating velocity check BMPs to mitigate further incision and degradation to the ditch.

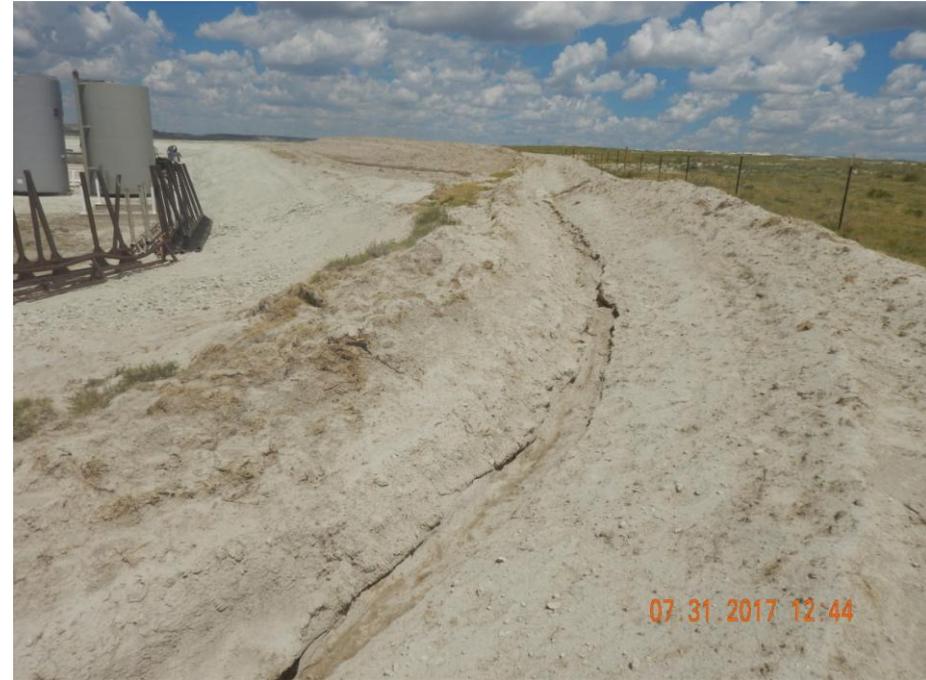
Photo 6: Photo taken from the southeast end of the location, facing north. Photo shows stormwater control ditch along perimeter of the location. Photo also shows stormwater erosion has begun to incise the perimeter ditch. Advise incorporating velocity check BMPs to mitigate further incision and degradation to the ditch.

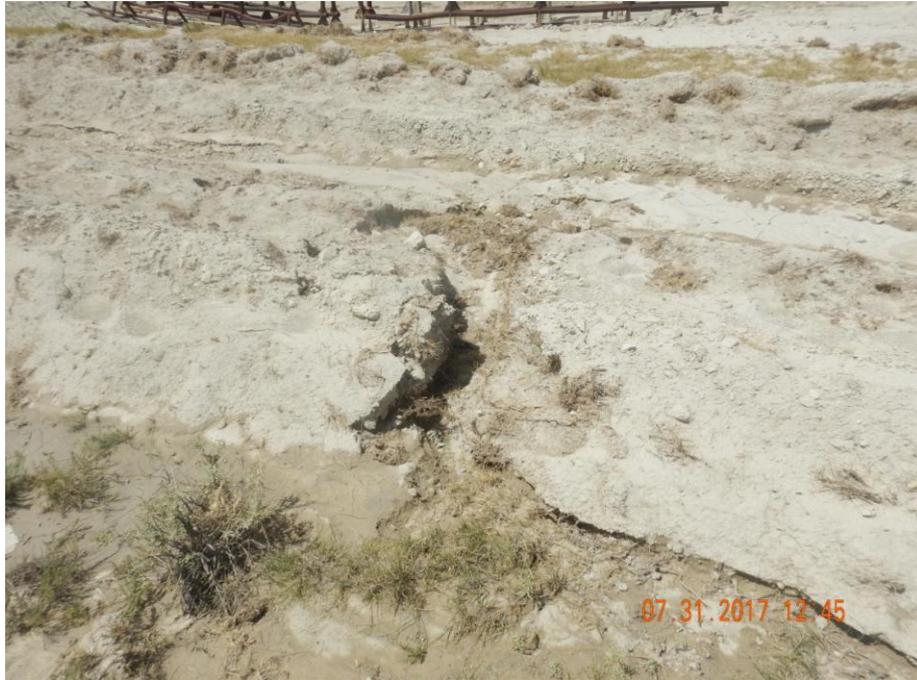
Photo 7: Photo taken from the storm water ditch on the east end of the location. Photo shows stormwater erosion has compromised the integrity of the ditch. Ditch does not appear to have been sufficiently consolidated. Without adequate consolidation, ditch will increase the sediment laden stormwater runoff from the location.

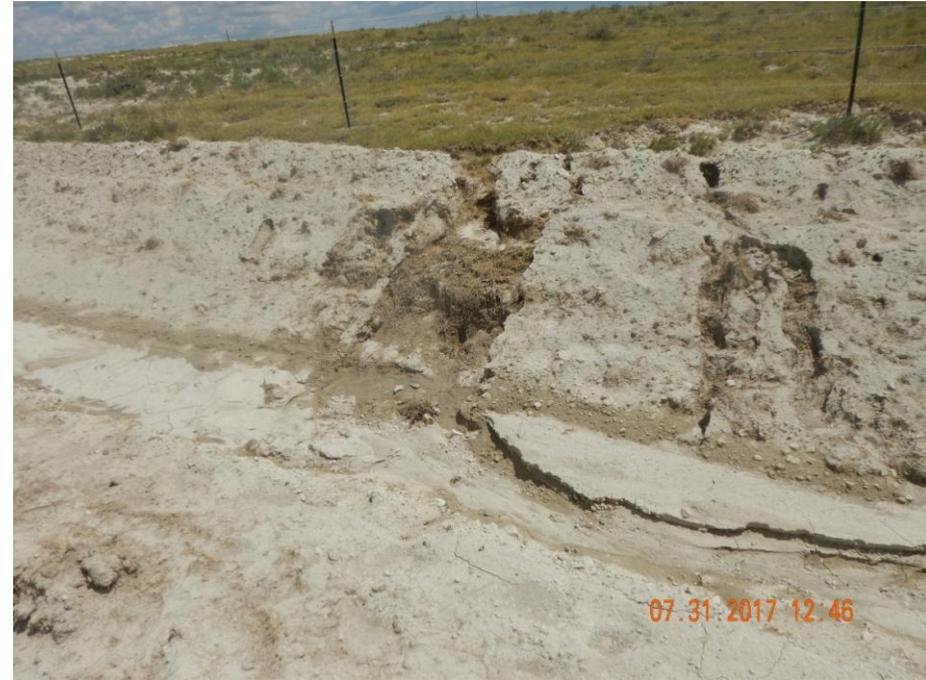
Photo 8: Photo taken from the storm water ditch on the east end of the location. Photo shows stormwater erosion has compromised the integrity of the ditch. Ditch does not appear to have been sufficiently consolidated. Without adequate consolidation, ditch will increase the sediment laden stormwater runoff from the location.

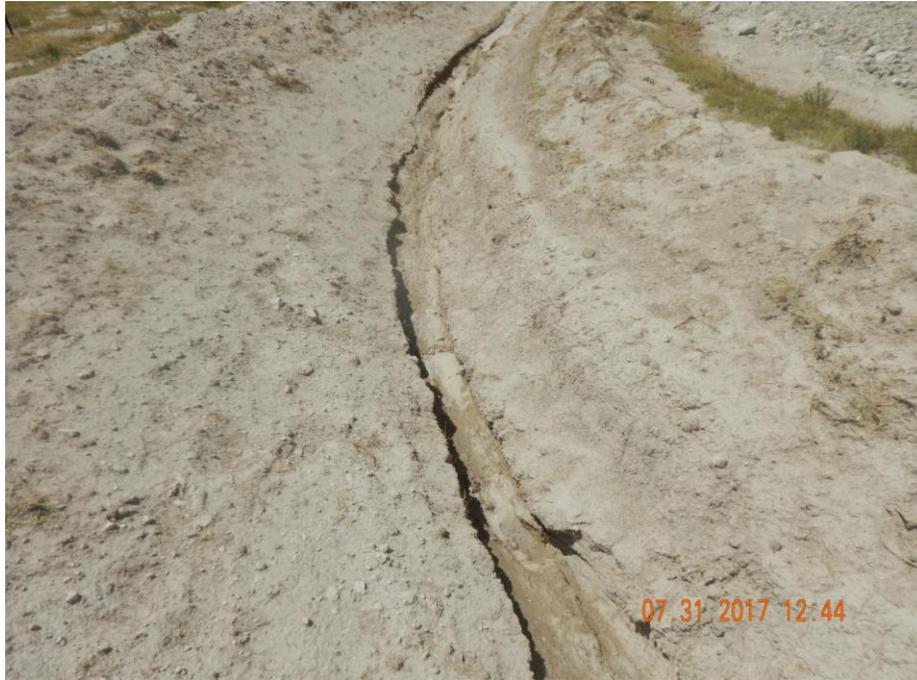
Photo 9: Photo taken from the stormwater control ditch on the east end of the location. Photo shows stormwater erosion has begun to incise the perimeter ditch. Advise incorporating velocity check BMPs to mitigate further incision and degradation to the ditch.

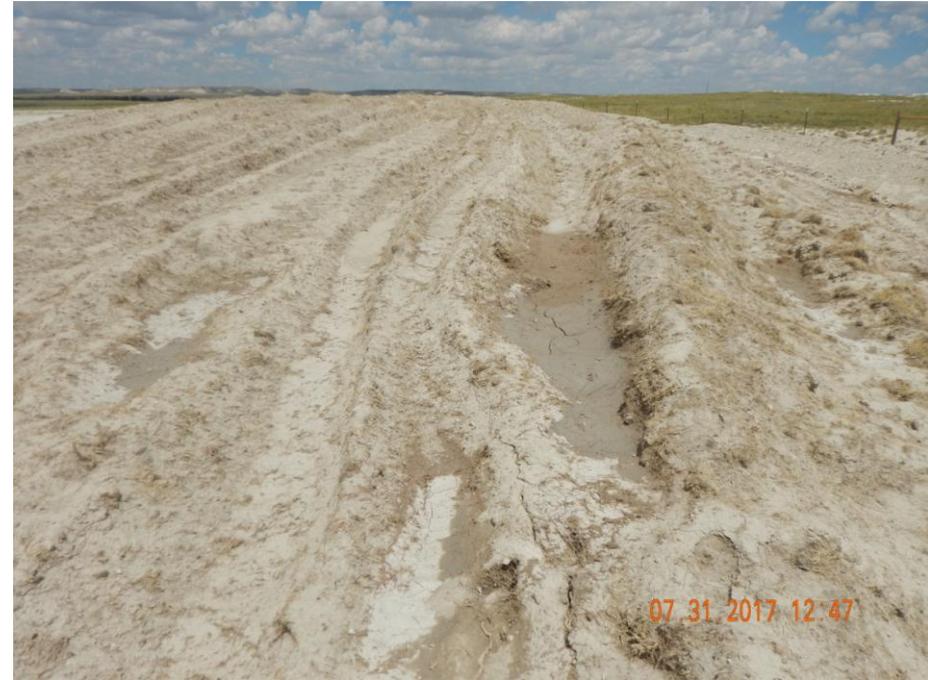
Photo 10: Photo taken from the topsoil pile on the east end of the location. Photo shows topsoil pile is loose, and does not appear to have sufficient protection; pile appears to be at risk to stormwater and wind erosion.

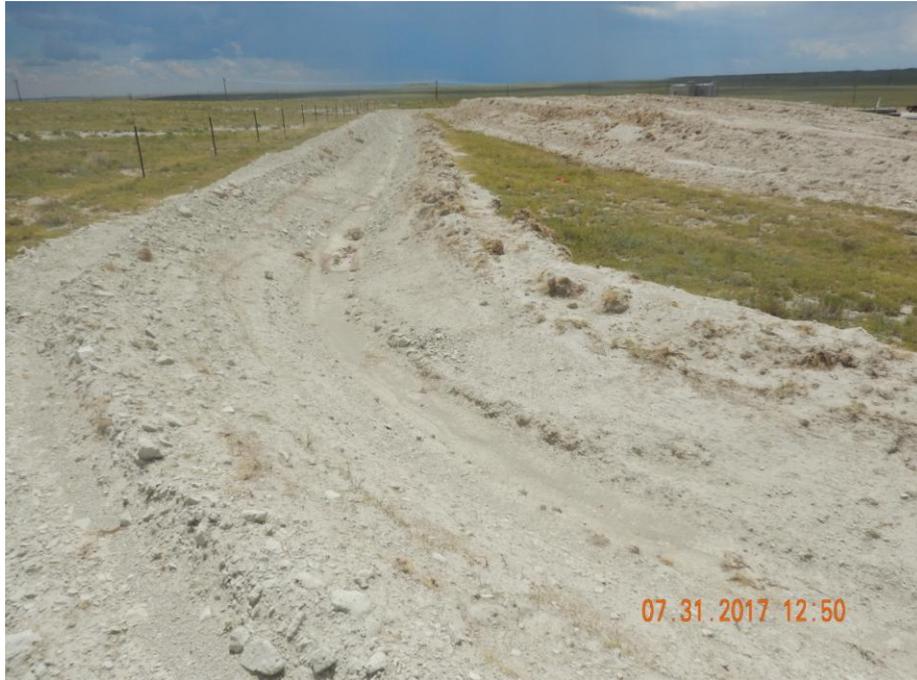
Photo 11: Photo taken from the northeast end of the location, facing south. Photo shows stormwater control ditch along perimeter of the location.

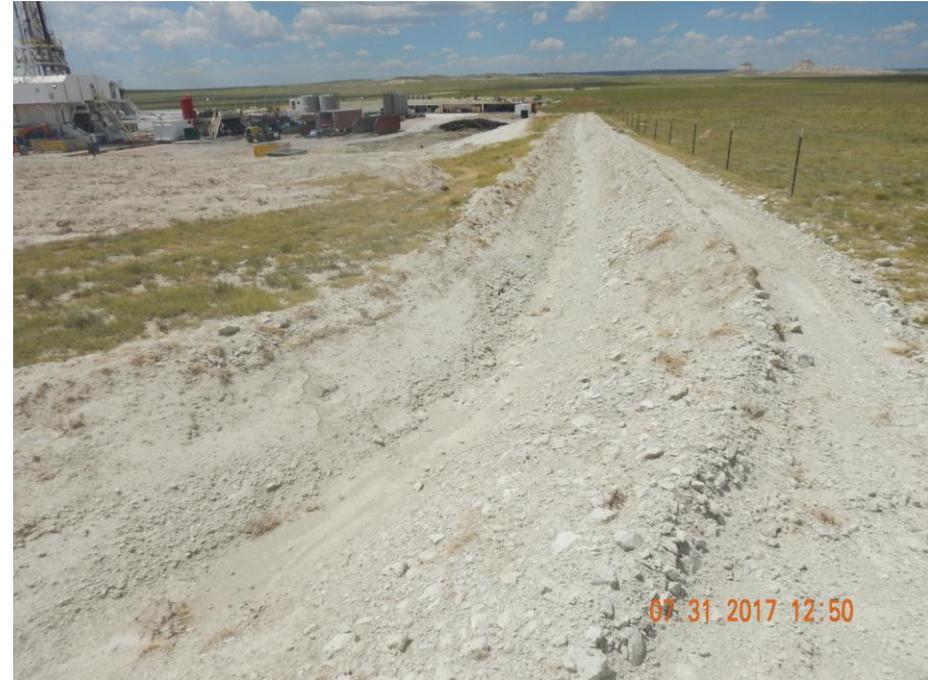
Photo 12: Photo taken from the northeast end of the location, facing south. Photo shows stormwater control ditch along perimeter of the location.

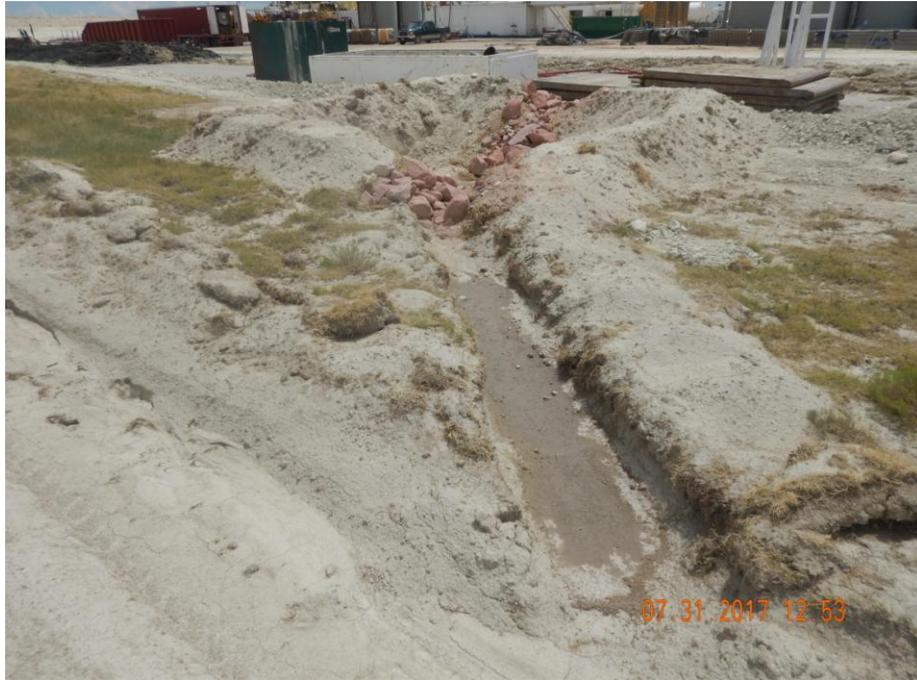
Photo 13: Photo taken from the north end of the location. Photo shows sediment trap outlet. Sediment appears to be in proper functioning condition.

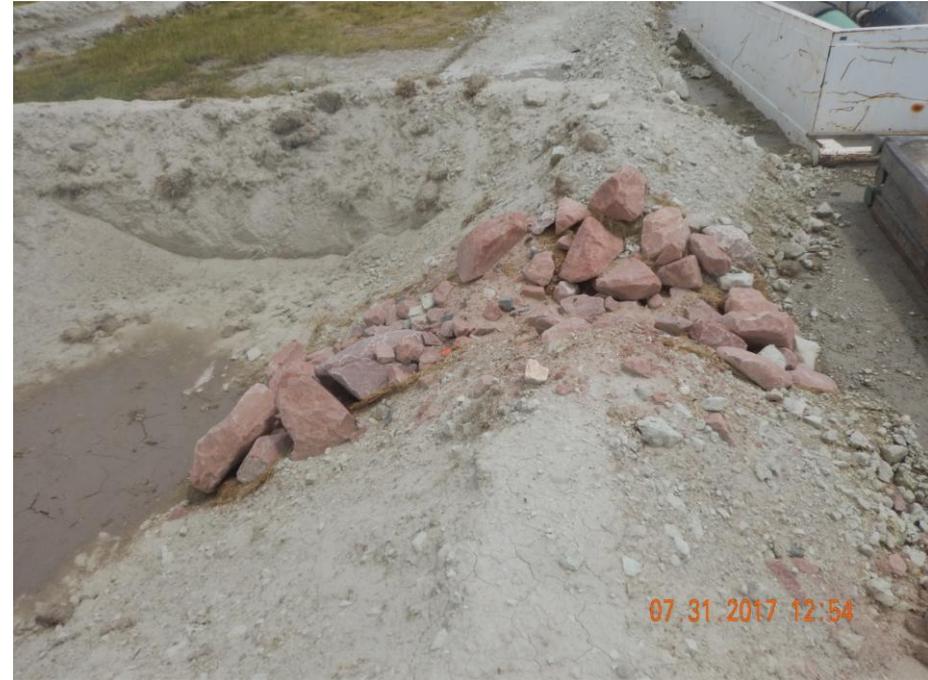
Photo 14: Photo taken from the north end of the location. Photo shows sediment trap inlet. Sediment appears to be in proper functioning condition.

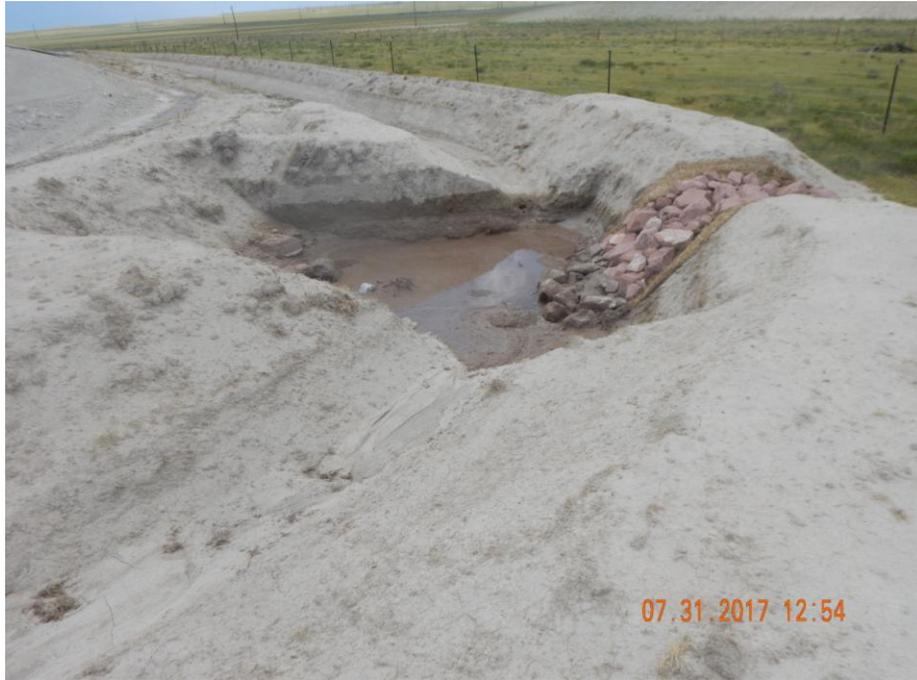
Photo 15: Photo taken from the northwest end of the location. Photo shows sediment trap.

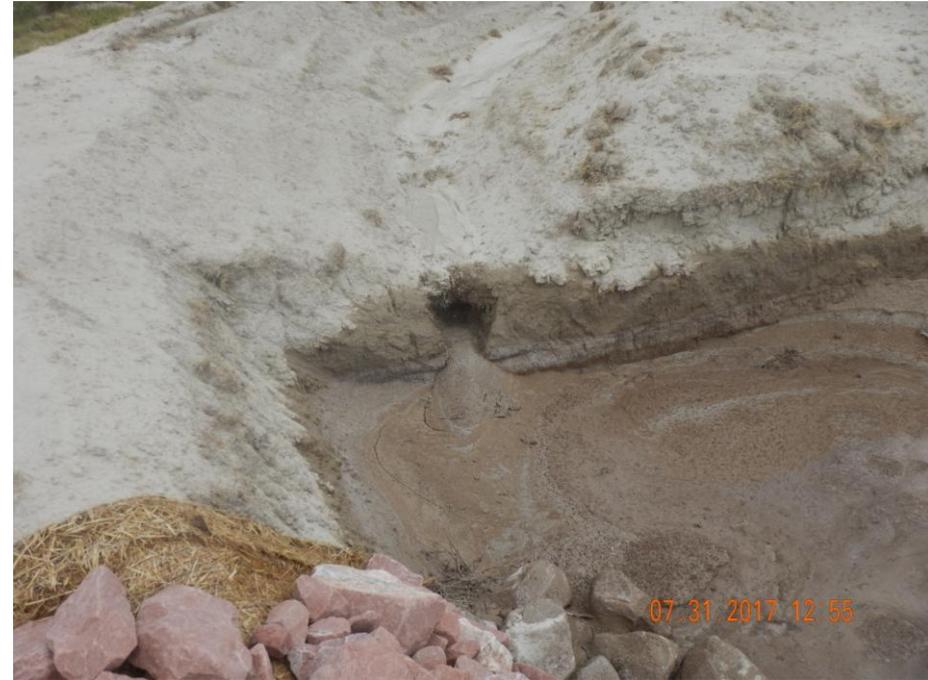
Photo 16: Photo taken from the northwest end of the location. Photo shows sediment trap. Photo shows stormwater erosion has begun to erode at the inlets of the trap. Sediment does not appear to have sufficient inlet protection

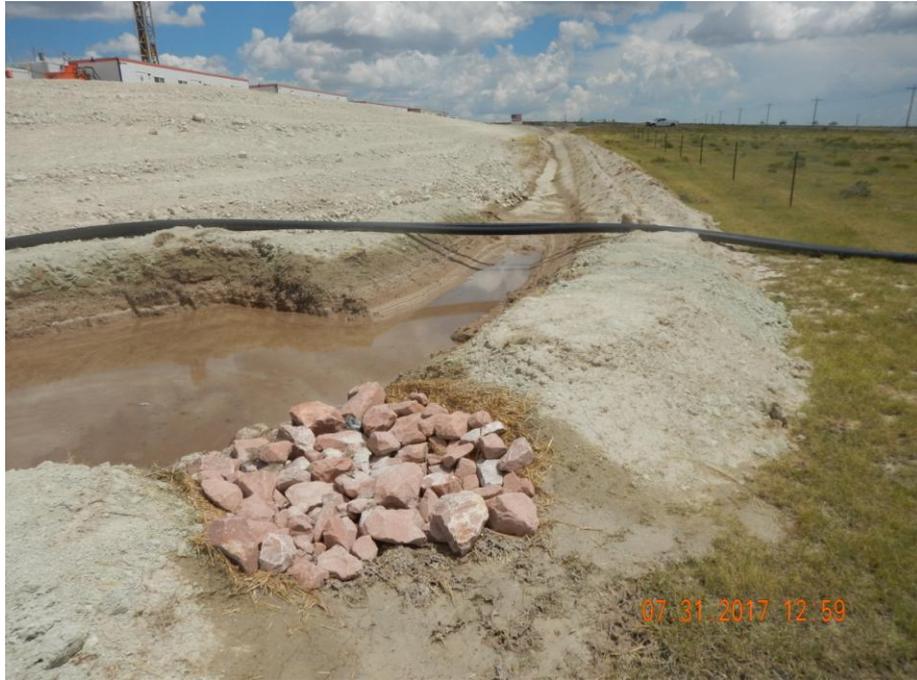
Photo 17: Photo taken from the southwest end of the location, facing east. Photo shows sediment trap and stormwater control ditch.

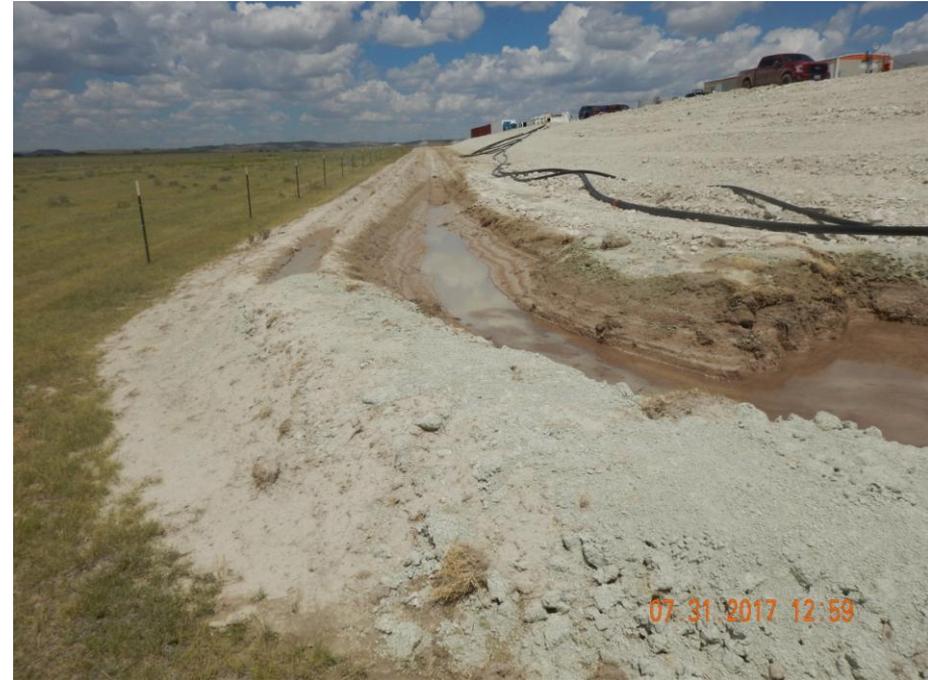
Photo 18: Photo taken from the southwest end of the location, facing north. Photo shows sediment trap and stormwater control ditch.

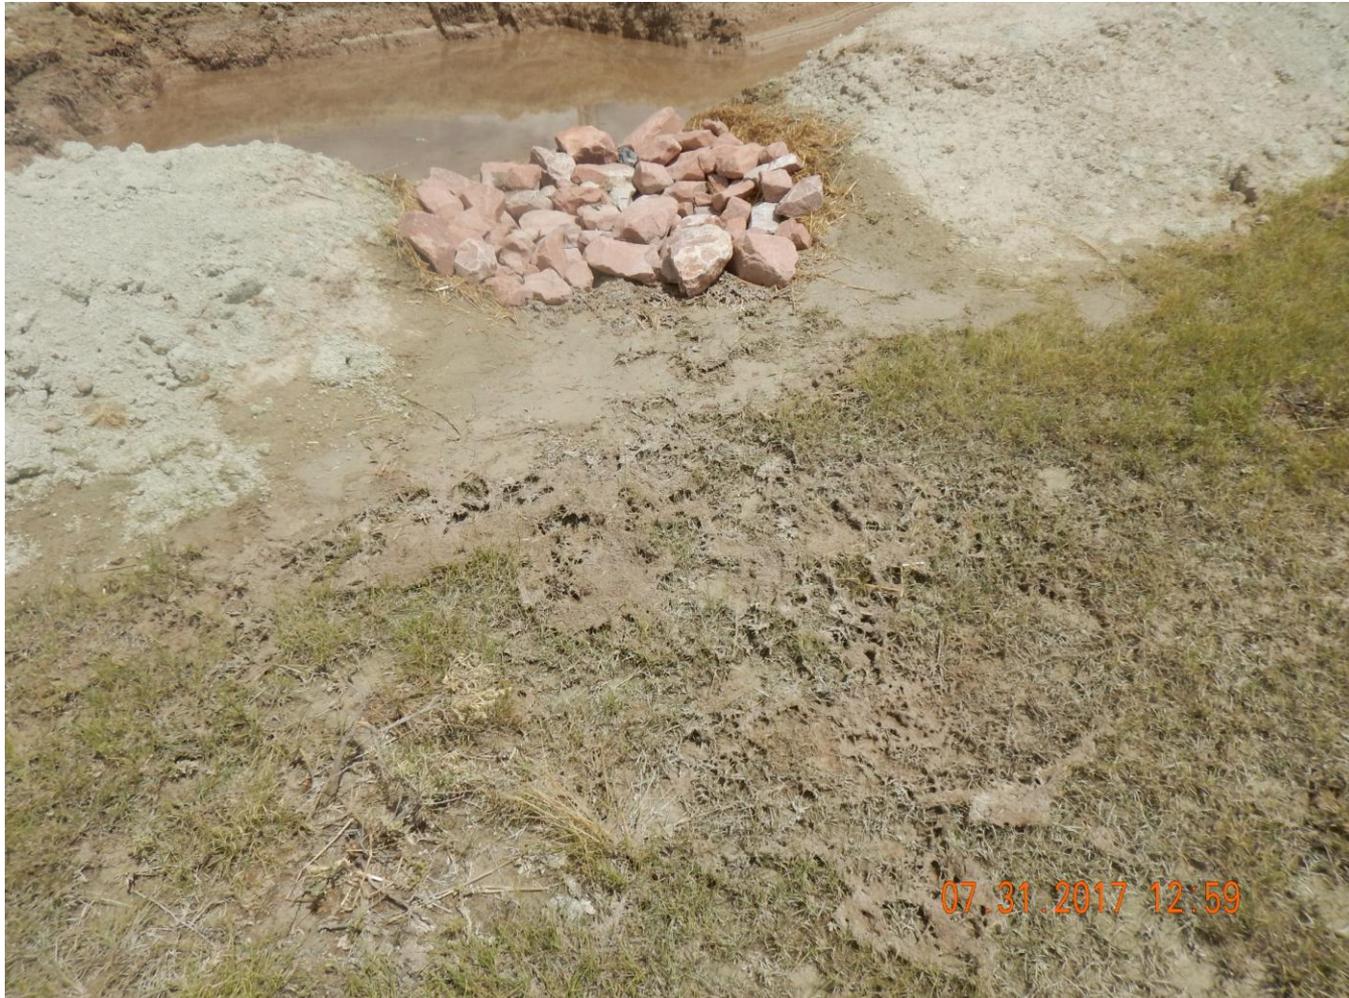
Photo 19: Photo taken from the sediment trap on the southwest corner of the location. Photo shows sediment laden stormwater has discharged from the location. Trap does not appear to have sufficient outlet protection.

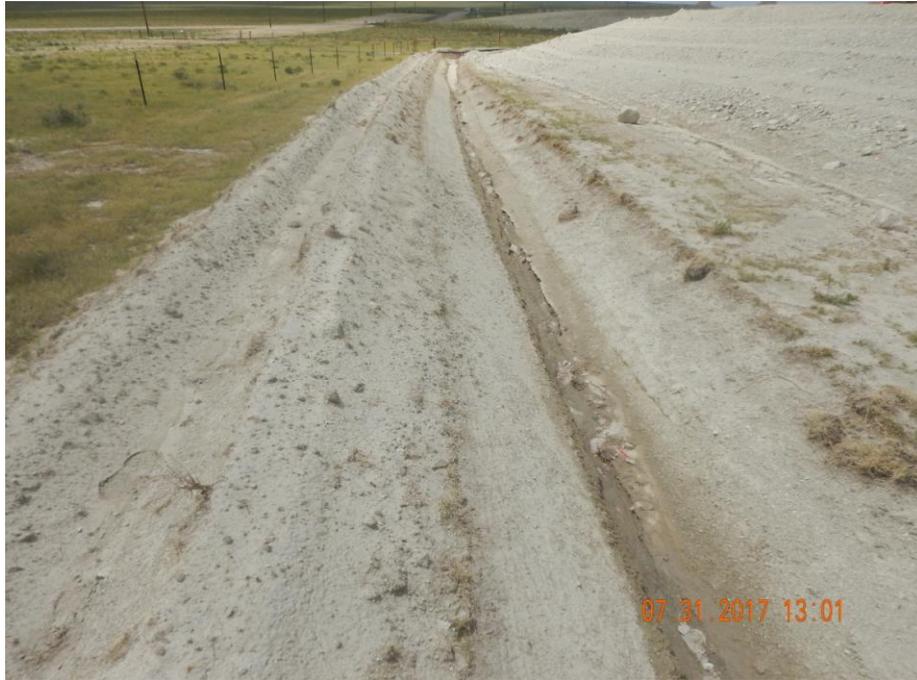
Photo 20: Photo taken from the stormwater control ditch on the east end of the location. Photo shows stormwater erosion has begun to incise the perimeter ditch. Advise incorporating velocity check BMPs to mitigate further incision and degradation to the ditch.

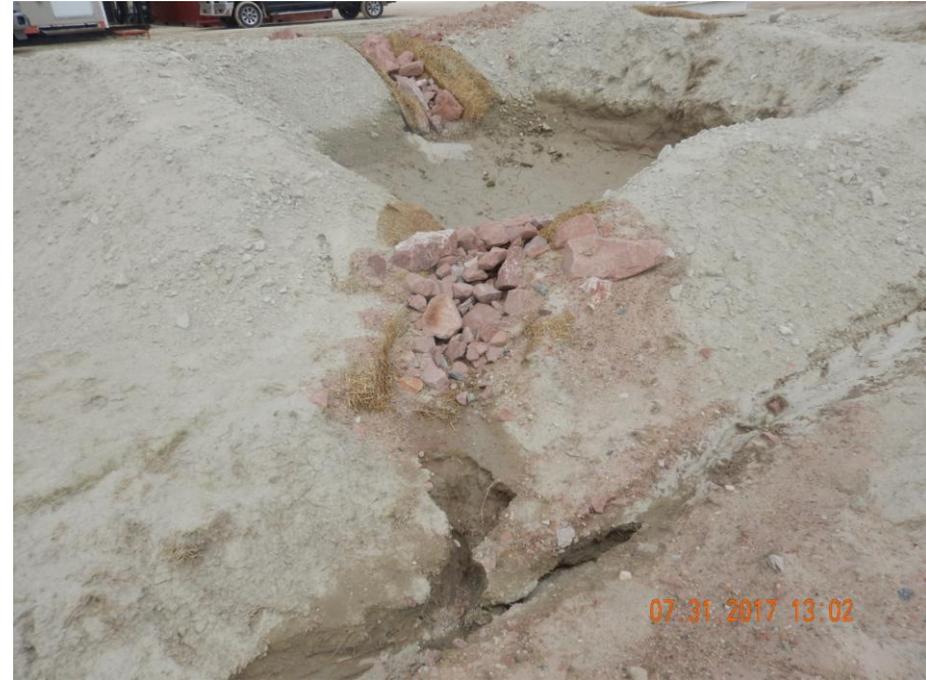
Photo 21: Photo taken from the south end of the location (west of cattle guard). Photo shows sediment trap. Photo shows stormwater erosion has begun to erode at the outlet of the trap, contributing to sediment laden stormwater discharge.. Sediment does not appear to have sufficient outlet protection.

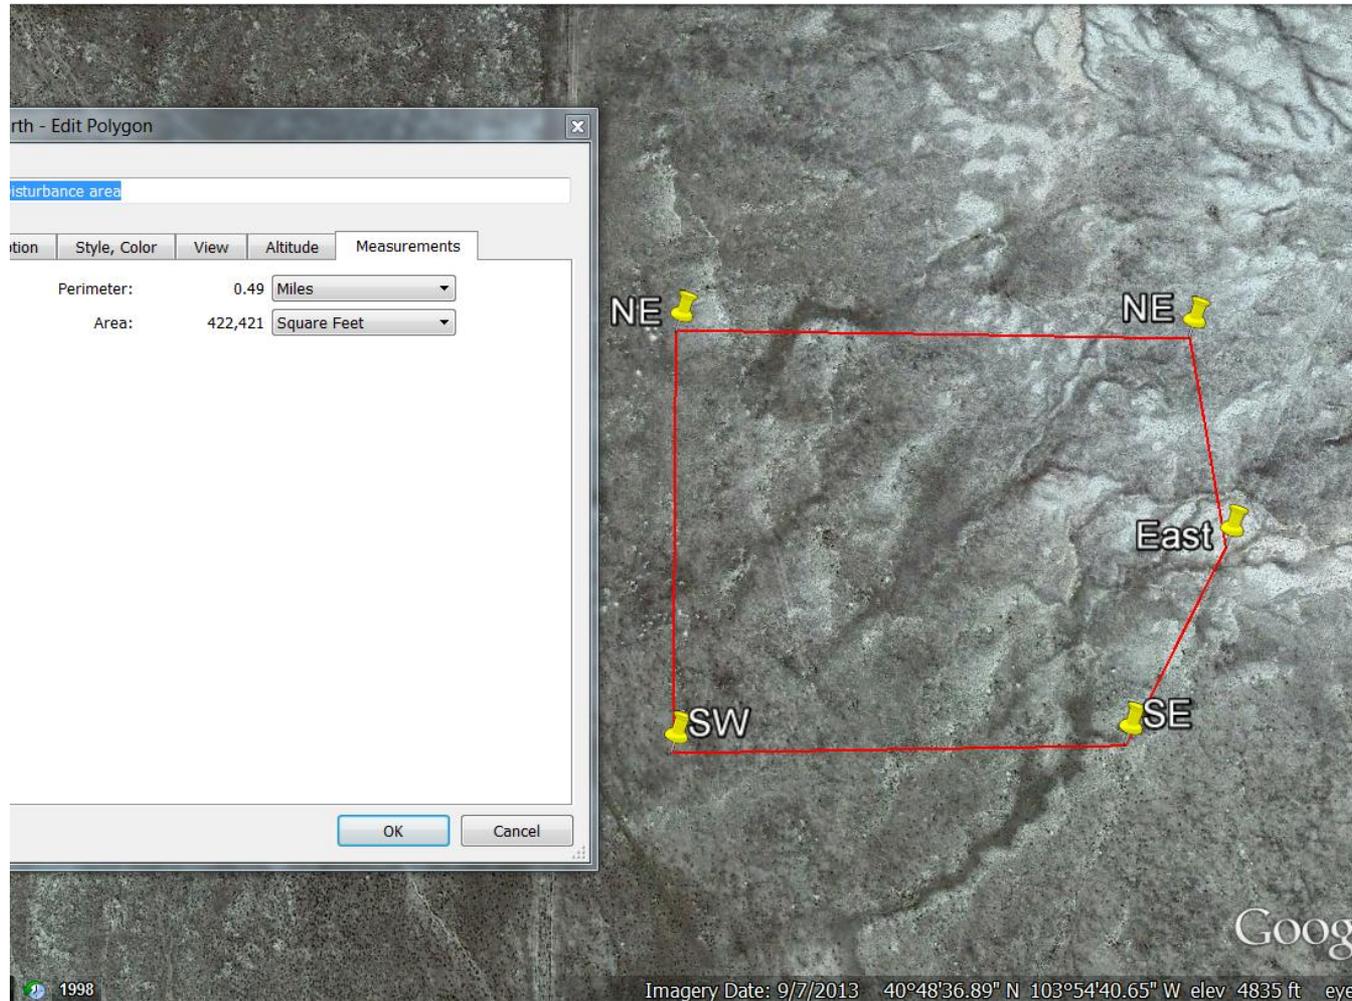
Photo 22: Aerial imagery of the location. Photo shows size of disturbance to be ~9.7 acres in size.
