Inspection Photos
Location ID: 418750

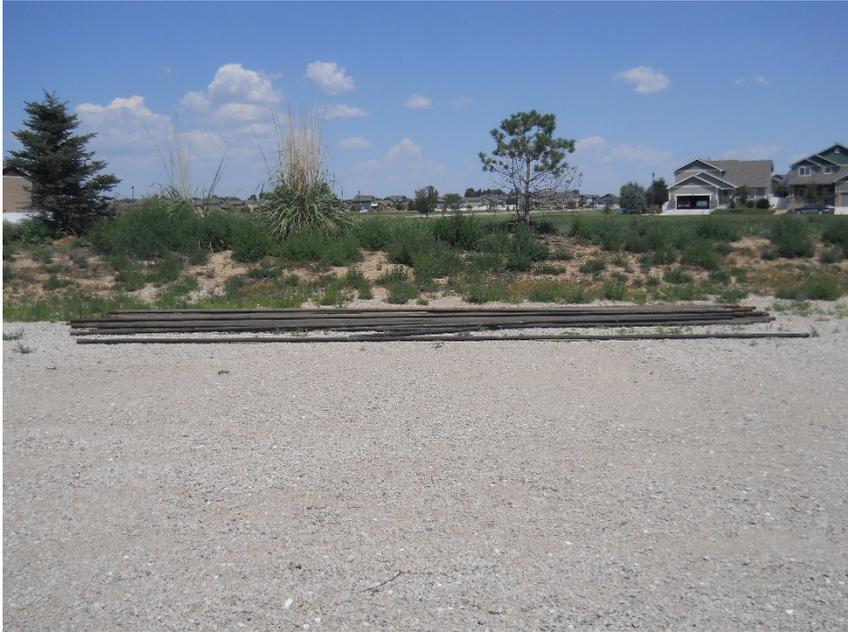
1) Tubing on ground north side of location

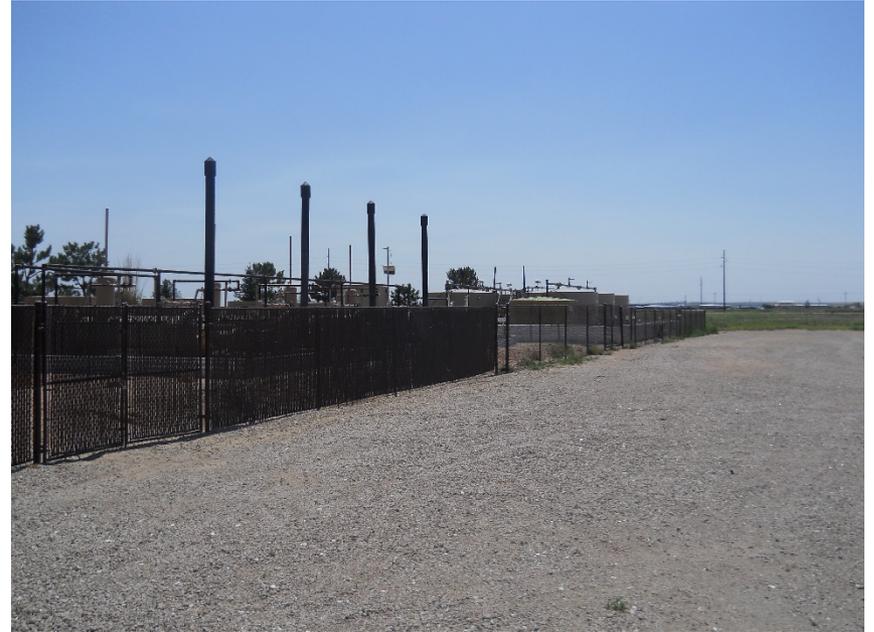
2) Battery looking south

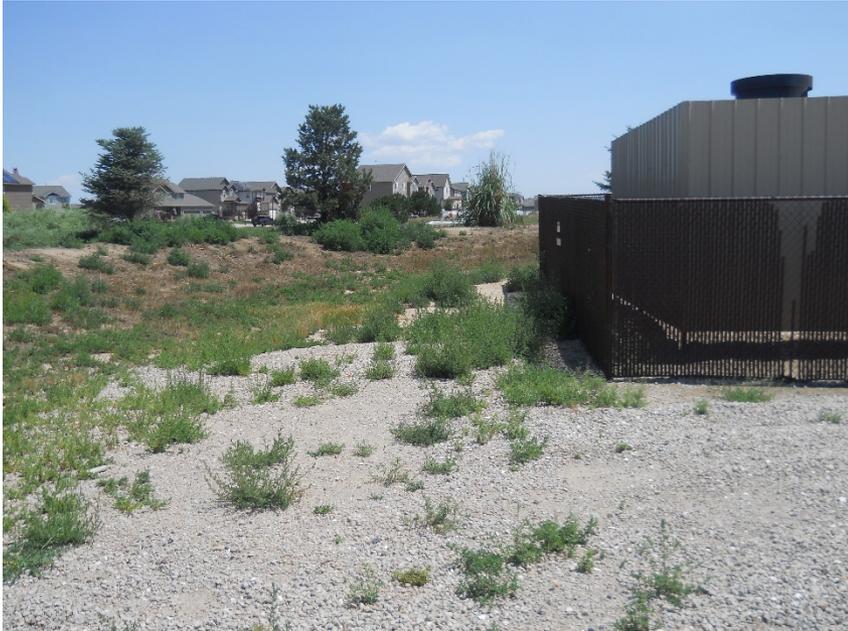
3) Weeds on east side of tank battery

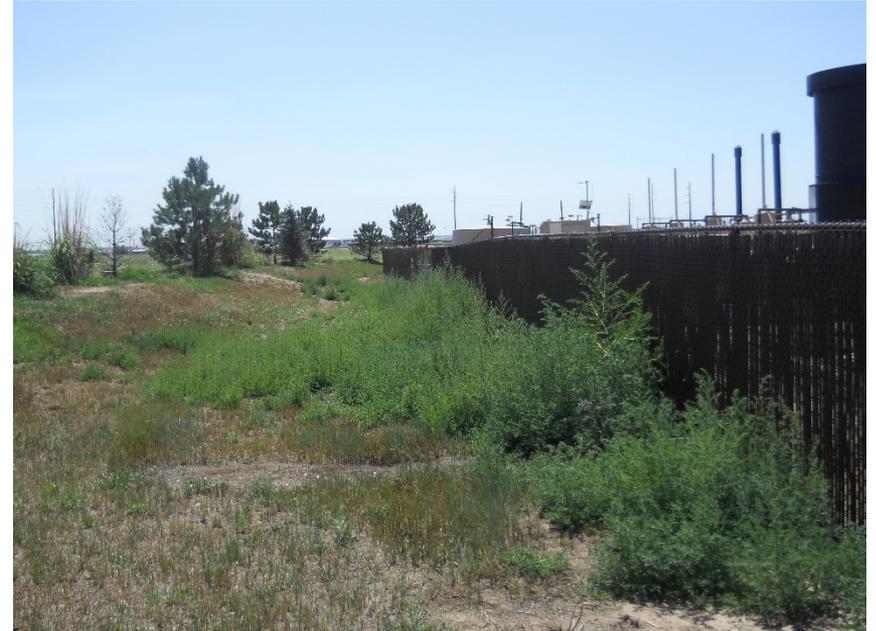
4) Weeds on east side of tank battery

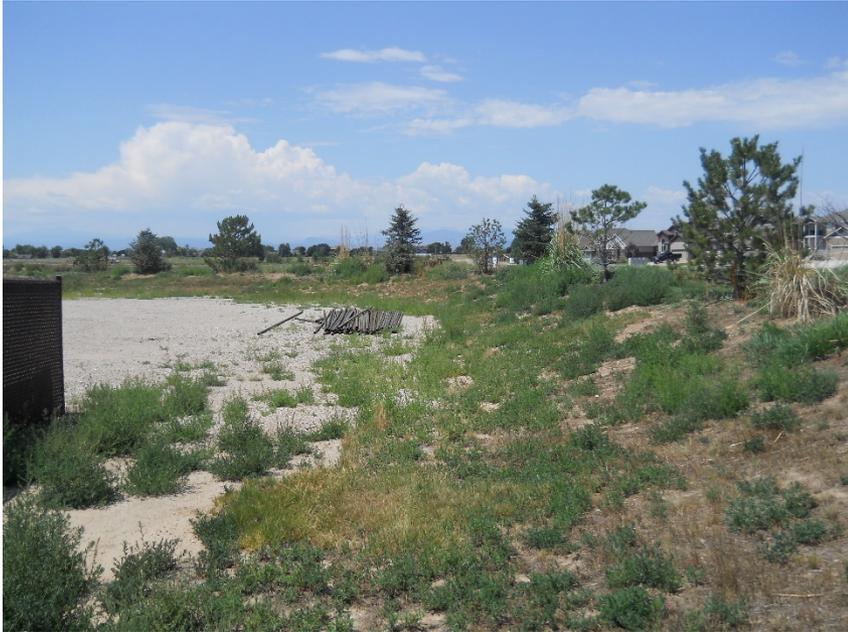
5) Weeds on north side of battery

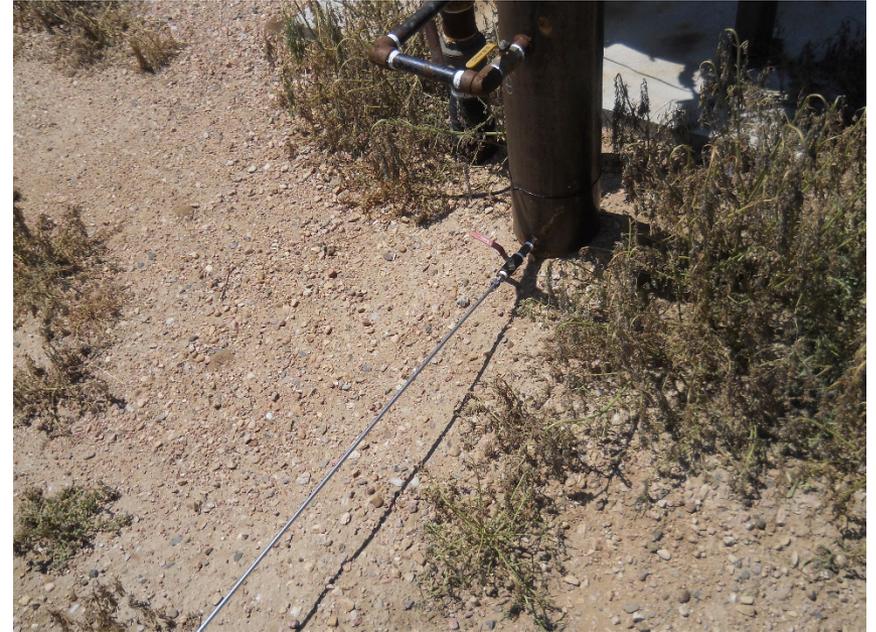
6) Scrubber drain on north ECD plumbed through fence

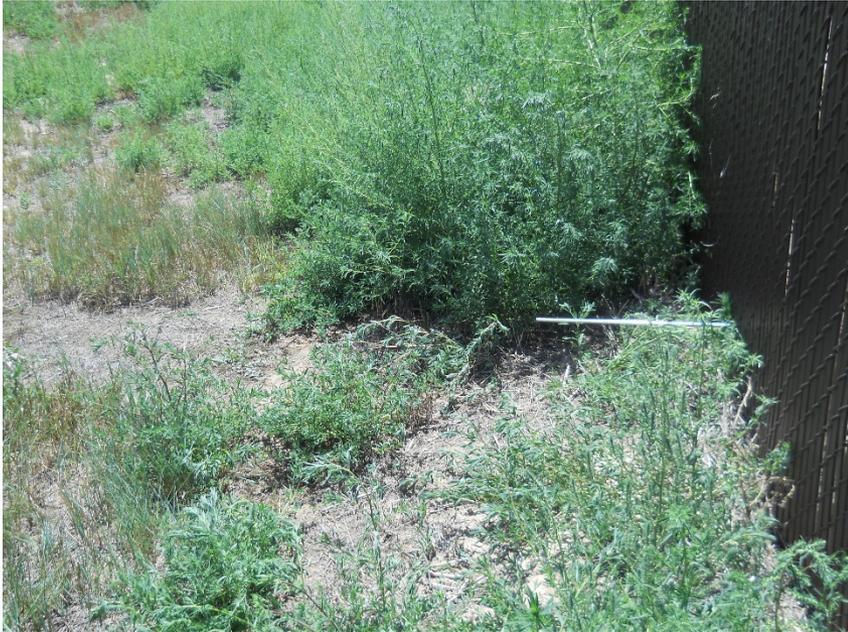
7) Scrubber drain plumbed outside of fence on east side of battery-note distressed vegetation

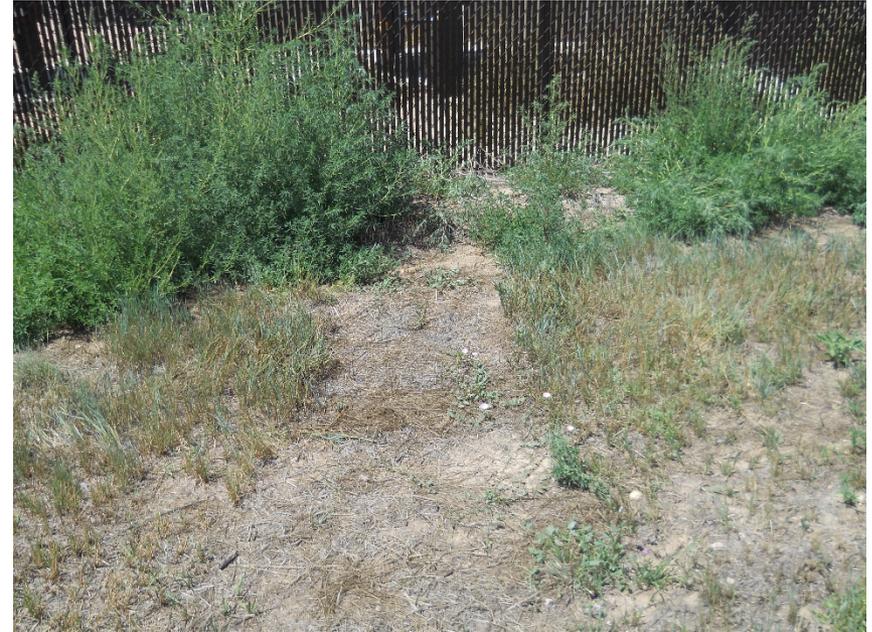
8) Distressed vegetation from ECD scrubber drain

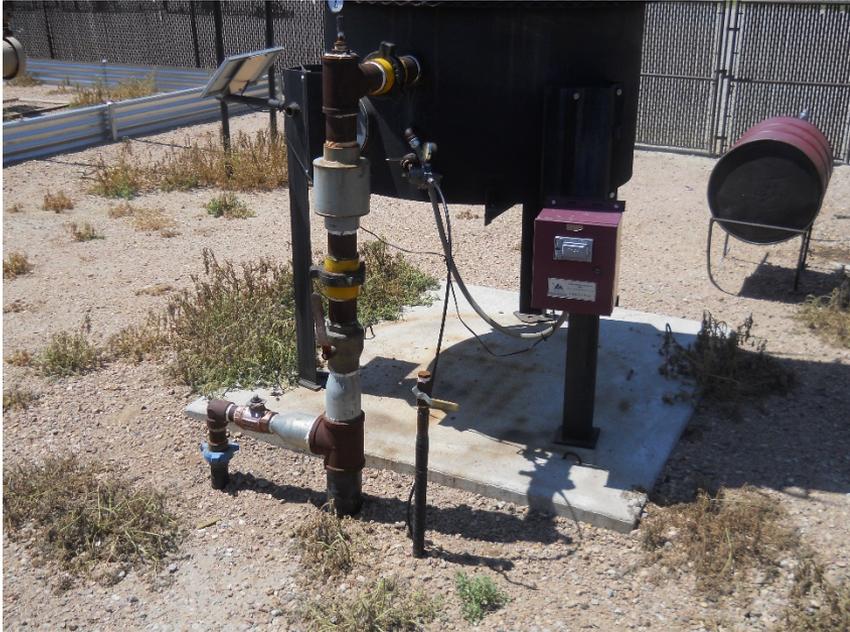
9) Unmarked/unused 1" steel riser at south ECD

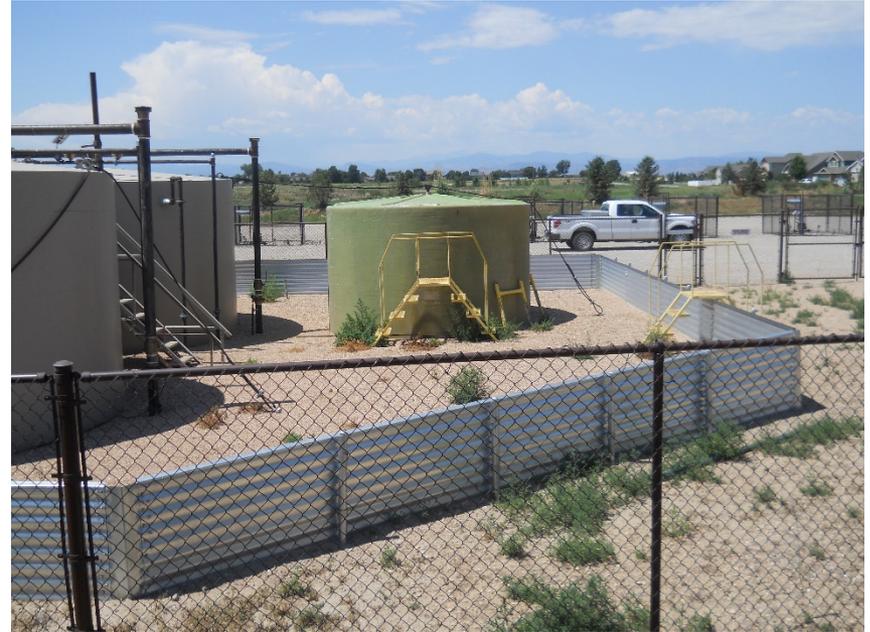
10) Weeds inside of tank battery looking west, no water tank signage

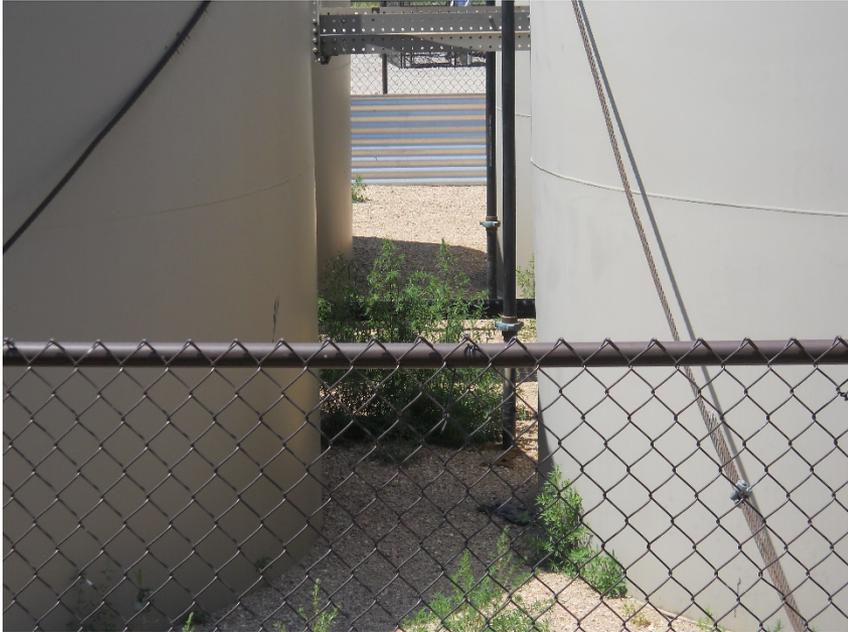
11) Weeds inside of tank battery

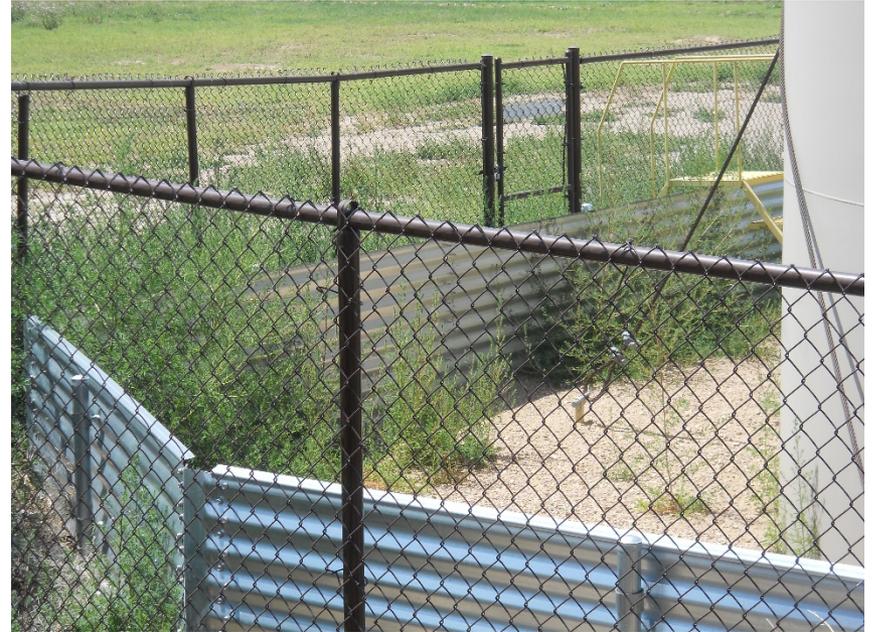
12) Weeds inside tank battery on south side

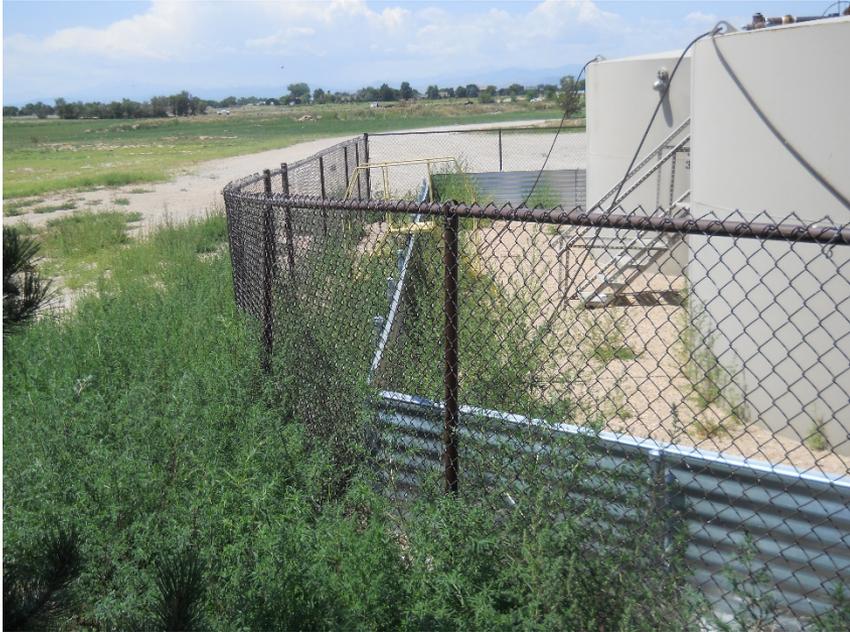
13) Weeds south of tanks

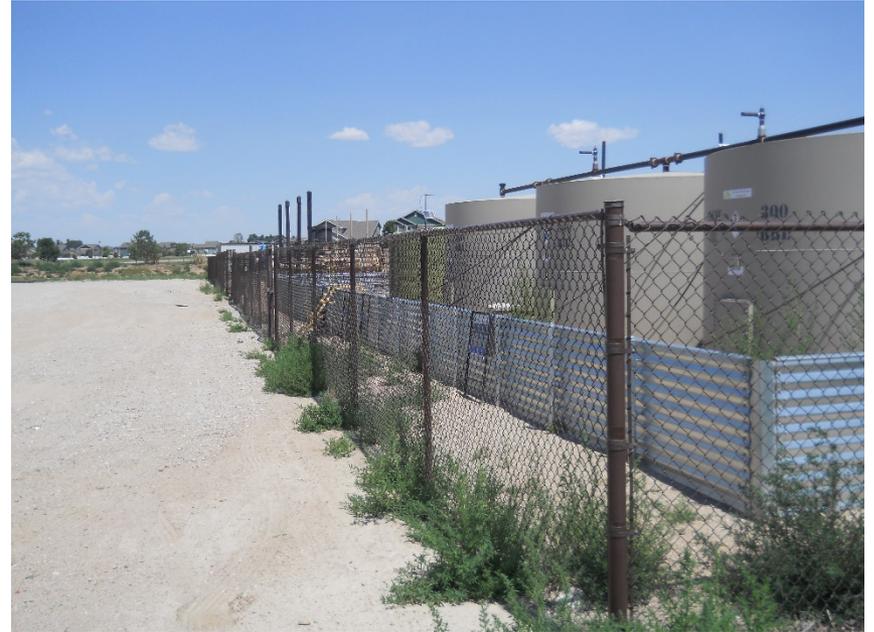
14) Weeds on west side of tanks looking north

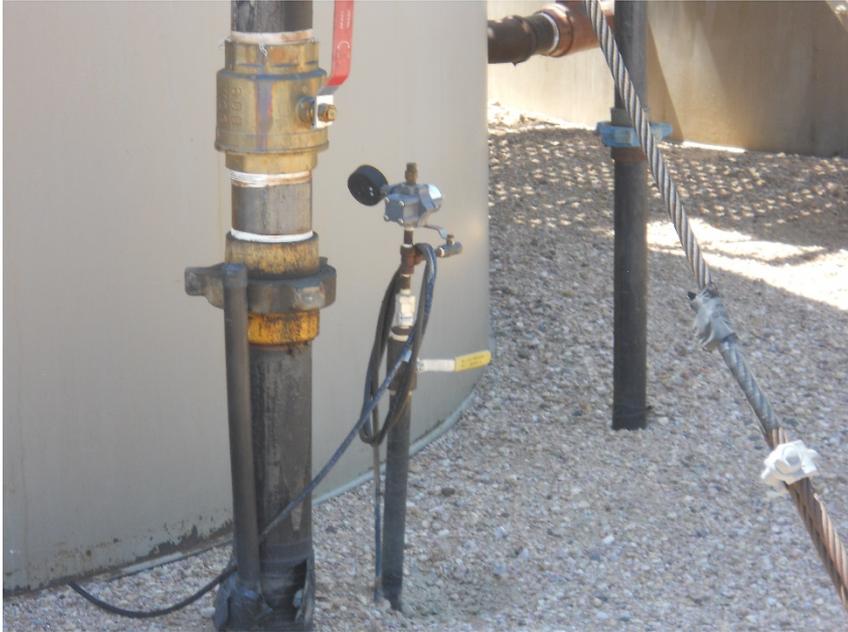
15) Unmarked/unused 1" steel riser next to northeast tank

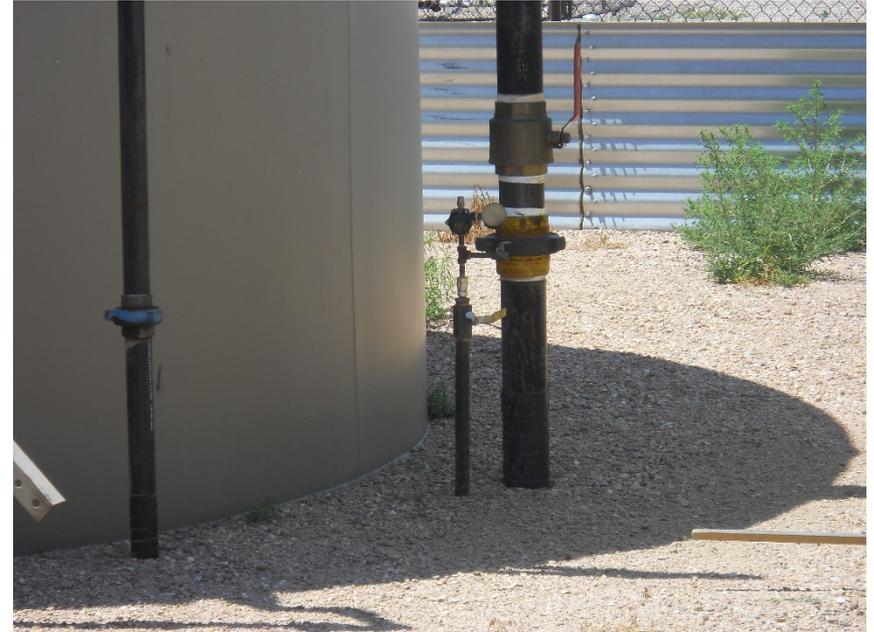
16) Unmarked/unused 1" steel riser next to northwest tank

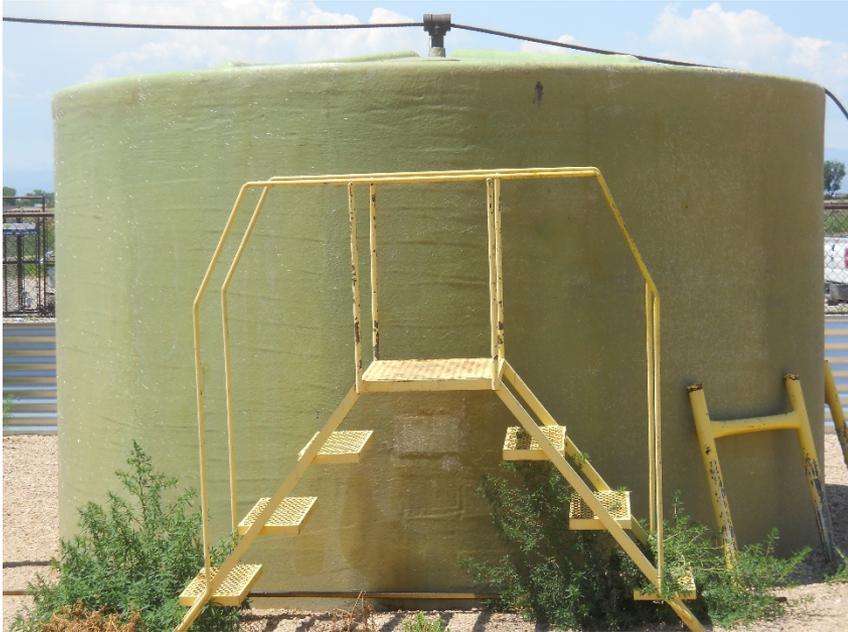
17) Weeds inside of berm, no signage on water tank labeling contents, capacity, NFPA label

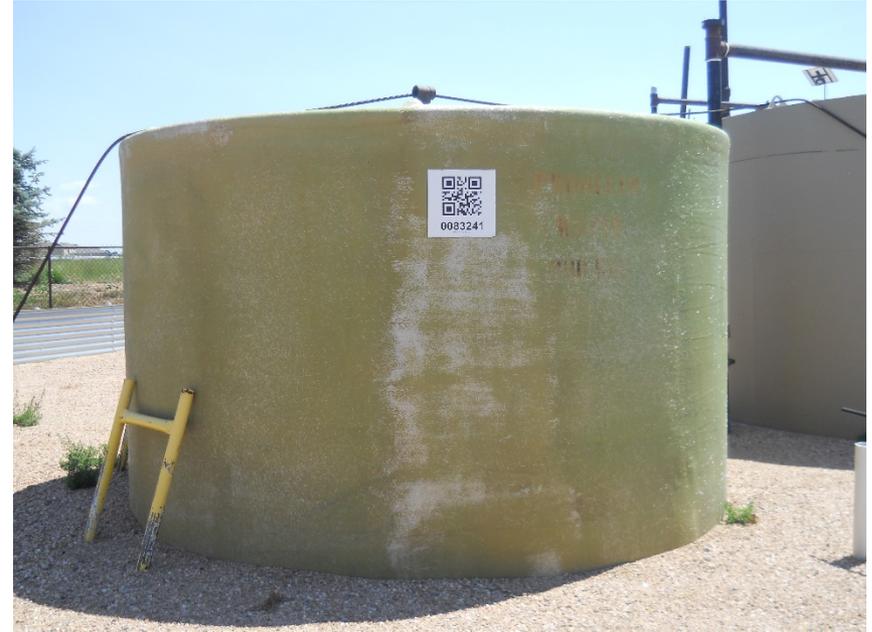
18) No signage on water tank

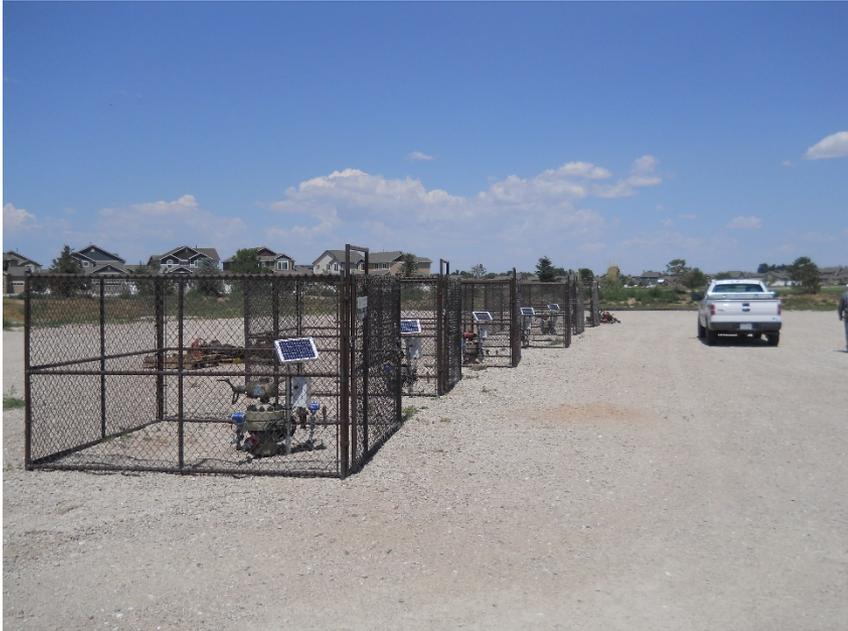
19) Wellheads looking north

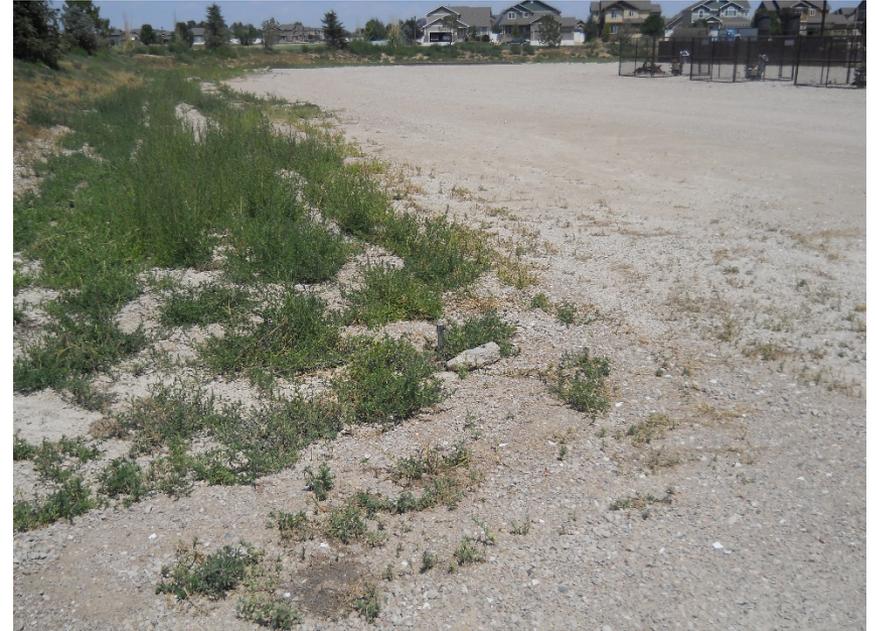
20) Unmarked anchor on southwest corner of entrance

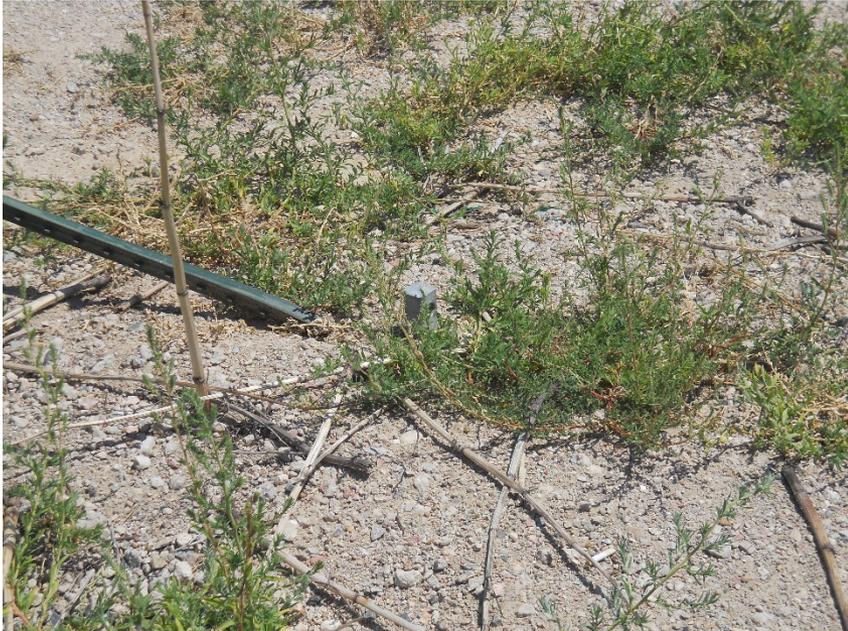
21) Unmarked anchor on northwest corner of location
