Inspection Photos
Location Name: Lambert 2
API: 05-001-08491

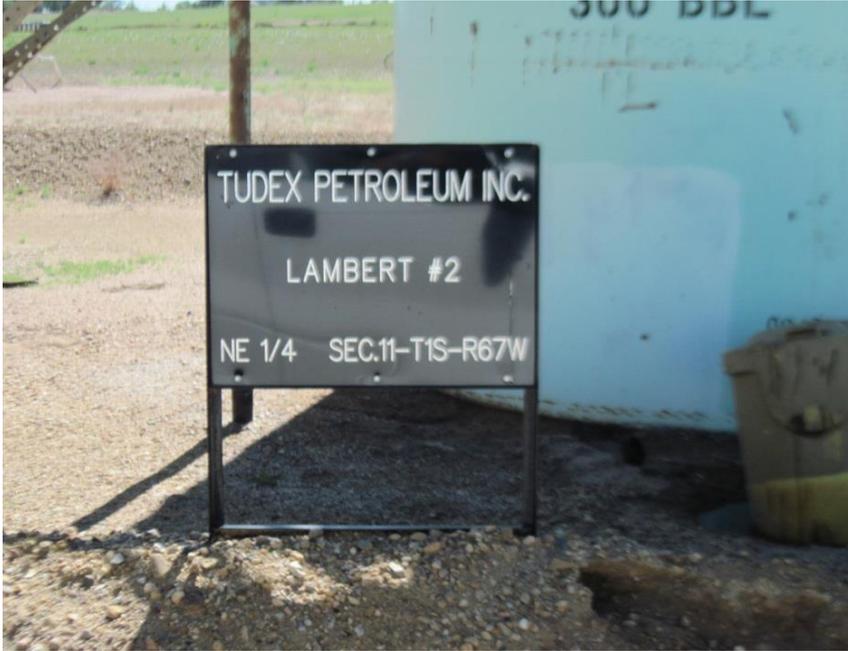
Battery signage from 6/20/2017 inspection, **Corrective action: No emergency contact info.**

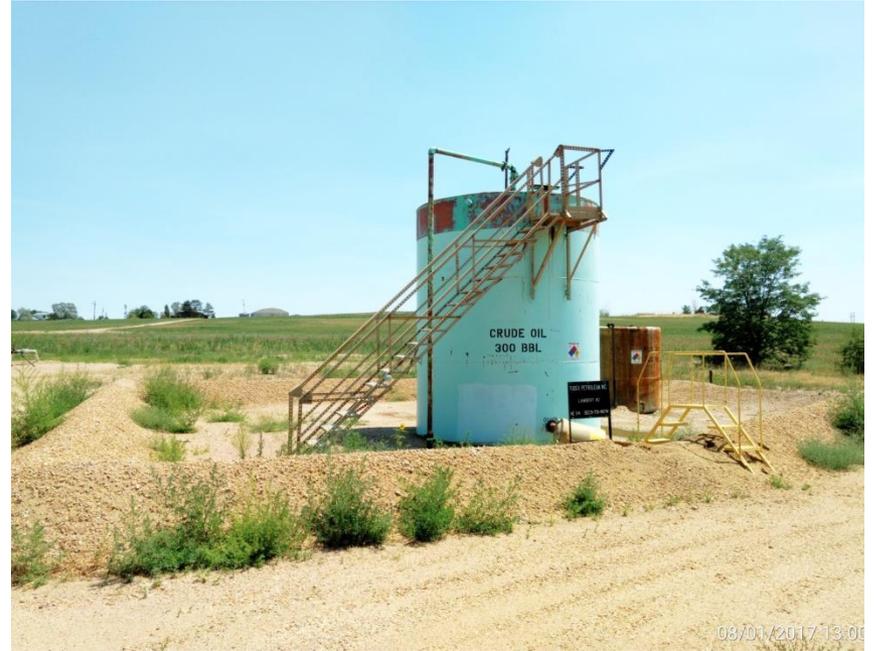
Battery signage, **Corrective action: No update on emergency contact info.**

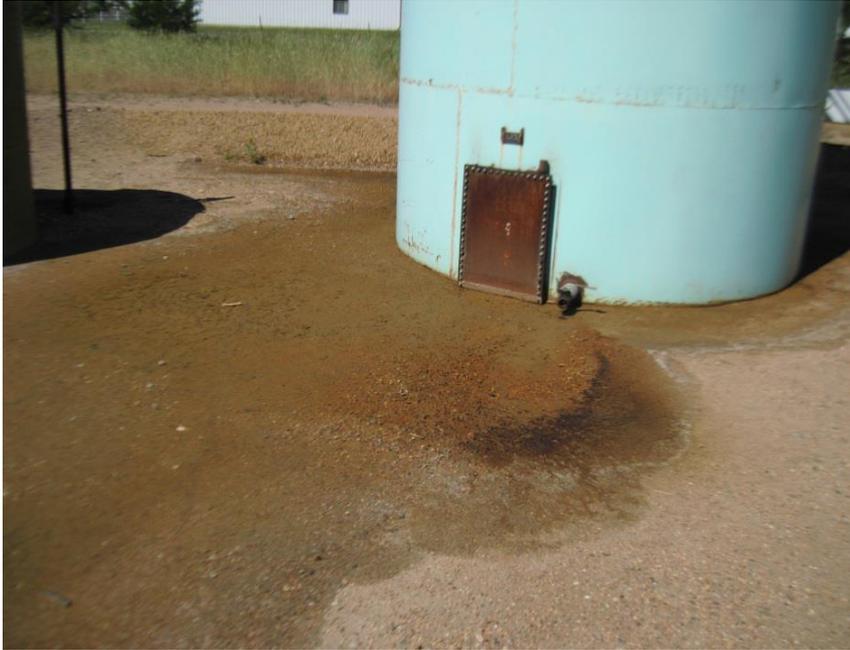
Inside oil/water tank berm, from 6/20/2017 inspection,
Corrective action: Stained soil.

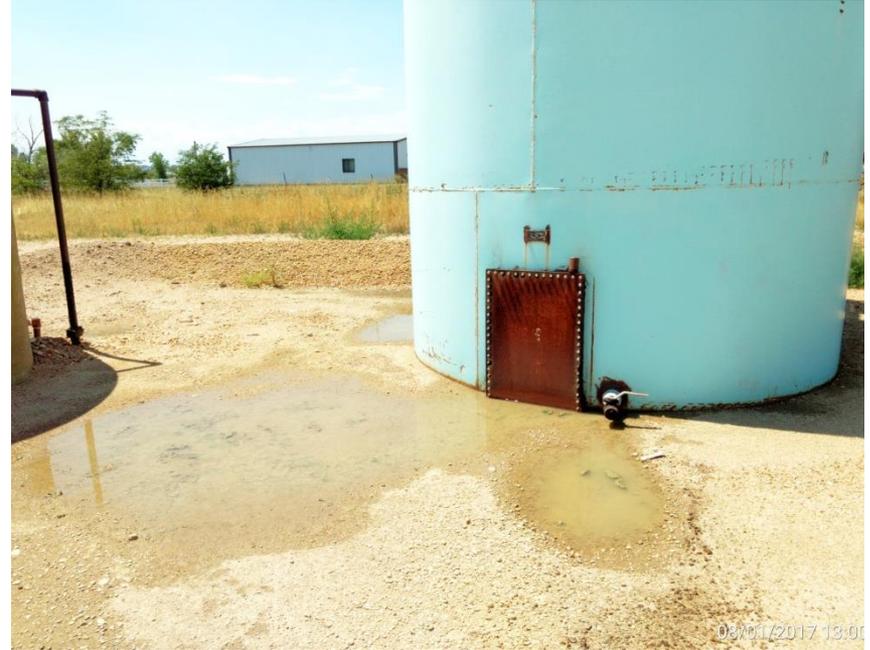
Inside oil/water tank berm, **Corrective action: Stained soil not remediated.**

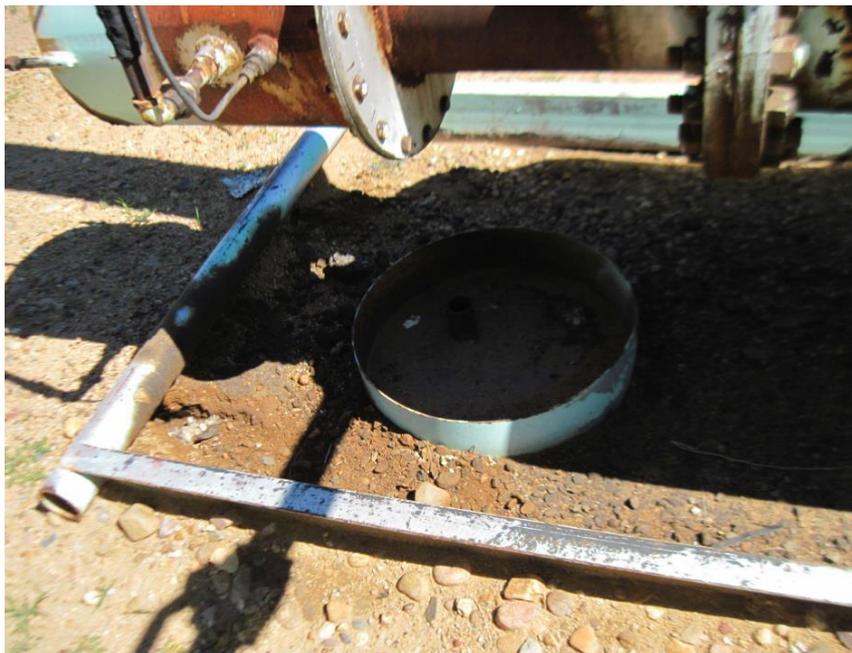
Separator, from 6/20/2017 inspection, **Corrective action: stained soil.**

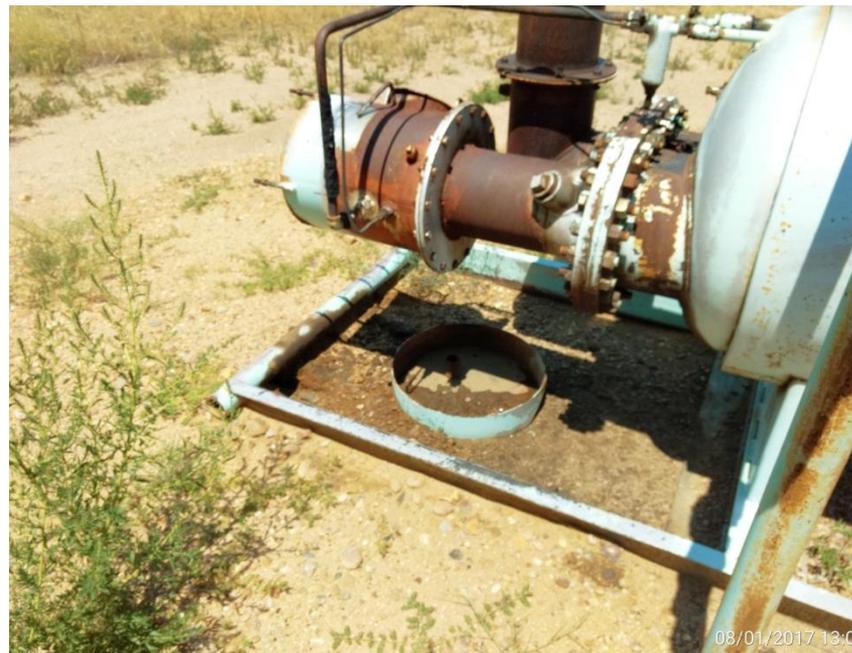
Separator fire tube, **Corrective action: stained soil not remediated.**

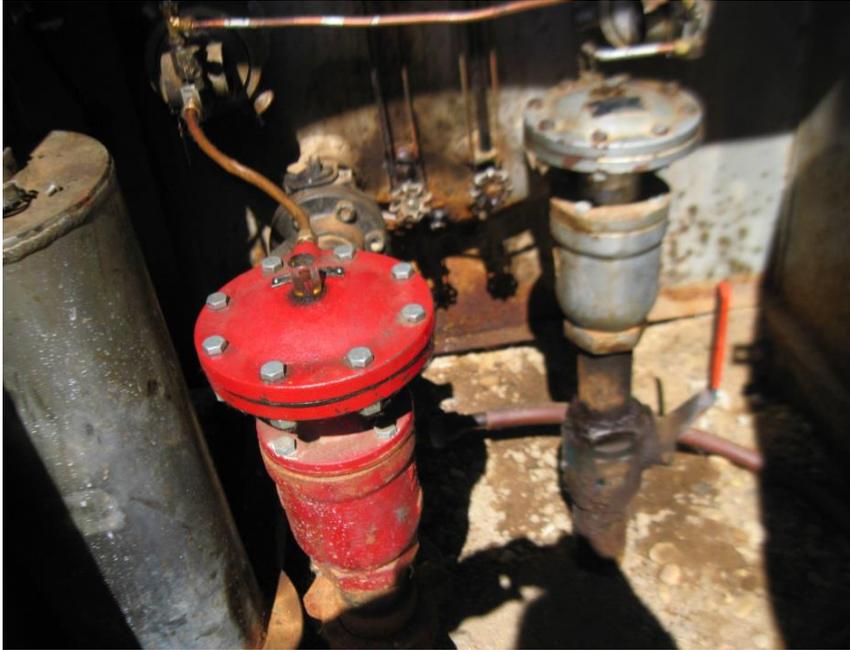
Separator cabinet from 6/20/2017 inspection, **Corrective action: stained soil, leaking dump line.**

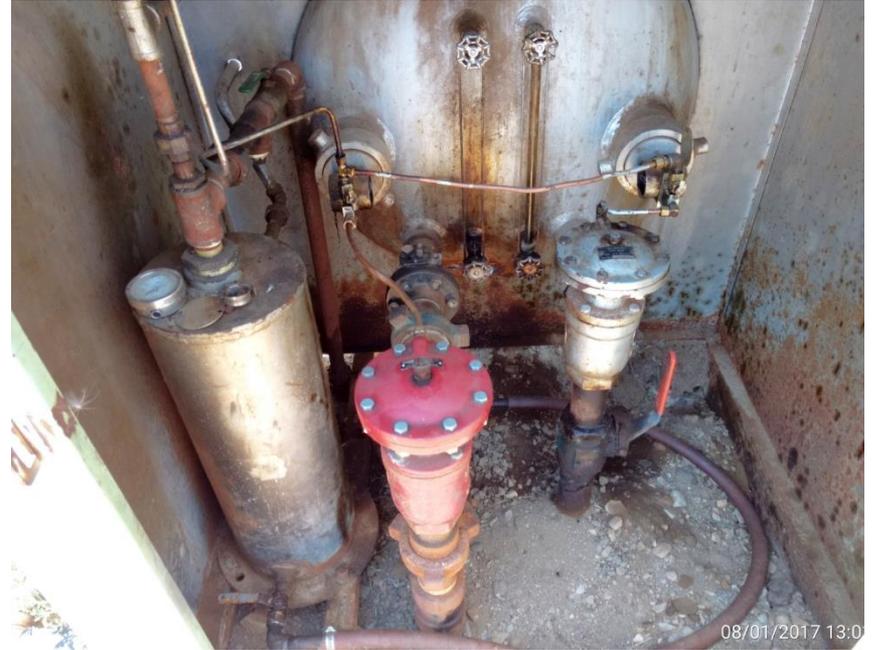
Separator cabinet, **Corrective action: Stained soil, leaking dump line.**

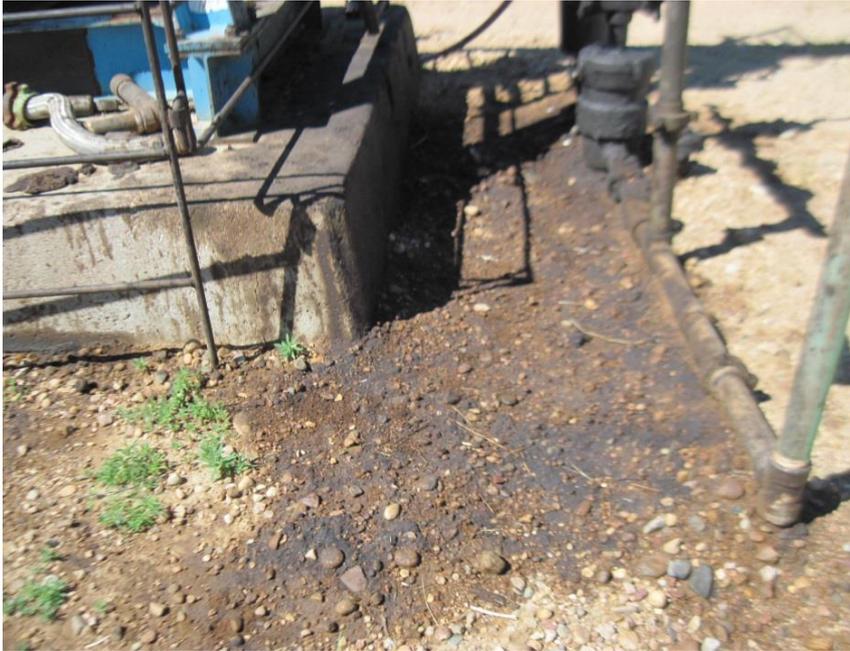
Wellhead from 6/20/2017 inspection, **Corrective action:**
Stained soil.

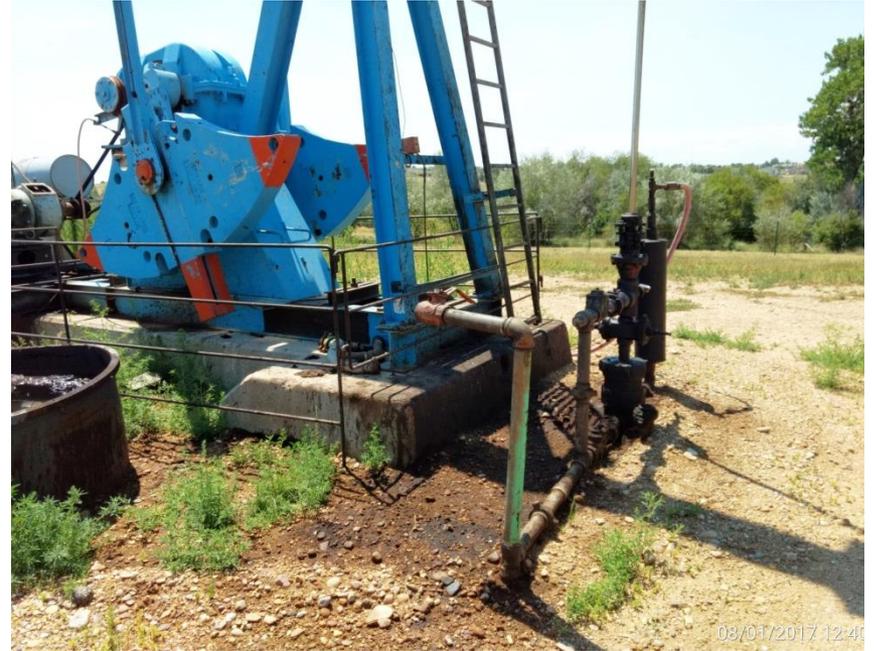
Weelhead, **Corrective action: Stained soil**

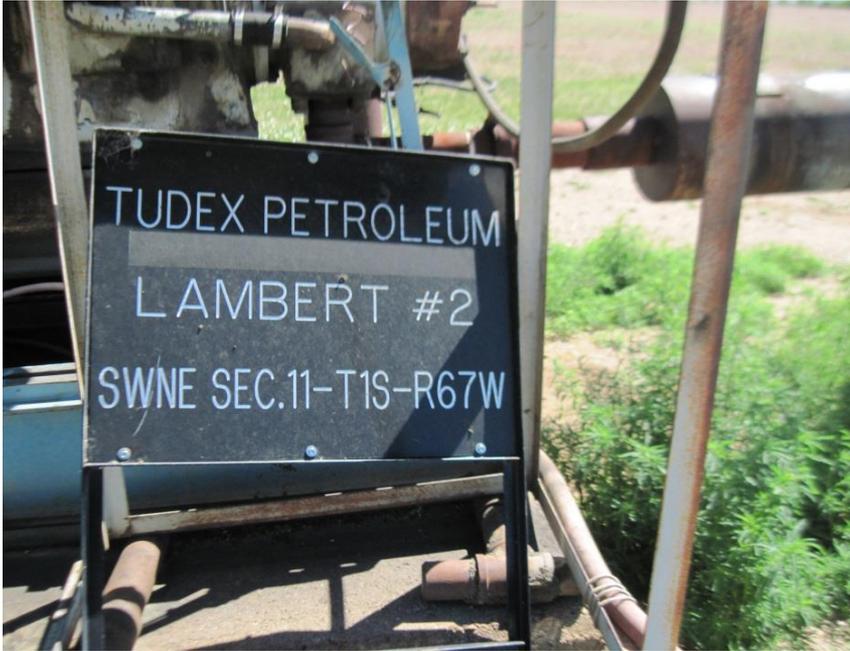
Wellhead signage from 6/20/2017 inspection, **Corrective action: No emergency contact info.**

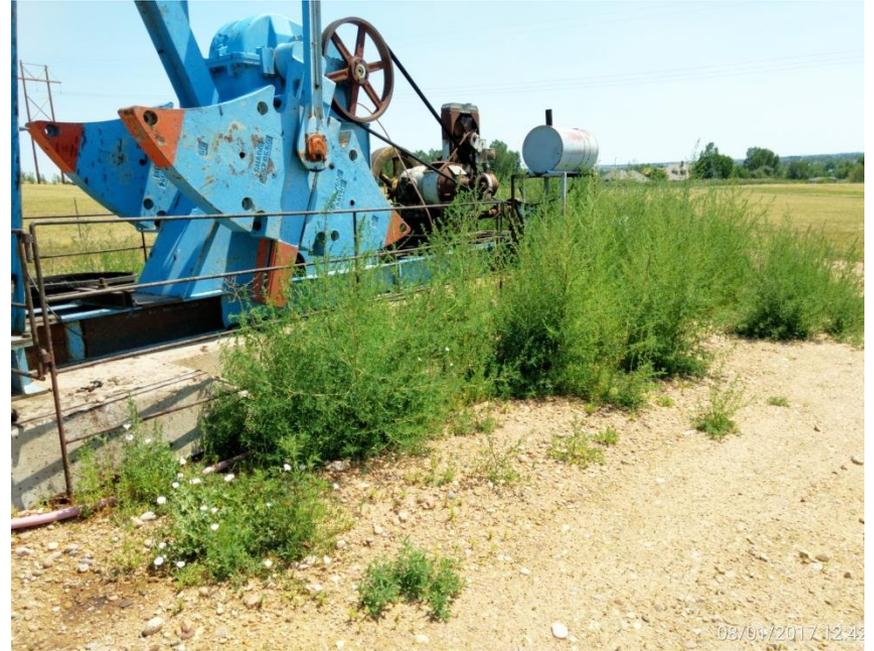
Wellhead, pumping unit, and prime mover, **Corrective action, no signage, overgrown weeds.**

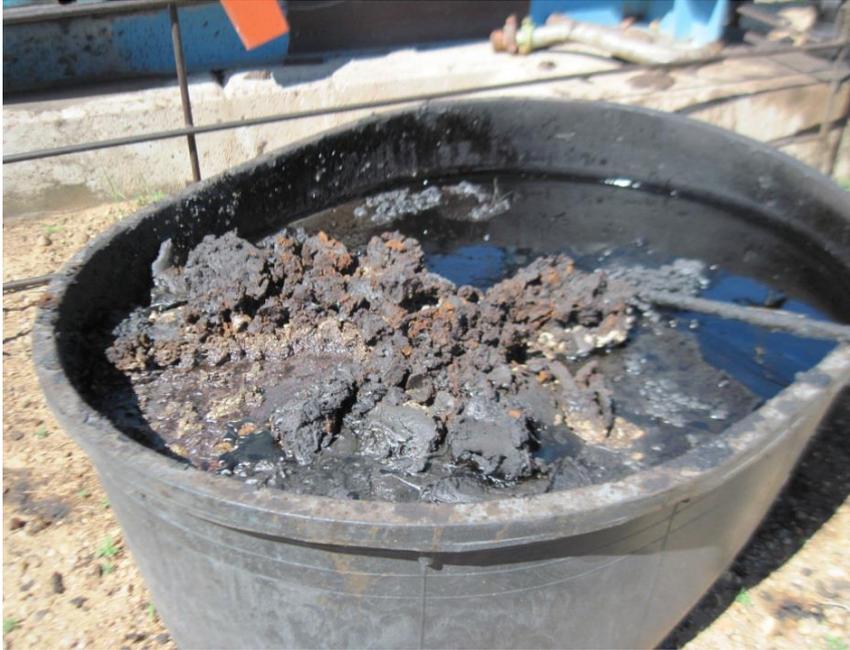
Pumping unit from 6/20/2017 inspection, **Corrective action: fittings and container full of paraffin.**

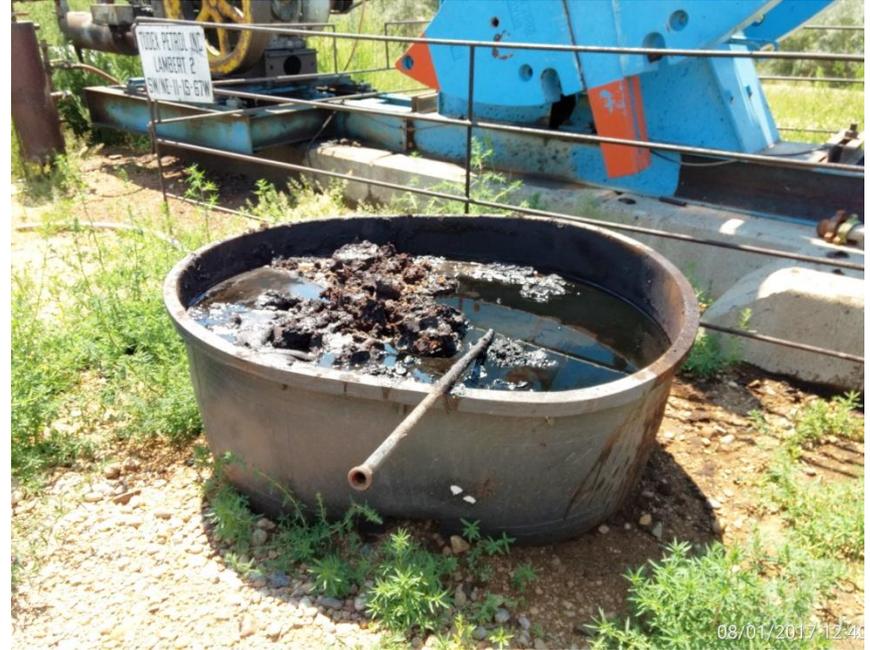
Pumping unit, **Corrective action: Container full of paraffin and fittings not remediated.**

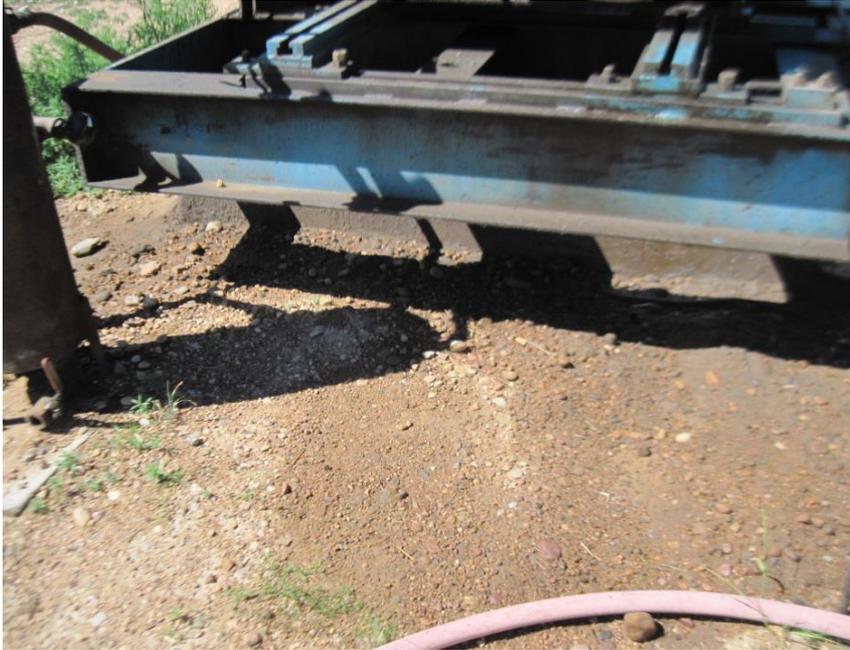
Pumping unit from 6/20/2017 inspection, **Corrective action:**
Stained soil around engine mounts and frame.

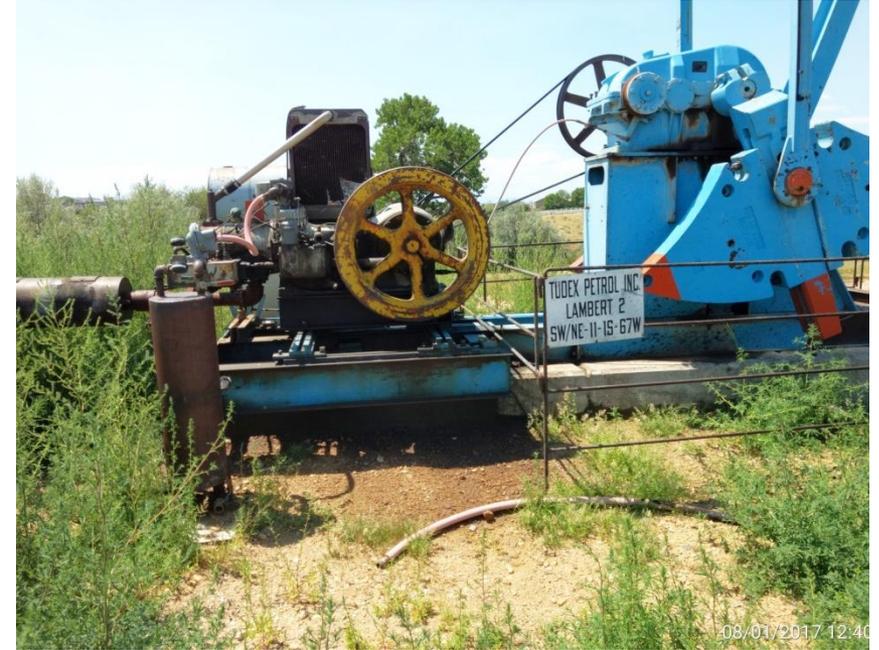
Pumping unit, **Corrective action:** **Stained soil around prime mover and pumping unit frame not remediated.**

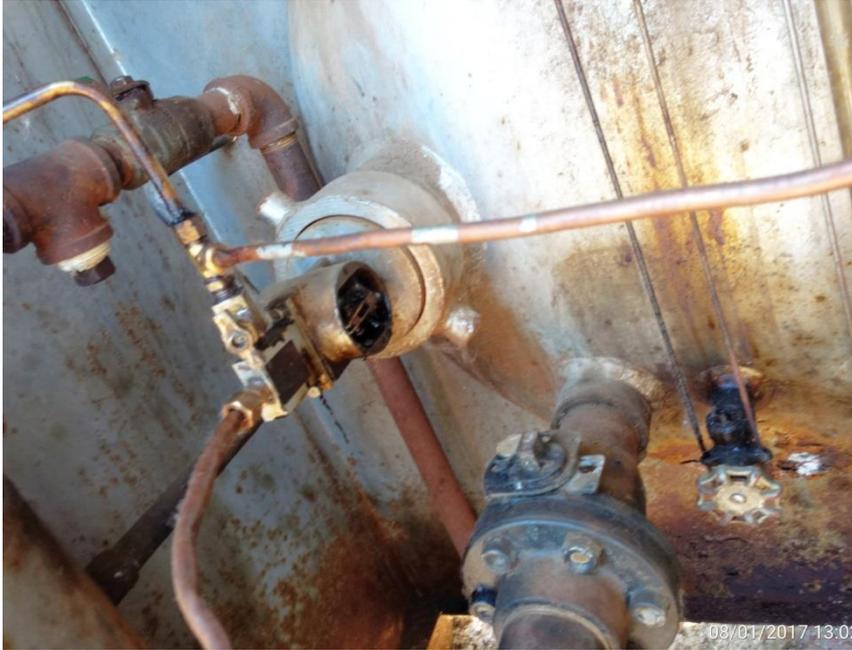
Separator Cabinet: **Corrective action: Visible leak on dump valve**

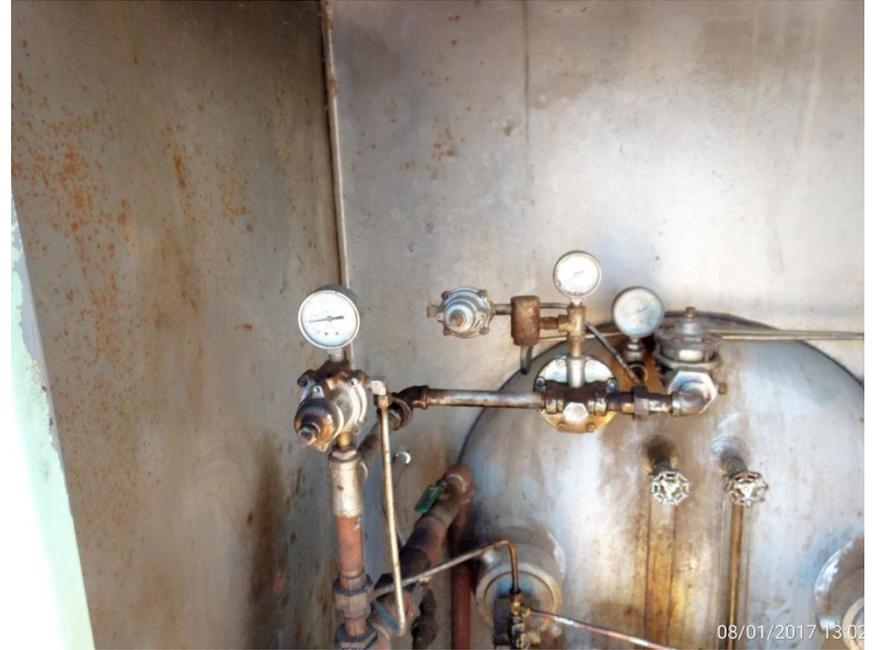
Separator cabinet, audible leak on scrubber pot, note pressure gauge.

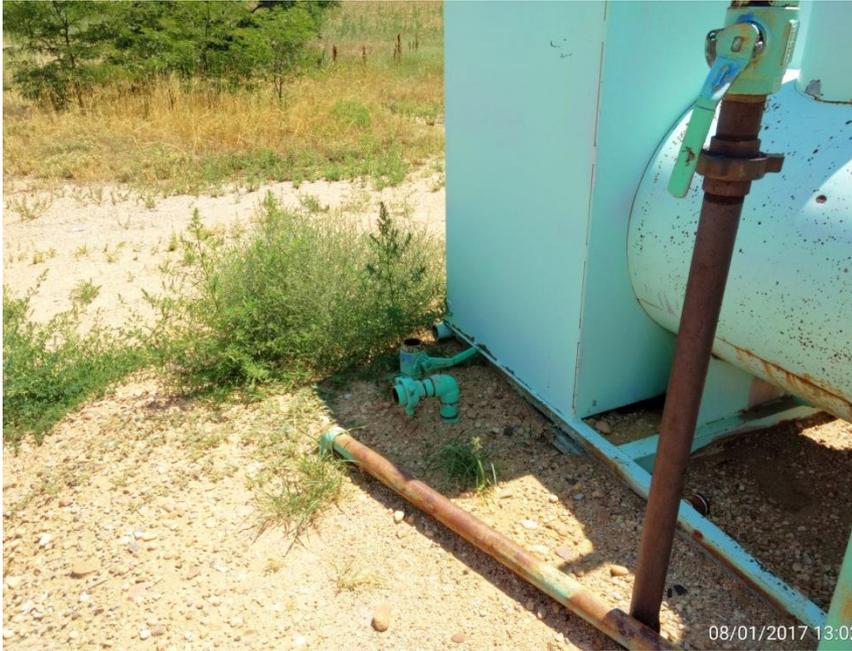
Unidentified risers at separator (2)
39.984927, -104.855866

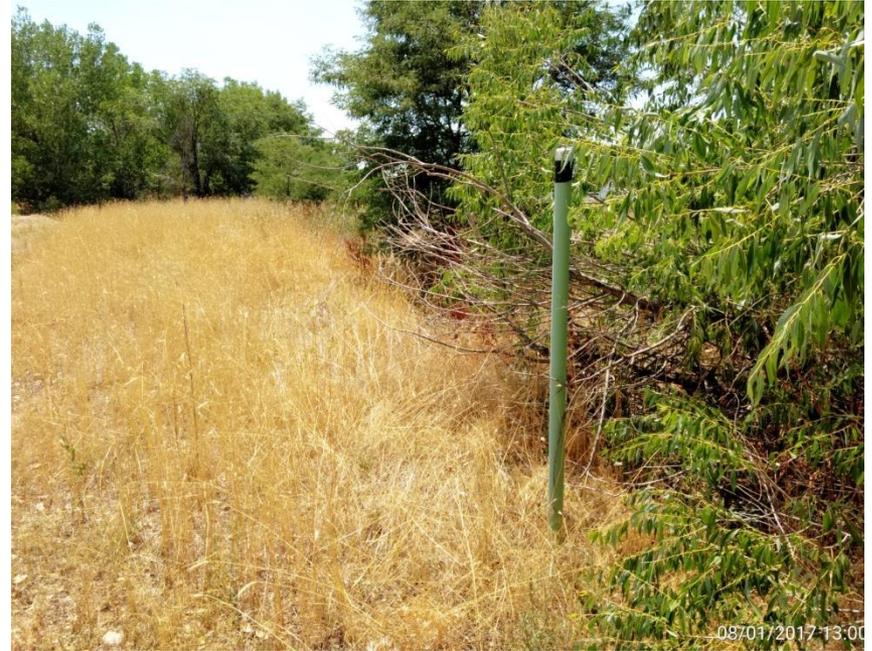
Unidentified riser at battery entrance (1)
39.985259, -104.856076

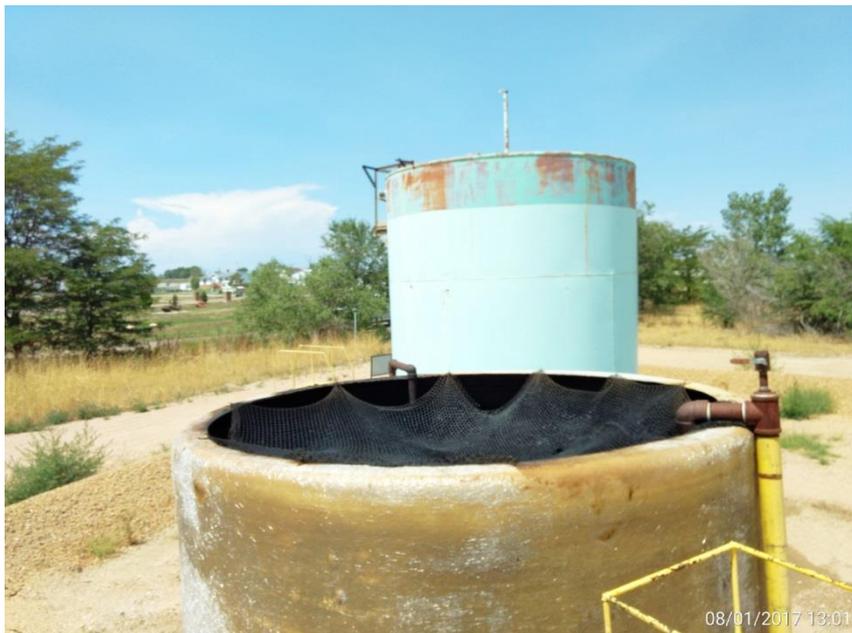
Water tank, **Corrective action: netting on open top ineffective.**
